## APPENDIX B2

### SADDLE DAM 1 PHOTOGRAPHIC LOG

PROJECT  
2017 ANNUAL GEOTECHNICAL INSPECTION  
MEADOWBANK GOLD MINE, NUNAVUT

TITLE  
**STORMWATER DIKE**

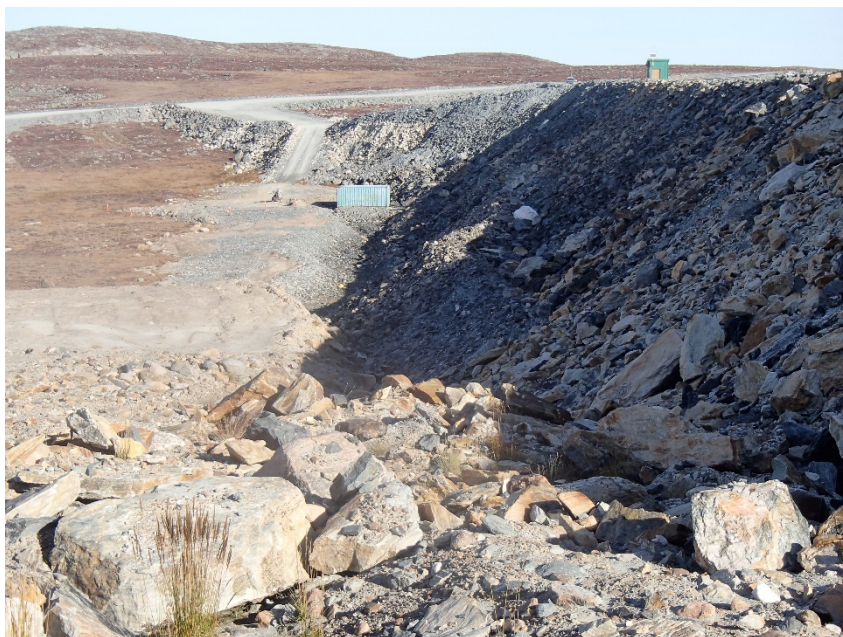
*Photograph B2-1 Saddle Dam 1*

**Description:** From the south abutment (Sta. 0+350) looking north at the downstream face. Notice the sea-can container where a sump is installed.

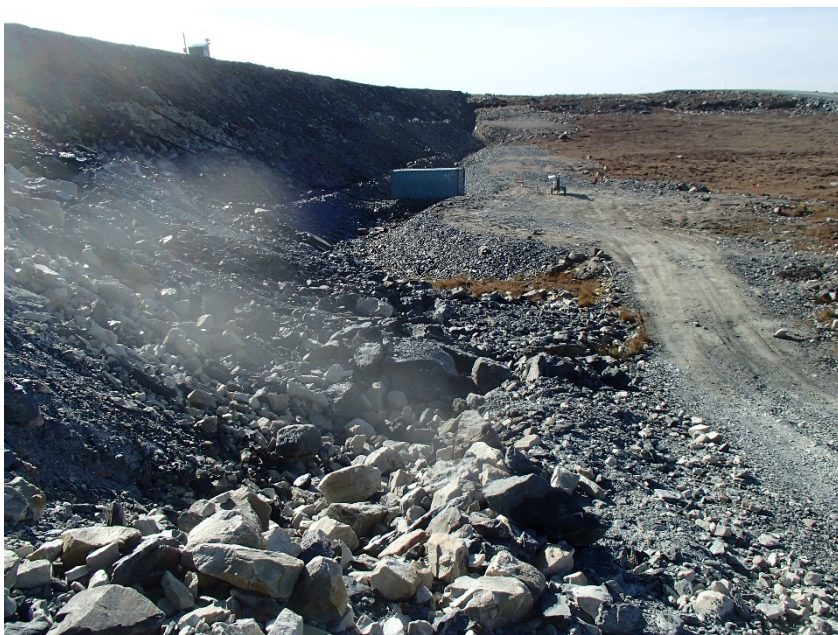
*Photograph B2-2 Saddle Dam 1*

**Description:** From Sta. 0+150 looking south at the downstream face. Notice the sea-can container where a sump is installed.

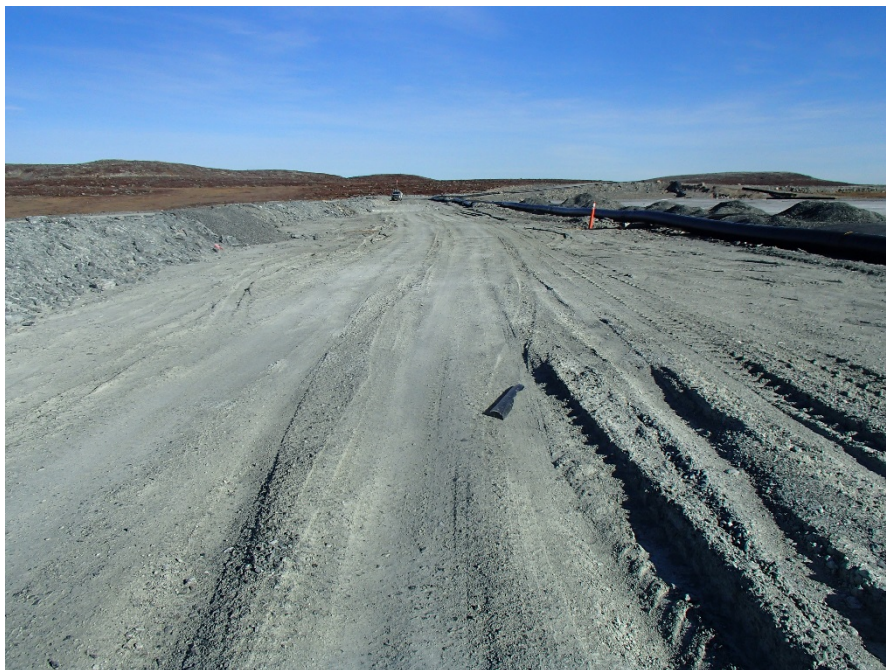
*Photograph B2-3 Saddle Dam 1*

**Description:** From approximately Sta. 0+225, looking north at the crest.

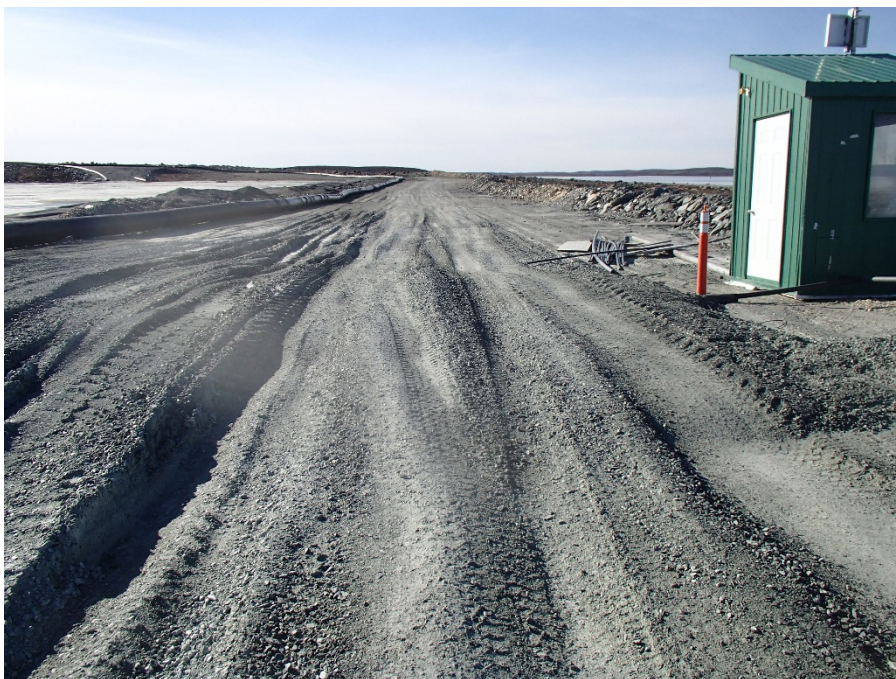
*Photograph B2-4 Saddle Dam 1*

**Description:** From approximately Sta. 0+225, looking south at the crest.

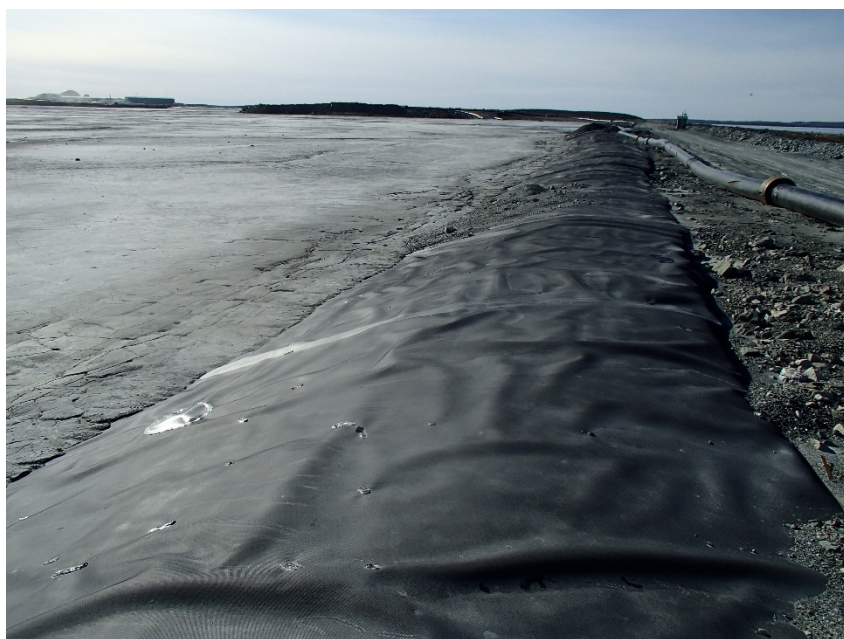
*Photograph B2-5 Saddle Dam 1*

**Description:** From approximately Sta. 0+055, looking south at the crest and upstream slope.

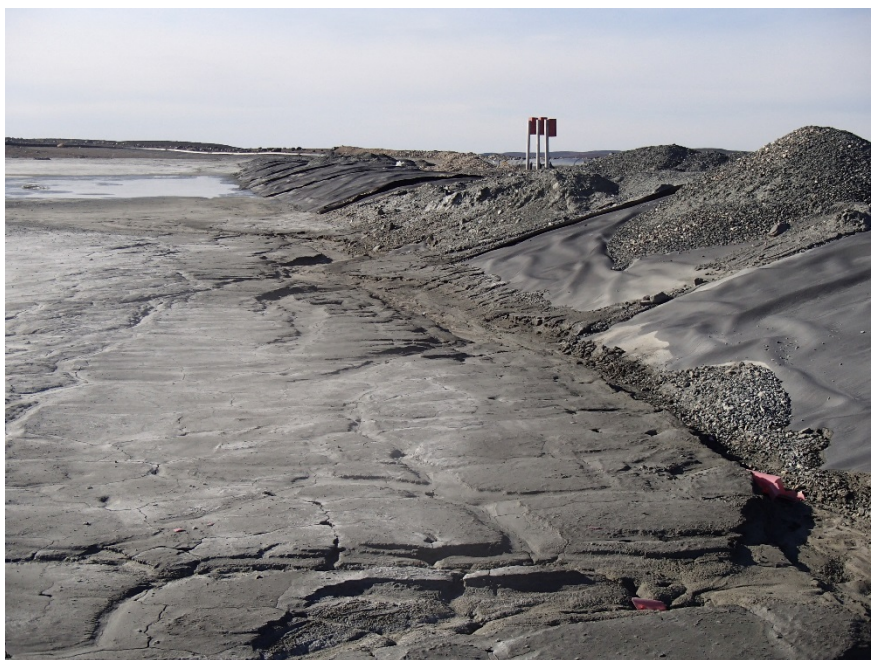
*Photograph B2-6 Saddle Dam 1*

**Description:** From approximately Sta. 0+195 upstream, looking south at the upstream slope. Adequate tailings beach against SD1. A small pond of water is present at the surface of the tailings and is not a concern.

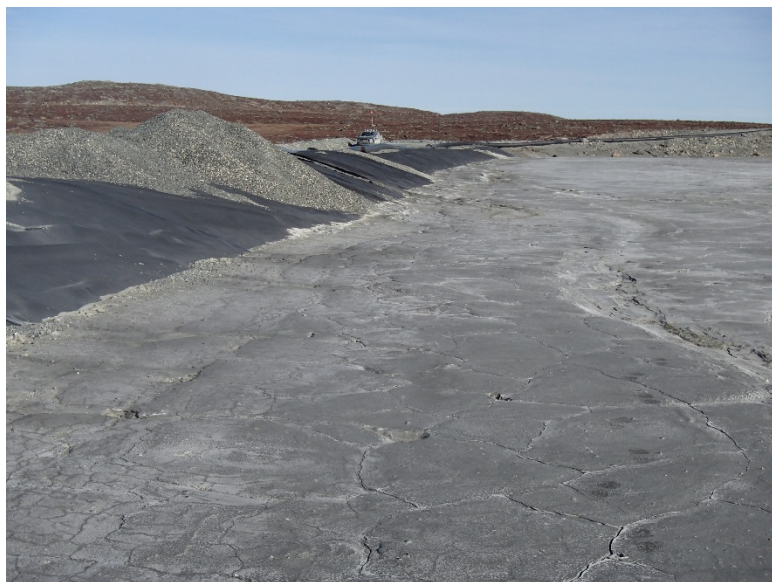
*Photograph B2-7 Saddle Dam 1*

**Description:** From approximately Sta. 0+195 upstream, looking north at the upstream slope. Adequate tailings beach against SD1.

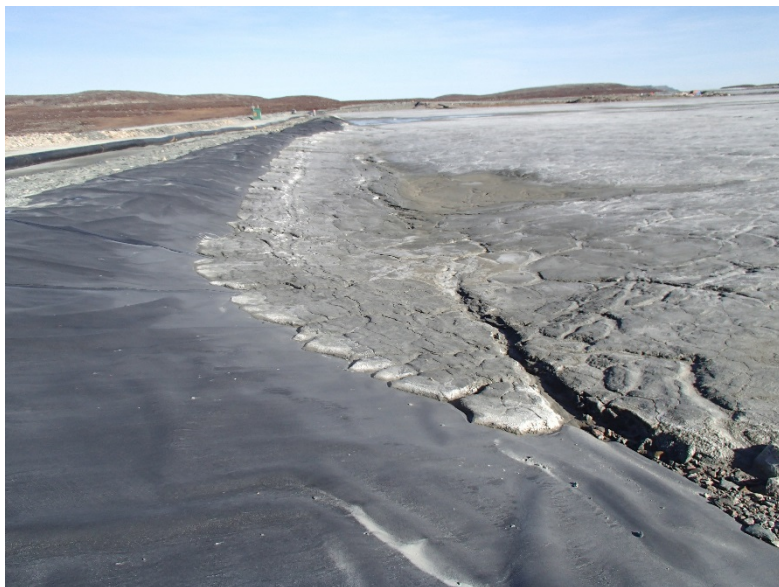
*Photograph B2-8 Saddle Dam 1*

**Description:** From the south abutment looking north at the upstream slope. Adequate tailings beach against SD1.

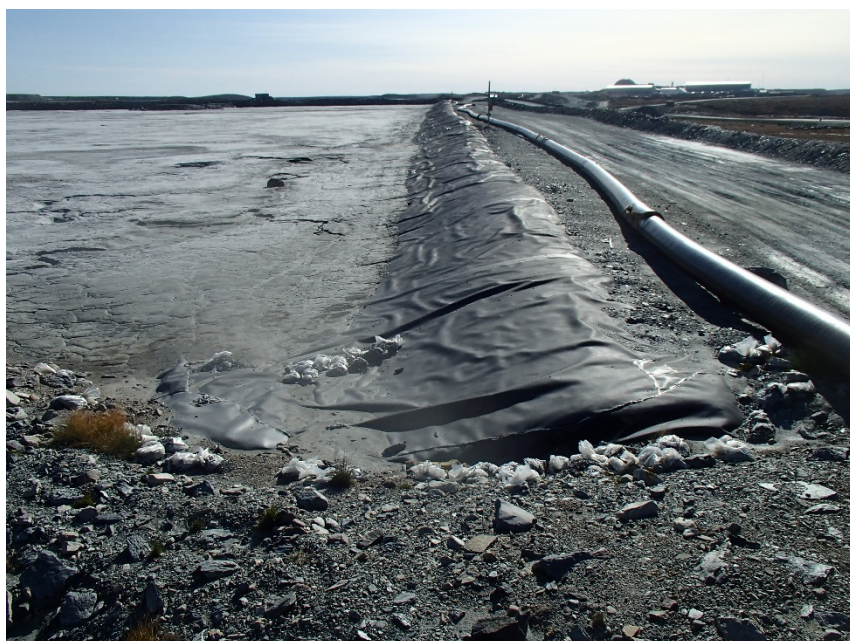
*Photograph B3-1 Saddle Dam 2*

| INSPECTION ITEM | OBSERVATIONS DATA | PHOTO | COMMENTS & OTHER DATA |
|---|---|---|---|
| 1.3 Distance to tailings pond (if applicable) | >200 m | | Adequate tailings beach |

**Description:** From Saddle Dam 2 (approximately Sta. 20+110) looking southeast at the crest and upstream slope of Saddle Dam 2. The tailings beach against SD2 is adequate.

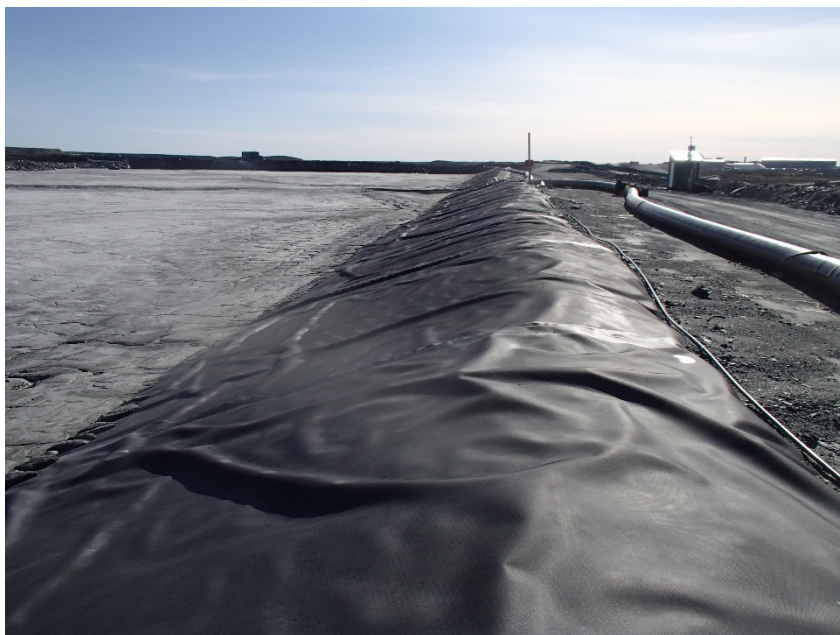
*Photograph B3-2 Saddle Dam 2*

**Description:** From approximately Sta. 20+370 looking southeast at the crest and upstream slope.

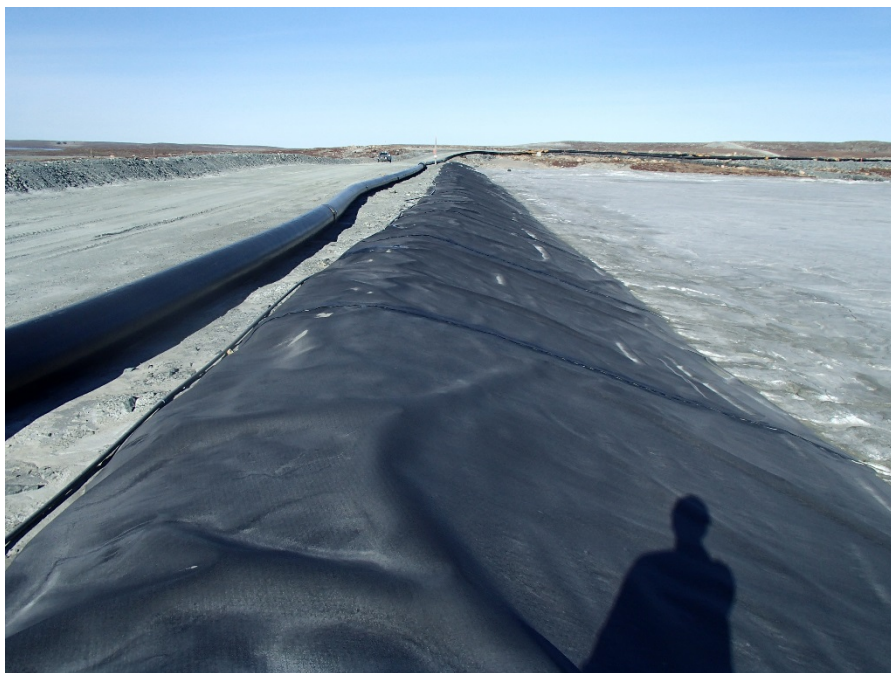
*Photograph B3-3 Saddle Dam 2*

**Description:** From approximately Sta. 20+370 looking northwest at the crest and upstream slope.

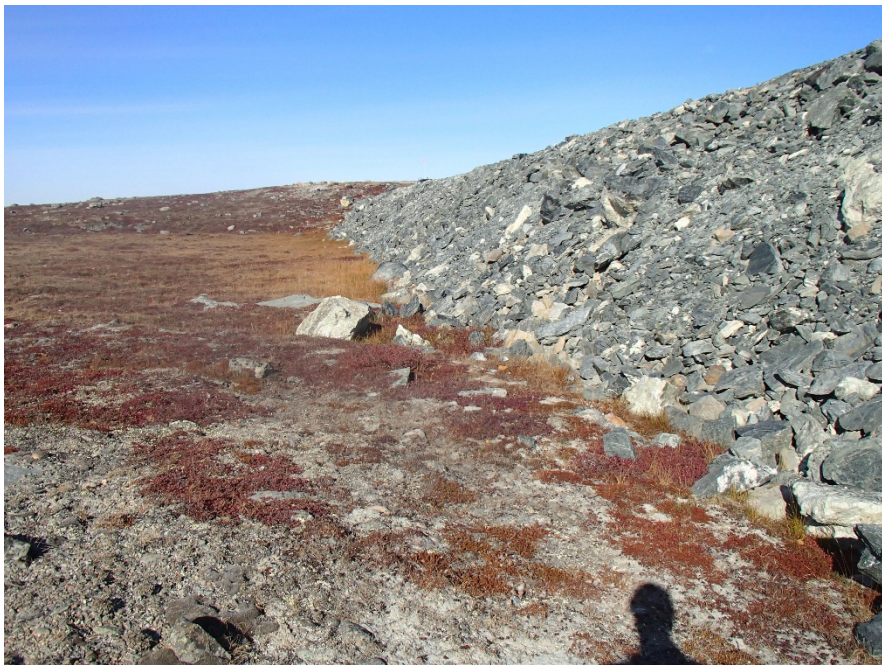
*Photograph B3-4 Saddle Dam 2*

| INSPECTION ITEM | OBSERVATIONS DATA | PHOTO | COMMENTS & OTHER DATA |
|---|---|---|---|
| 4.6 Other unusual conditions | Yes | | Water is still ponding within the rockfill embankment between 20+275 to 20+475 approximately. |

**Description:** From approximately Sta. 20+210 downstream, looking northwest at the downstream toe.

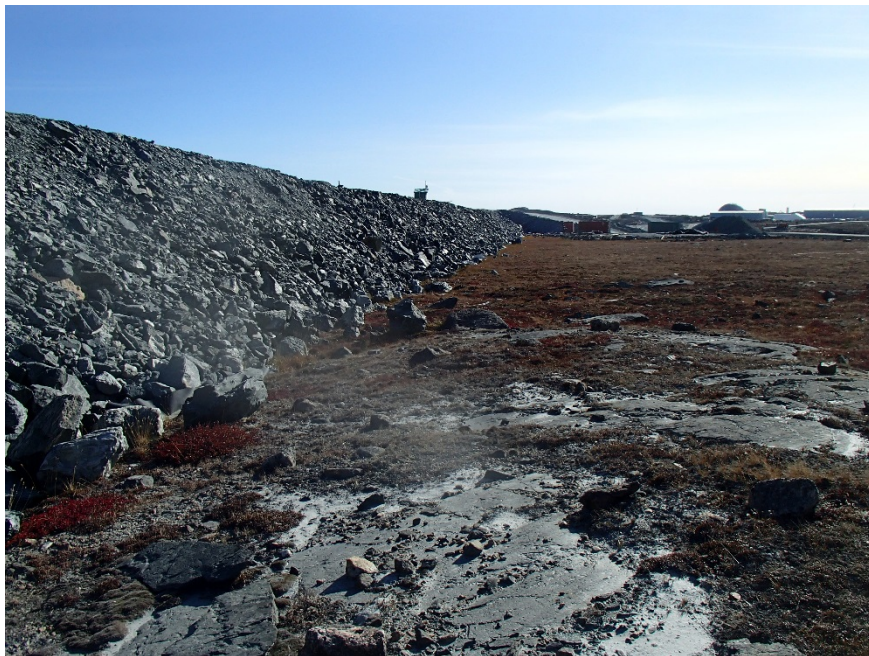
*Photograph B3-5 Saddle Dam 2*

**Description:** From approximately Sta. 20+210 downstream, looking southeast at the downstream toe.

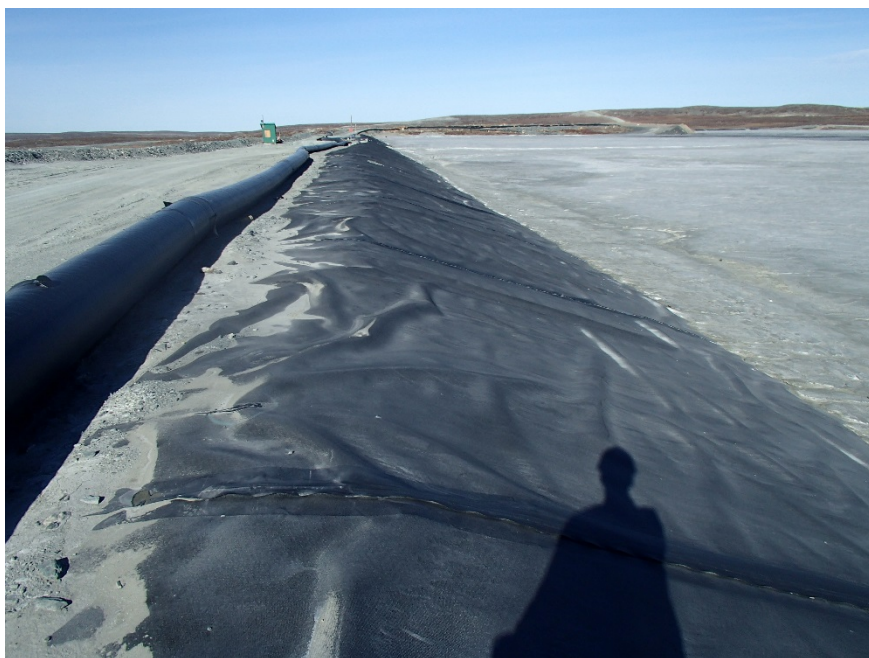
*Photograph B3-6 Saddle Dam 2*

**Description:** From approximately Sta. 20+525, looking northwest at the crest.

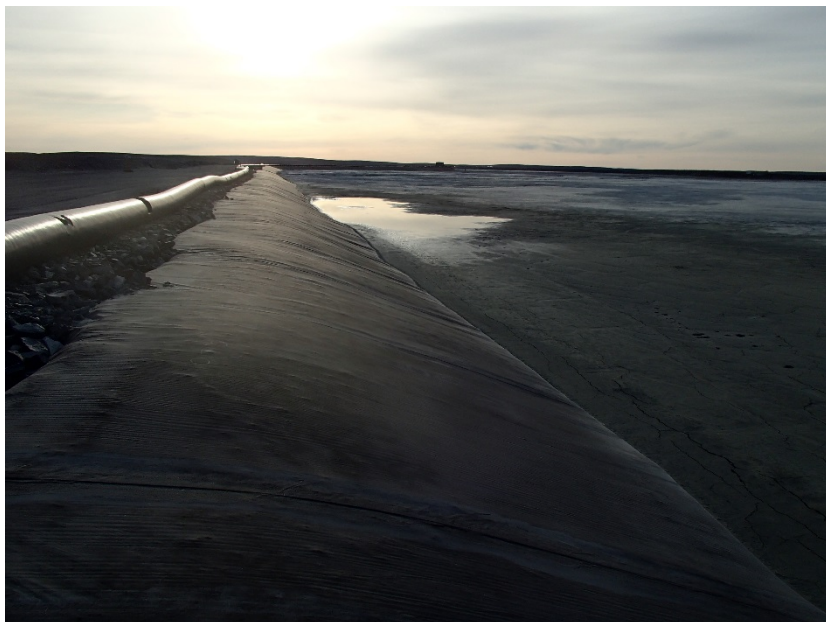
*Photograph B4-1 Stormwater Dike*

| INSPECTION ITEM | OBSERVATIONS DATA | PHOTO | COMMENTS & OTHER DATA |
|---|---|---|---|
| 1.3 Distance to tailings pond (if applicable) | Adequate (North Cell) | | Adequate beach in place all along the dike on North Cell. Some shallow water ponding against dike in some places (from 10+550 to 10+950 approximately).<br>Water has reached the toe of the structure in the South Cell. |

**Description:** From the east abutment (11+100 approximately), looking west at the upstream face. Shallow water ponding against portion of the dike (less than 30 cm deep). The tailings beach is considered adequate.

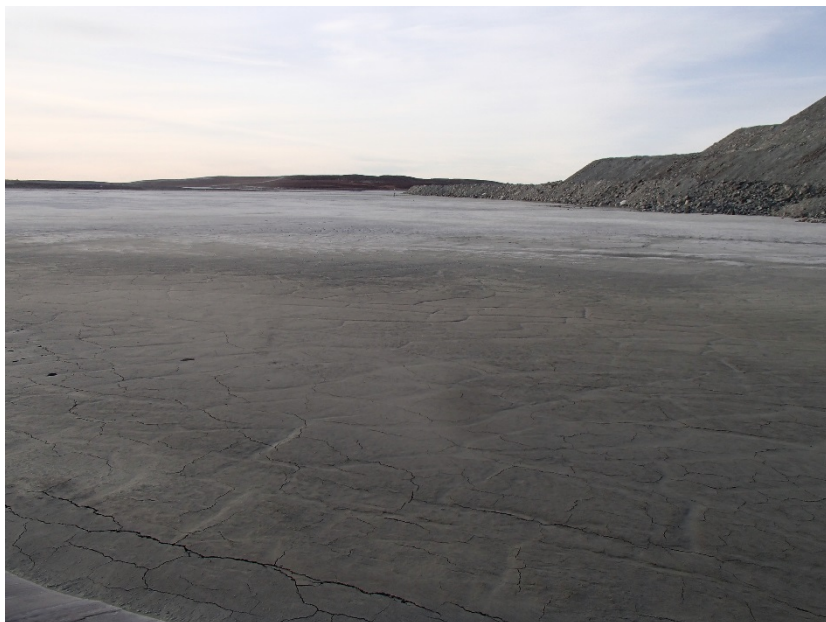
*Photograph B4-2 Stormwater Dike*

**Description:** From the east abutment (11+100 approximately), looking northwest at the North Cell.

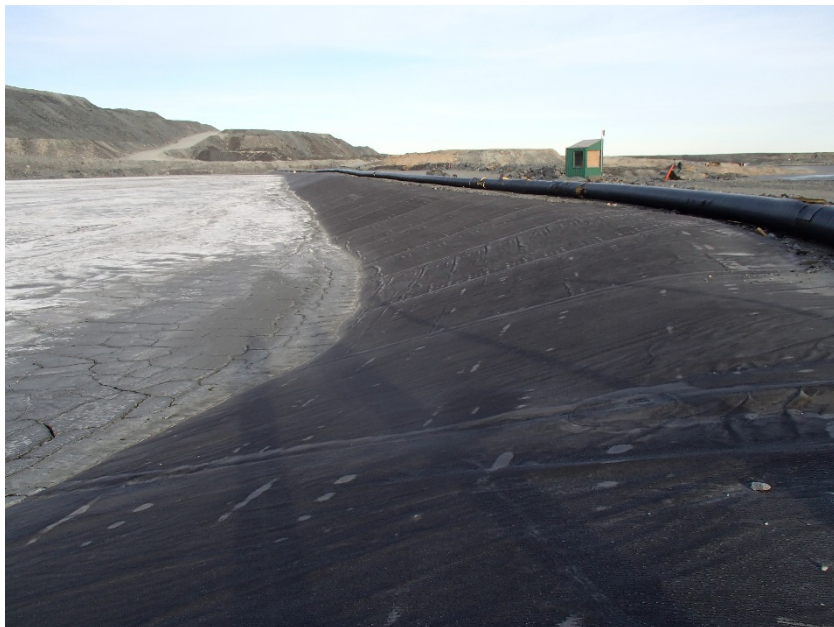
*Photograph B4-3 Stormwater Dike*

**Description:** From Sta. 10+650 looking east at the upstream slope. Adequate tailings beach.

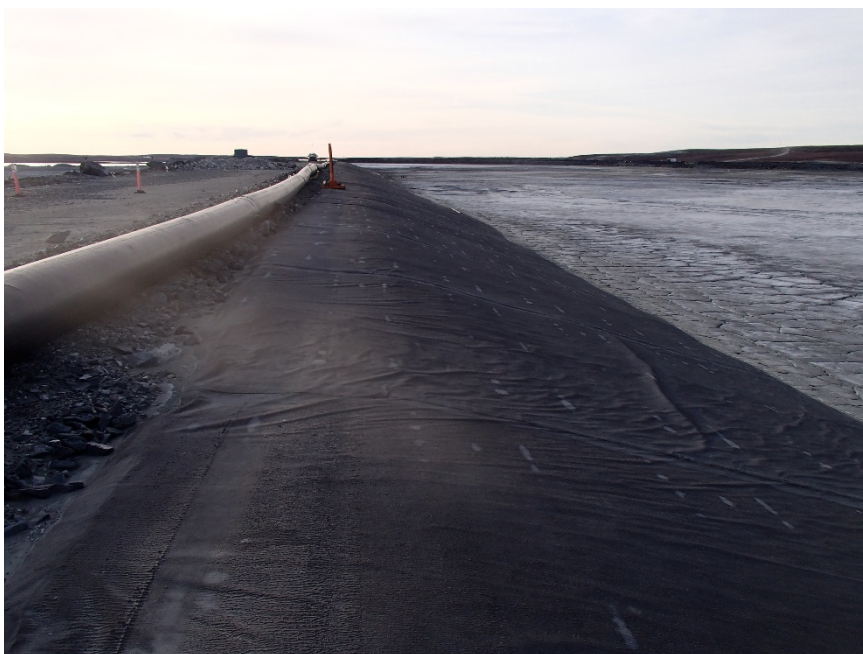
*Photograph B7-4 Stormwater Dike*

**Description:** From Sta. 10+650 looking west at the upstream slope. Shallow water against portion of Stormwater Dike. The tailings beach is adequate.

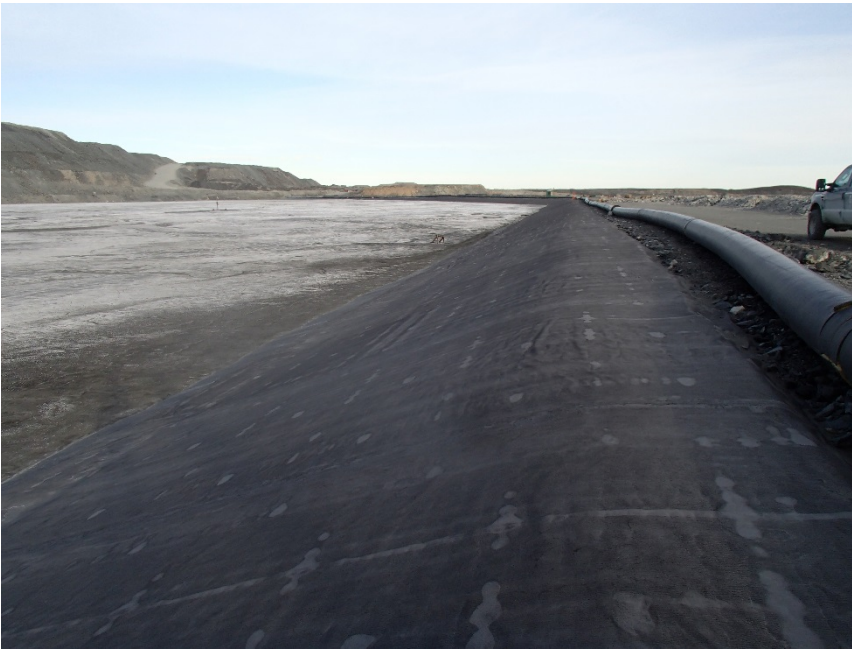
*Photograph B7-5 Stormwater Dike*

**Description:** From approximately Sta. 10+450 looking east at the upstream slope. Adequate tailings beach.

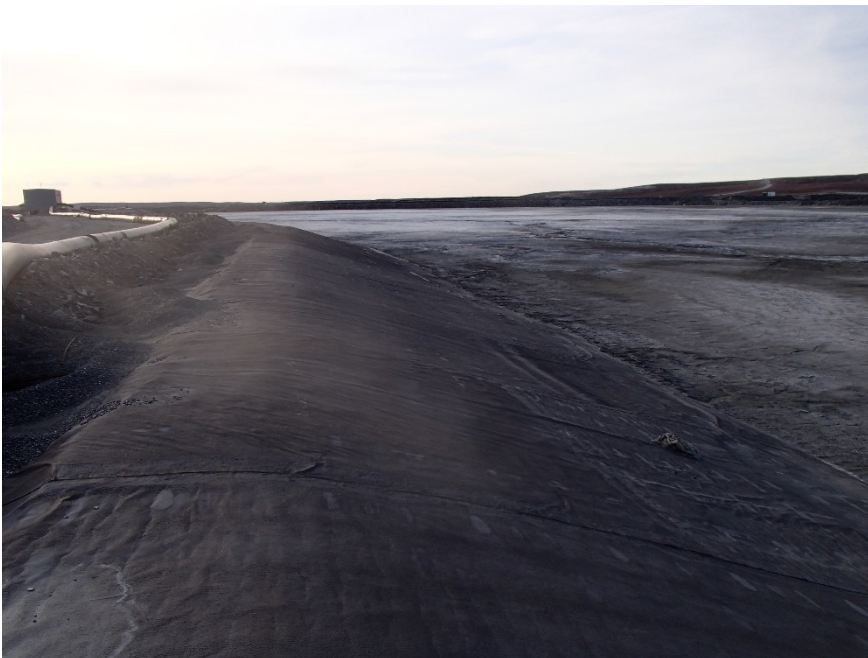
*Photograph B7-6 Stormwater Dike*

**Description:** From approximately Sta. 10+450 looking west at the upstream slope. Adequate tailings beach.

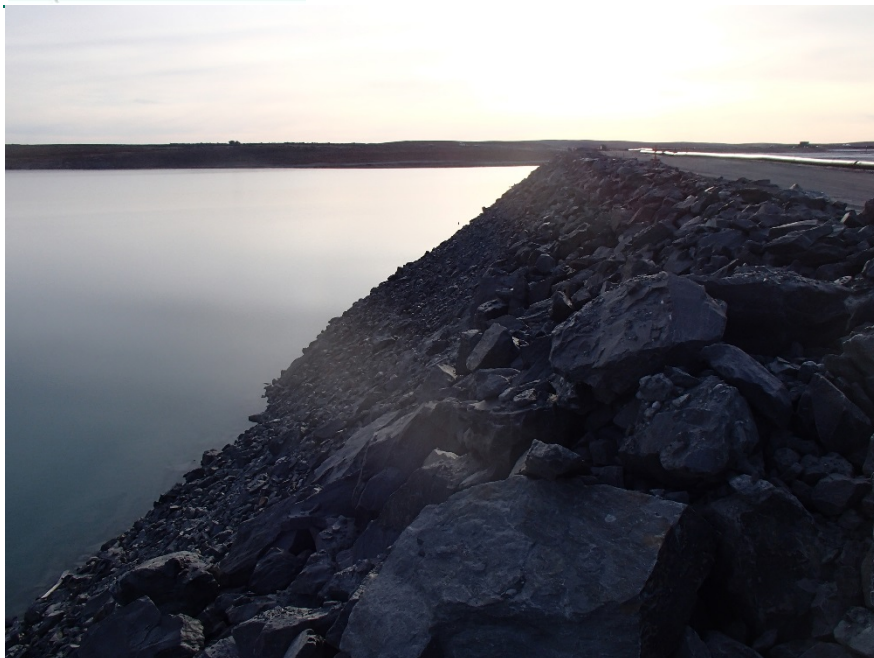
*Photograph B7-7 Stormwater Dike*

**Description:** From approximately Sta. 11+075, looking southwest at the downstream slope. Oblique tension fractures extending from side to side of the dike are present in this zone.

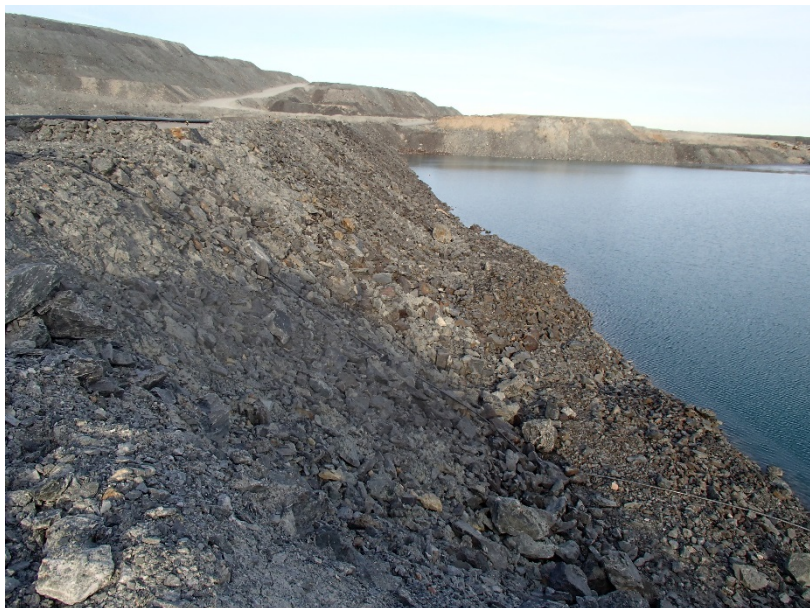
*Photograph B7-9 Stormwater Dike*

**Description:** From Sta.10+650, looking east at the crest and the downstream slope.

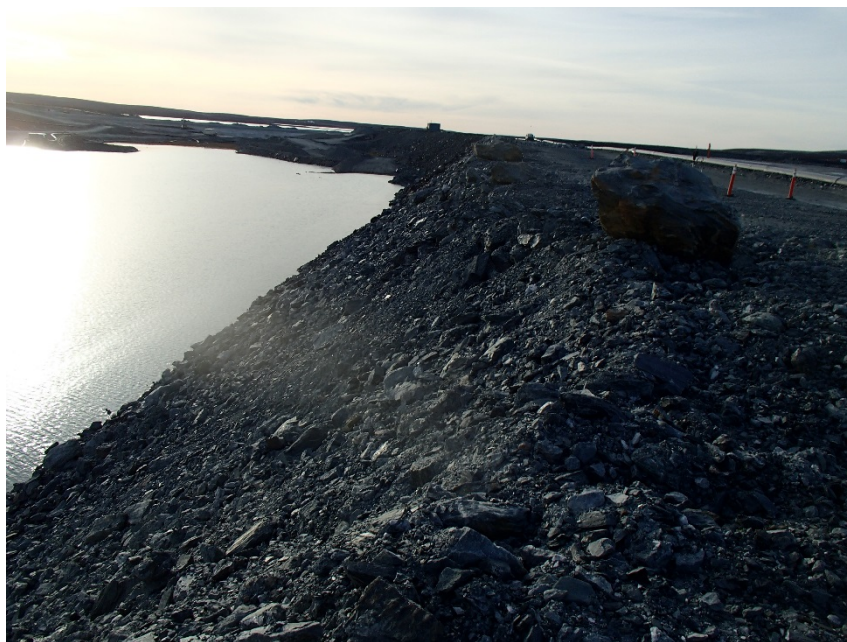
*Photograph B7-10 Stormwater Dike*

| INSPECTION ITEM | OBSERVATIONS DATA | PHOTO | COMMENTS & OTHER DATA |
|---|---|---|---|
| <b>4. DOWNSTREAM TOE AREA</b> | Not visible | | Downstream toe and berm is submerged by the South Cell pond. The berm was constructed at the downstream toe to stabilise the movement and cracks observed in 2016. |

**Description:** From Sta.10+650, looking west at the crest and the downstream slope. A stabilization buttress was built to stabilize the movement of the dike.

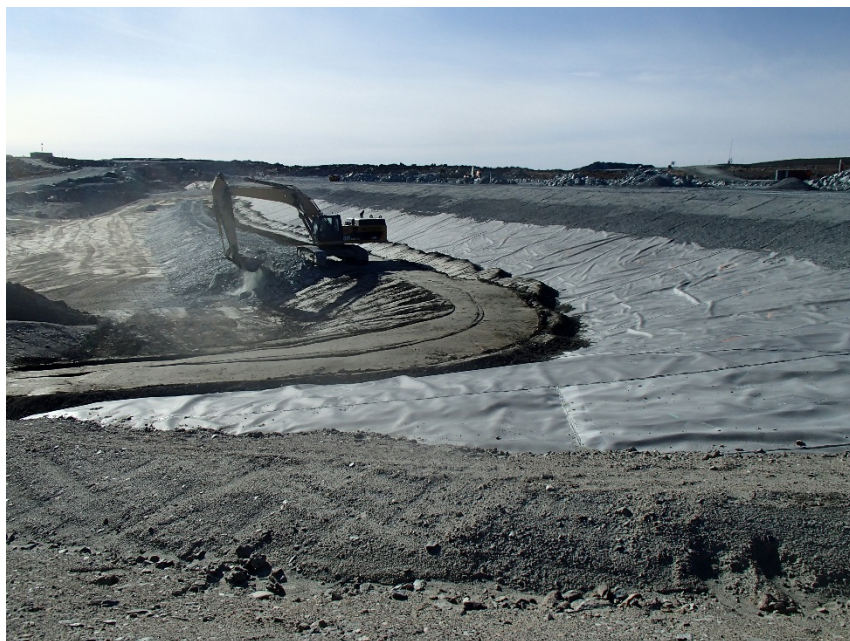
*Photograph B5-1 Saddle Dam 3*

**Description:** From approximately Sta. 20+610 looking south at the upstream slope.

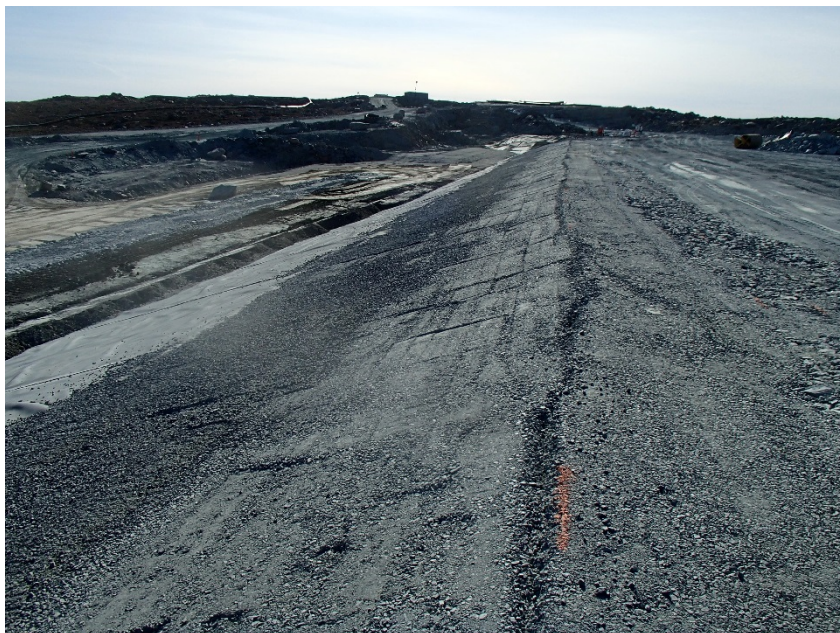
*Photograph B5-3 Saddle Dam 3*

**Description:** From Sta. 20+700, looking southeast at the crest and the upstream slope.
