## APPENDIX B5 SADDLE DAM 2 PHOTOGRAPHIC LOG

2017 ANNUAL GEOTECHNICAL INSPECTION  
MEADOWBANK GOLD MINE, NUNAVUT

## APPENDIX B6 RECORD OF DAM INSPECTION

**Client:** AEM **By:** Yves Boulianne  
**Project:** Meadowbank **Date:** September 13, 2017  
**Location:** Saddle Dam 4 **Reviewed:** Yves Boulianne

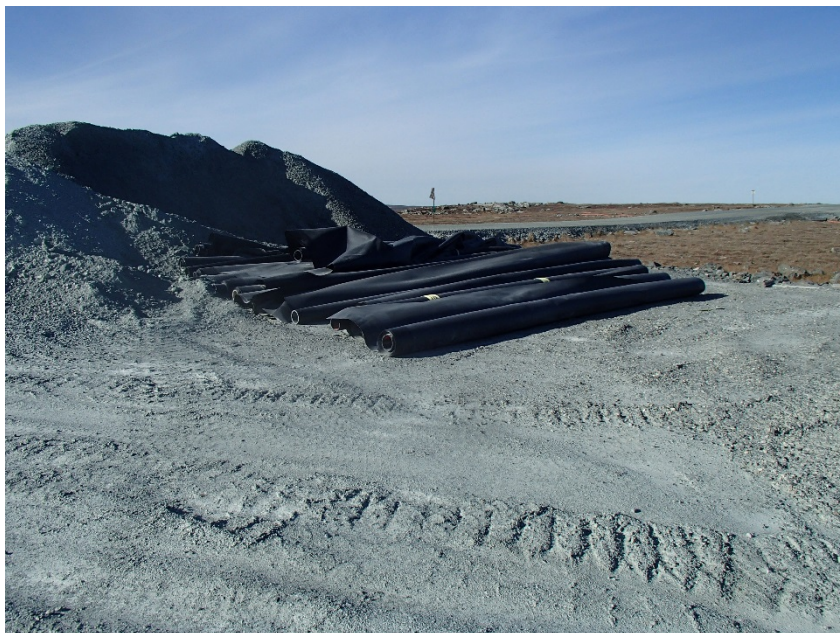
*Photograph B5-5 Saddle Dam 3*

**Description:** LLDPE stored directly on the ground on the downstream side of SD3.

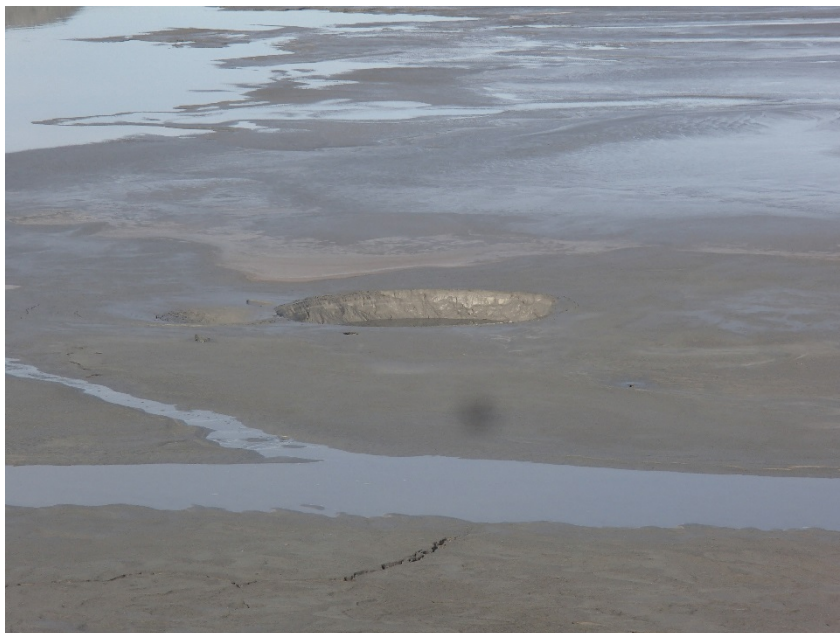
*Photograph B6-7 Saddle Dam 4*

| INSPECTION ITEM | OBSERVATIONS DATA | PHOTO | COMMENTS & OTHER DATA |
|---|---|---|---|
| 6.5 Other Unusual Conditions | Yes | 605 | Presence of sinkholes in the tailings, up to 2 m wide in diameter at the time of the inspection. |

**Description:** View of a depression in the tailings upstream of Saddle Dam 4, about 2 m wide in diameter.

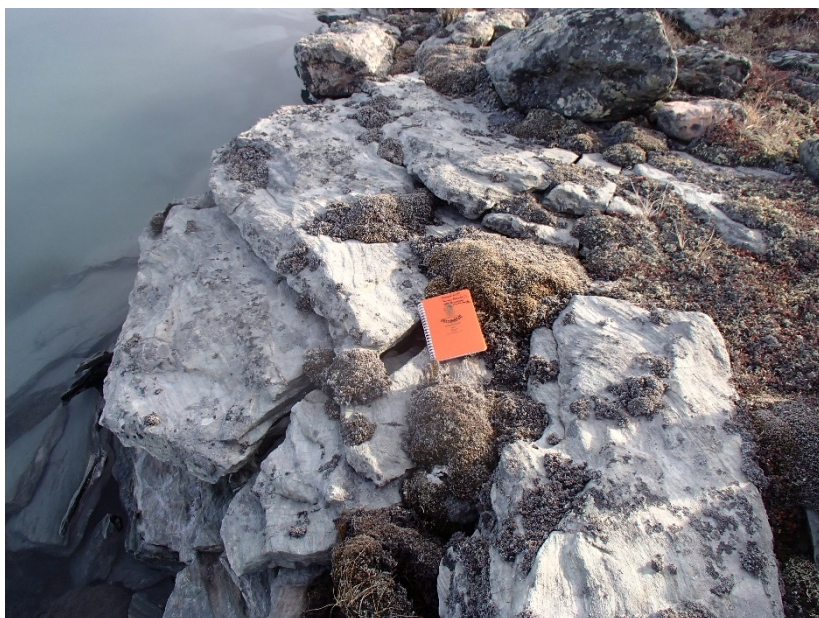
*Photograph B6-8 Saddle Dam 4*

**Description:** View of the bedrock on the northwestern extremity Saddle Dam 4. Important surface cracks are visible.

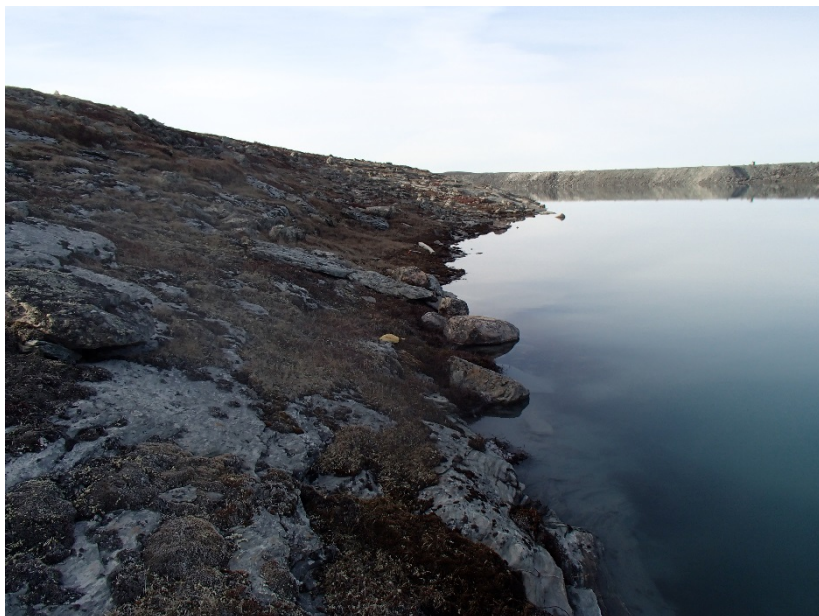
*Photograph B6-9 Saddle Dam 4*

| INSPECTION ITEM | OBSERVATIONS DATA | PHOTO | COMMENTS & OTHER DATA |
|---|---|---|---|
| 5.1 Seepage at contact zone (abutment/embankment) | None observed | 607 | Highly fractured bedrock observed at the western abutment. |

**Description:** From the northwestern extremity Saddle Dam 4, looking northwest at the South Cell towards Stormwater Dike.

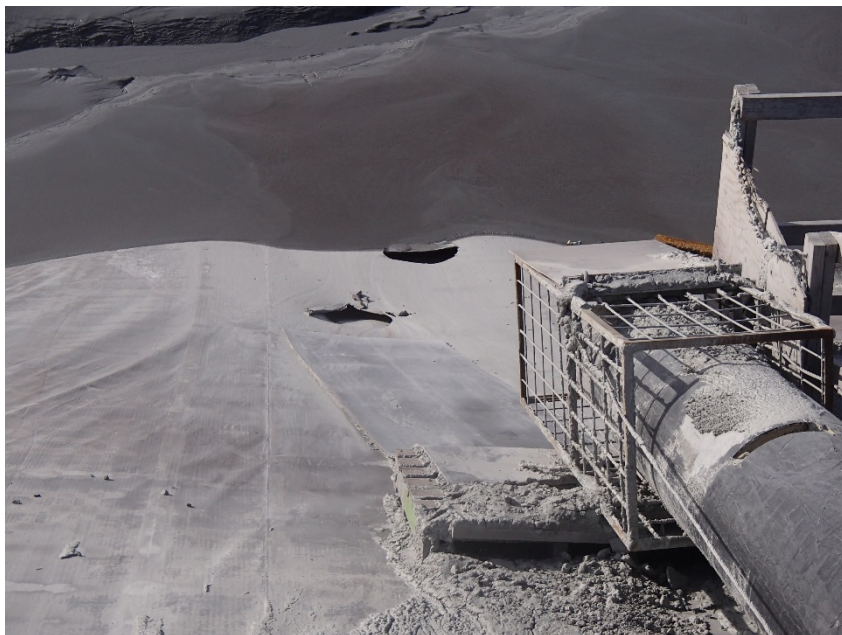
*Photograph B7-3 Central Dike and Saddle Dam 5*

**Description:** From approximately Sta. 0+370 looking west at one of the deposition points. The Teranap is damaged and some material has been eroded. The LLDPE liner has not been affected.

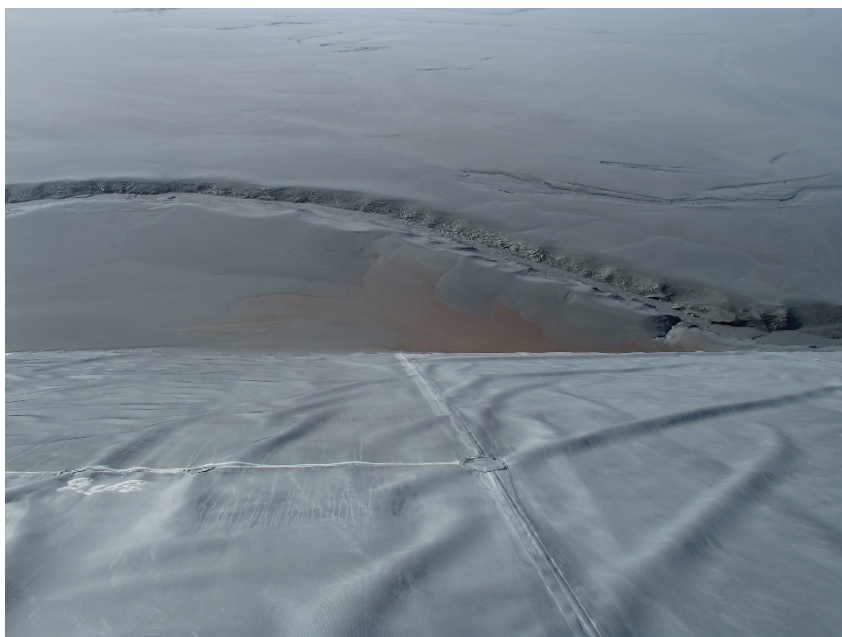
*Photograph B7-4 Central Dike and Saddle Dam 5*

| INSPECTION ITEM | OBSERVATIONS DATA | PHOTO | COMMENTS & OTHER DATA |
|---|---|---|---|
| 6.5 Other Unusual Conditions | Yes | 596 | A small pond of orange water is present on the surface of the tailings, against the structure. |

**Description:** From approximately Sta. 0+425 looking west at the South Cell. A small pond with an orange colour is present in the tailings.

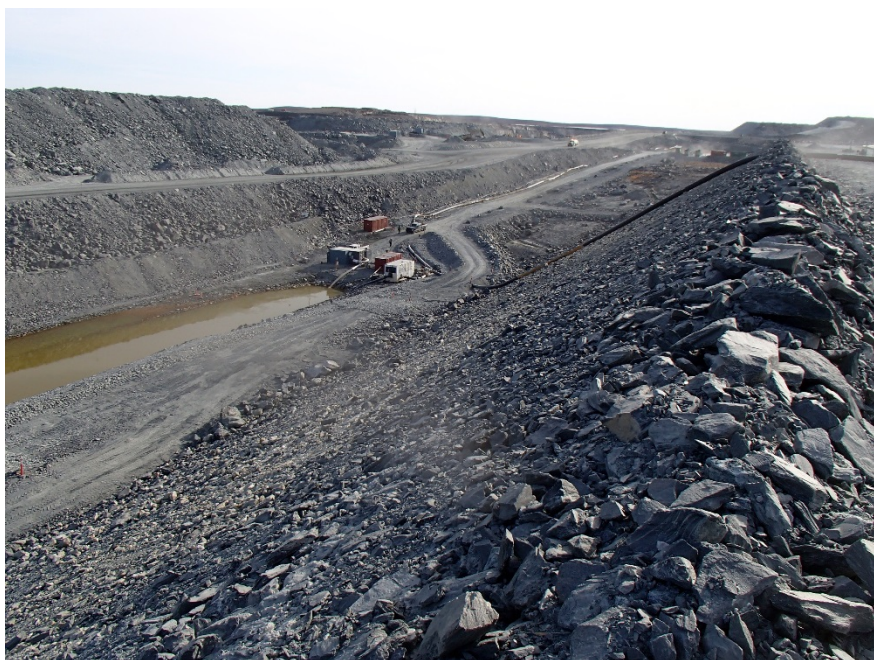
*Photograph B7-9 Central Dike and Saddle Dam 5*

| INSPECTION ITEM | OBSERVATIONS DATA | PHOTO | COMMENTS & OTHER DATA |
|---|---|---|---|
| 4.1 Seepage from Dam | Yes | | Presence of a water pond formed by seepage on the downstream side between the downstream toe and West Road (0+300 to 0+830 approximately). The pond is pumped back to the South Cell and maintained at El. 115 m. The pumping rate was 550 m <sup>3</sup> /hr at the time of the inspection. |

**Description:** From approximately Sta. 0+720 looking southeast at the downstream slope and toe. View of the downstream pond and pumping system.

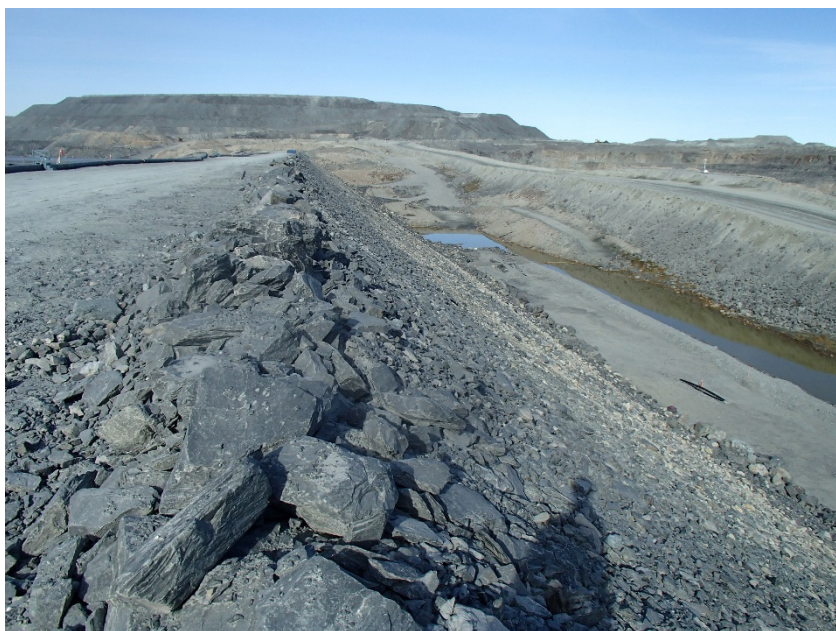
*Photograph B7-10 Central Dike and Saddle Dam 5*

**Description:** From approximately Sta. 0+720 looking northeast at the downstream slope and toe. View of the downstream pond and pumping system.

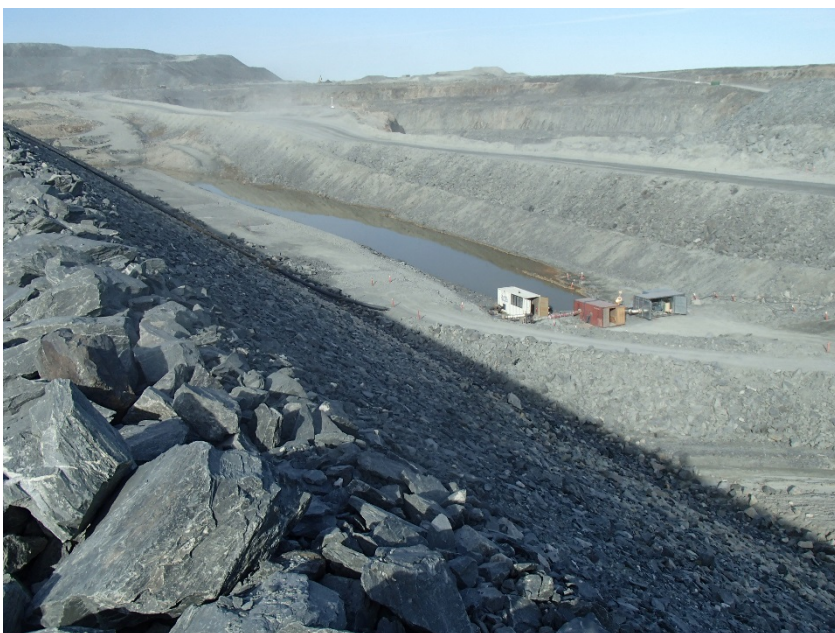
*Photograph B7-18 Central Dike and Saddle Dam 5*

**Description:** From approximately Sta. 0+925 downstream of Central Dike, looking northeast at the downstream slope. View of the downstream pond and pumping
