2017 ANNUAL GEOTECHNICAL INSPECTION
MEADOWBANK GOLD MINE, NUNAVUT

APPENDIX C3

TSF North Cell Instrumentation Data

**MDRB # 22
P3 – STORMWATER DIKE
UPDATE**

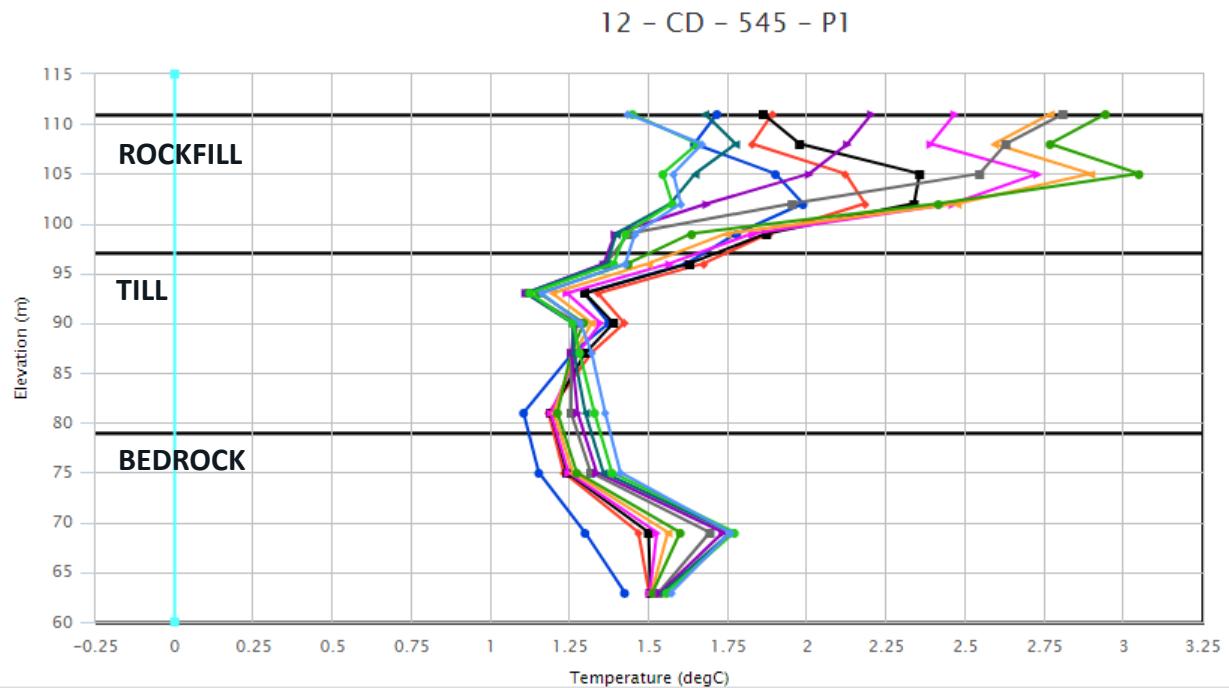
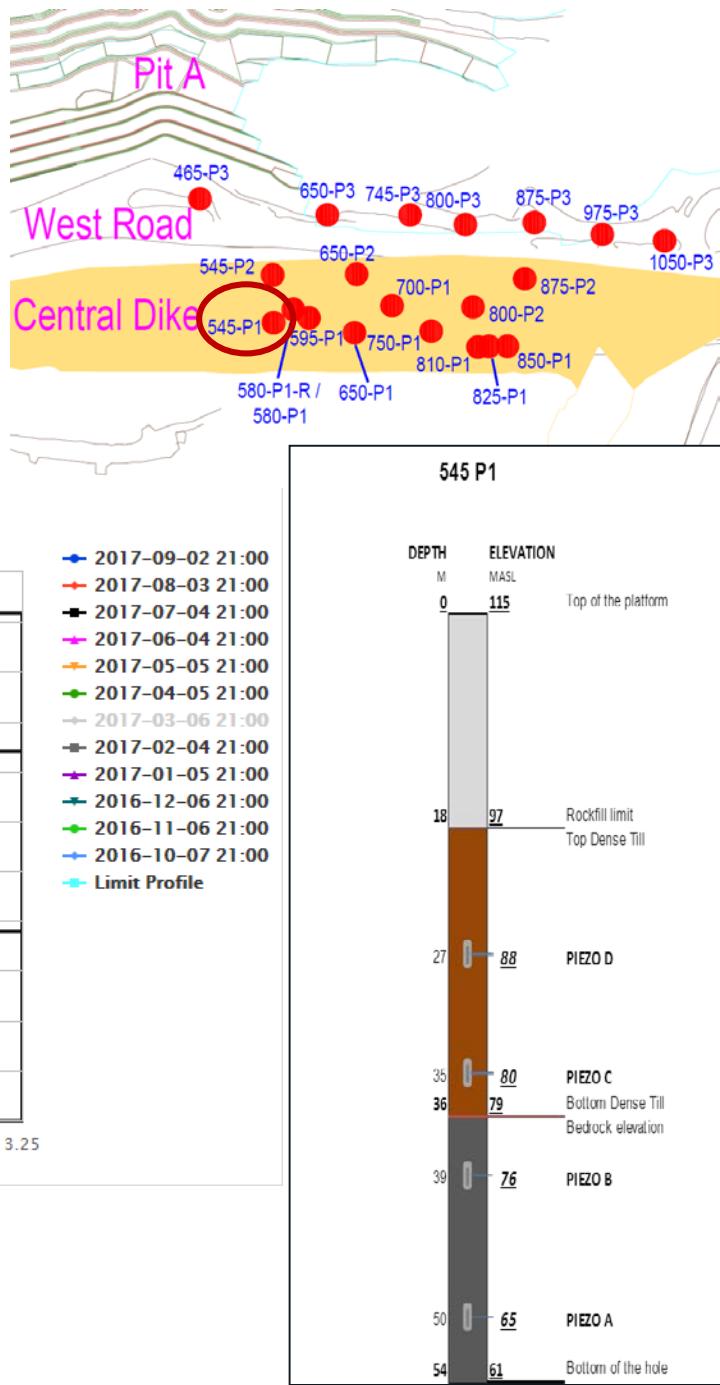
THERMISTOR 545-P1

- 545-P1 thermistor is showing the same temperature profile than last year. Warmer peak observed at elevation 70m since the installation.
- Temperature in the bedrock/till unit is in between 1.1 and 1.75°C.

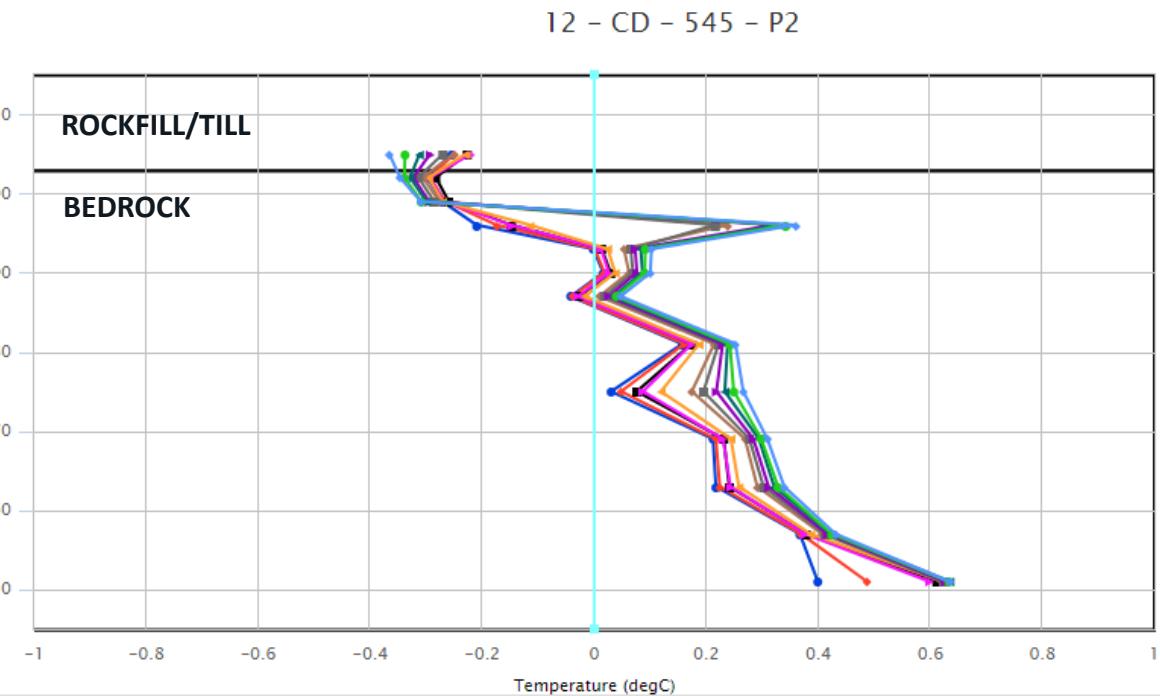
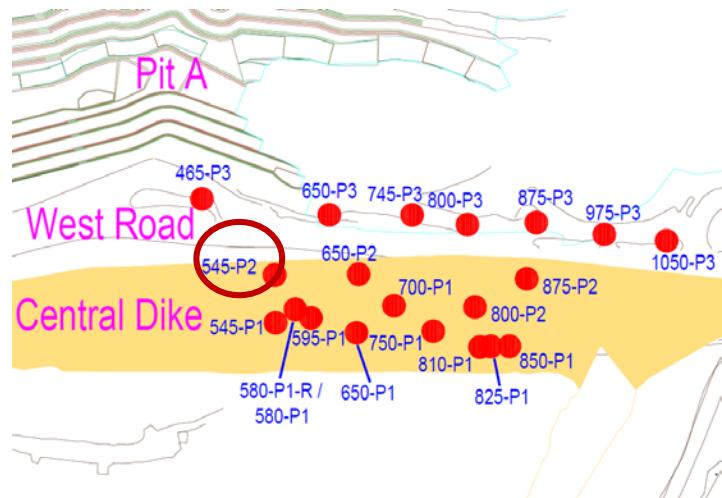
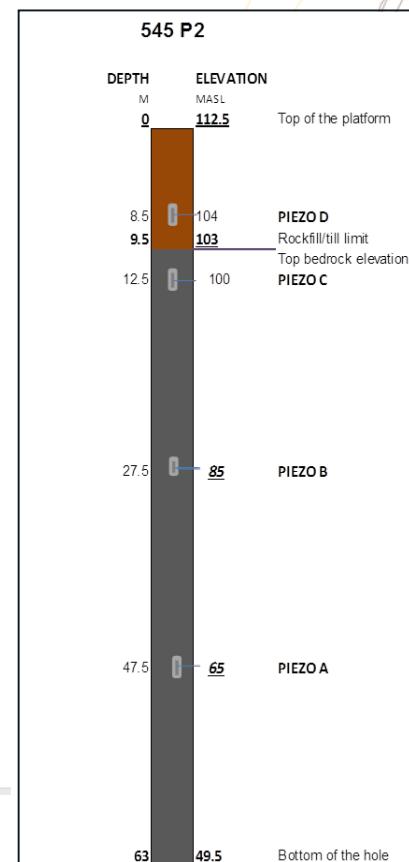
THERMISTOR 545-P2

- ↗ Temperature peak observed on the bead located at El. 96m from January 2015 to March 2017;
- ↗ In January 2015 readings was switched from manual to automatic;
- ↗ In March 2017, AVW multiplexer was changed and temperature profile was back to its original profile;
- ↗ Investigation still on going – interpretation of data must be done with precaution.

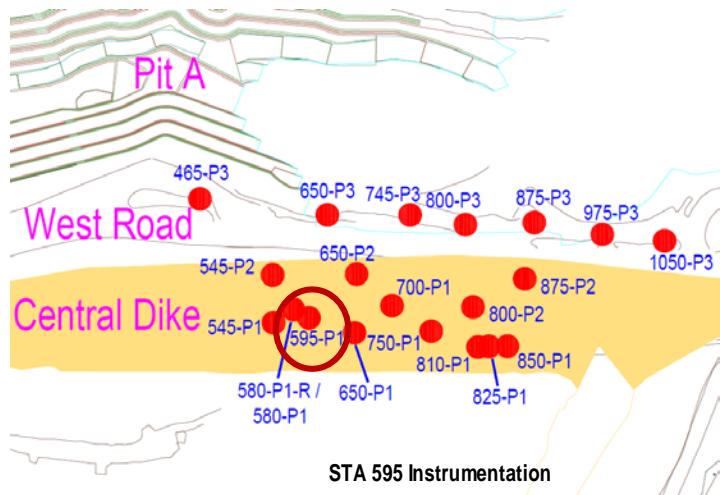
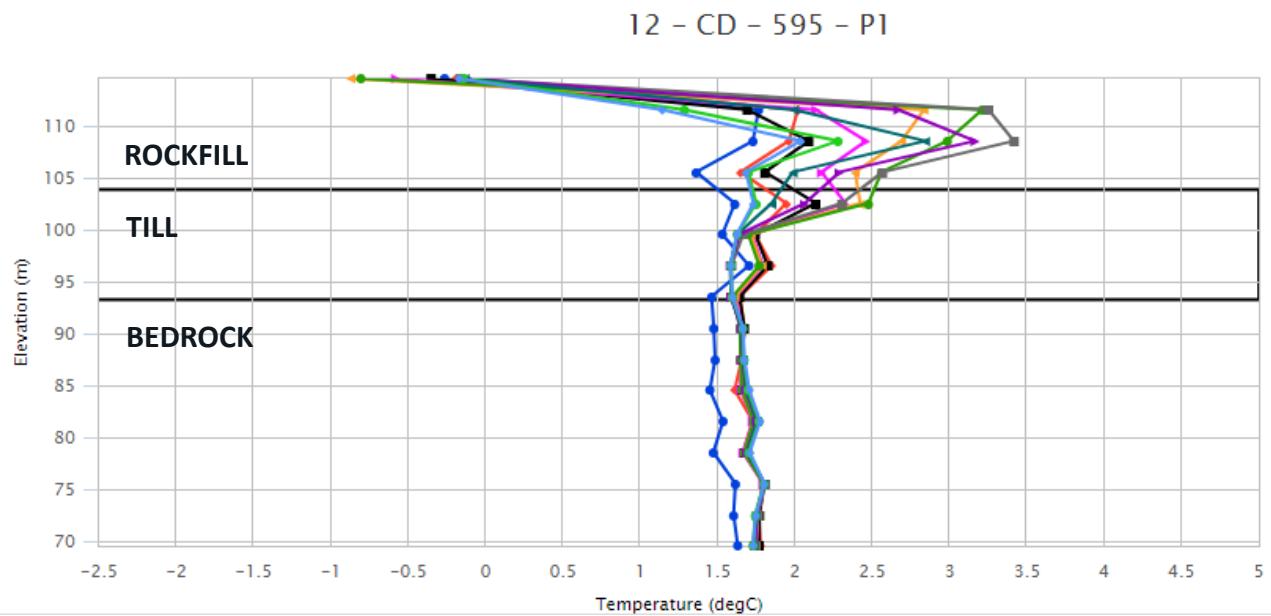
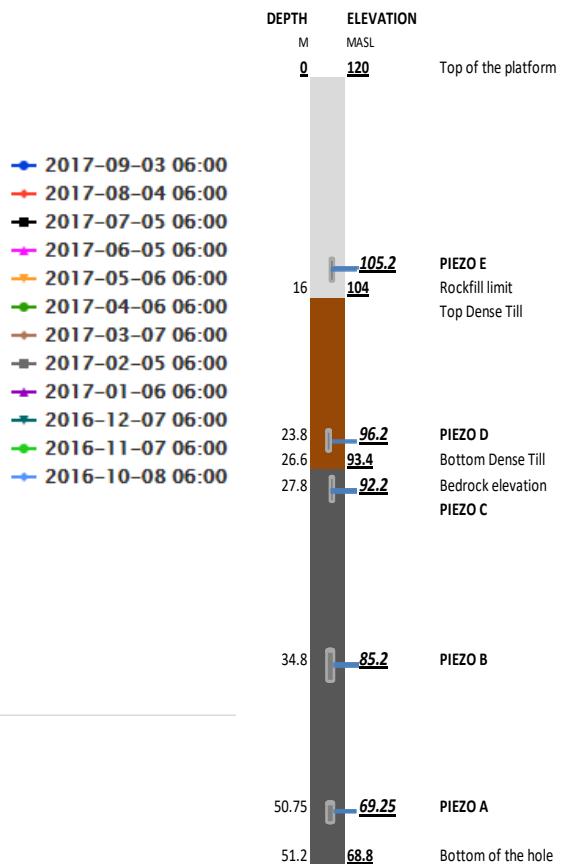
THERMISTOR 595-P1

- Temperature in the bedrock/till unit is in between 1.5 and 1.75°C.
- Glitch of 0.25°C could be caused by the automatization works done in August 2017.

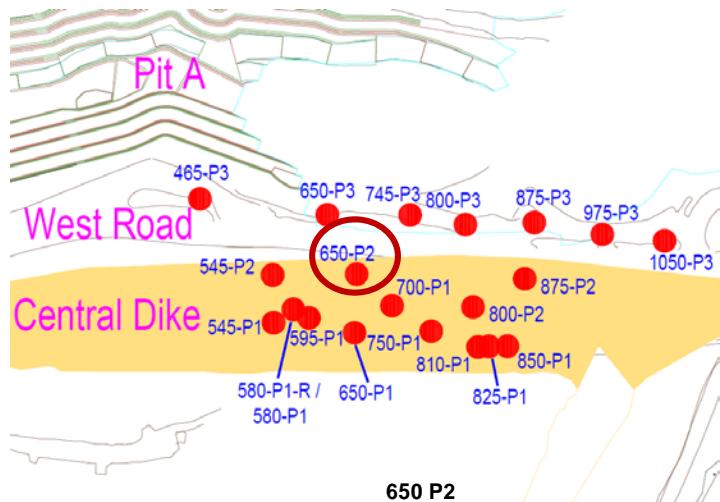
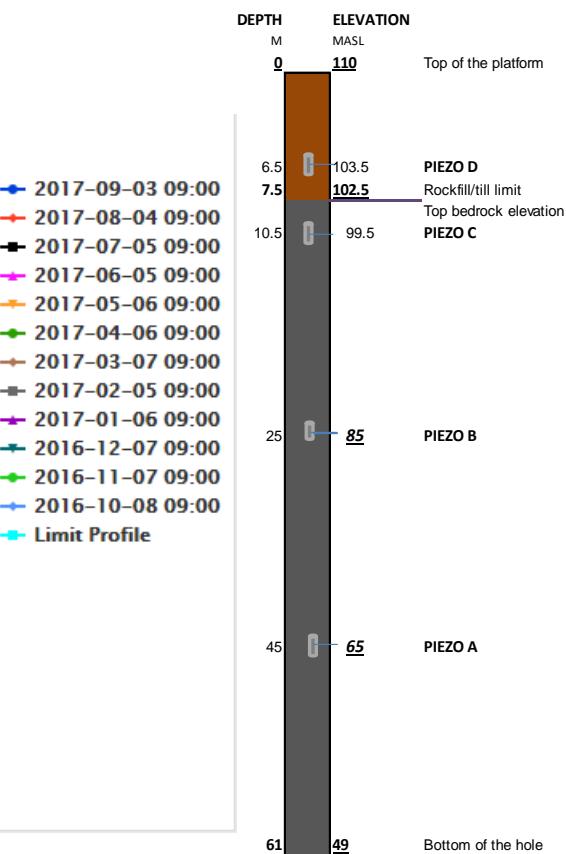
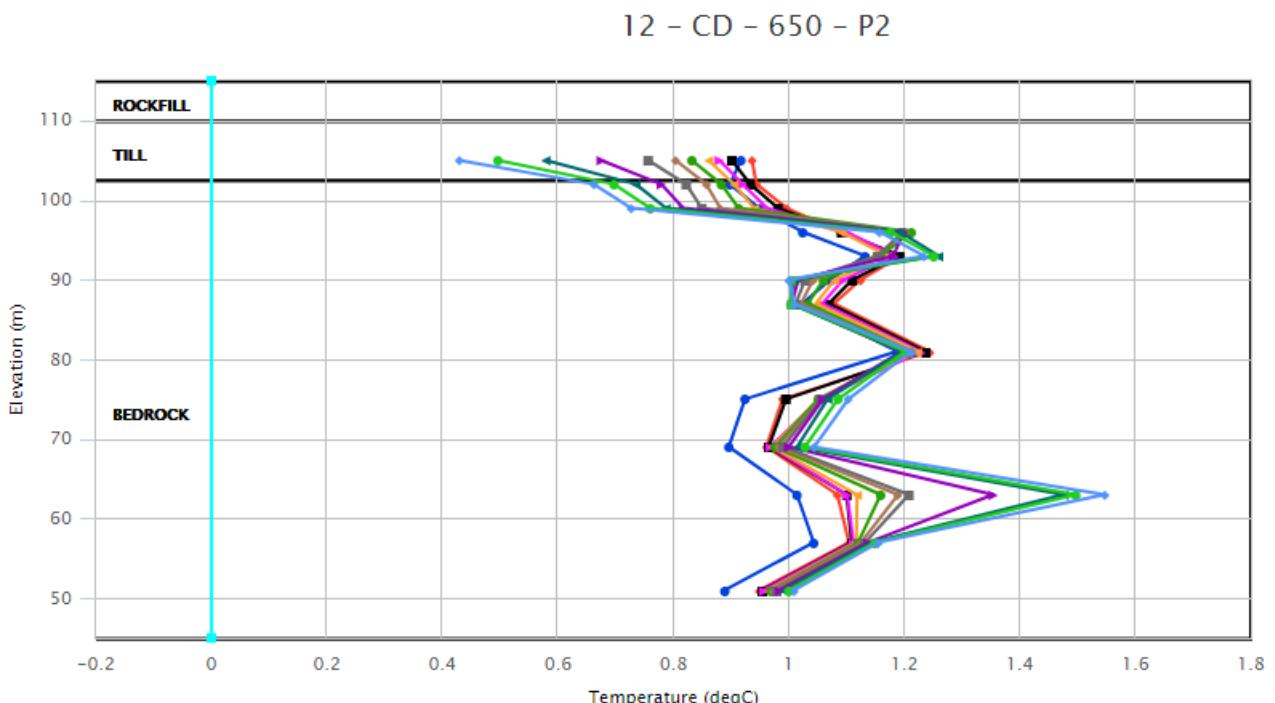
THERMISTOR 650-P2

- Cooling trend observed below El. 80 similar to 2016 readings.

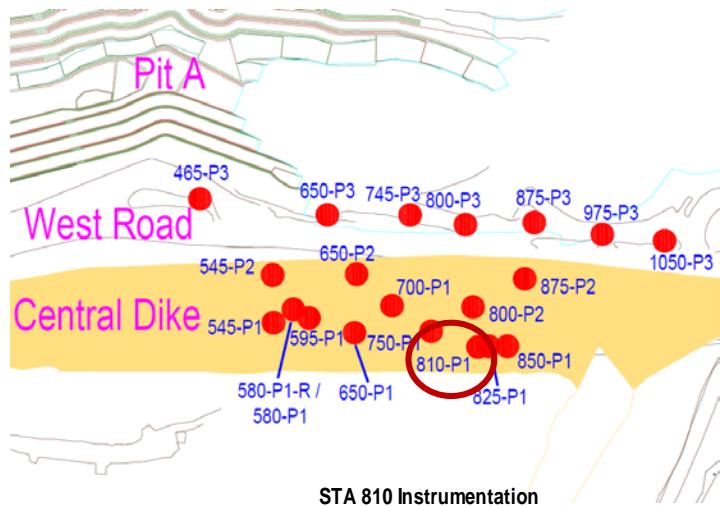
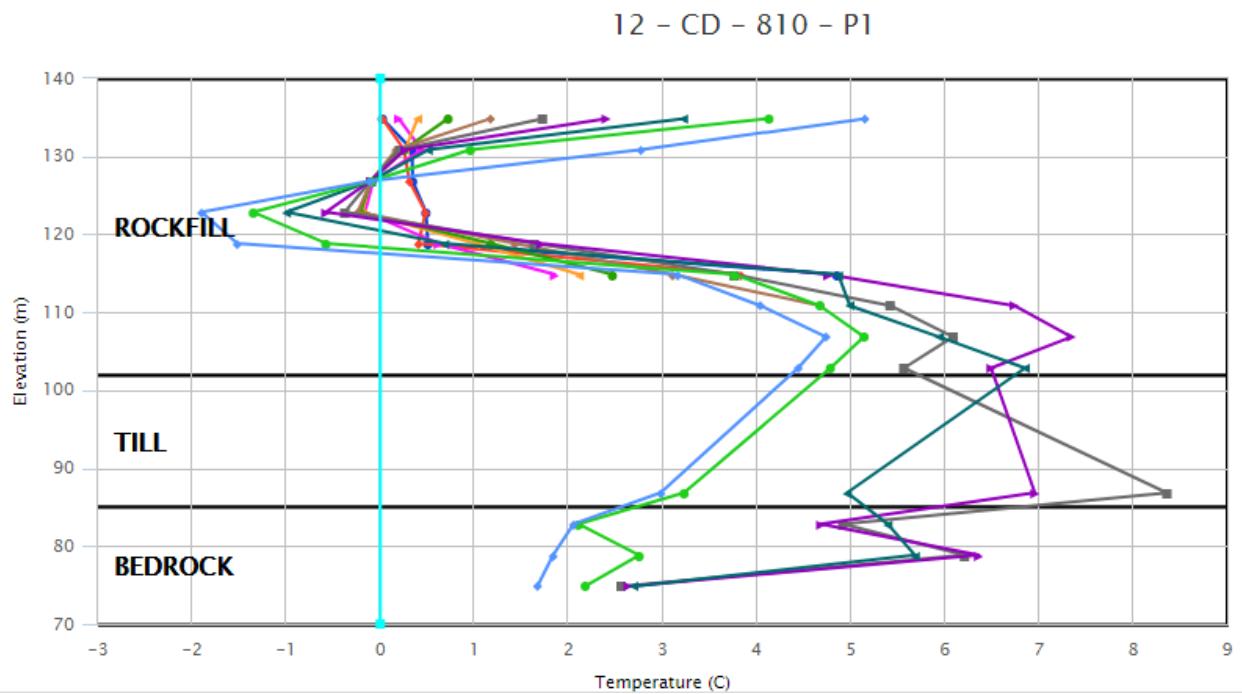
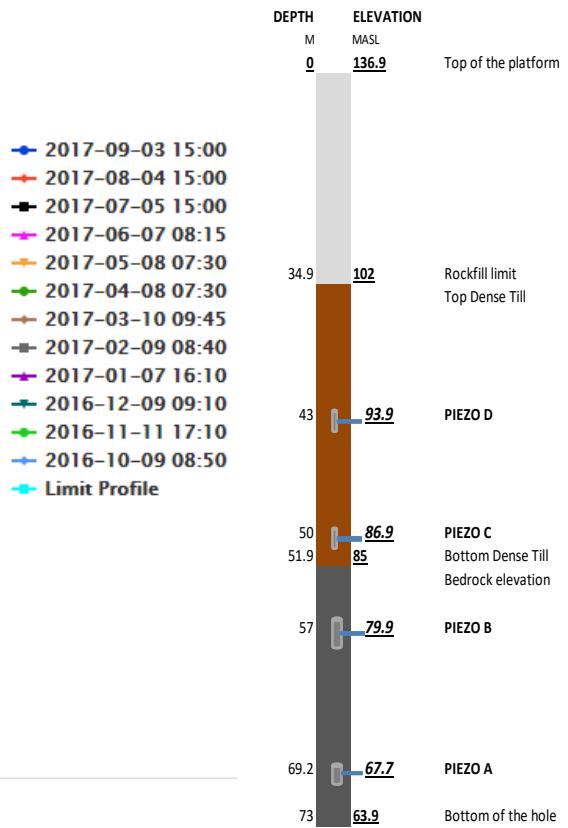
THERMISTOR 810-P1

- ↗ Bead below El. 114.84 m stop working in February 2017
- ↗ Higher temperature observed in this hole (might be the instrument progressively failing)

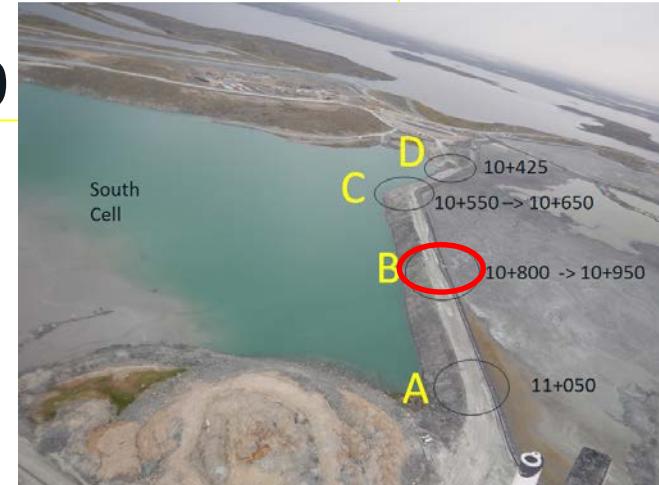
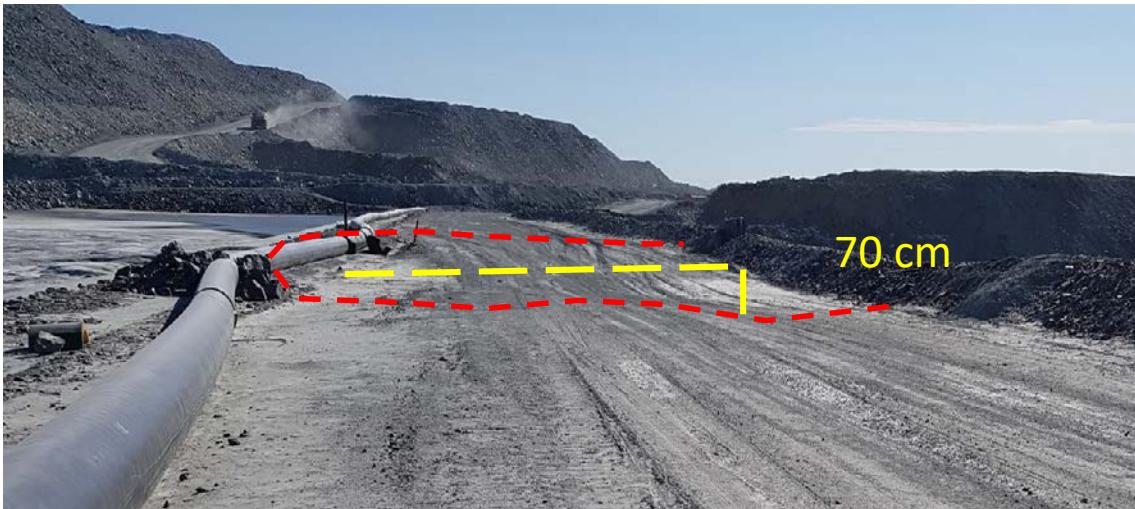
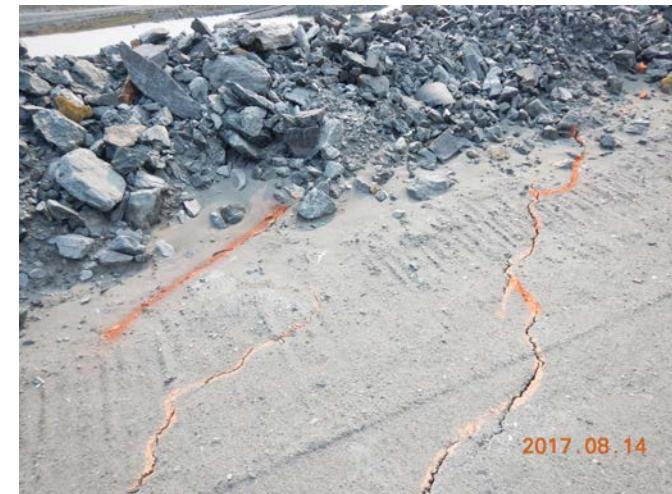
AREA OF MOVEMENT-10+800 TO 10+950

- ↗ Observed initially on July 5th 2017
- ↗ Depression present in previous year but deeper and larger amplitude this year
- ↗ Cracks were not present before

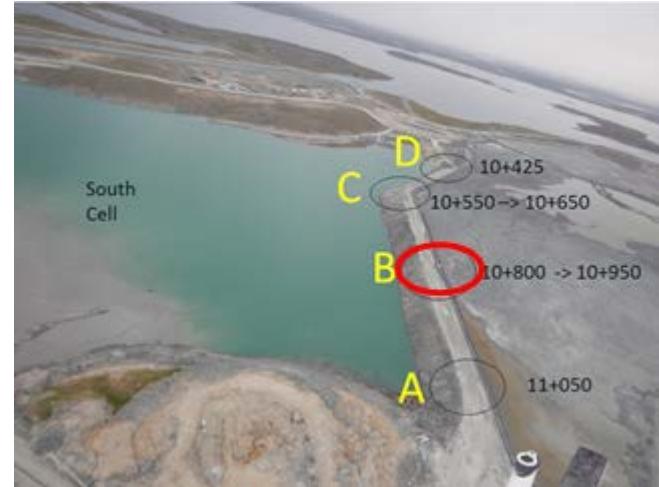
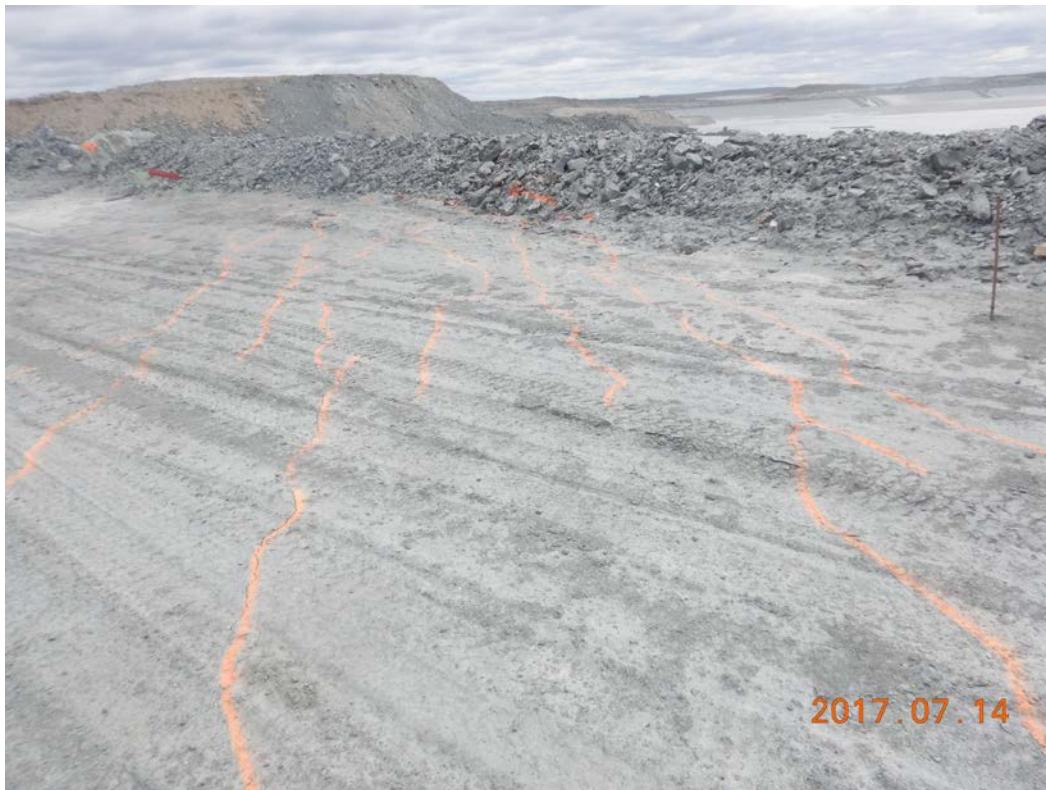
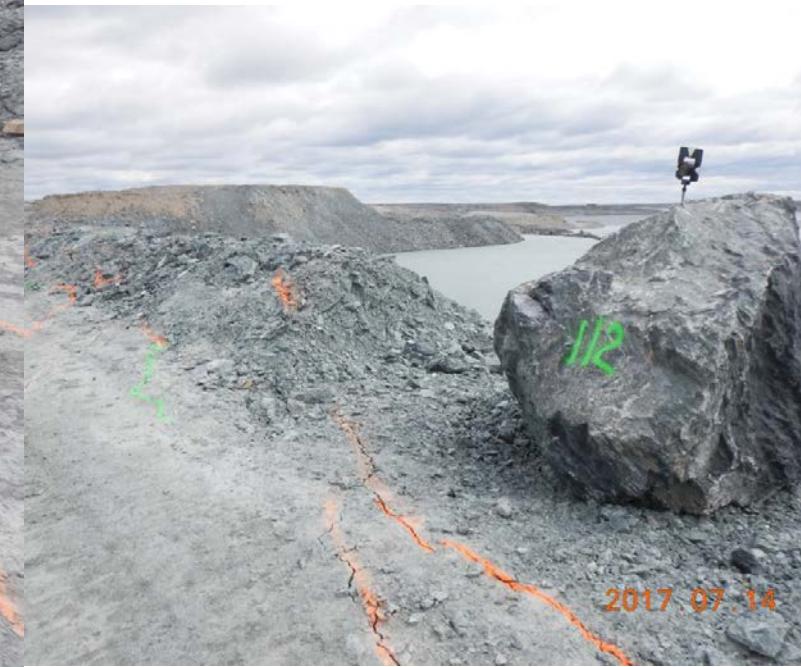
PICTURE OF MOVEMENT – 10+800 TO 10+950

- ↗ Cracks crossing the crest at 40° from CL
 - Did not progressed much during summer
- ↗ Longitudinal cracks along the crest
 - Constantly opened to up to 5cm wide

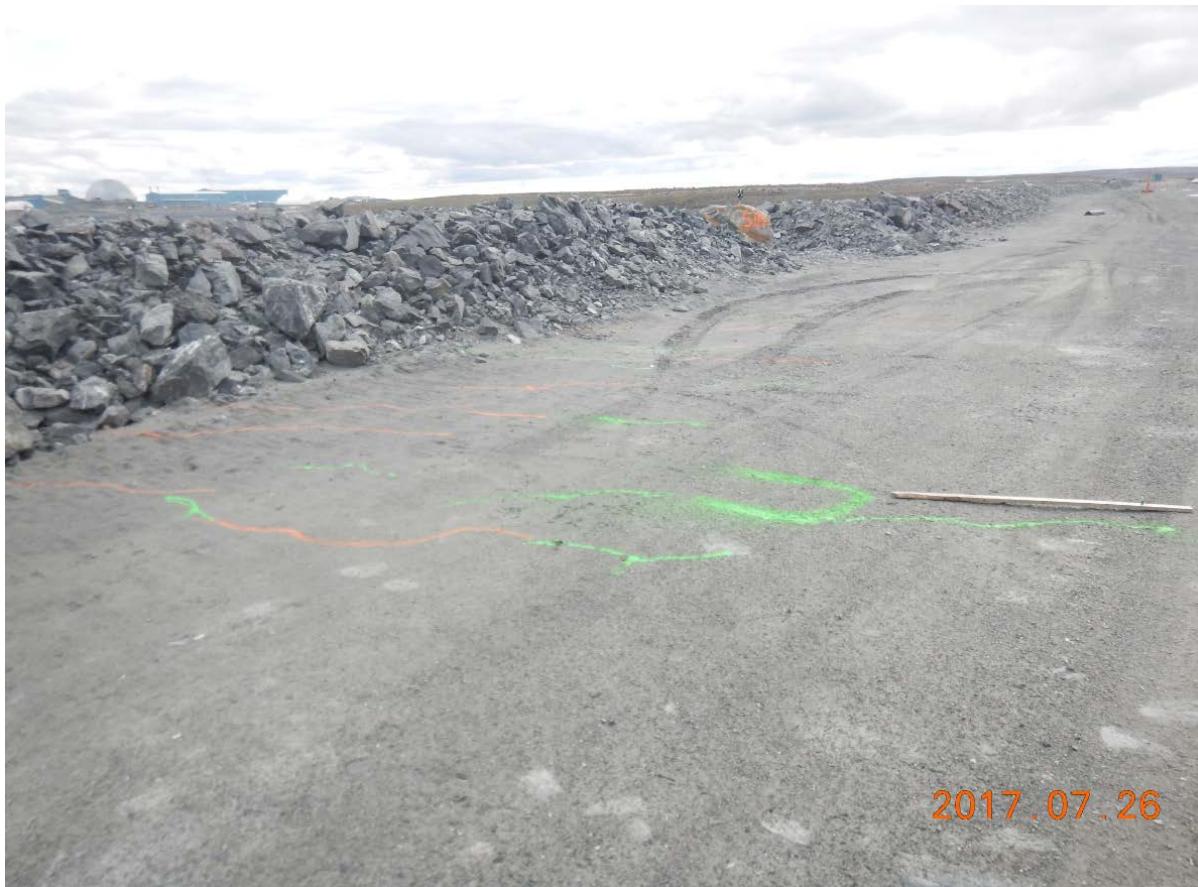
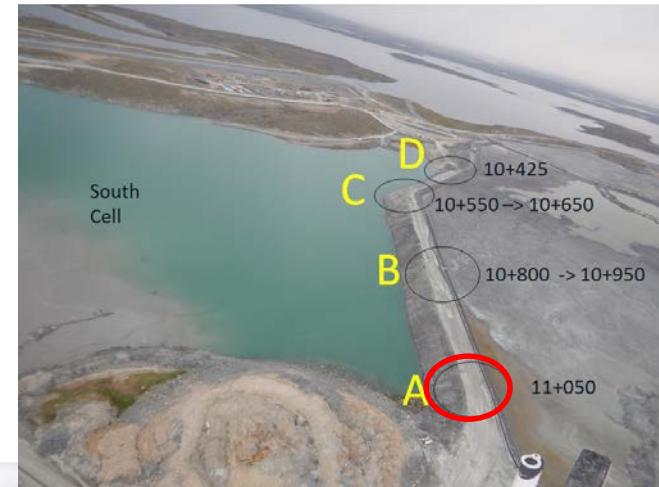
PICTURE OF MOVEMENT – 11+050

- Observed initially on July 15th 2017
- Appeared when water reached the toe in the area
- Crack width relatively small (<1cm)
- Cracks did not progressed
