**2017 ANNUAL GEOTECHNICAL INSPECTION
MEADOWBANK GOLD MINE, NUNAVUT**

APPENDIX D

All-Weather Private Road (AWPR)

Inspection of the Facilities Along the All-Weather Private Road

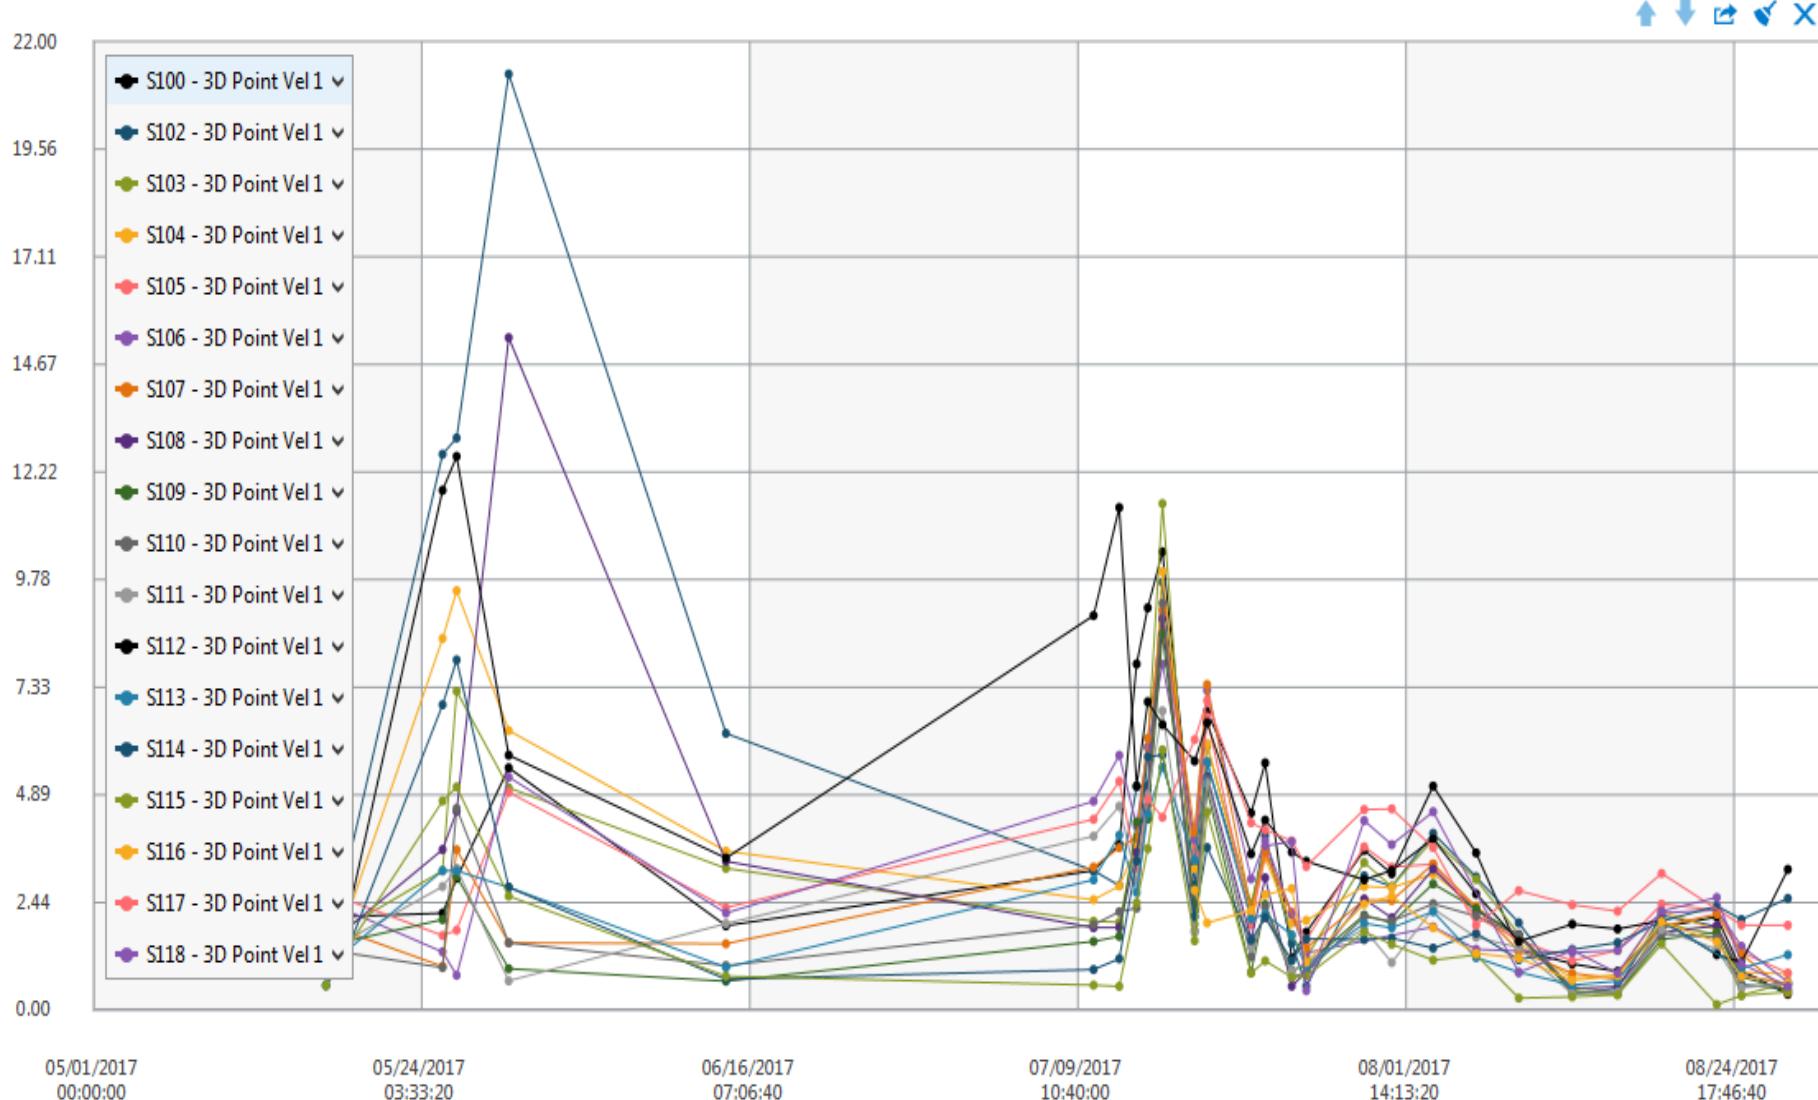
3D velocity since freshet

Decreasing velocity from average 5mm/day to 1.5mm/day

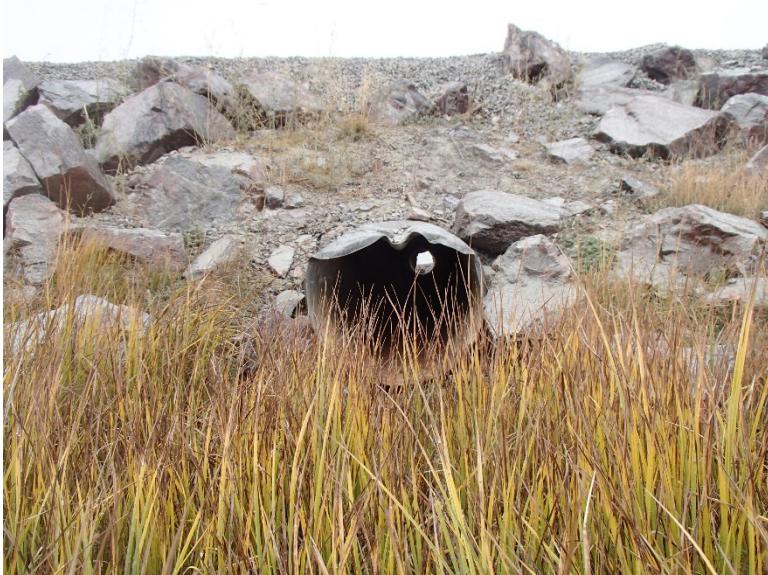
Photograph D1-1: PRC1 km 0+430

Description: View of culvert inlet, in good condition no sign of obstruction.

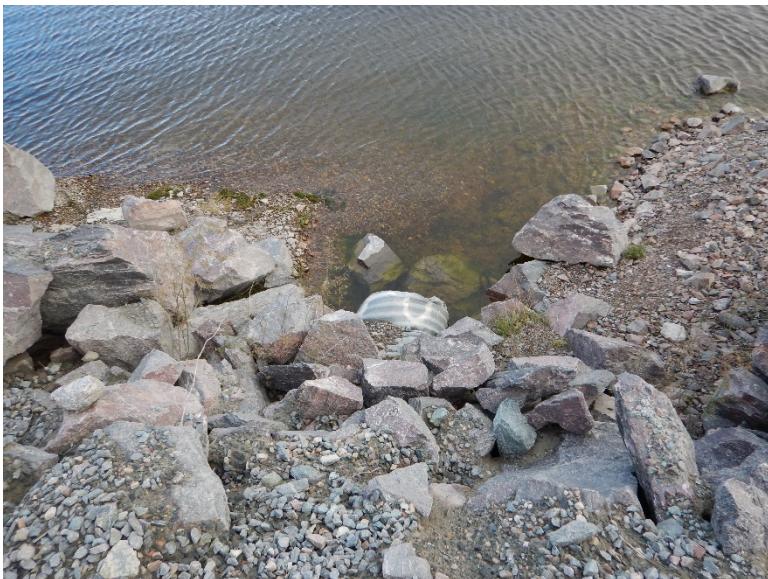
Photograph D1-2: PRC1 km 0+430

Description: View of culvert outlet. The outlet is slightly damaged and obstructed. The culvert is still functional and in overall good condition.

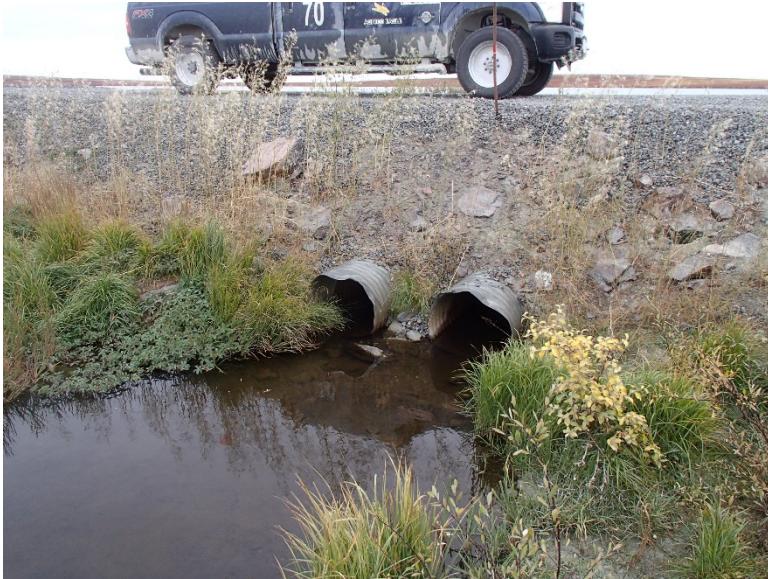
Photograph D1-3: PRC2 km 0+470

Description: View of culverts inlet. In good condition.

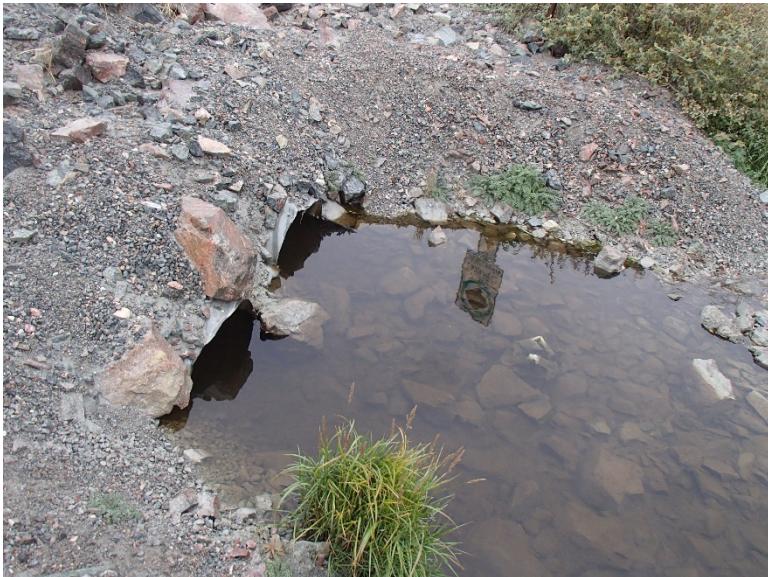
Photograph D1-4: PRC2 km 0+470

Description: View of culverts outlet. In good condition.

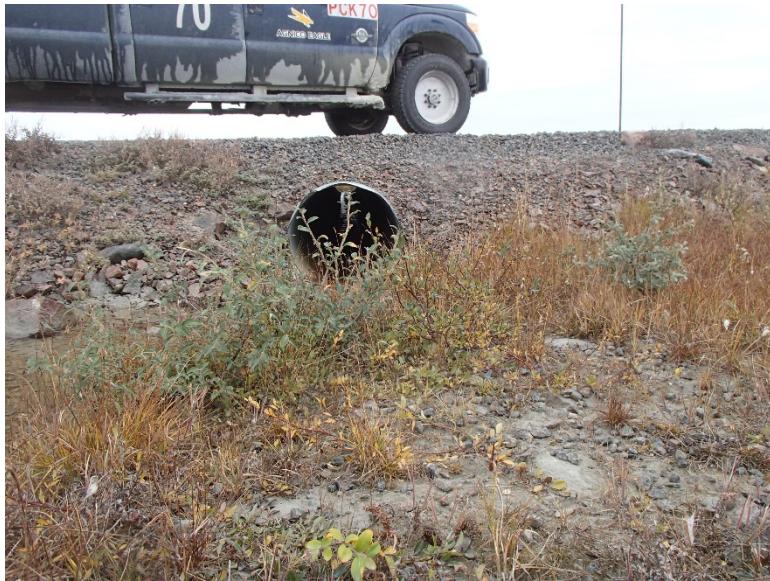
Photograph D1-5: PRC3 km 1+380

Description: View of culvert inlet. In good condition.

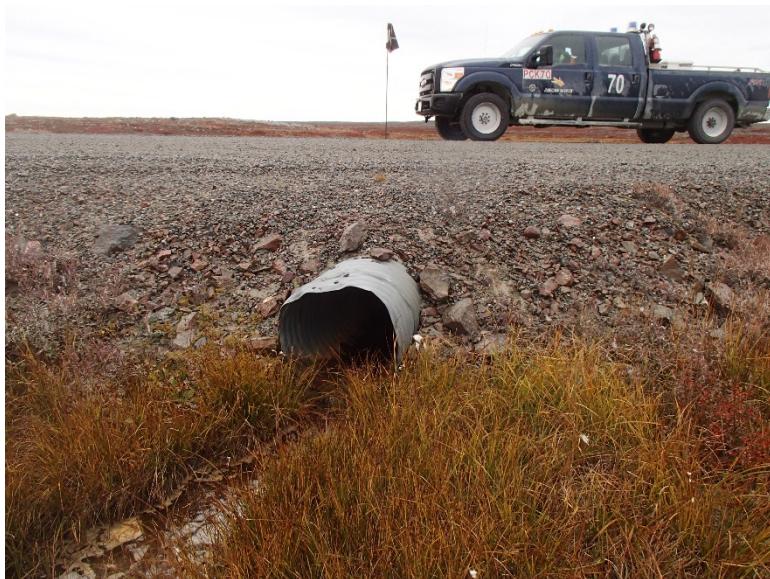
Photograph D1-6: PRC3 km 1+380

Description: View of culvert outlet. In good condition.

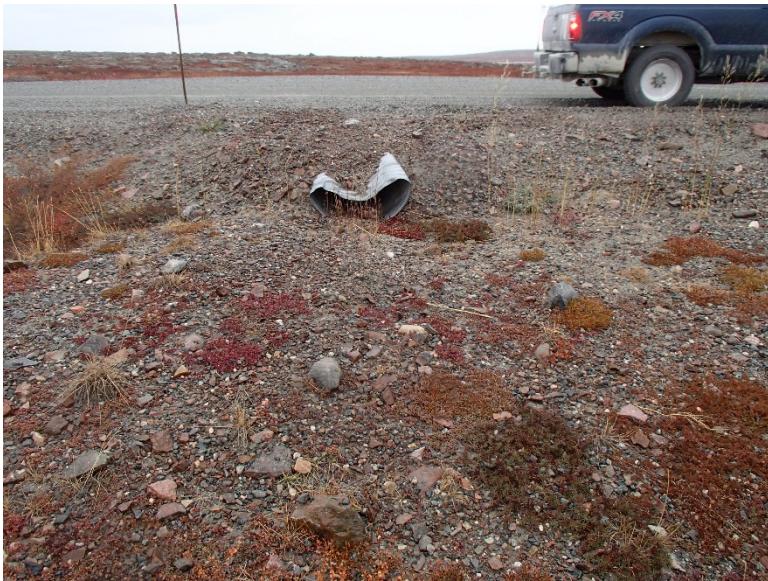
Photograph D1-7: R-00A km 2+550

Description: View of culvert inlet. The inlet is partially collapsed. No sign of flow.

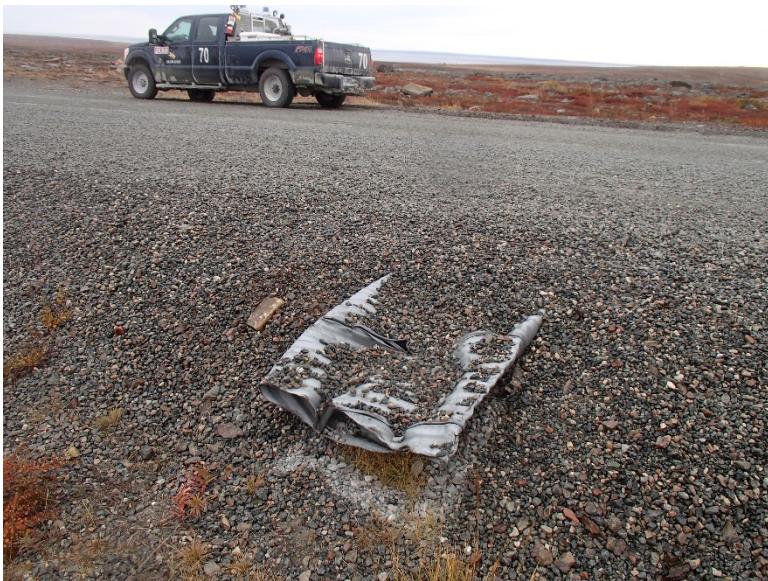
Photograph D1-8: R-00A km 2+550

Description: View of culvert outlet. The outlet is collapsed and the road bed cover is too thin to provide protection. No sign of flow.

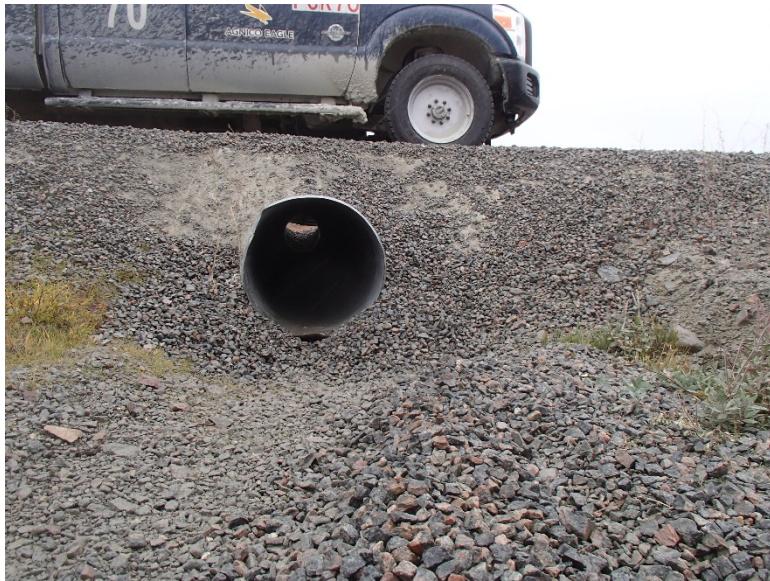
Photograph D1-9: unnamed km 5+700

Description: View of the culvert inlet. Good condition, inlet is short in length as the road rolling surface is at the edge of the inlet.

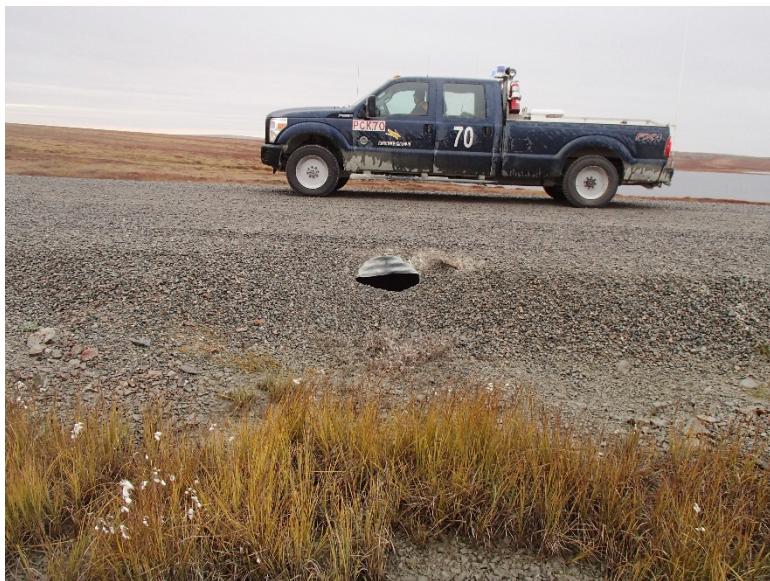
Photograph D1-10: unnamed km 5+700

Description: View of the culvert outlet. Outlet partially buried in gravel.

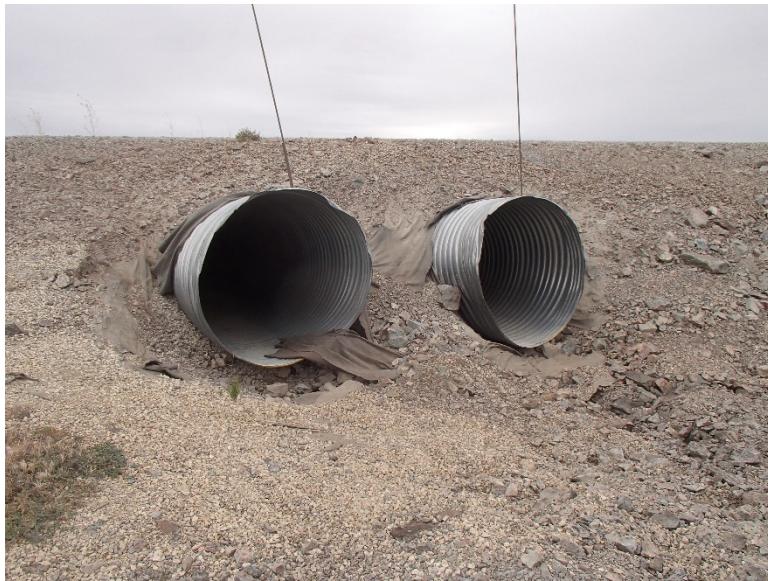
Photograph D1-11: PC-17A km 8+830

8+830	PC-17A		Sign of erosion beneath the inlet and flow of water occurring beneath the culvert. The 1800 CSP were installed too high. While conditions are not perfect, they have proven stable over the past years. No sign of degradation from last year on both the inlet and outlet sides.
8+850	PC-17	2x1200 mm CSP	In good condition
9+952	PC-1	1x600 mm CSP	In good condition
10+580	R-03	1x600 mm CSP	In good condition
12+050	R-04	1x1200 mm CSP	In good condition
12+745	PC-13	1x600 mm CSP	In good condition
13+250	Quarry 2		Slope remediation in progress.
13+405	PC-2	1x600 mm CSP	In good condition
13+685	PC-3	1x600 mm CSP	In good condition
13+950	unnamed	1x600 mm CSP	In good condition
14+910	PC-4	1x600 mm CSP	In good condition

Description: View of the culverts inlet. No sign of degradation since last year.

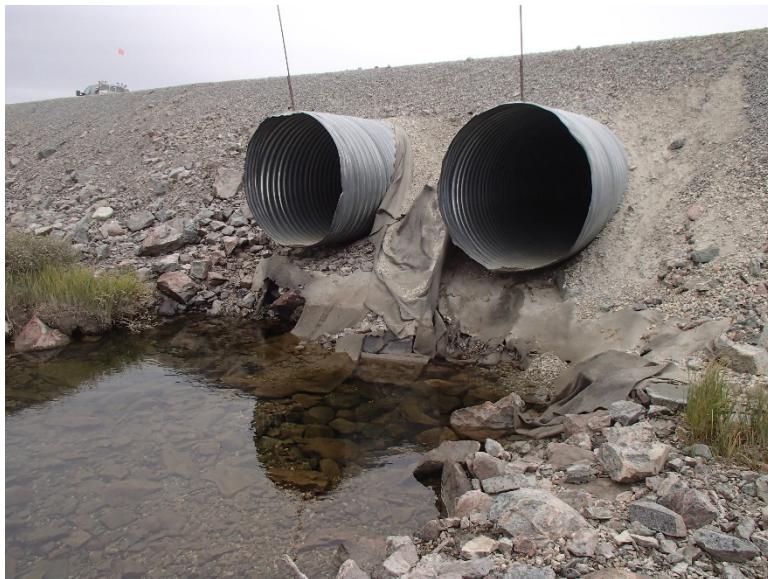
Photograph D1-12: PC-17A km 8+830

Description: View of the culverts outlet. No sign of degradation since last year.

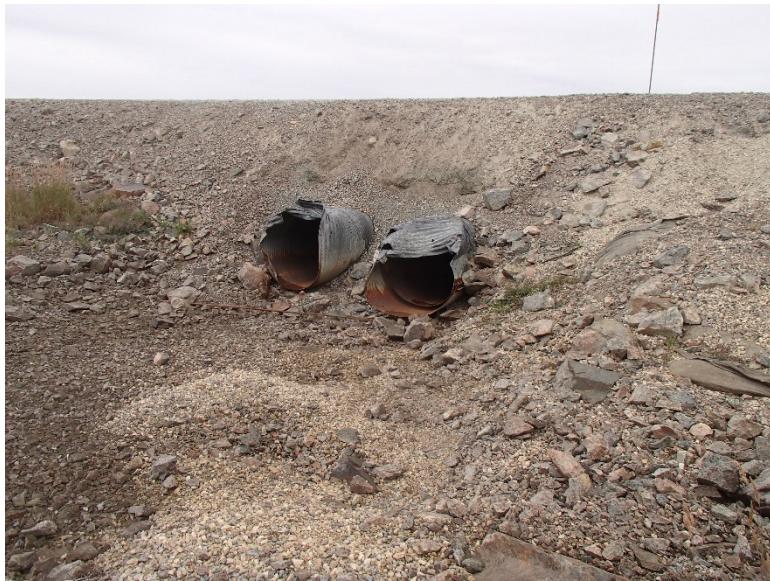
Photograph D1-13: PC-17 km 8+850

Description: View of the culverts inlet. Good condition.

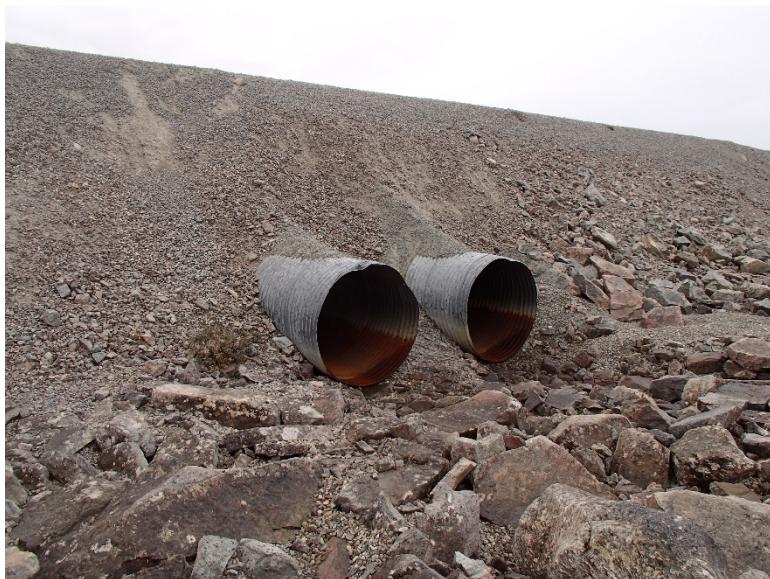
Photograph D1-14: PC-17 km 8+850

Description: View of the culverts outlet (right side of the picture). Good condition.

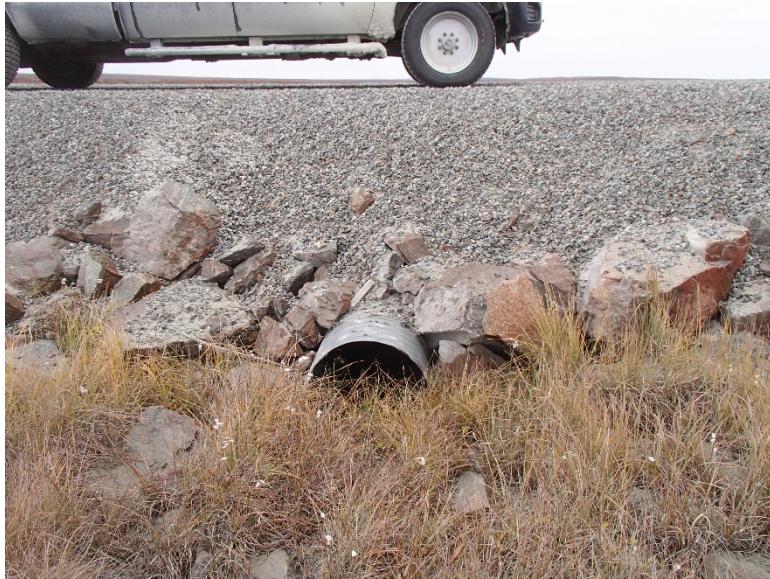
Photograph D1-15: PC-1 km 9+952

Description: View of the culvert inlet. In good condition.

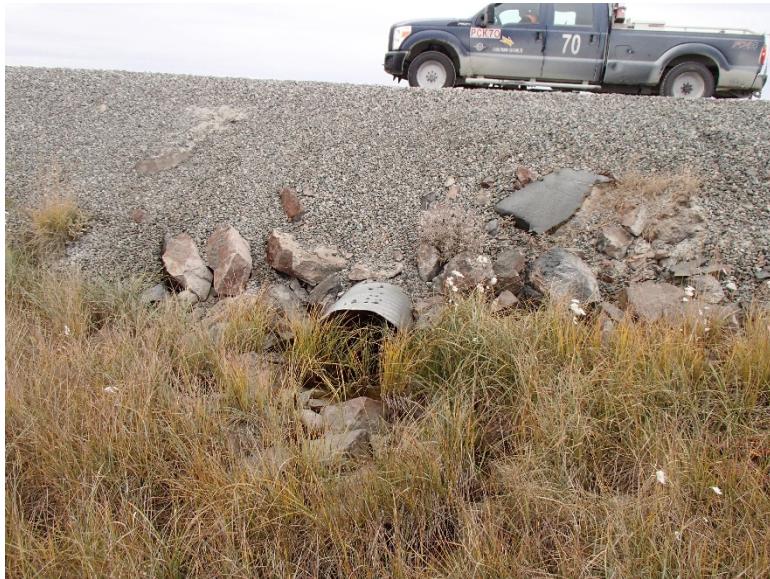
Photograph D1-16: PC-1 km 9+952

Description: View of the culvert outlet. In good condition.
