WATER LICENCE INSPECTION FORM

Licensee	Licensee Representative					
THE CITY OF IQALUIT	N/A					
License No. / Expiry	Representative's Title					
8BC-BTN1920	--					
Land / Other Authorizations	Land / Other Authorizations					
3AM-IQA1626	--					
Date of Inspection	Inspector					
October 24, 2019	Jonathan MESHER					
Activities Inspected						
<input type="checkbox"/> Camp	<input type="checkbox"/> Drilling	<input type="checkbox"/> Mining	<input checked="" type="checkbox"/> Construction	<input type="checkbox"/> Reclamation	<input type="checkbox"/> Fuel Storage	
<input type="checkbox"/> Roads/Hauling	<input type="checkbox"/> Other:		<input type="checkbox"/> Other:

SECTION 1	<input checked="" type="checkbox"/> Comments	<input type="checkbox"/> Non-Compliance with Act or Licence	<input type="checkbox"/> Action Required
Background	<p>The licensee plans to repair the abutments of three bridges in Iqaluit: the Road to Nowhere Bridge, the Apex Road Bridge, and Astro Hill Road Bridge. Previous licence No. 8BC-BTN1819 expired in May 2019 and authorized work on the Bridge to Nowhere only. The activities to be included in the replacement licence are:</p> <ul style="list-style-type: none"> -

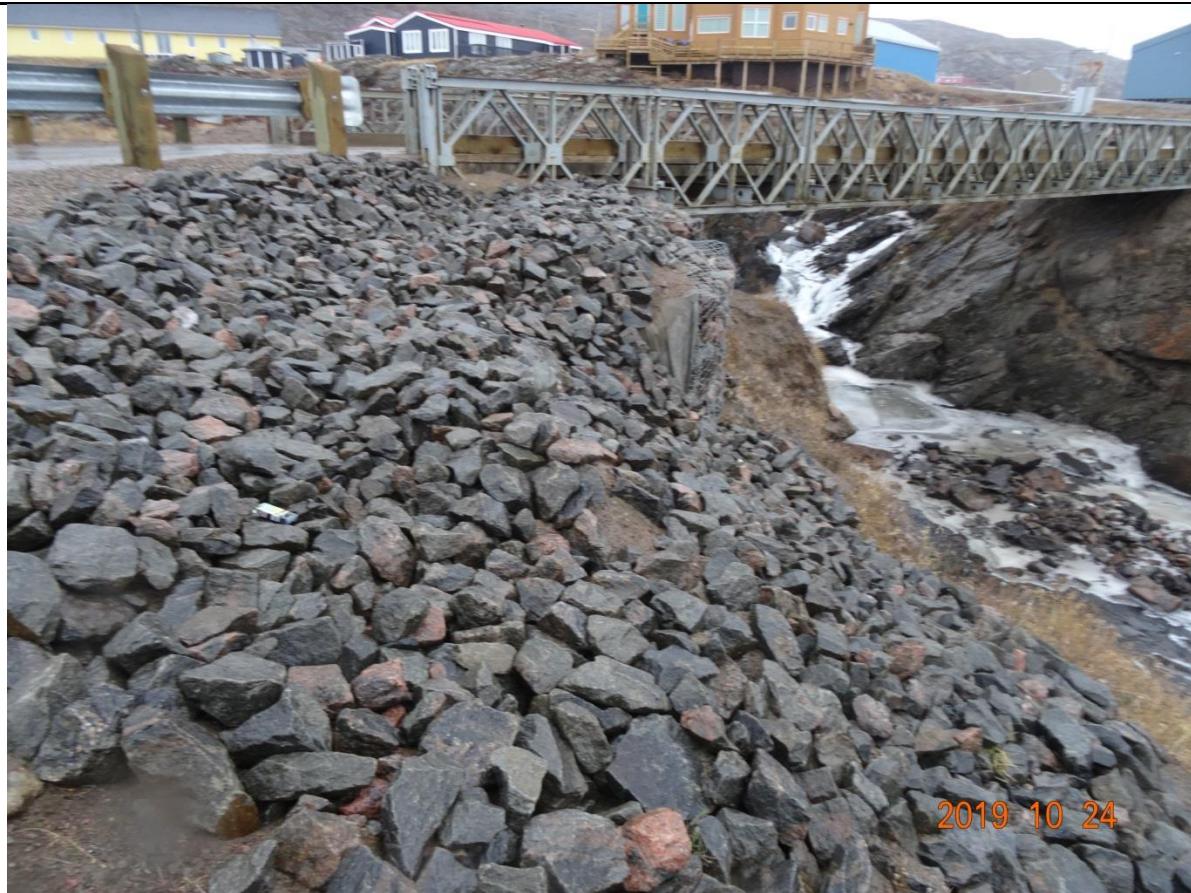
Date	Camera	Inspector	Authorization
	Sony Cyber-shot	J.Mesher	8BC-BTN
Photo Log			
Photo 1

Description: Apex Bridge

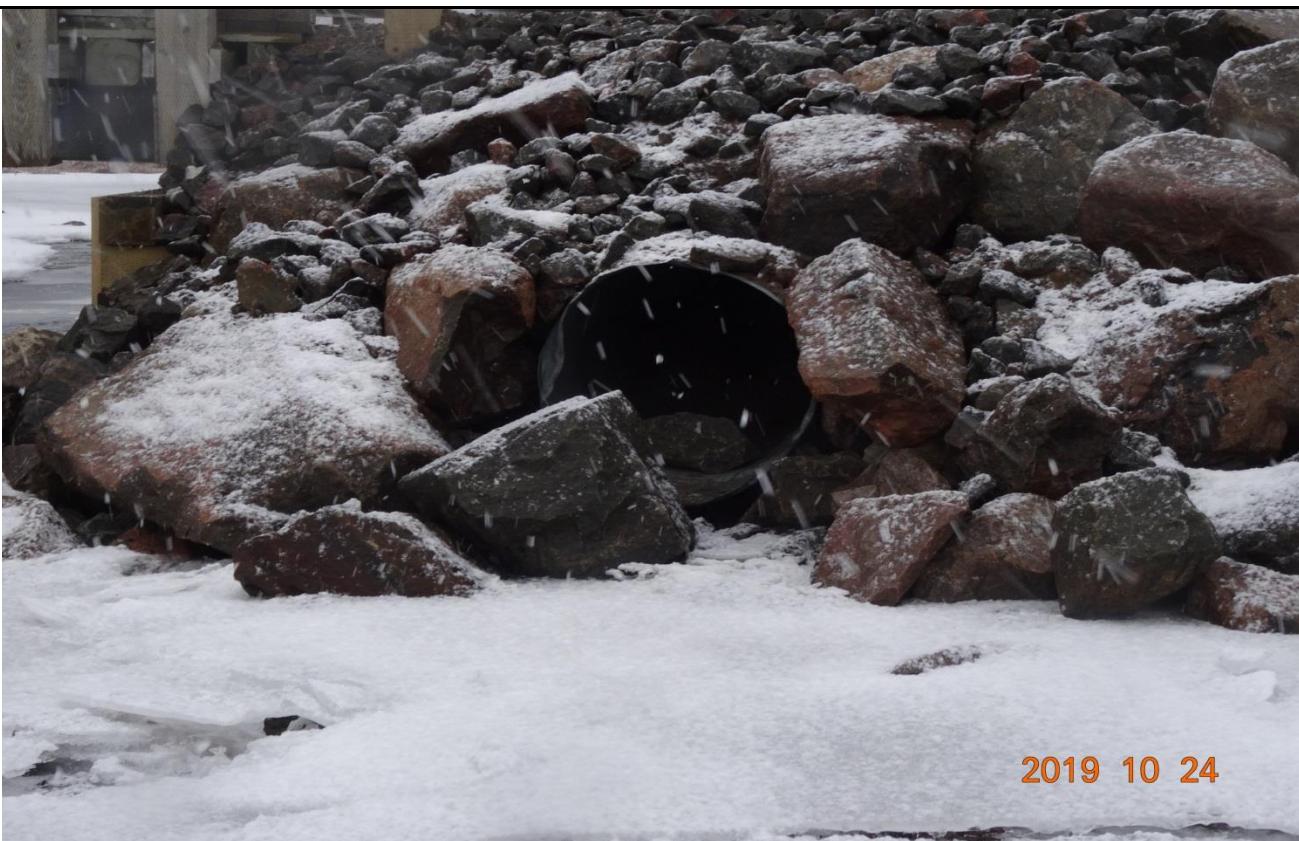
Photo 3

Road to Nowhere Bridge	<ul style="list-style-type: none"> During the inspection there were no signs of waste entering water or water usage related to this licence. The inspector noted that the existing culverts on the bridge have been covered on the downstream side, The licensee has informed the inspector that these culverts have been covered prior to this licence. 		
Apex Road Bridge	<ul style="list-style-type: none"> During the inspection there were no signs of waste entering water or water usage related to this licence. There were no concerns noted during the inspection of this bridge and upgrades completed.

Description: Upstream side on Road to Nowhere Bridge

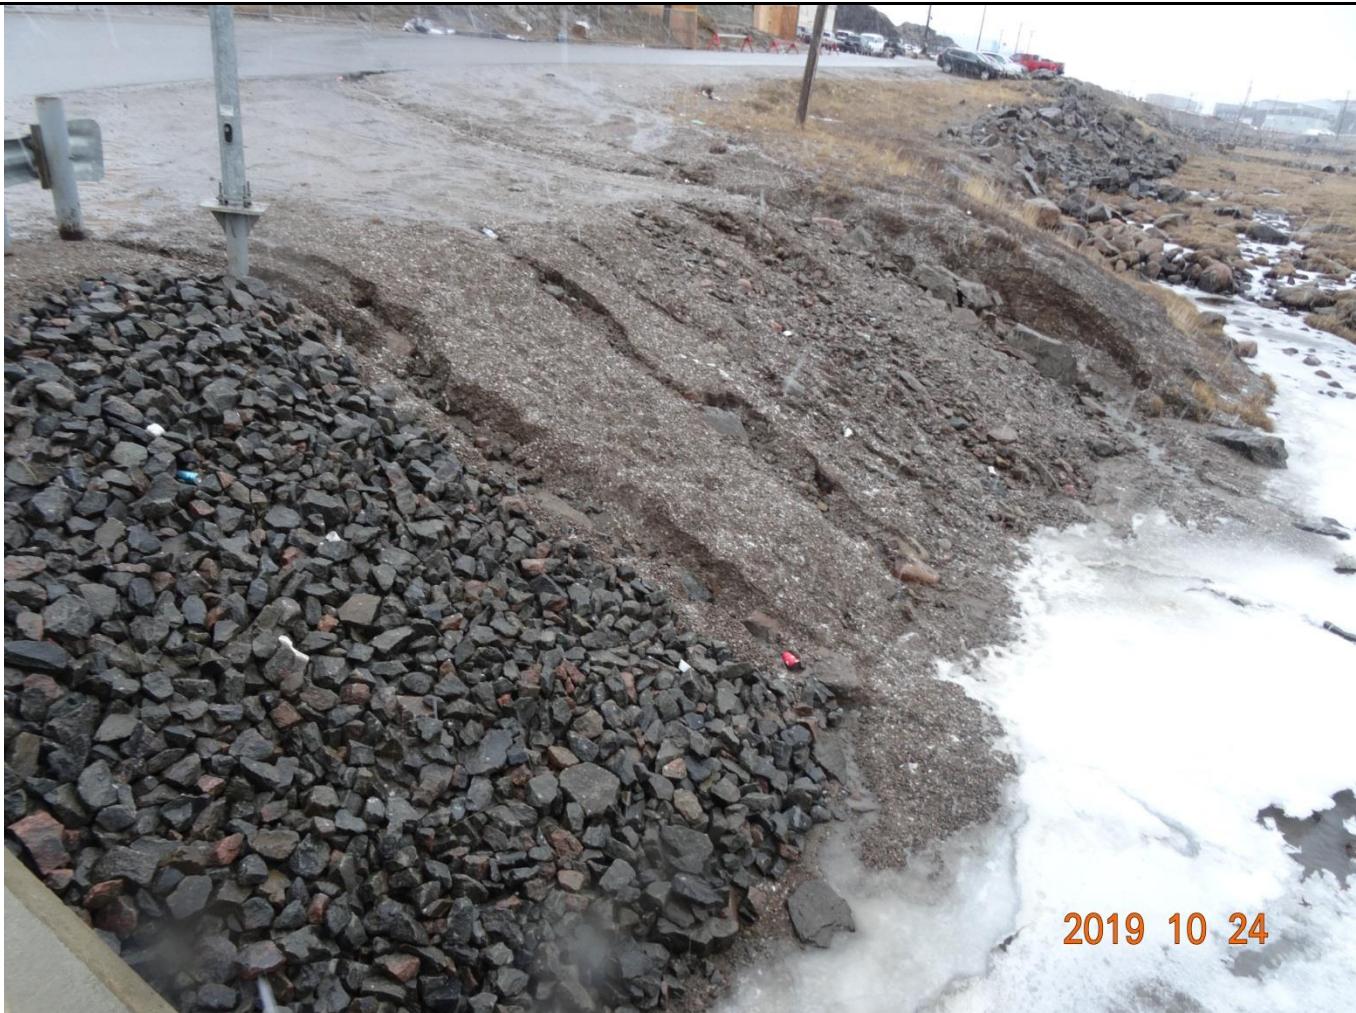
Photo 4

- During the inspection there were no signs of waste entering water or water usage related to this licence.
- While inspecting the bridge the inspector noted significant erosion on the North West side of the bridge.
- This erosion appears to be outside of the scope of the licence 8BC-BTN1920 but, it is in out of contravention of PART D, Item 6 of the licence 3AM-IQA162. This licence is issued to the same licensee therefore the inspector is requesting that the licensee install appropriate erosion measures to prevent this erosion from occurring.

Description: Astro Hill Erosion

• PART D, Item 6 of the licence 3AM-IQA1626 states that; "The Licensee shall not cause erosion to the banks of any body of Water and shall provide the necessary controls to prevent such erosion." Therefore the City of Iqaluit is to install the necessary controls to prevent such erosion; this work is to be completed prior to Freshet 2020 to ensure this erosion is not occurring during times with high volume of surface waters and to ensure compliance with the Water licence. The licensee is to provide photos of this work once completed.
