WATER LICENCE INSPECTION FORM

Licensee	Licensee Representative
Department of National Defence	Nicolas Billette
Licence No. / Expiry	Representative's Title
8BC-NNF2124	Environmental Coordinator
Land / Other Authorizations	Land / Other Authorizations
Date of Inspection	Inspector
July 9, 2022	Joseph Monteith
Activities Inspected	
<input checked="" type="checkbox"/> Camp: <input type="checkbox"/> Construction: <input type="checkbox"/> Drilling: <input checked="" type="checkbox"/> Fuel Cache: <input type="checkbox"/> Mining: <input type="checkbox"/> Reclamation: <input type="checkbox"/> Roads/Hauling: <input type="checkbox"/> Other:

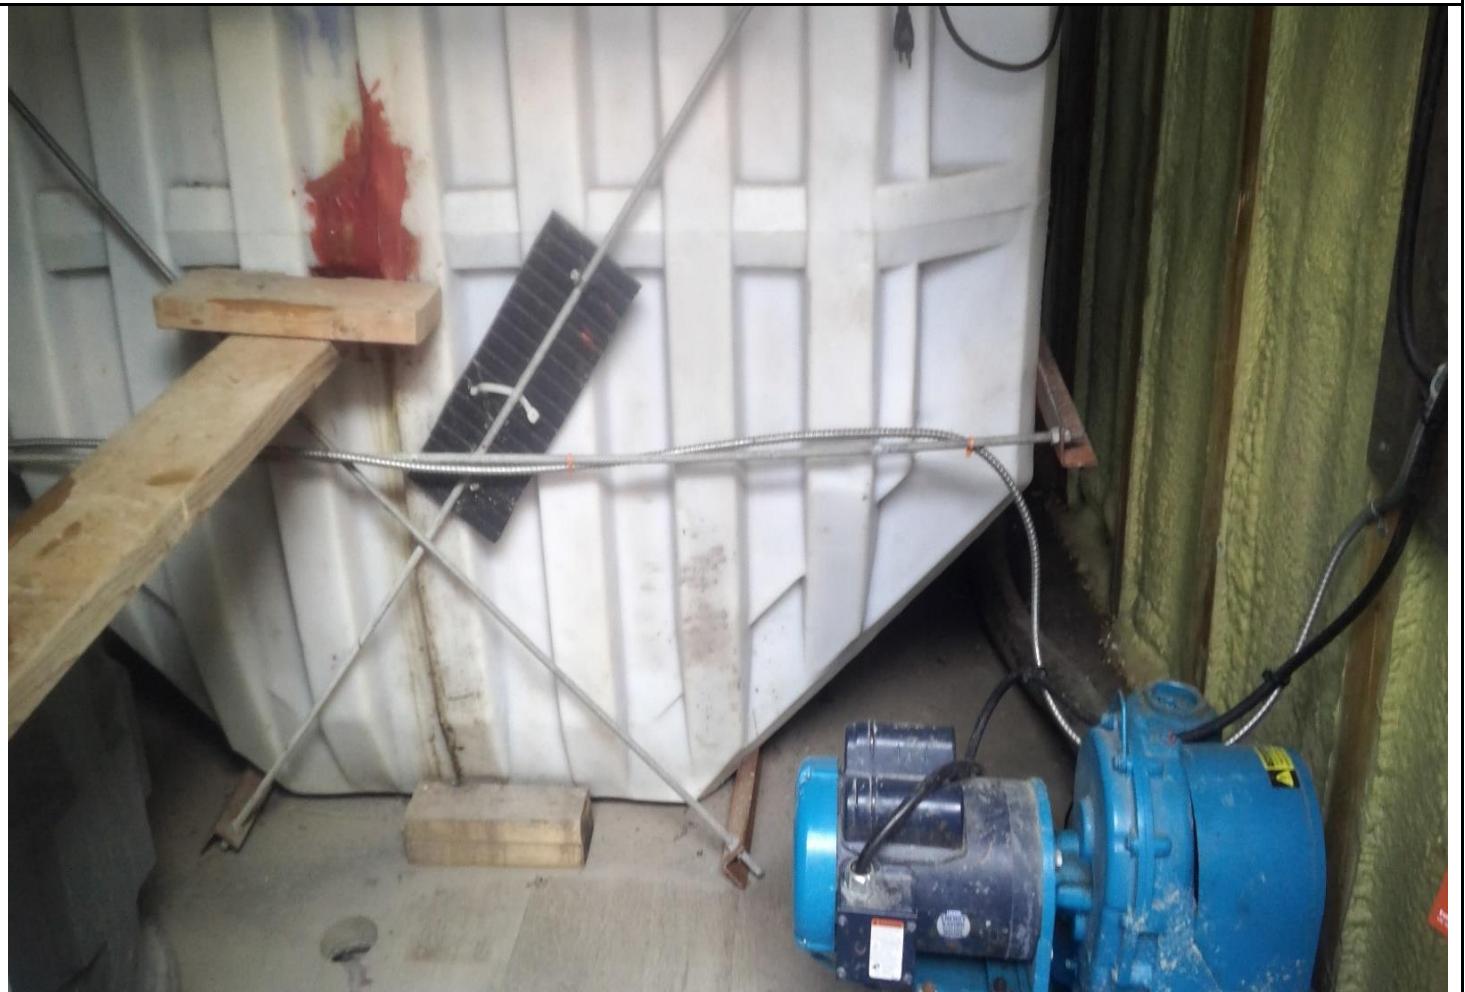
Photo 3

2. The water is held in a water storage tank located in a sea can next to the living quarters building (photo 2 & 3)
3. On April 1, 2022 Sylvia Ekelik, Nunavut Water Board sent Water Resource Officer(WRO) Joseph Monteith a copy of the Department of National Defence's 2021 Annual Report. In the annual report, there was no use of water, due to the closure of activity due to COVID-19 Restrictions.
4. 2 x Water Delivery Trucks on site (photo 4 & 5)
5. Water Usage Log shows Between May 27, 2022 and July 14, 2022, 291,000 Litres (291 m³) withdrawn from the Arctic Bay Water Source. They are authorized for 1200m³ a year (photo 22).

Description: Water Storage Tank #2, with water pump

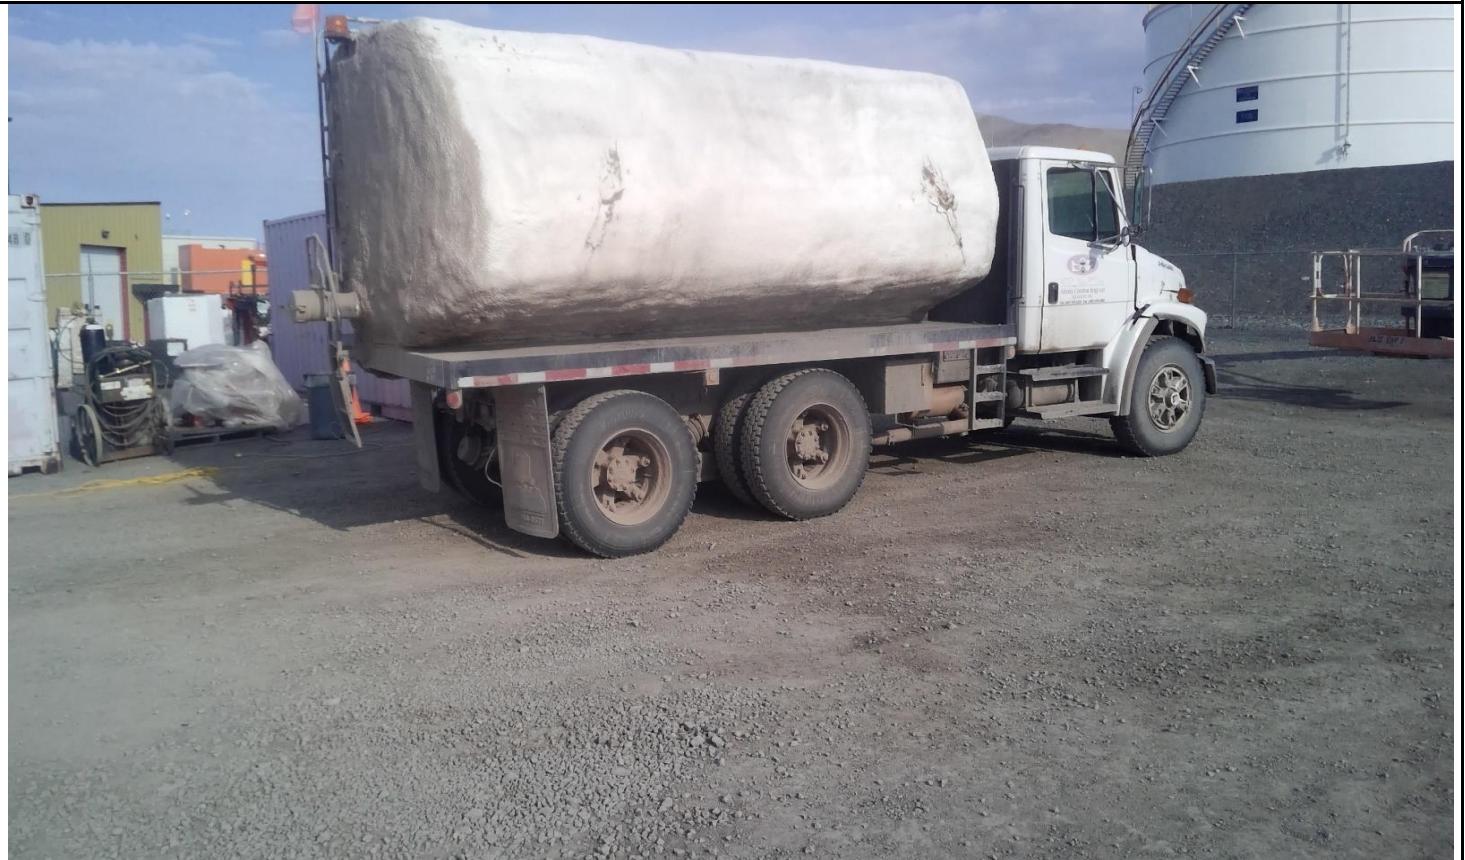
Photo 4

Description: White Insulated Mobile Storage Tank for Water.

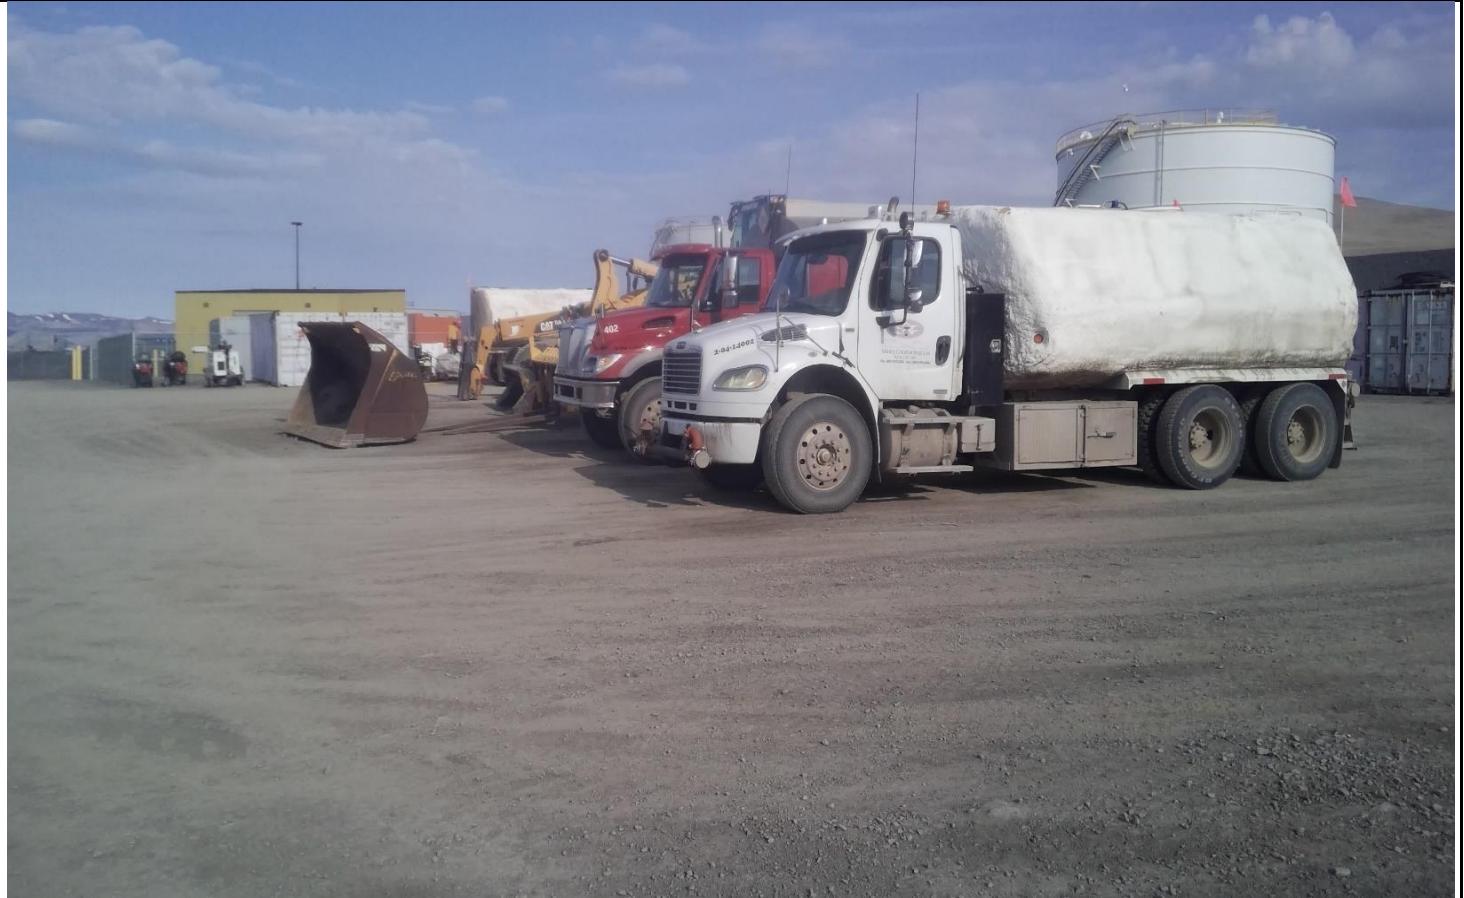
Photo 5

Description: all equipment historically stored near the water body were removed. No signs of banks being disturbed. White insulated mobile storage tanks for water.

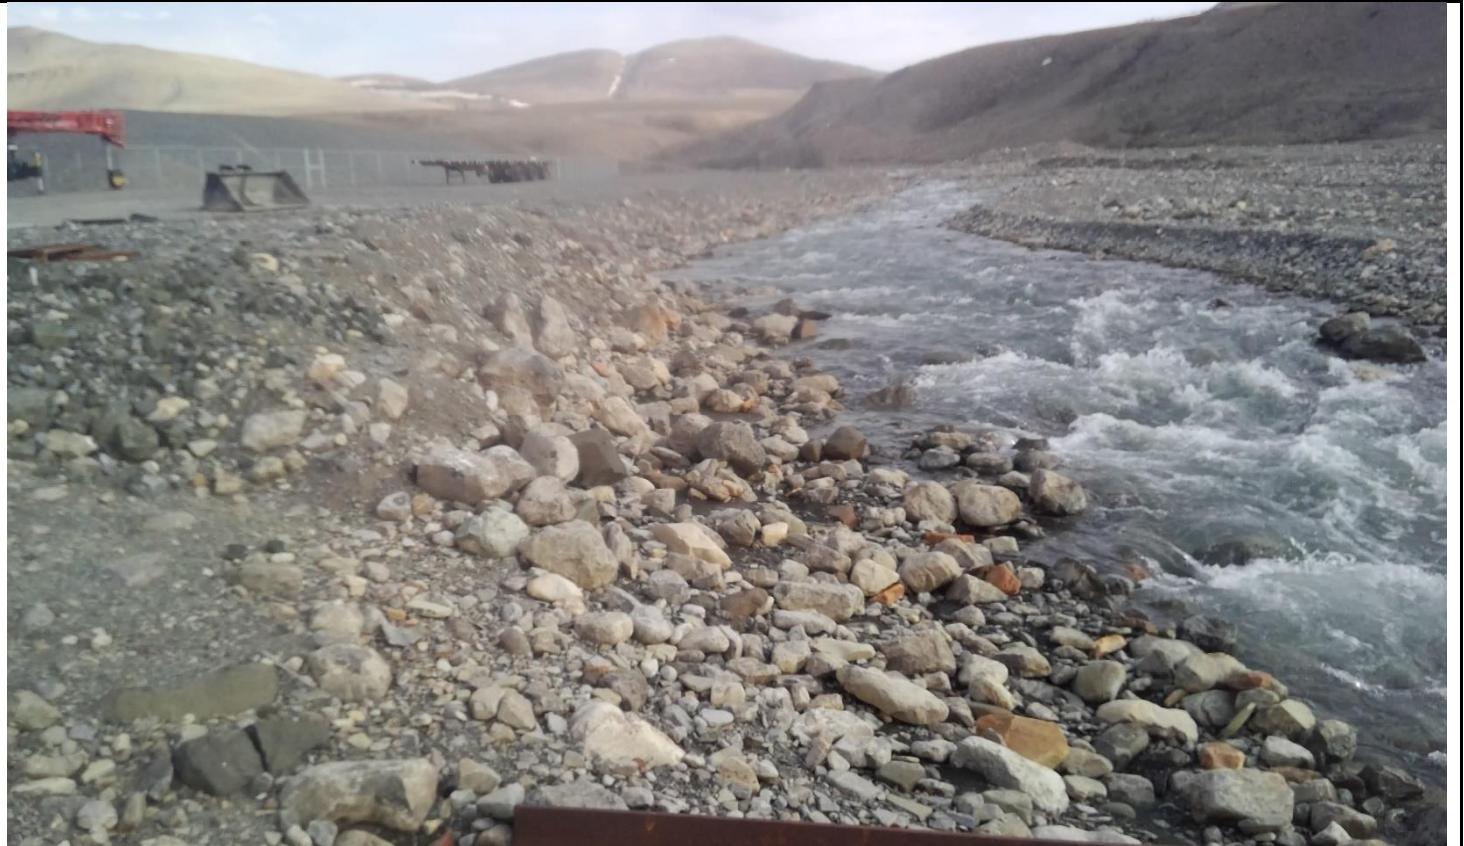
Photo 6

Description: Site of monitoring station at Twin Creeks. No concerns.

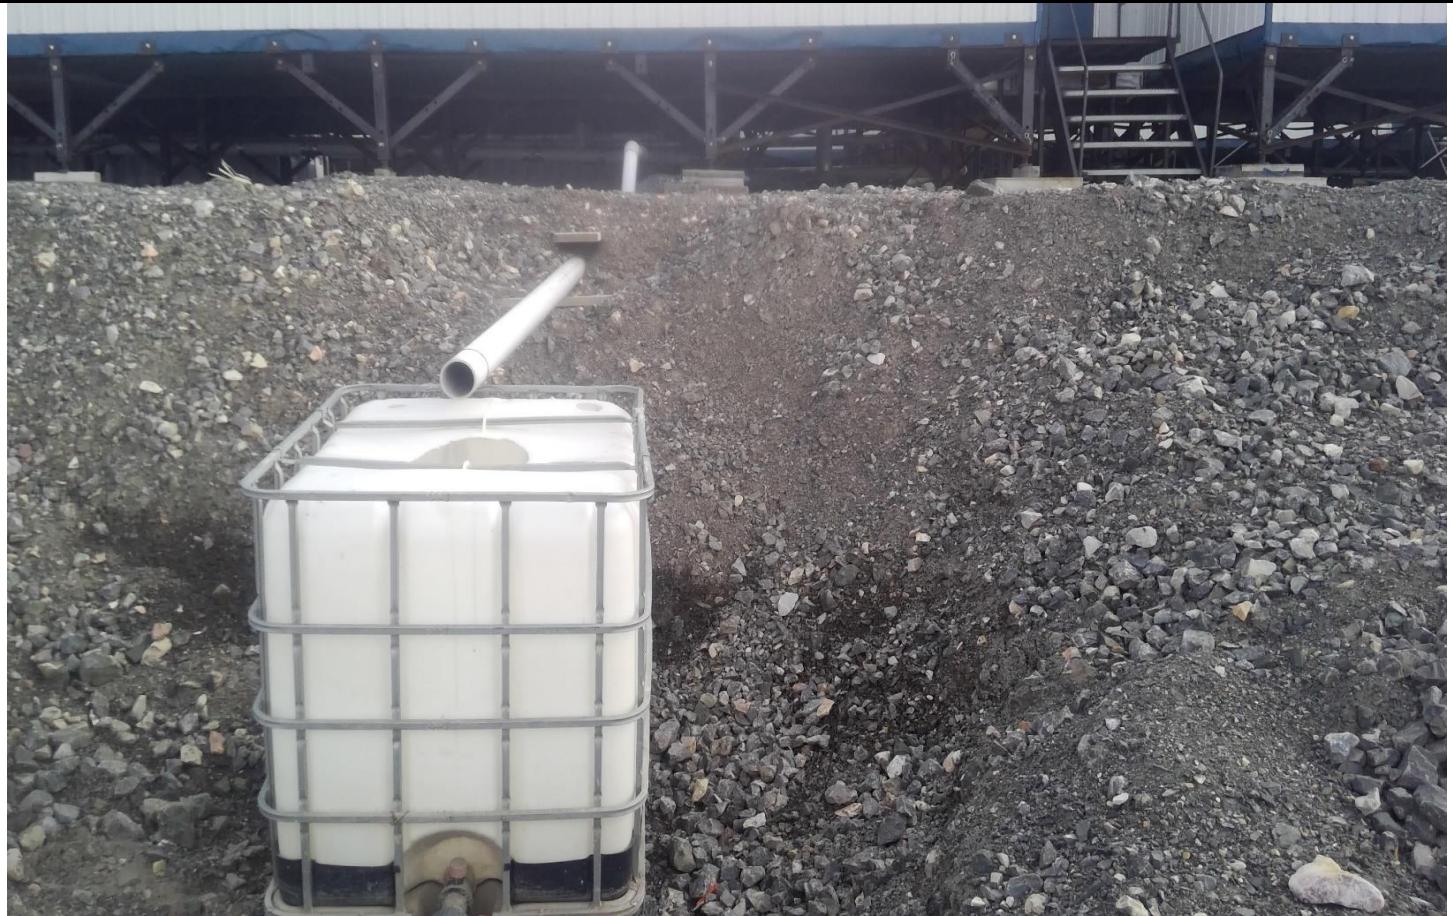
Photo 7

Description: Grey Water Sump Pit.

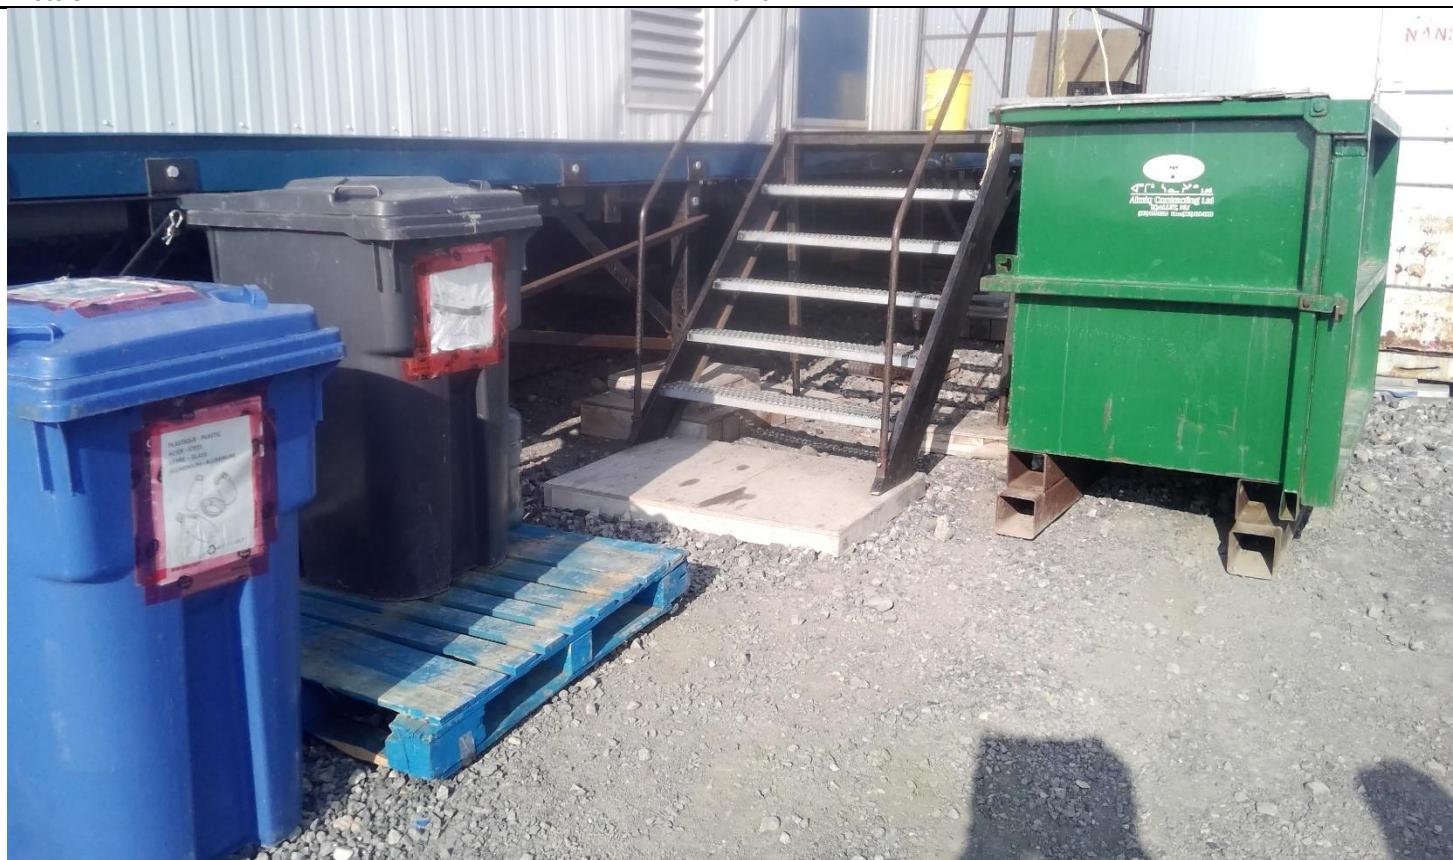
Photo 8

Description: Waste storage bins top corner pushed under a support for a cement pouring bucket.

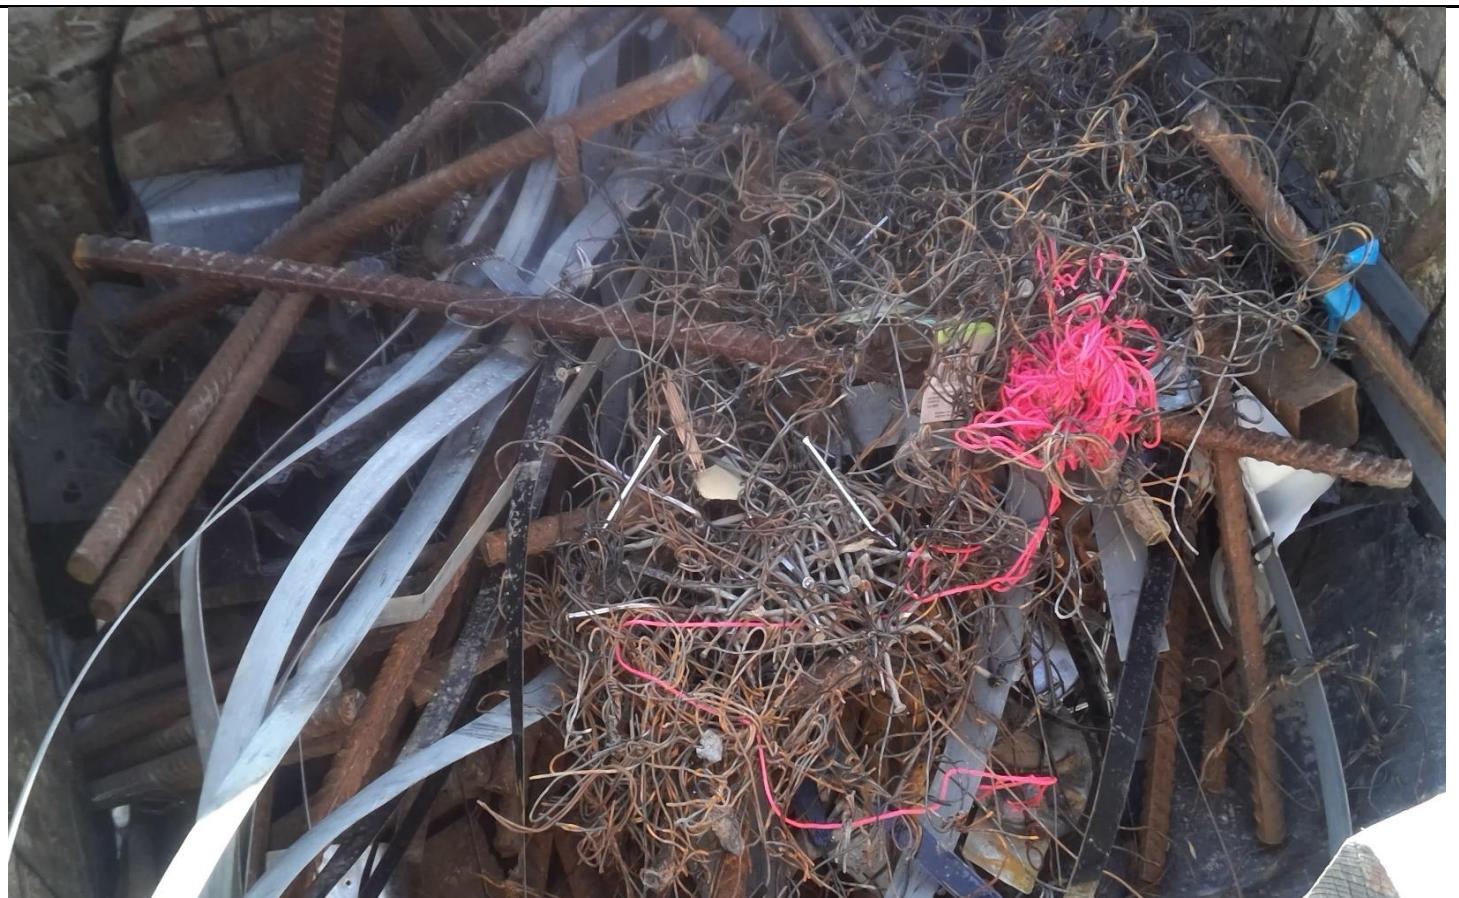
Photo 9

Description: Bulk Metal Waste Storage.

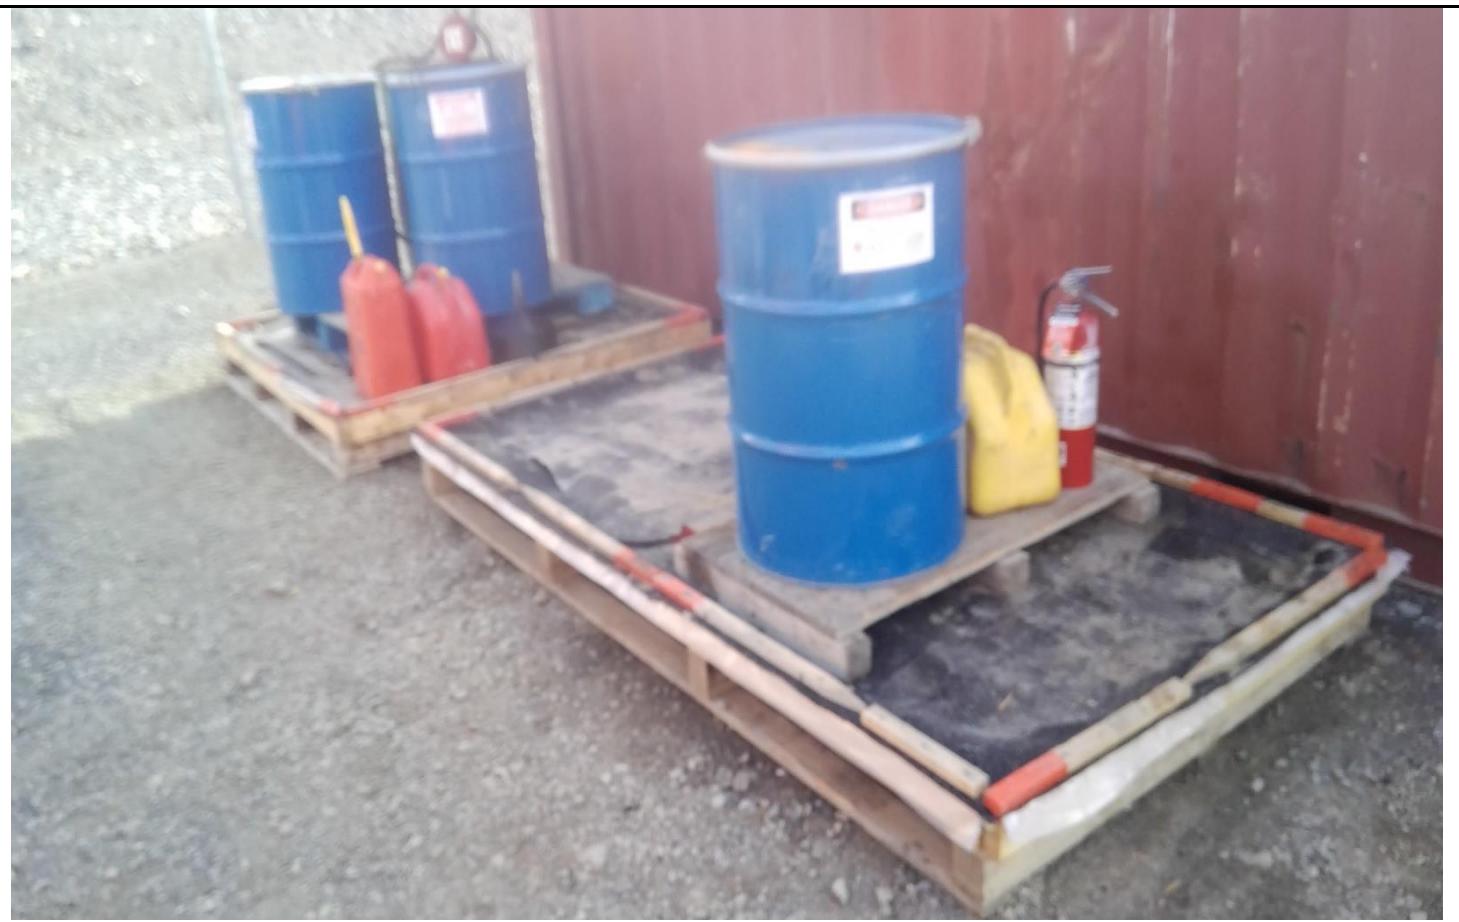
Photo 10

Description: Hazardous material placement, in secondary containment. Fuel pump, and ope

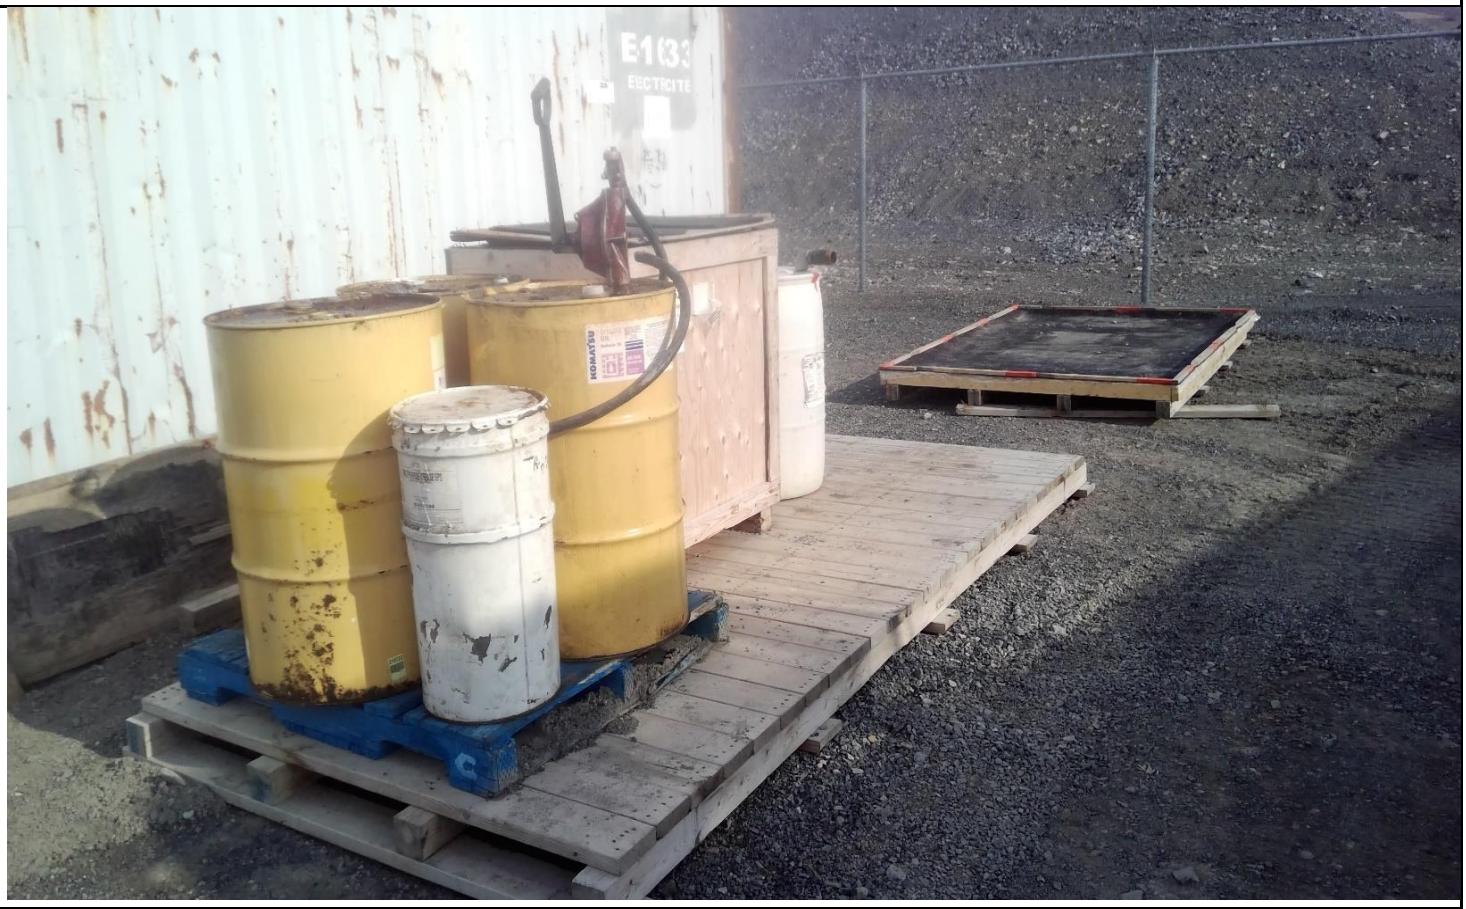
Photo 11

17. Hazardous Waste Storage inside a sea can away from the external elements (photo 12).
18. 2 x Fuel Transfer station, one of the transfer stations wasn't in secondary containment (photo 10 & 11).
19. Waste Batteries on Pallet (photo 15).

Description: Fuel Transfer Station. No secondary containment. No signs of spills.

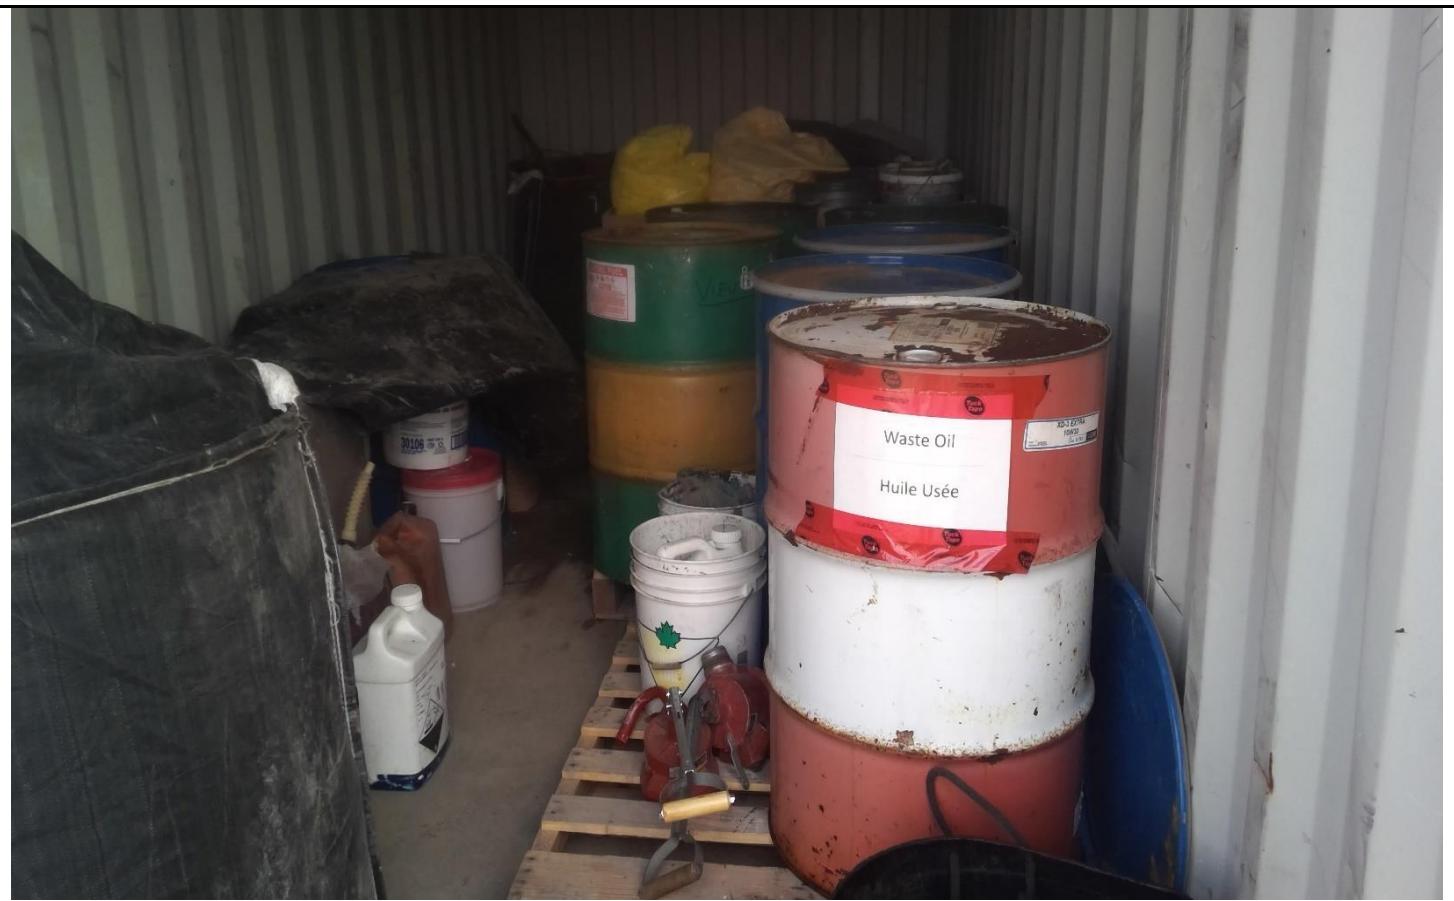
Photo 12

Description: Hazardous Waste Storage in sea can.

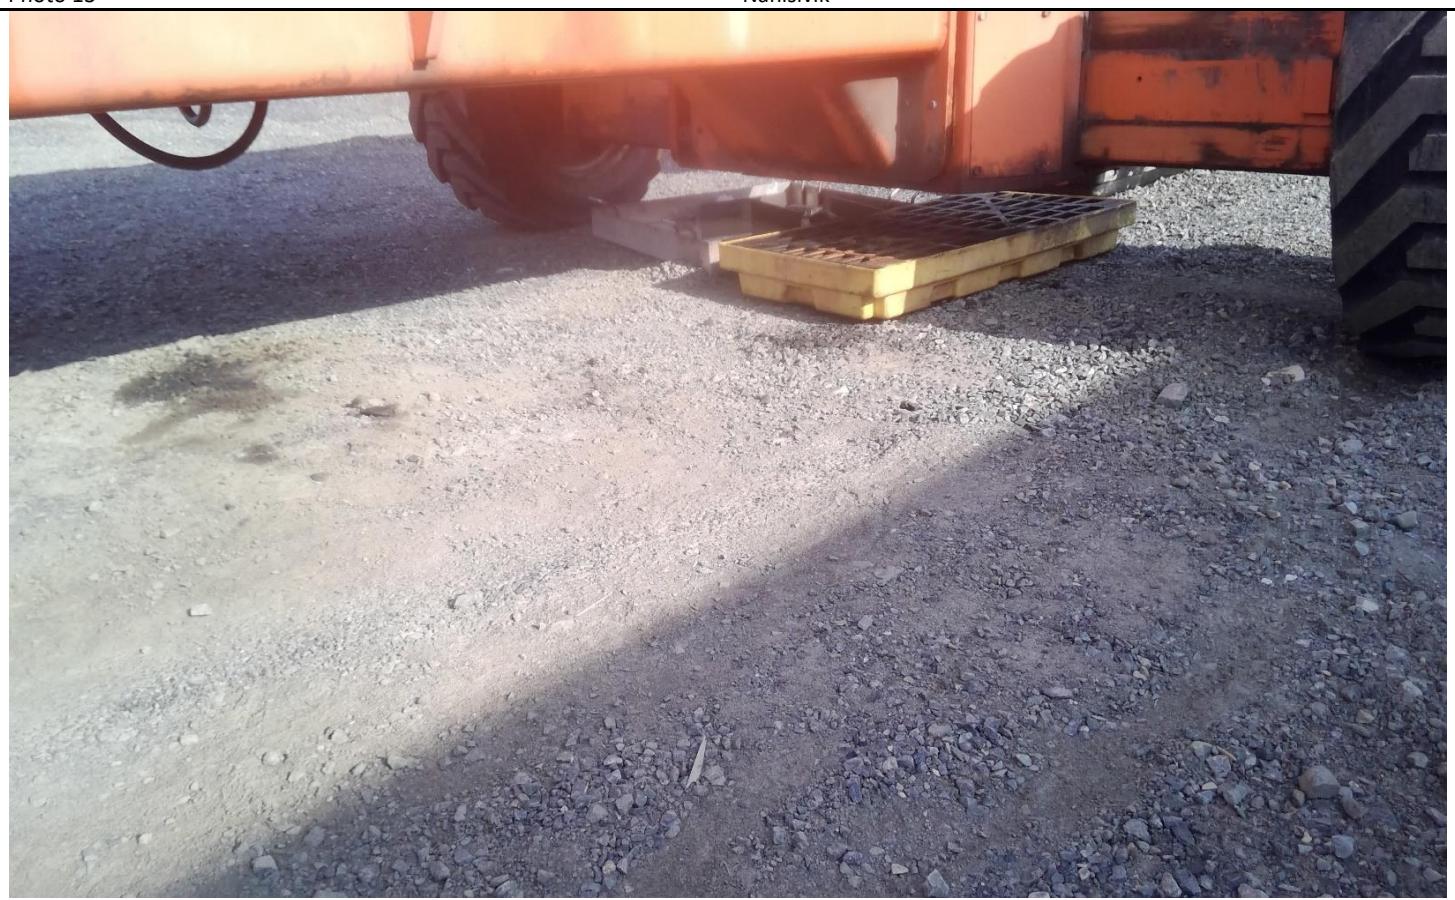
Photo 13

20. 4 spill reports were submitted in 2022. All spills were below the reportable quantity for reporting as outlined in the NT/NU Spills Working Group Agreement, and have been closed off in the Spills Database as remediated. All spills listed have been cleaned up.
21. Spill Report 2022-365 was submitted on July 17, 2022, for 22.73 Litres of Diesel
22. Spill Report 2022- 003 was submitted on January 1, 2022, for 9 Litres of Diesel
23. Spill Report 2022-285 was submitted on June 18, 2022, for 20 Litres of Diesel
24. Spill Report 2022-374 was submitted on July 22, 2022, for 30 Litres of Diesel.
25. 3 signs of spills observed on site (photo 13,14,22)

Description: sign of spill under Fork Lift. Secondary containment berm used as a drip pan, and a drip pan under fork lift.

SECTION 2	<input type="checkbox"/> Comments	<input type="checkbox"/> Non-Compliance with Act or Licence	<input checked="" type="checkbox"/> Action Required
3 x minor spills observed on site. Provide a detailed report for each spill report submitted as per the condition of the license.			
SECTION 3	<input type="checkbox"/> Comments	<input checked="" type="checkbox"/> Non-Compliance with Act or Licence	<input type="checkbox"/> Action Required
If during the term of this License an unauthorized discharge of waste occurs, or if such a discharge is foreseeable, the Licensee shall: a. Employ the approved Emergency and Spill Response Plan; b. Report the spill immediately to the NWT/NU 24-Hour Spill Line at (867) 920-8130 and to the Inspector at (867) 975-4284; and c. For each spill occurrence, submit to the Inspector, no later than thirty (30) days after initially reporting the event, a detailed report that will include the amount and type of spilled product, the GPS location of the spill, and the measures taken to contain and clean up the spill site.

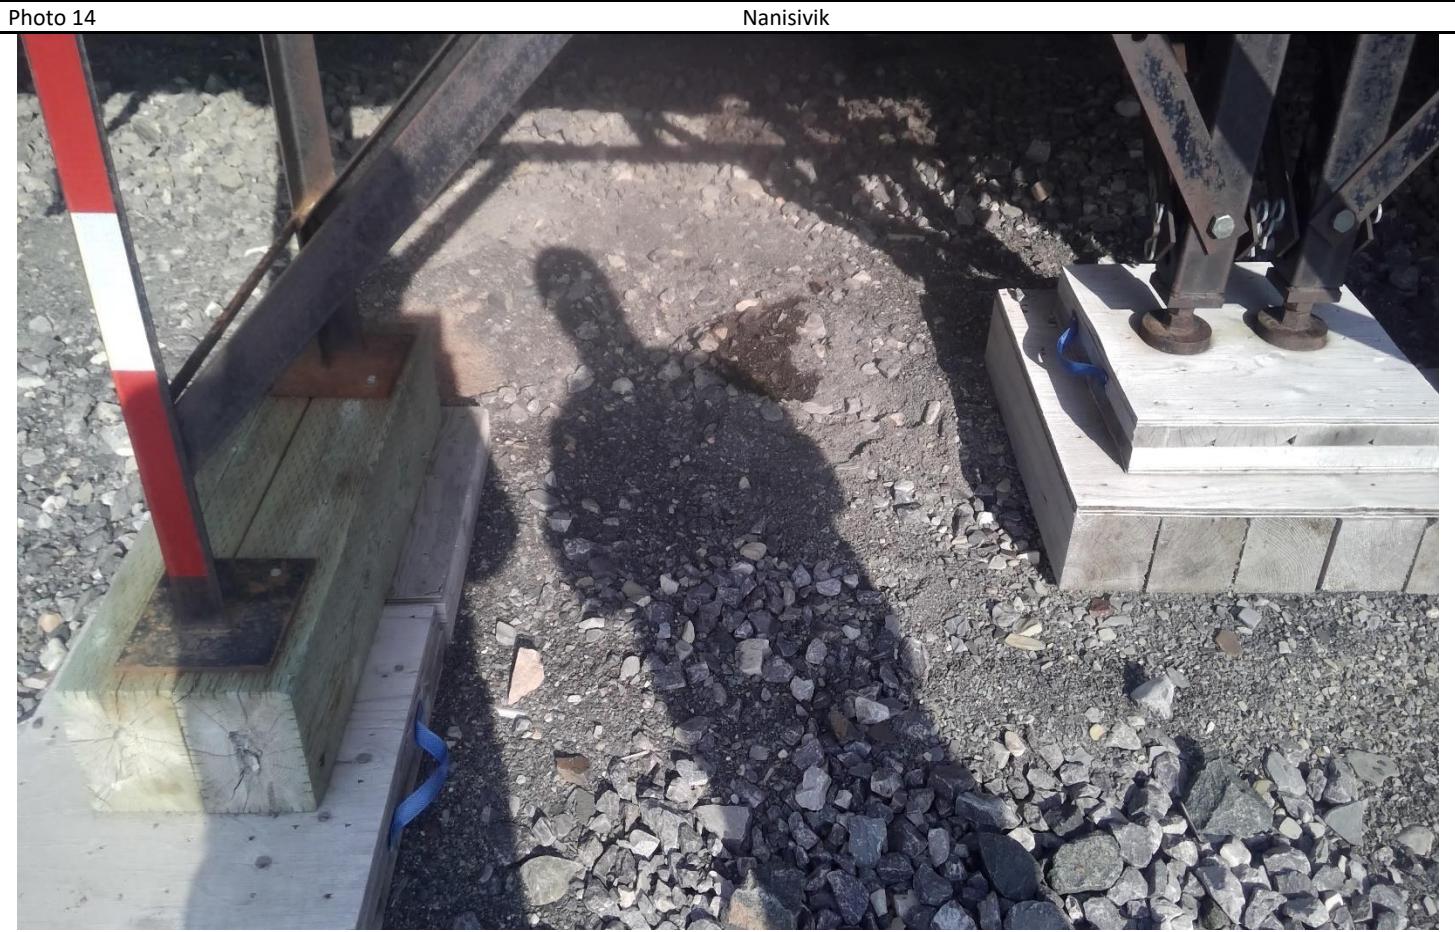
Photo 14

Description: sign of spill under building. Leak coming from building.

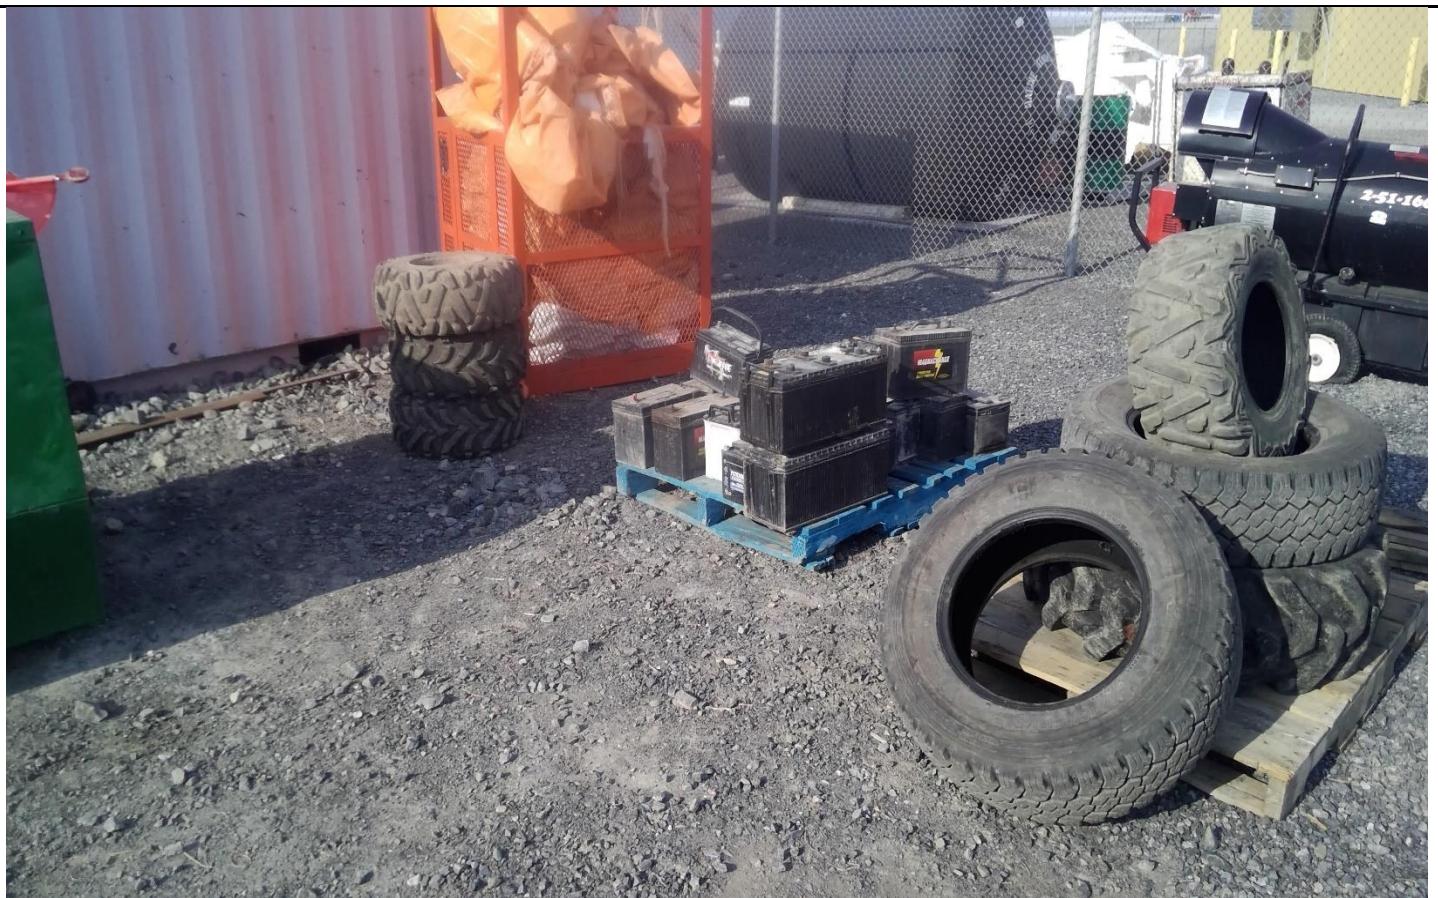
Photo 15

Description: Hazardous Waste Storage. Batteries on pallet waiting for transport to an approved waste disposal facility.

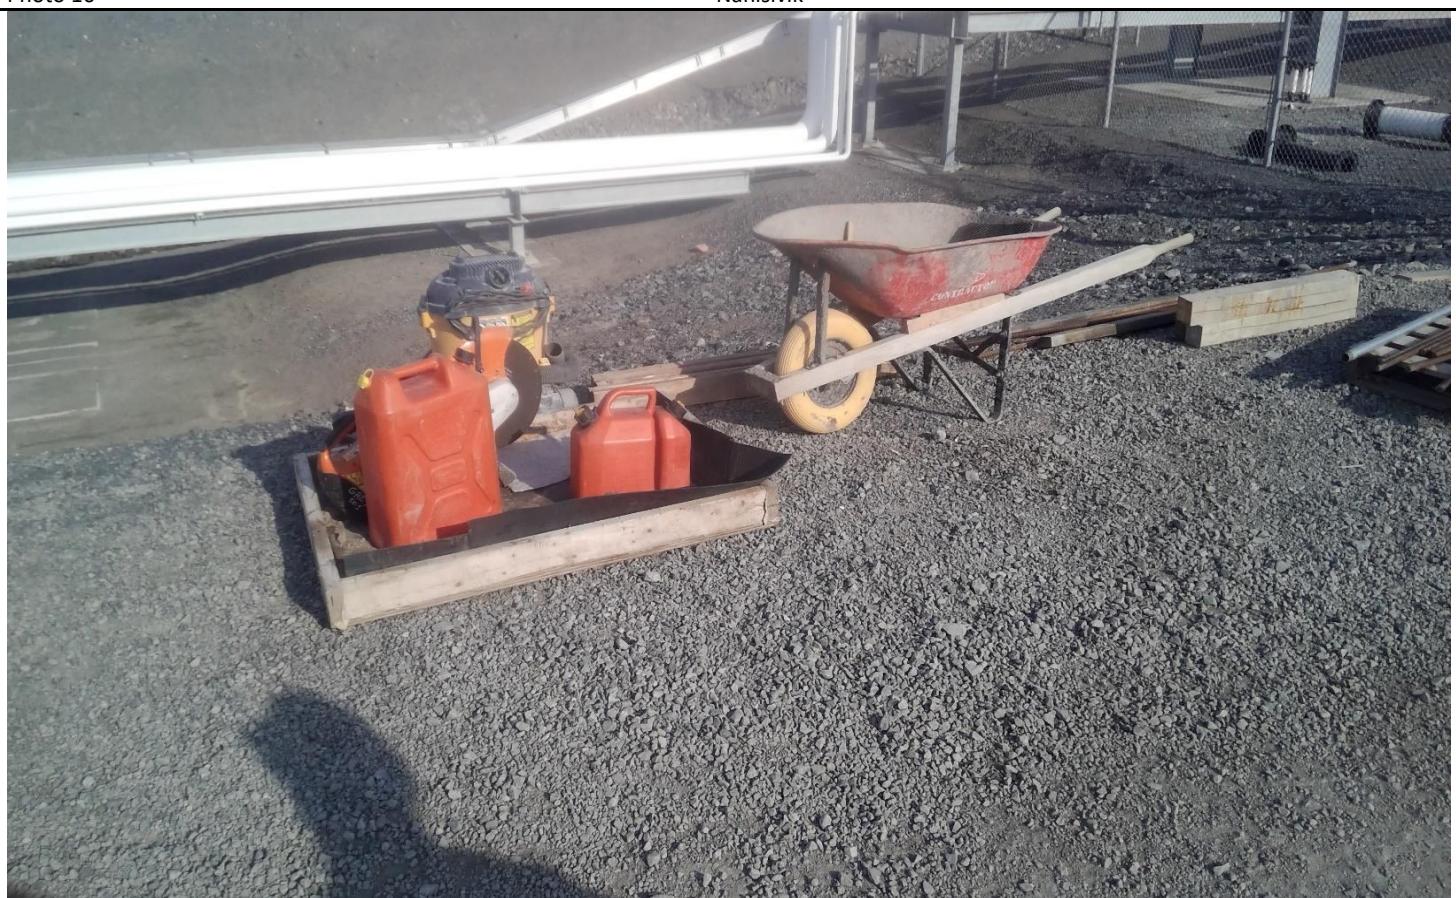
Photo 16

Description: 2 x fuel tanks in secondary containment.

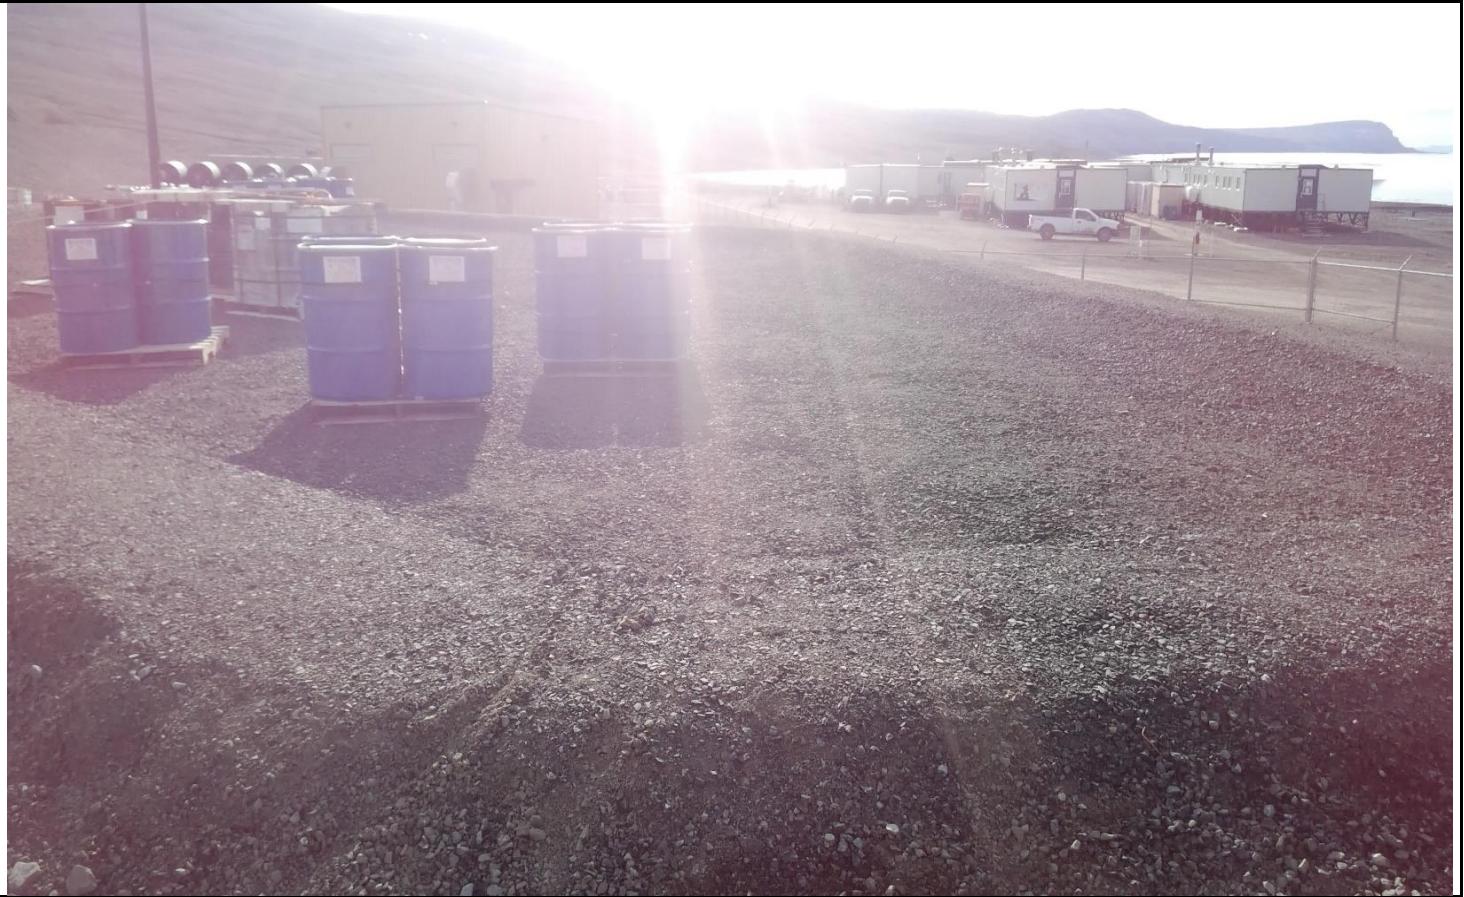
Photo 17

16. A fuel Cache was observed on site. The fuel cache is a bermed structure with secondary containment. There was 16 drums on 4 pallets, and 1x 900 Litre Tote Storage Container within the secondary containment (photo 17).

Description: 5 pallets of Fuel in drums. 1 900L tote Storage Container in secondary containment berm.

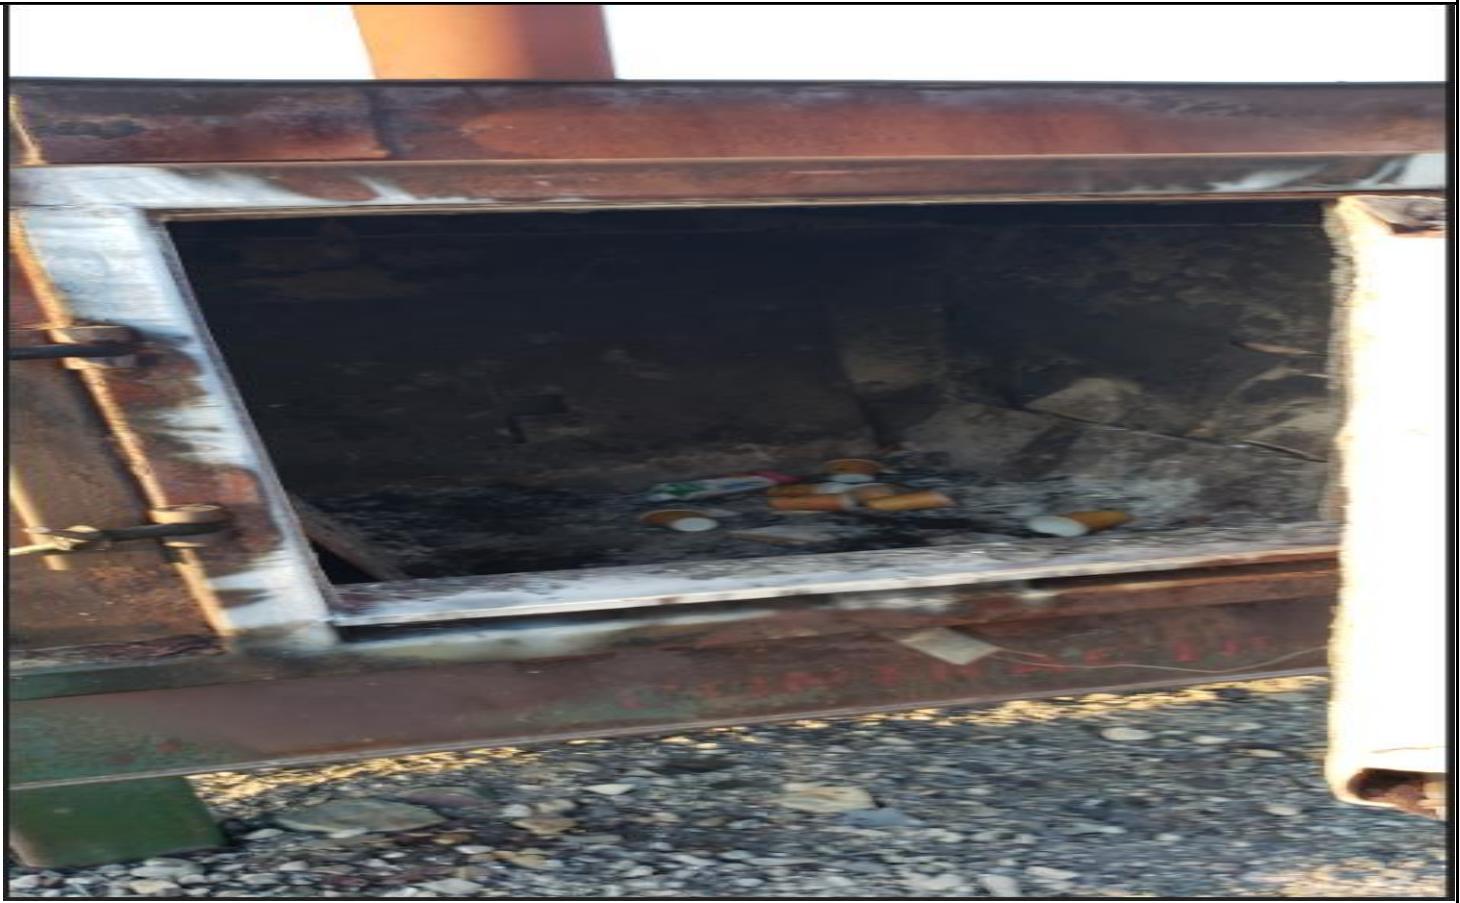
Photo 19

Description: No signs of any unauthorized items being incinerated.
