WATER LICENCE INSPECTION FORM

Licensee	Licensee Representative
Department of National Defence	Nicolas Billette
Licence No. / Expiry	Representative's Title
8BC-NNF2124	Environmental Coordinator
Land / Other Authorizations	Land / Other Authorizations
Date of Inspection	Inspector
July 9, 2022	Joseph Monteith
Activities Inspected	
<input checked="" type="checkbox"/> Camp: <input type="checkbox"/> Construction: <input type="checkbox"/> Drilling: <input checked="" type="checkbox"/> Fuel Cache: <input type="checkbox"/> Mining: <input type="checkbox"/> Reclamation: <input type="checkbox"/> Roads/Hauling: <input type="checkbox"/> Other:

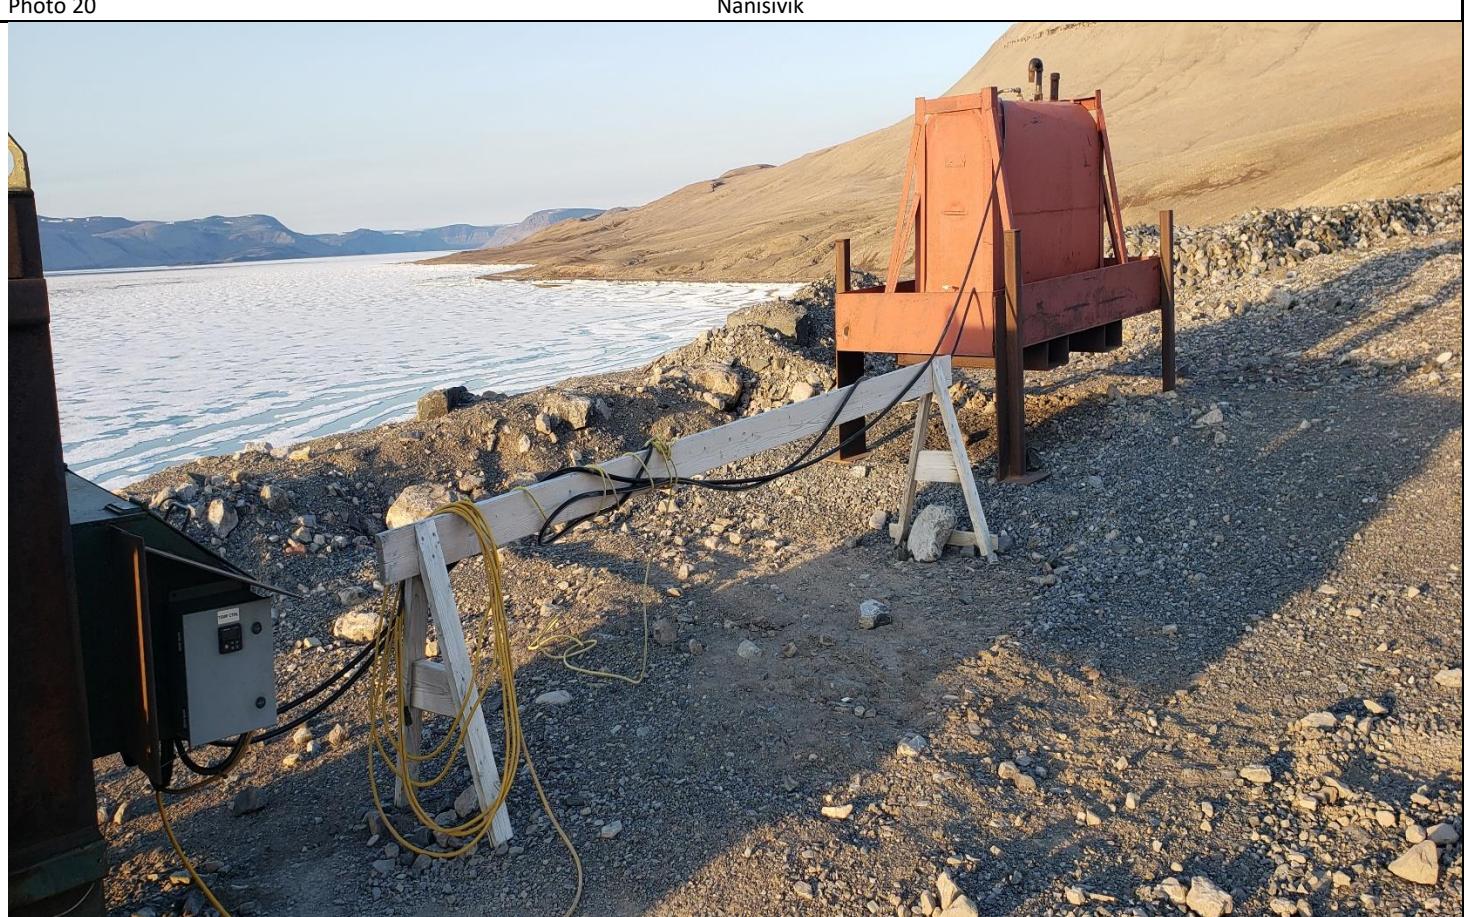
Photo 20

Description: Incinerator to Fuel Storage Tank. Electrical and fuel lines. Sign of spill under fuel storage tank.

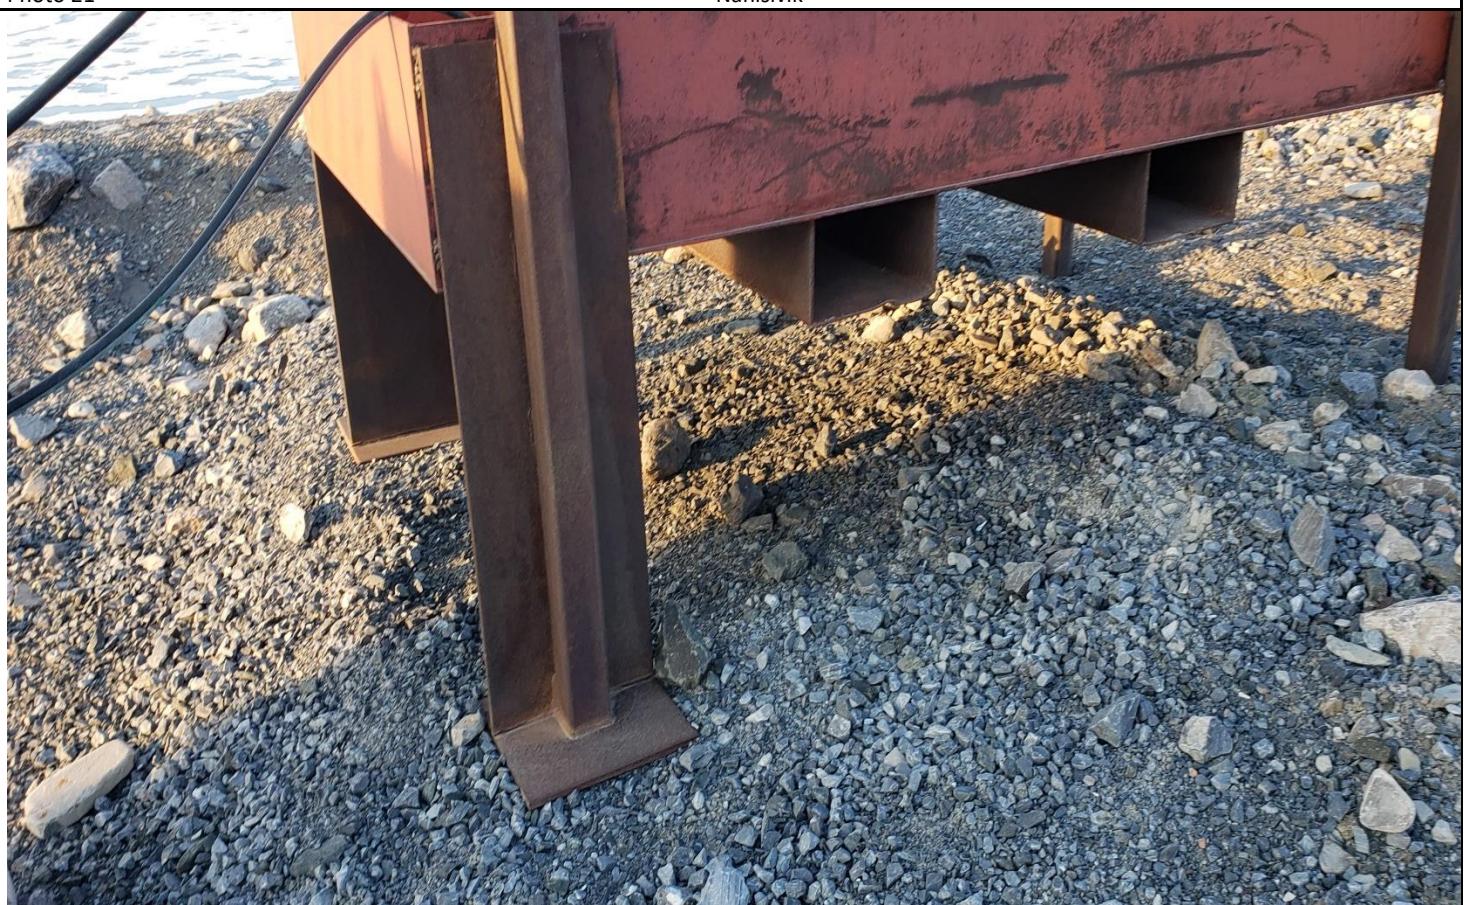
Photo 21

Description: sign of spill under fuel storage tank.
