Cape Christian, August 31st, 2009

RE: Mitigation Plan to Restore all Impacted Grounds and Waters on the “Old Roadway” – Road between Clyde River and Cape Christian

Identification of Impacted Sites and Proposed Restoration Methods

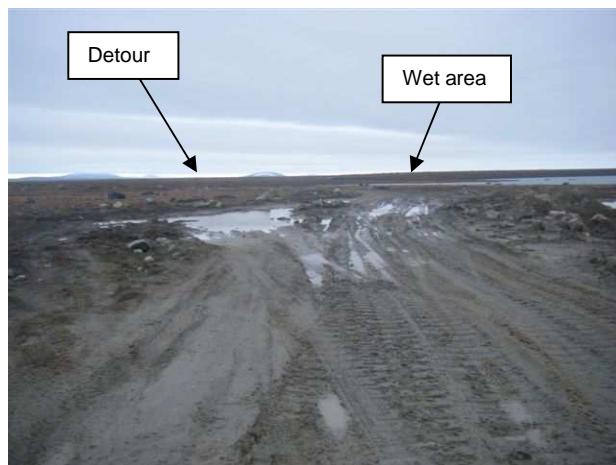
The **first** impacted area is located 2.7 km from the Cape Christian camp. The area is a detour made around a wet area as shown in picture 1.

Picture 1: Area 1 to be restored (2.7 km from the camp)

- Wet area of the old roadway will be backfilled and brought to grade;
- The detour will be dewatered by pumping into the tundra 30 m away from any water course;
- The detour will be filled to grade, landscaped and crowned;
- The detour will be blocked by rocks, to match adjacent terrain.

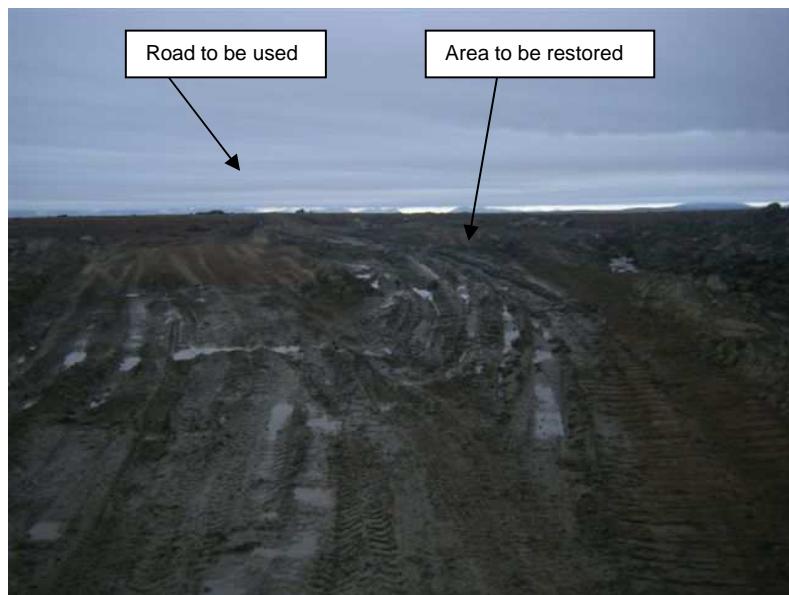
The **second** impacted area is located 2.9 km from the Cape Christian camp. It is also a detour made around a wet area (see picture 2).

Picture 2: Area 2 to be restored (2.9 km from the camp)

This area comprises 3 road paths that all require mitigation. The measures to be implemented are:

- The left area that will be used as the road will need to be backfilled, graded and compacted;
- The 2 bypass paths (to the right) will be regarded, crowned;
- Drainage will be promoted away from the area;
- The unused path will be blocked with rocks, to match the adjacent terrain.

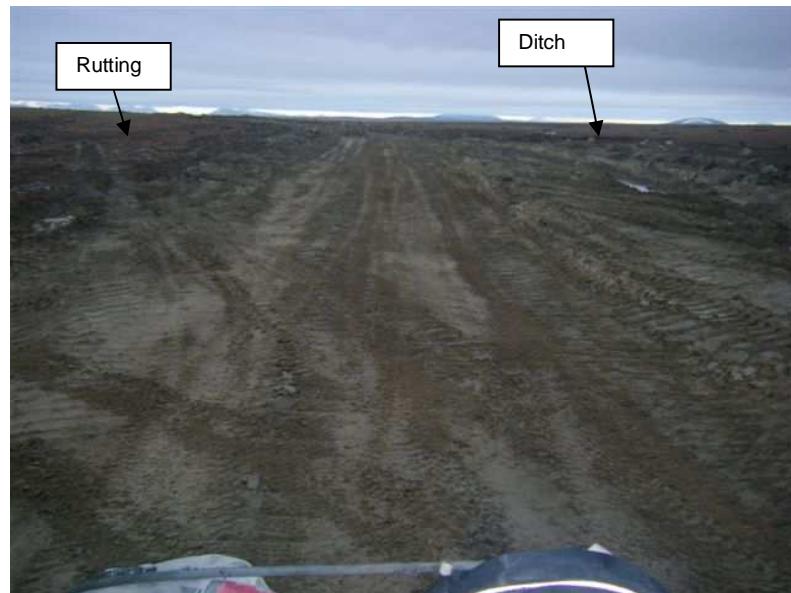
The **third** impacted area is located between 3.1 and 3.8 km from the Cape Christian camp. This is a section of the old road that is not anymore planned to be used. As shown on the map (see attached), that section of the road path was re-routed to avoid very wet areas. The next 6 pictures show the impacted areas within that section of the old road.

Picture 3: Area 3 to be restored (3.1 to 3.8 km from the camp)

- All pounded water will be pumped out and drained into the tundra at least 30 meters from any water course;

- Drainage ditches will be backfilled;
- The road will be backfilled to grade and crowned using stockpiled material beside the road or additional fill that will be hauled if needed;
- All rutted area will be graded to match the surrounding terrain;
- The entrances of that road section will be blocked by rocks to ensure damages are not done from further vehicles and equipment.

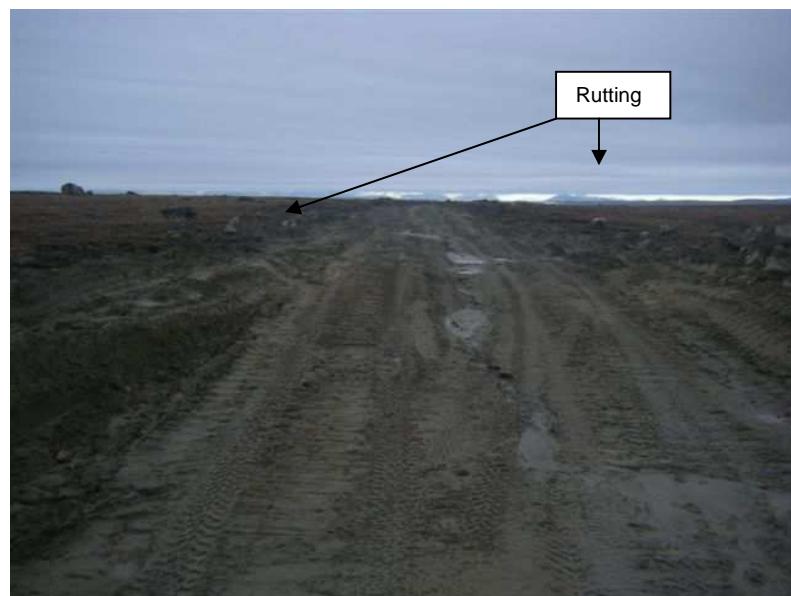
Picture 4: Area 3 to be restored (3.1 to 3.8 km from the camp)

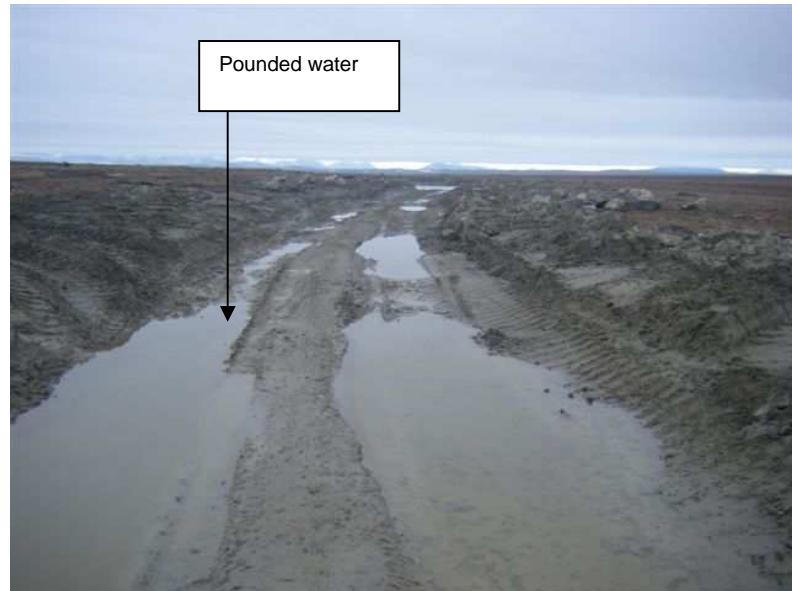
Picture 5: Area 3 to be restored (3.1 to 3.8 km from the camp)

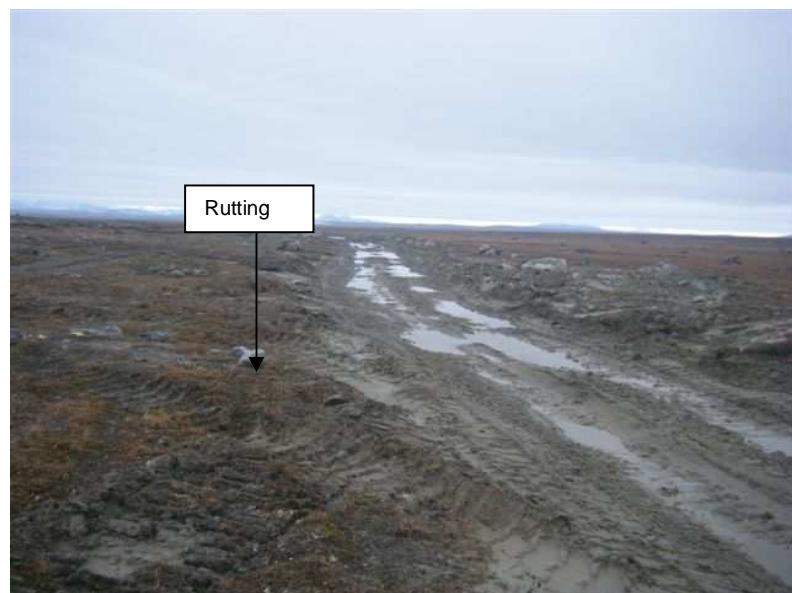
Picture 6: Area 3 to be restored (3.1 to 3.8 km from the camp)

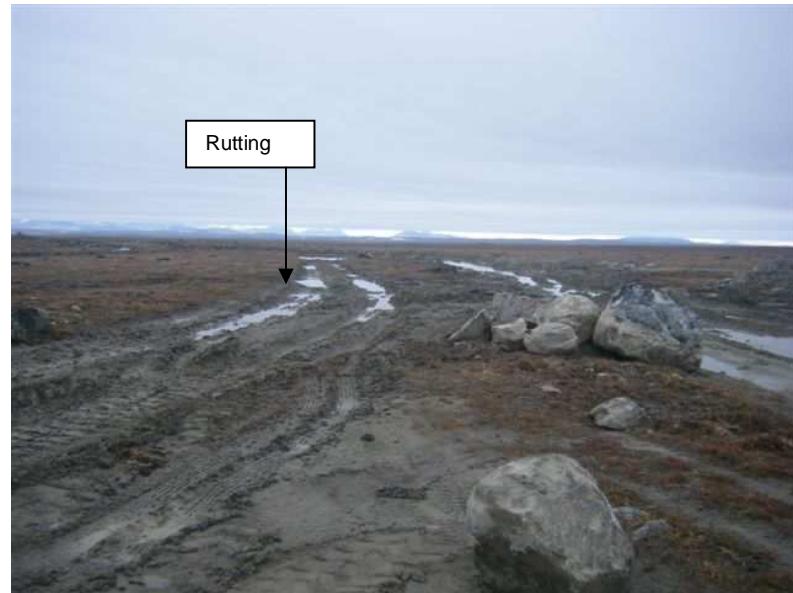
Picture 7: Area 3 to be restored (3.1 to 3.8 km from the camp)

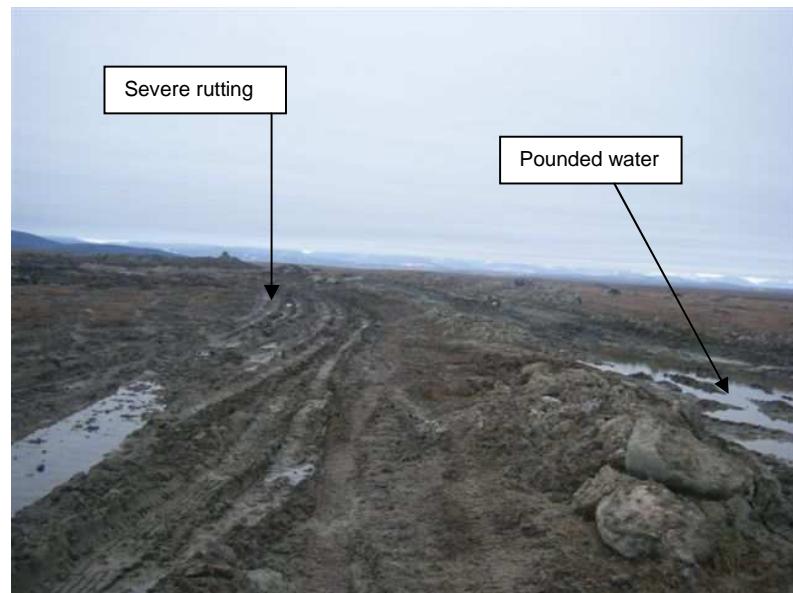
Picture 8: Area 3 to be restored (3.1 to 3.8 km from the camp)

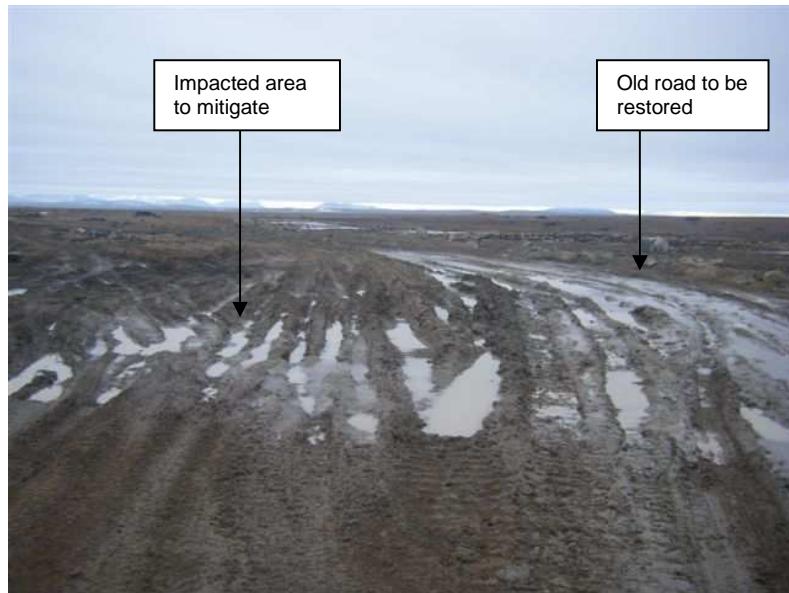
The **forth** impacted area is located at 4.4 km from the camp. This is again a detour area from the old road that was made to avoid a very wet spot. The area can be viewed through picture #9.

Picture 9: Area 4 to be restored (4.4 km from the camp)

- The right hand side that will be used for the road will need to be backfilled above grade;
- The left hand side back-bladed and sloped for drainage;
- Fill will be added as needed to ensure the area matches the surrounding terrain.

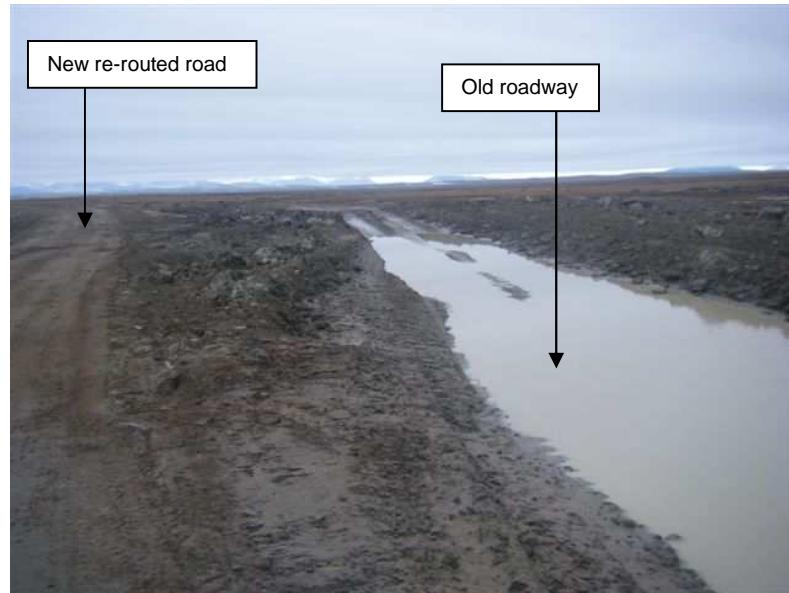
The **fifth** impacted area is located at the crossing where the new re-routed road is starting and splits from the old roadway. This area is located at 4.6 km from the Cape Christian site. Picture 10 shows the area that will need to be restored.

Picture 10: Area 5 to be restored (4.6 km from the camp)

- All pounded water will be pumped out and drained into the tundra at least 30 meters from any water course;
- The old road will be backfilled to grade and crowned using stockpiled material beside the road or additional fill that will be hauled if needed;
- The entrances of that road section will be blocked by rocks to ensure damages are not done from further vehicles and equipment.

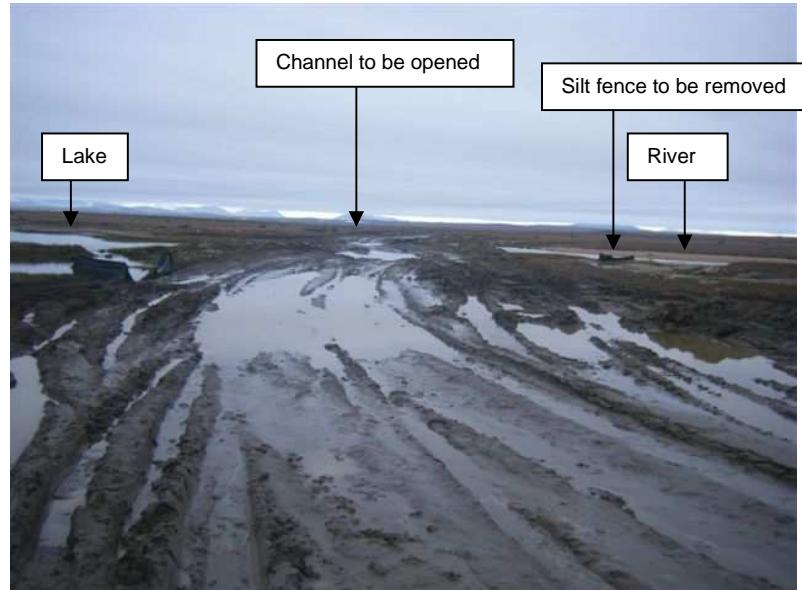
The **sixth** area is located at 4.8 km from the camp area. It is a location where a culvert (#3) was initially planned to be installed. Silt fences are installed in the area to prevent the entry of any sediment. Picture 11 shows the impacted area. The mitigation plan will include:

Picture 11: Area 6 to be restored (4.8 km from the camp)

- Dewater, backfill and crown low areas;
- Open the channel between the lake on the left and the river on the right at the location where culvert number 3 was supposed to be installed originally;
- On a 10 feet section wide within that channel, place rip-rap material in the bed to minimize any impact should the path be used again in the future by ATVs;
- After the channel is built, remove the silt fences to allow for fish passage.

For the impacted area 6, silt fences are already installed at the inlet and the outlet of the stream channel that will need to be opened to allow fish passage. Those silt fences will also remain when rip-rap material will be placed into the bed on a 10 feet wide section, to mitigate any further passage by ATVs should the path be used by residents of Clyde River as it has been the case for many years. The silt fence will be removed once any sediment will have settled after the above mentioned work will be completed.

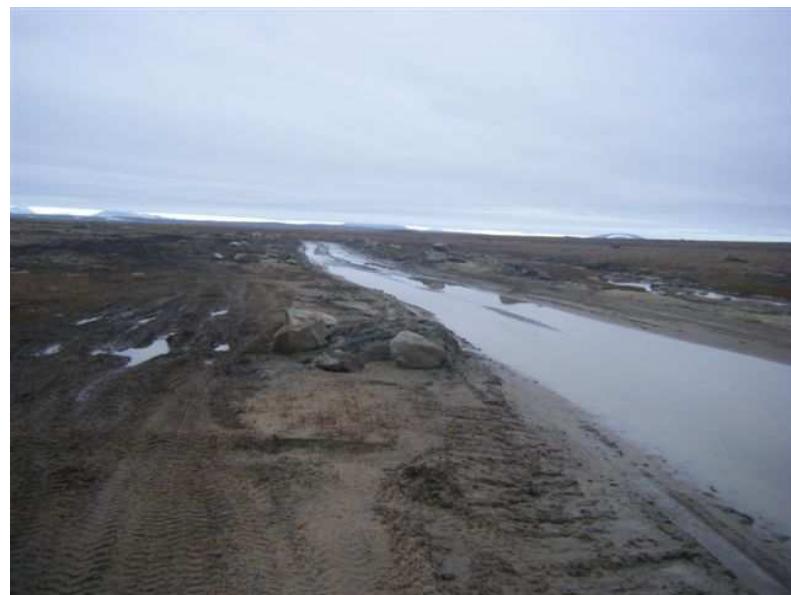
The **seventh** area is located between the 5.0 and 5.1 km from the camp where there are 2 impacted areas with pounding water. Pictures 12 and 13 show the locations and the areas which will need mitigation.

Picture 12: Area 7 to be restored (5 km from the camp)

- Dewater and drain into the tundra at least 30 meters from any water course;
- Rutting on the side will be back-bladed;
- All stockpiled gravel material will be used for backfill and/or levelled;
- Backfill and crown as required matching the surrounding terrain.

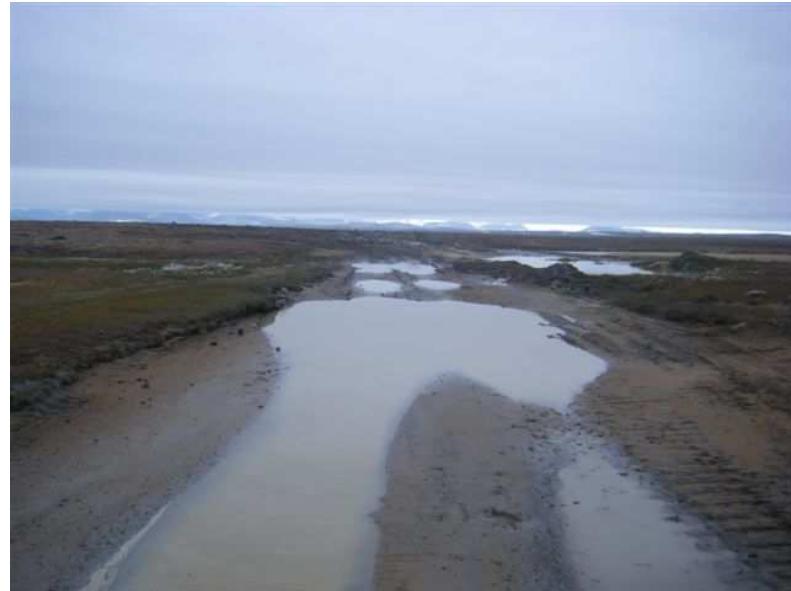
Picture 13: Area 7 to be restored (5.1 km from the camp)

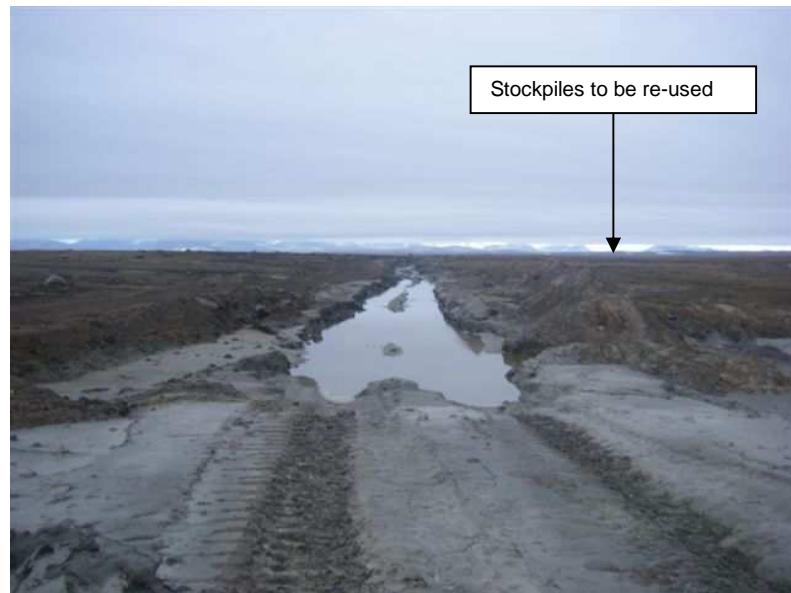
The **eighth** impacted area is located 5.2 km from the camp. It is a portion of the old roadway that sank in and was by-passed on the side. Picture 14 shows the area.

Picture 14: Area 8 to be restored (5.2 km from the camp)

- Dewater and drain into the tundra at least 30 meters from any water course;
- Left side path to be back-bladed and scarified to promote growth;
- Ditches to be backfilled and covered with rocks;
- Backfill the old roadway and crown as required matching the surrounding terrain.

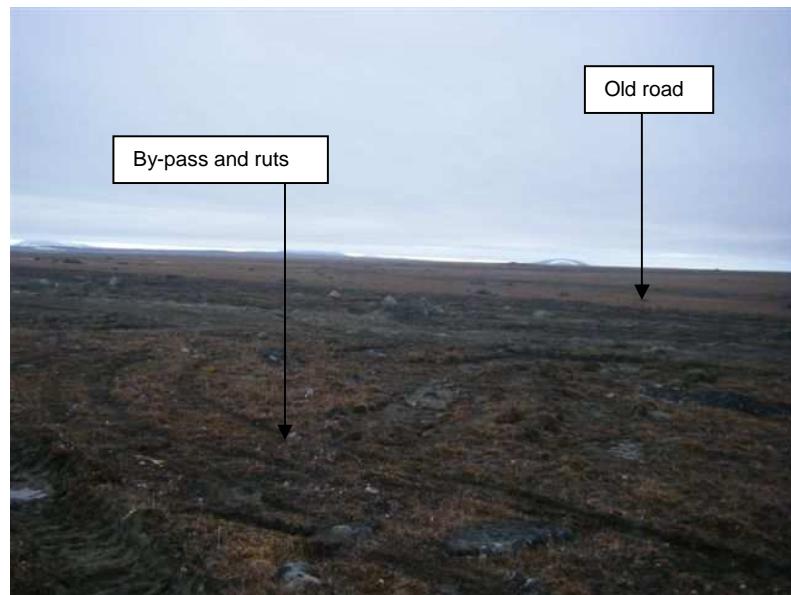
The **ninth** impacted area is located on the old roadway at 5.5 km from the Cape Christian camp site. Damages were made by attempting a by-pass to the old road that became too wet as shown on picture 15.

Picture 15: Area 9 to be restored (5.5 km from the camp)

- The by-pass area will be back-bladed and levelled to match the surrounding area;
- The old road will be dewatered, backfilled and crowned.

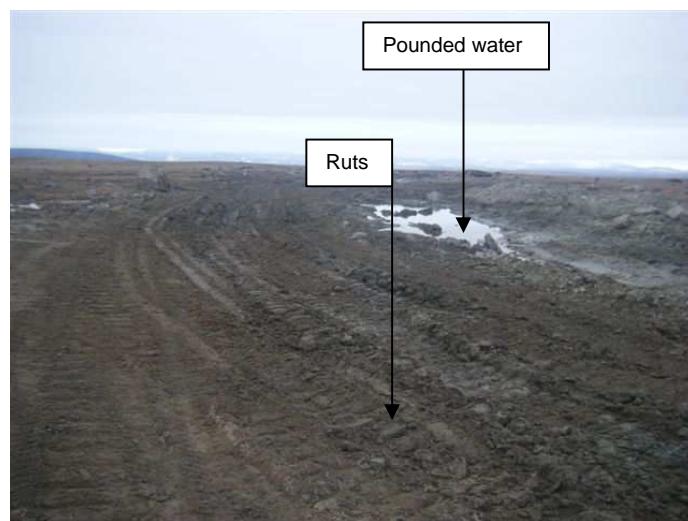
The **tenth** impacted areas are located between 5.7 and 6.1 km from the camp in three small distinct locations having similar impacts (ruts, pounded water). Pictures 16 to 18 show these locations.

Picture 16: Area 10 to be restored (5.7 km from the camp)

- Dewater and drain into the tundra at least 30 meters from any water course;
- Backfill the old roadway and crown as required matching the surrounding terrain.

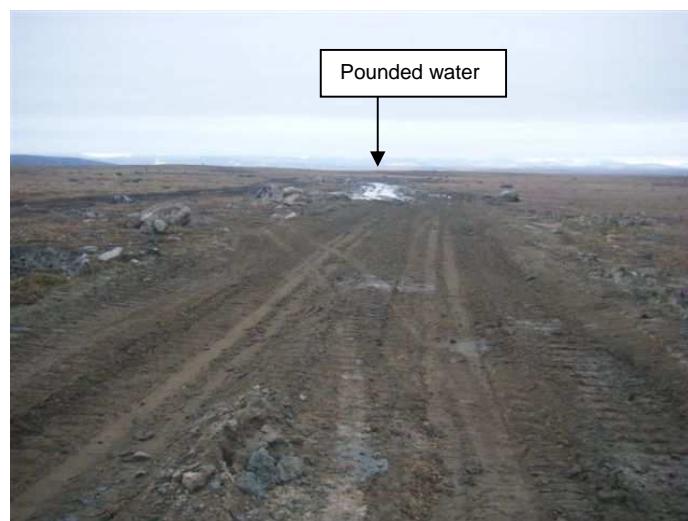
Picture 17: Area 10 to be restored (5.9 km from the camp)

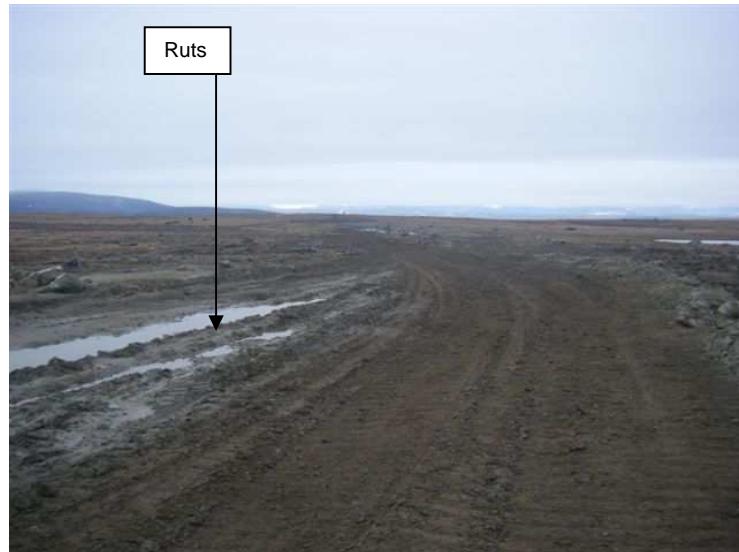
Picture 18: Area 10 to be restored (6.1 km from the camp)

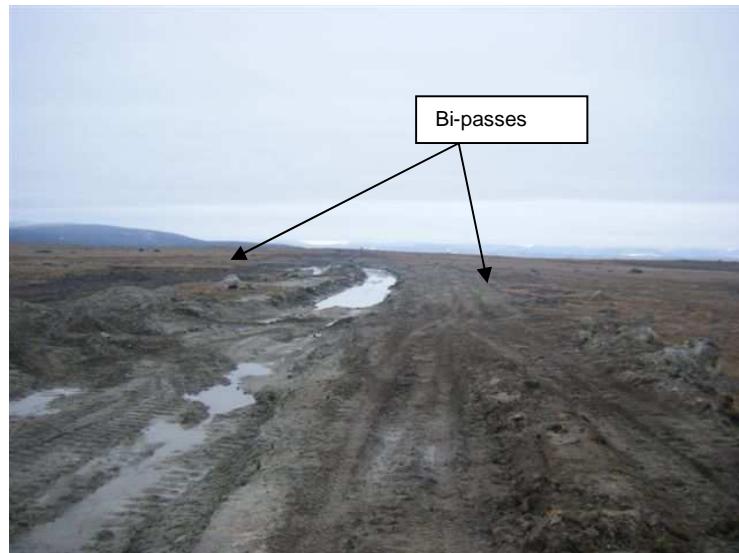
The **eleventh** impacted area is located 6.2 km from the camp. The old road has sunk in and by-passes were used on both sides to the damaged section. Picture 19 shows the location.

Picture 19: Area 11 to be restored (6.1 km from the camp)

- The old road will be dewatered, backfilled and crowned to the matching grades;
- The material from the right sided by-pass will be used to backfill the old road. The ground will then be scarified;
- The left sided by-pass will be dewatered, backfilled and crowned.

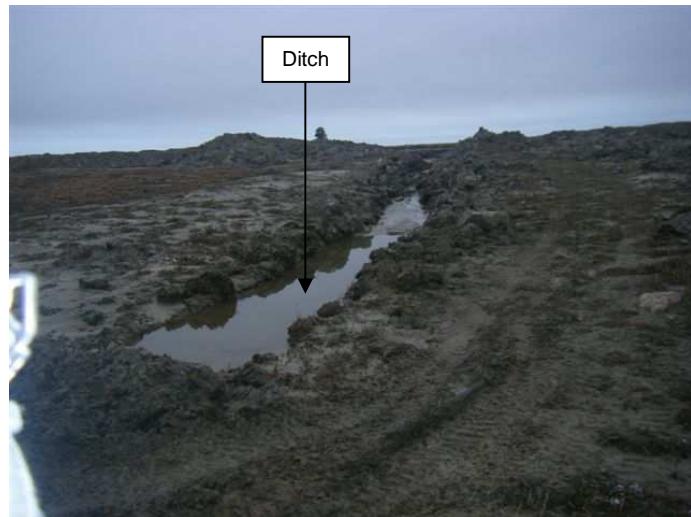
The twelfth impacted area consists in a ditch that was constructed earlier to drain the old roadway. The area is located 6.3 km from the camp. The ditch as shown in pictures 20 and 21 drains into the tundra that is sloped toward a lake.

Picture 20: Area 12 to be restored (6.3 km from the camp)

- Install a silt fence at the end of the ditch;
- Backfill the ditch with stockpiled material and cover with rock;

For the impacted area 12, the potential impact would result from the overflow of pounded water in the ditch that will eventually flow into the downstream lake. In order to prevent any sediment to enter the lake, a silt fence will be installed prior to remediation work and will be maintained in place until it is observed that the water flow condition has ceased over time.

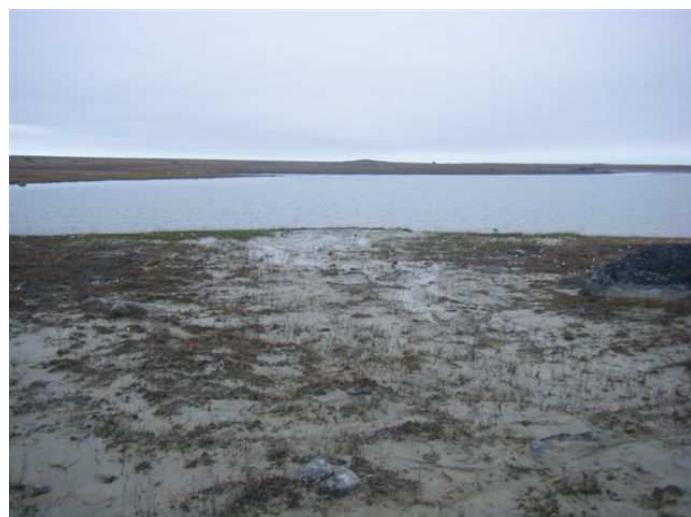
Picture 21: Area 12 - view of the lake from the end of the ditch

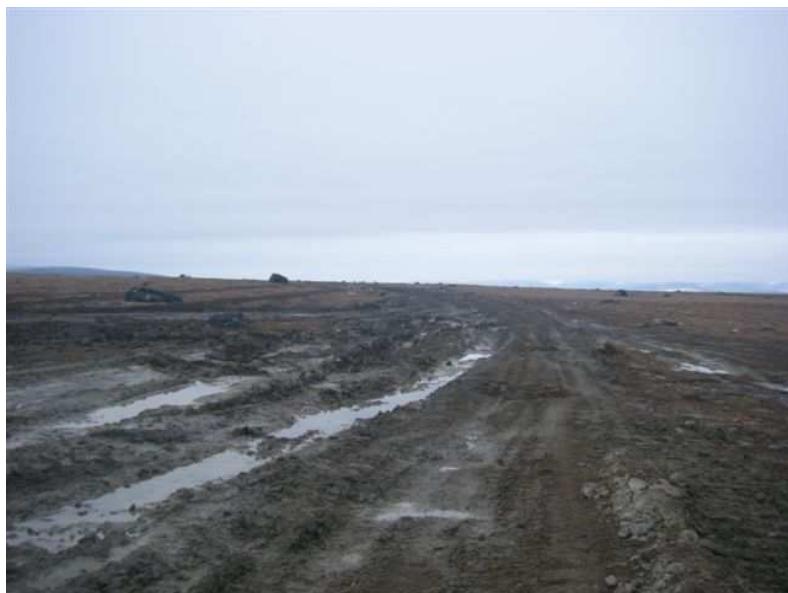
The **thirteenth** impacted area along the old roadway is located at 6.6 km from the Cape Christian camp. The area consists in a relatively small muddy section that has rutting. Picture 22 shows the area.

Picture 22: Area 13 to be restored (6.6 km from the camp)

- Dewater and drain into the tundra at least 30 meters from any water course;
- Backfill the old roadway and crown as required matching the surrounding terrain.

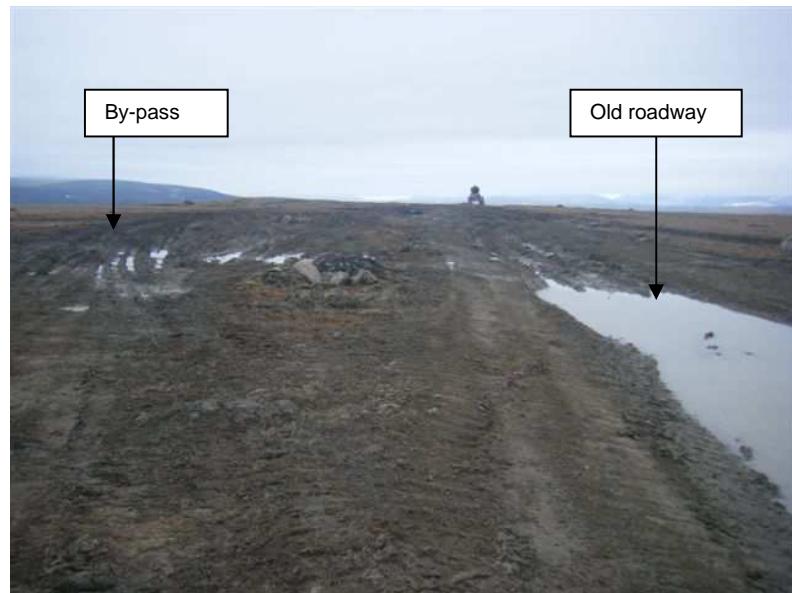
The **fourteenth** impacted area consists in a by-pass on the left side of the road to avoid a muddy section of the road filled with pounded water. This area is located 7.0 km away from the Cape Christian camp. Picture 23 shows a view of the area.

Picture 23: Area 14 to be restored (7.0 km from the camp)

- Dewatering and draining pounded water onto the old roadway into the tundra at least 30 meters from any water course;
- Backfilling the old roadway and grading as required to match the surrounding terrain;
- Back-blade the left-side by-pass and backfilling as required.

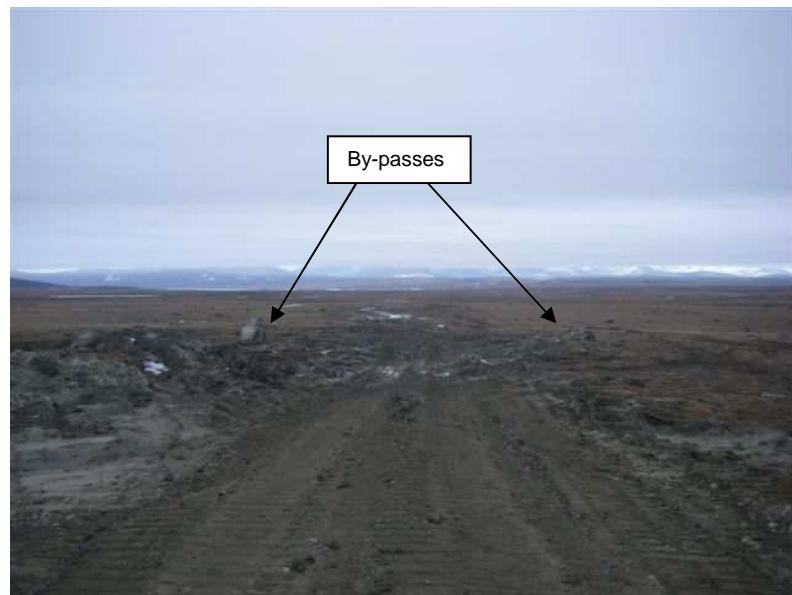
The **fifteenth** impacted area is located at 7.2 km from the camp, just after the old above ground storage tank. Again, several by-passes to the old roadway were made avoiding a very wet spot. Picture 24 shows the area.

Picture 24: Area 15 to be restored (7.2 km from the camp)

- Dewatering and draining pounded water onto the old roadway into the tundra at least 30 meters from any water course;
- Backfilling the old roadway and grading as required to match the surrounding terrain;
- Back-blade the by-passes and backfilling as required.

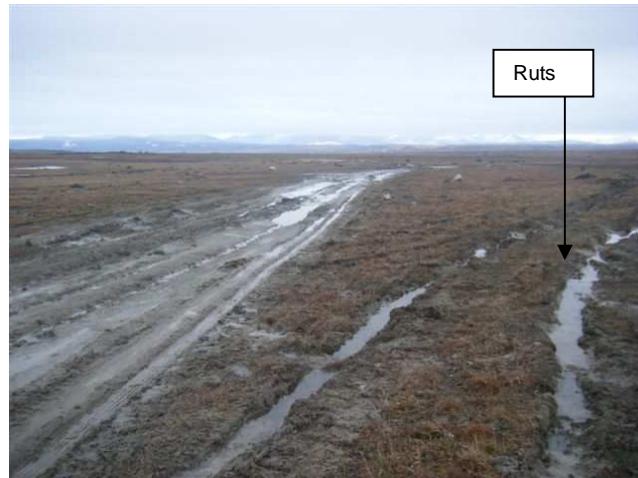
The sixteenth impacted area consists in two short locations that have similar damages: ruts from the passage of vehicles in a soft and wet area. The two sections are located at 7.7 km and 7.9 km from the camp. Pictures 25 and 26 show these locations.

Picture 25: Area 16 to be restored (7.7 km from the camp)

- Dewatering and draining pounded water onto the old roadway and within rutted areas into the tundra at least 30 meters from any water course;
- Backfilling the old roadway and ruts and grading as required to match the surrounding terrain;
- Back-blade the ruts and backfilling as required.

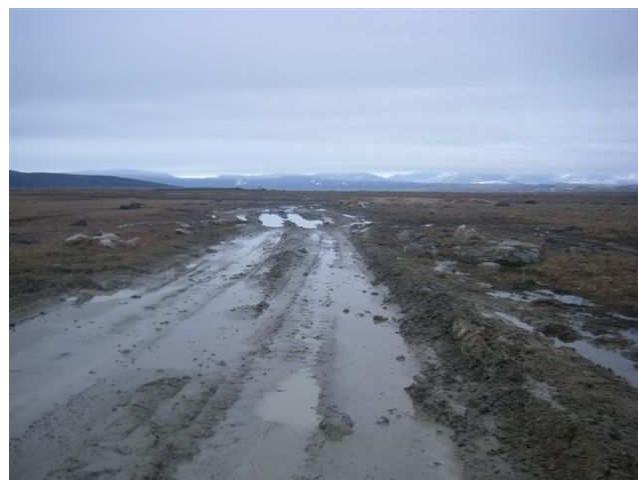
Picture 26: Area 16 to be restored (7.9 km from the camp)

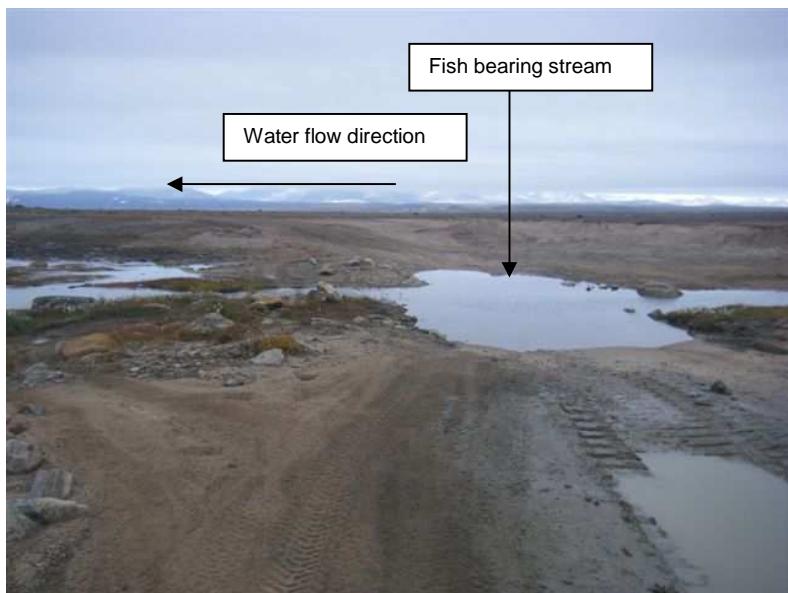
The seventeenth impacted area is where culvert #2 was supposed to be installed as per the initial plan. The impacted area is located 8.1 km from the Cape Christian camp. Picture 26 shows the location of the stream which was found to be fish bearing.

Picture 27: Area 17 to be restored (8.1 km from the camp)

This area is not so damaged but in order to restore the old roadway in such a manner to protect waters, the following mitigation measures are to be implemented:

- Install silt fences downstream of the channel prior to any work onto the stream;
- Ensure the stream channel is opened for fish passage where culvert number 2 was supposed to be installed originally;
- On a 10 feet section wide within that channel, place rip-rap material in the bed to minimize any impact should the path be used again in the future by ATVs;
- After the channel is built, remove the silt fences to allow for fish passage.

Finally, for the impacted area number 17, a silt fence will be installed downstream before any work into the streambed will be initiated. The flow channel does not appear to be blocked for fish passage at this stage and in stream work will probably be limited in the installation of rip-rap material on a 10 feet wide section perpendicular to the road path. The silt fence will be removed after work once it will be observed that any sediment created has settled.

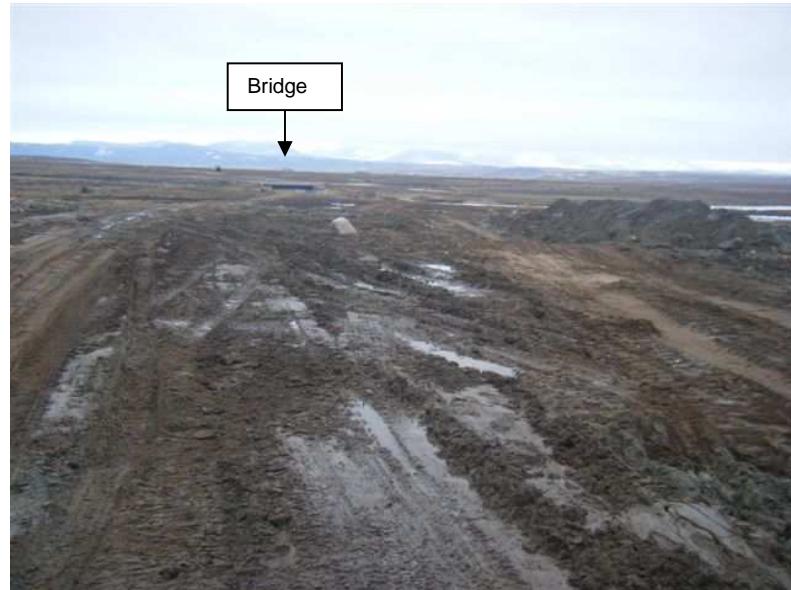
The eighteenth and last impacted area is located just after the newly constructed bridge, 8.8 km from the Cape Christian bridge. Picture 28 shows the area that will need to be restored.

Picture 28: Area 18 to be restored (8.8 km from the camp)

The right side on the road will be repaired and remain. The left side will be back-bladed and landscape to match the surrounding ground
