ROAD BETWEEN THE HAMLET OF CLYDE RIVER AND CAPE CHRISTIAN

Mitigation Report 2010 Season

Licence No. 8BW-CLY0810

January 2011

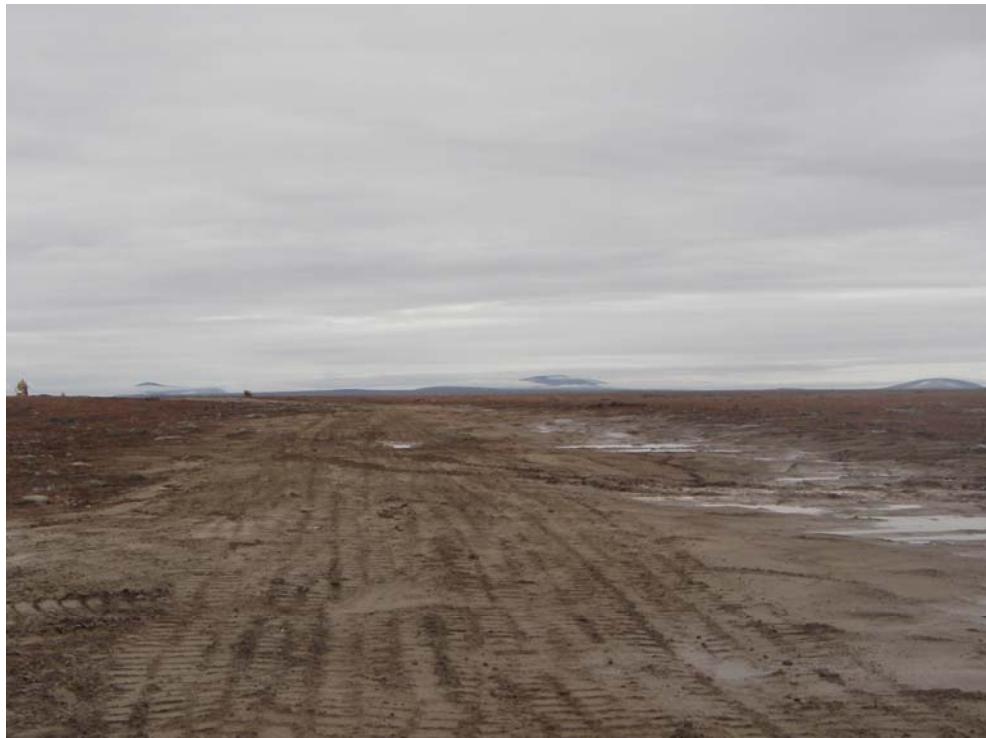
Photo 1: view of the mitigated section in area 3

In 2010, a large portion of area 3, area 4 and area 5 were mitigated by using an excavator and cut and fill to fill the ditches and any holes and to landscape the areas to match the surrounding terrain. The pictures below illustrate the results of the mitigation work done in August 2010.

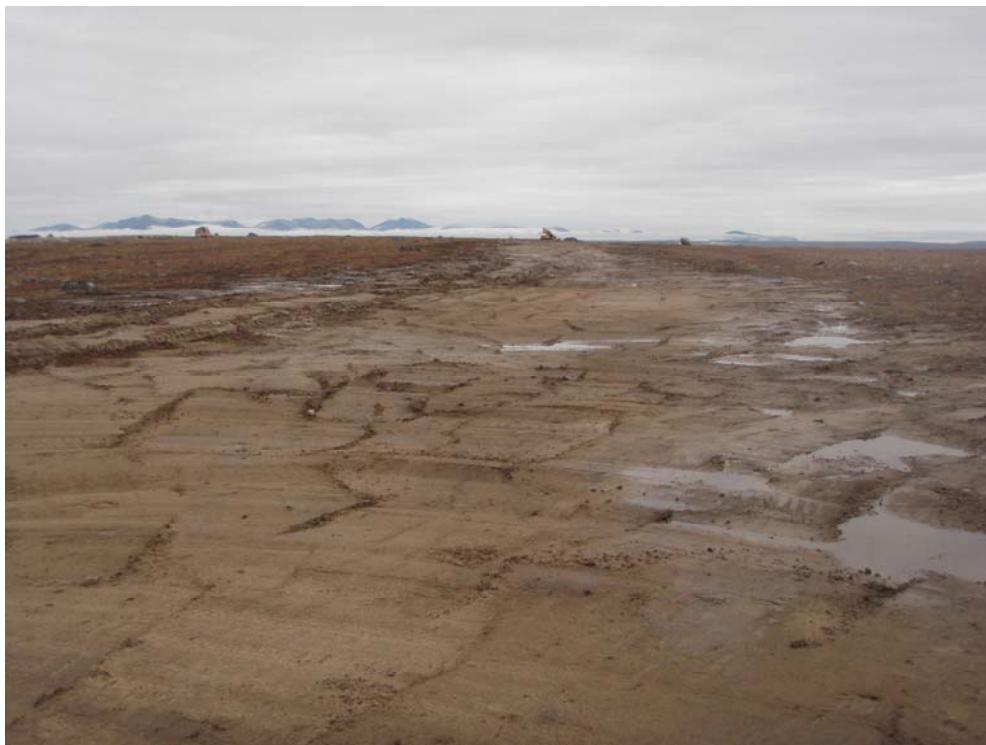
Photo 2: view of the mitigated section in area 4

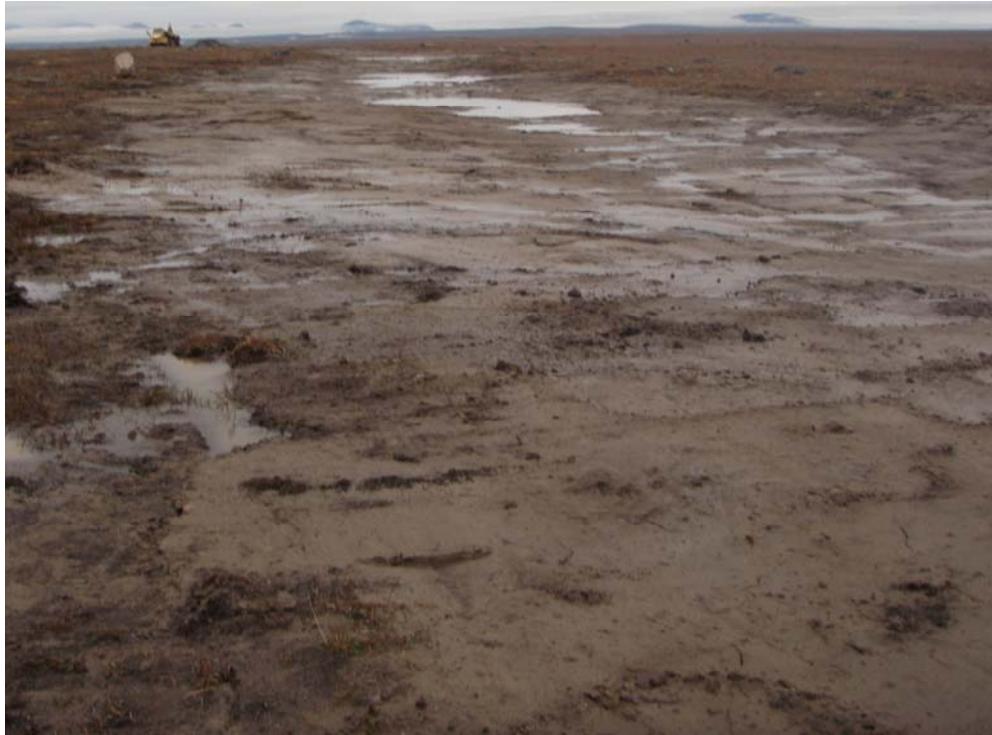
Photo 3: view of the mitigated section in area 5
