ROAD BETWEEN THE HAMLET OF CLYDE RIVER AND CAPE CHRISTIAN

Annual Report 2010 Season

Licence No. 8BW-CLY0810

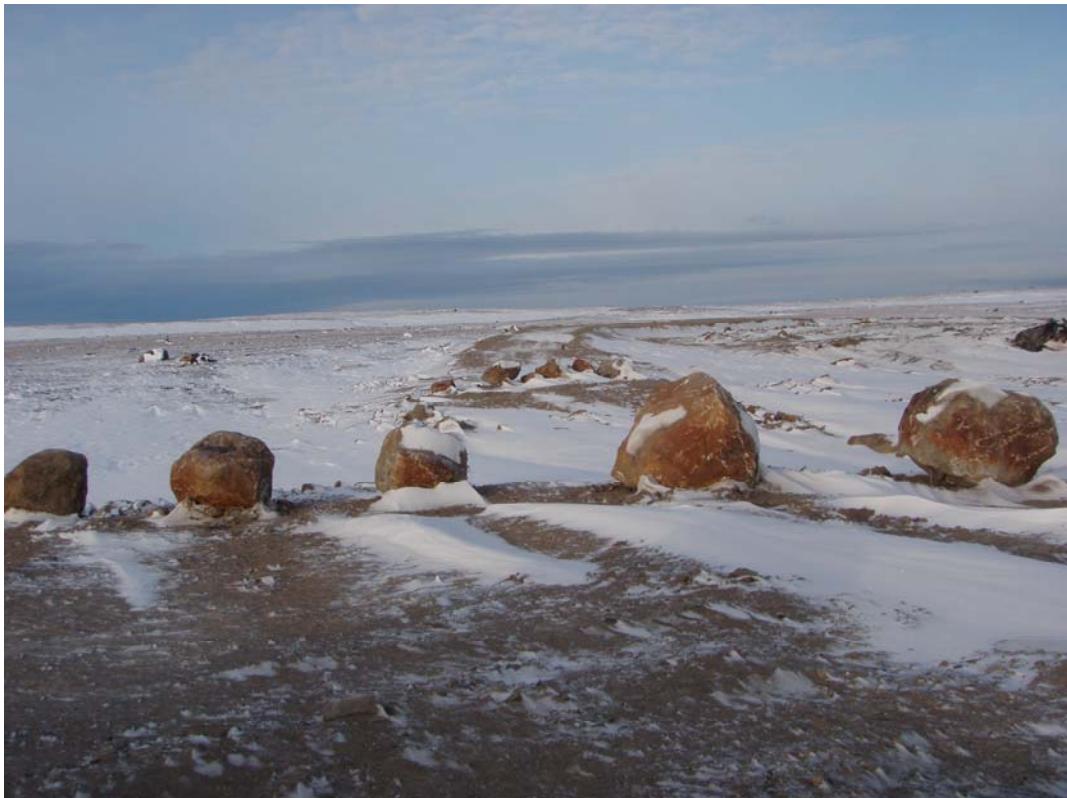
On July 5-6, 2009 four 48 inch culverts were installed at crossing 9 and covered with geotextile and soil. The clean up of Cape Christian was completed at the end of September 2010. The culverts and all material were removed; the geotextile was discharged in the landfill. Note that the culverts were removed while the river was frozen.

Figure 1 : view of the water crossing 9 after dismantlement

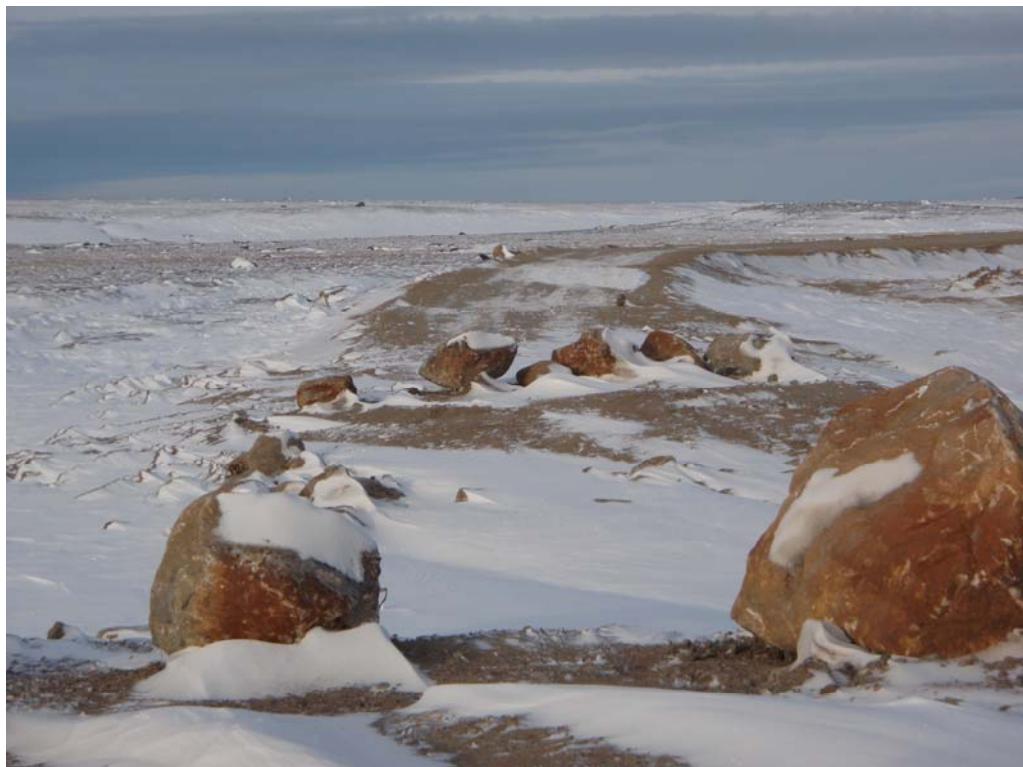
Figure 2 : view of the water crossing 9 after dismantlement

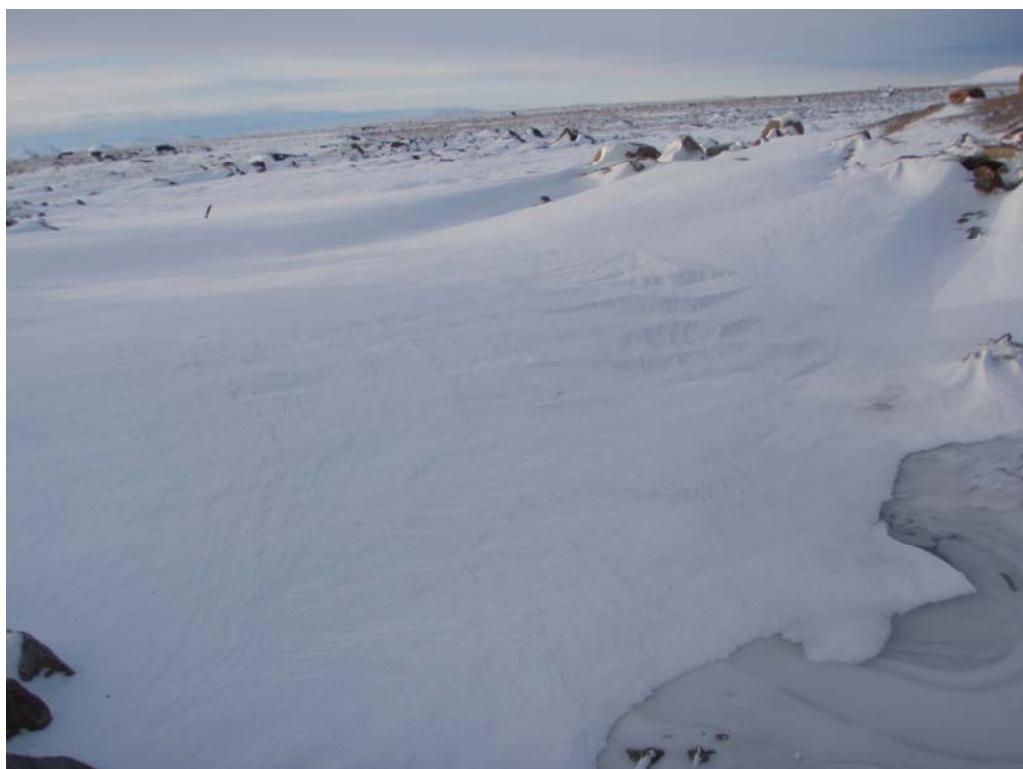
Figure 3 : river channel after removal of culverts at crossing no9

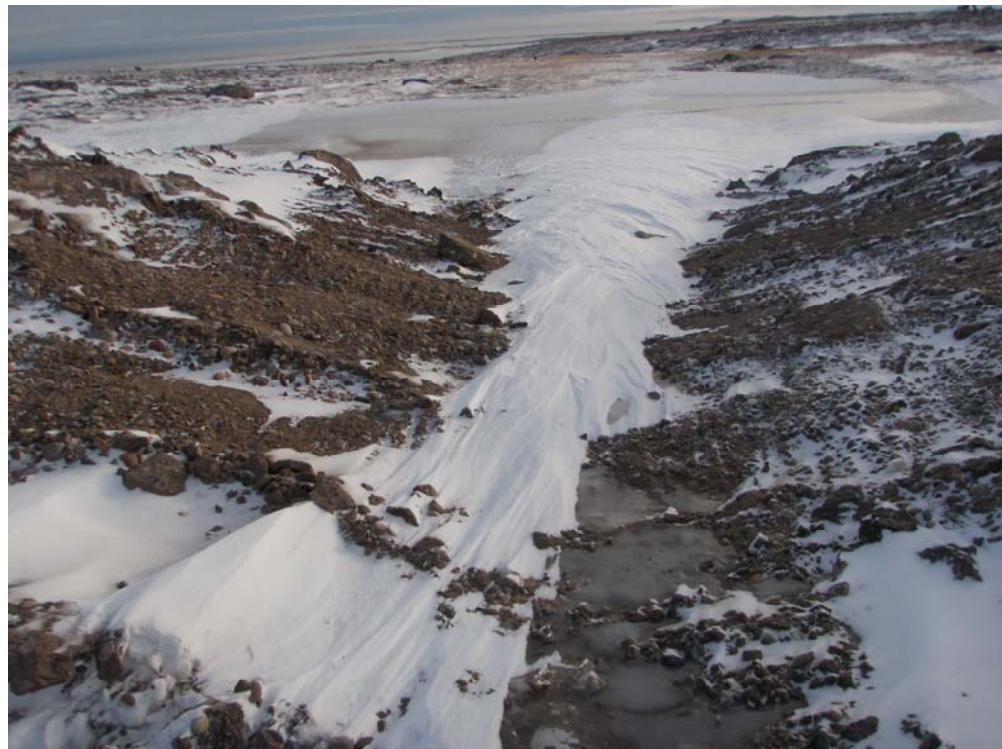
Crossing 10 was constructed on July 6, 2009. A 24 inch culvert was placed and held in place with a geotextile and soil cover. In late September 2010, the culvert was removed. The crossing allows the flow of the upstream pond into the large downstream pond across the roadway.

Figure 4 : Crossing 10 dismantled

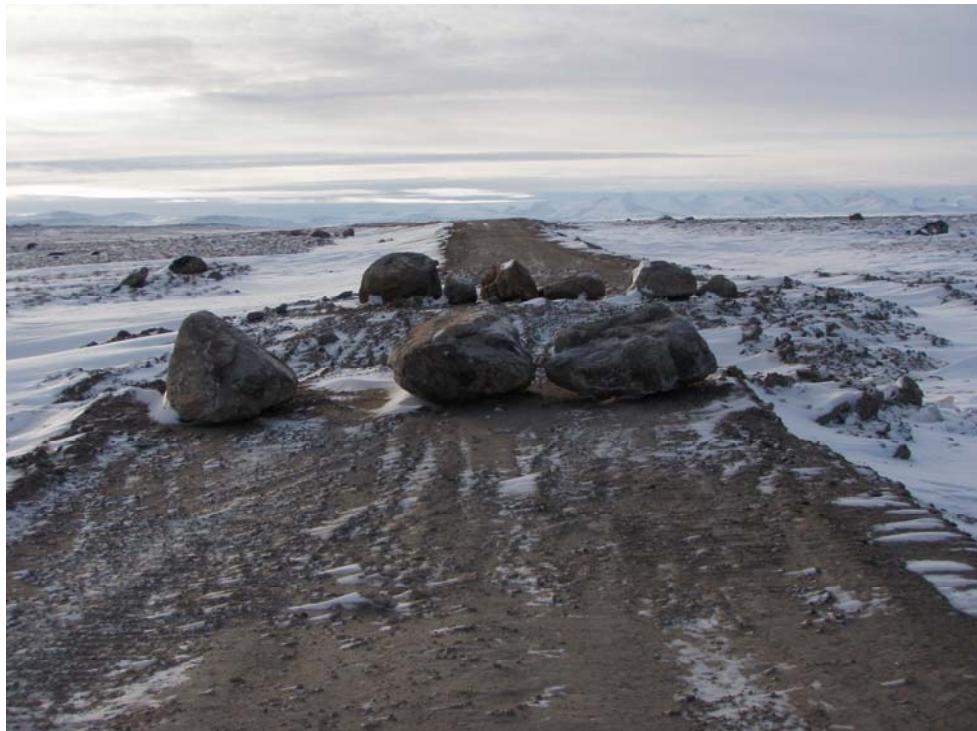
At Crossing 11 a 24 inch culvert was placed across the stream in July 9, 2009 and kept in place with a geotextile and soil cover. At the end of September 2010, the culvert was removed and the granular material was recovered. Gentle slopes were left in place to minimise erosion.

Figure 5 : crossing 11 after removal of the culvert

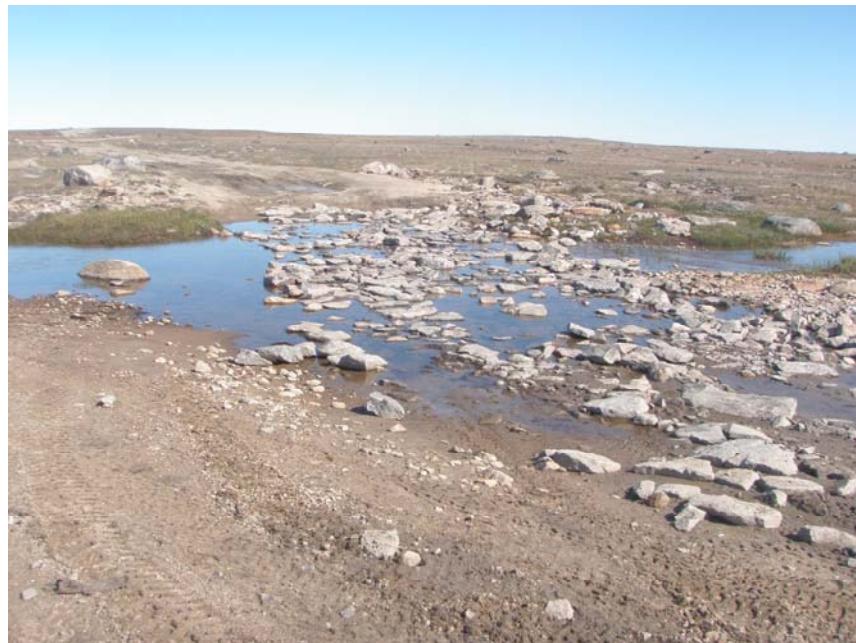
At former crossing 2, rocks were placed in the river bed to minimize damages when citizens from Clyde River use this passage with their ATVs.

Figure 6 : view of crossing 2

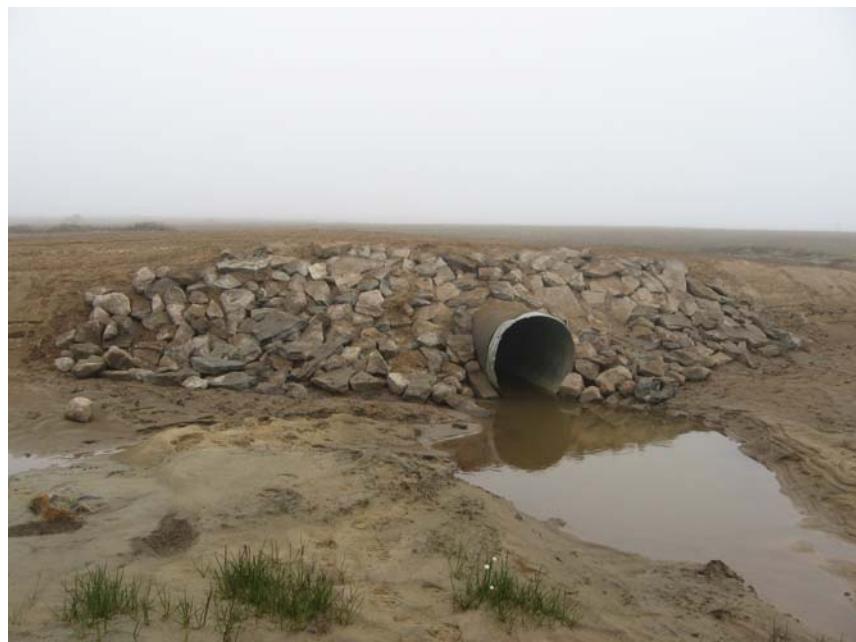
At former crossing 5, the slopes were stabilized with the placement of rocks to prevent the runoff of sediments into fish bearing water.

Figure 7 : view of crossing 5

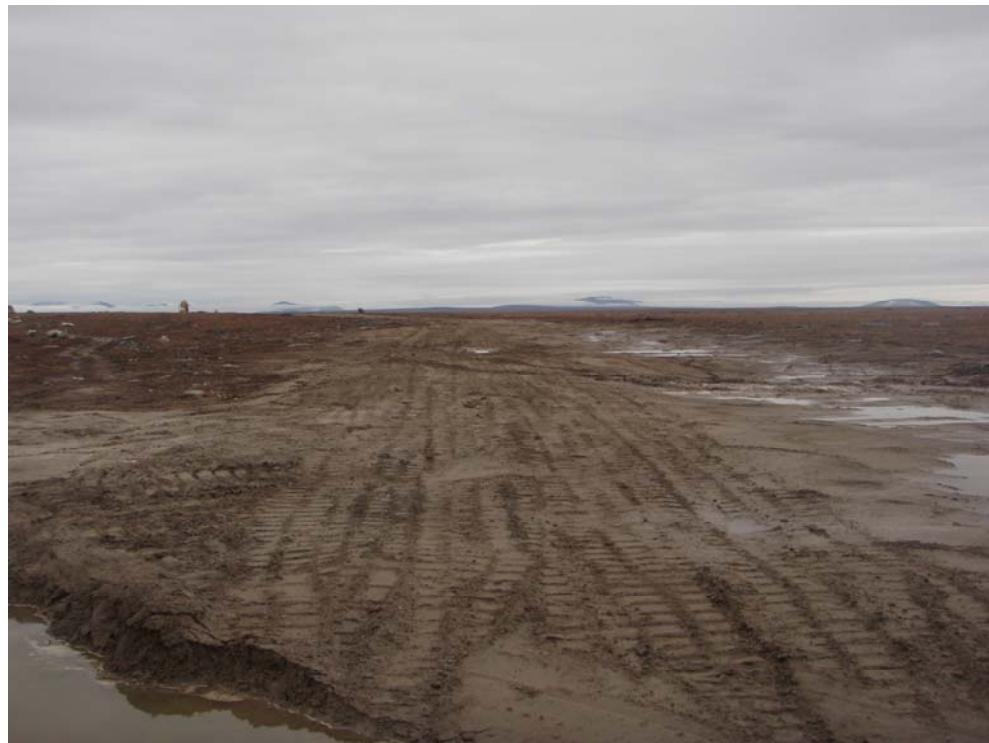
In 2010, a large portion of area 3, area 4 and area 5 were mitigated by using an excavator and cut and fill to fill the ditches and any holes and to landscape the areas to match the surrounding terrain. The pictures below illustrate the results of the mitigation work done in August 2010.

Figure 8: view of the mitigated section in area 3

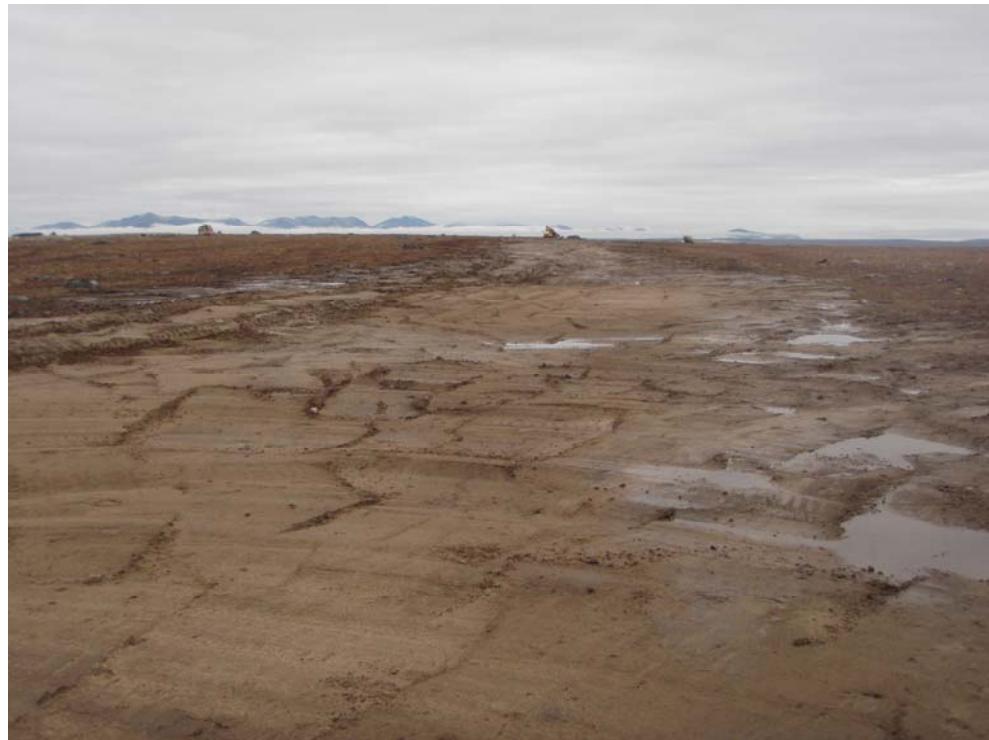
Figure 9: view of the mitigated section in area 4

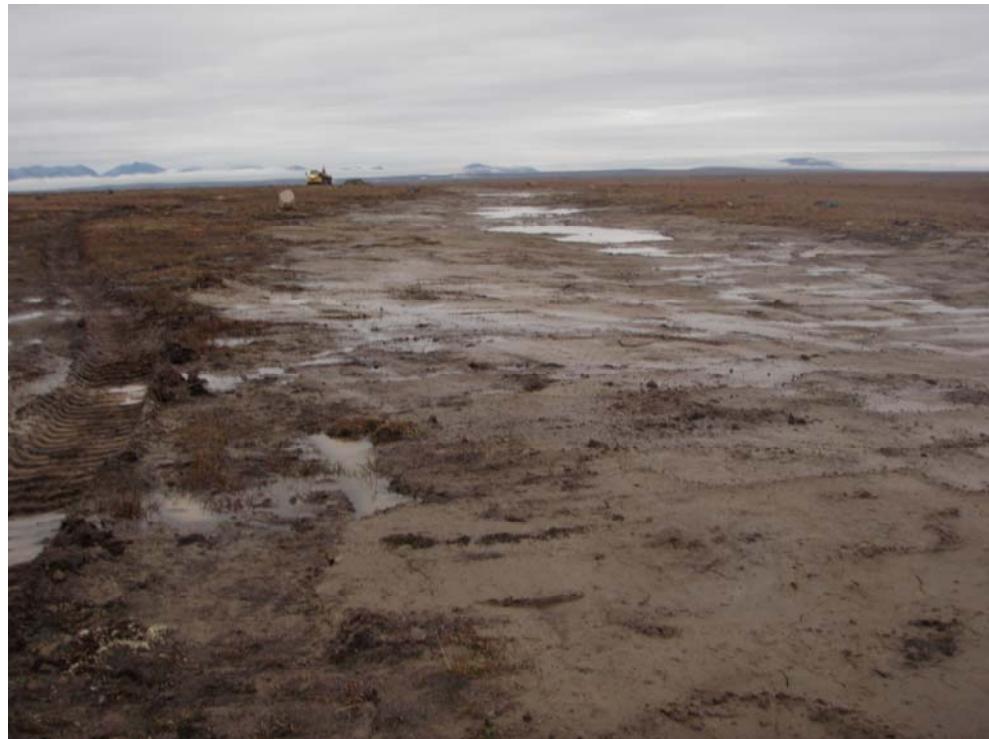
Figure 10: view of the mitigated section in area 5

As mentioned, Qikiqtaaluk Corporation will complete the work during the 2011 field season as per the abandonment and restoration plan submitted.
