NWB Annual Report

Project Name: Cape Christian Road

Subject: Recommendations regarding the existing road from Clyde River to Cape Christian
Ref: QIE-001

Groupe Alphard inc. (Alphard) is proud to present its inspection report of the existing road from Clyde River to Cape Christian (Nunavut). This report outlines the current state of the road and the recommendations regarding the rehabilitation/stabilization of the road.

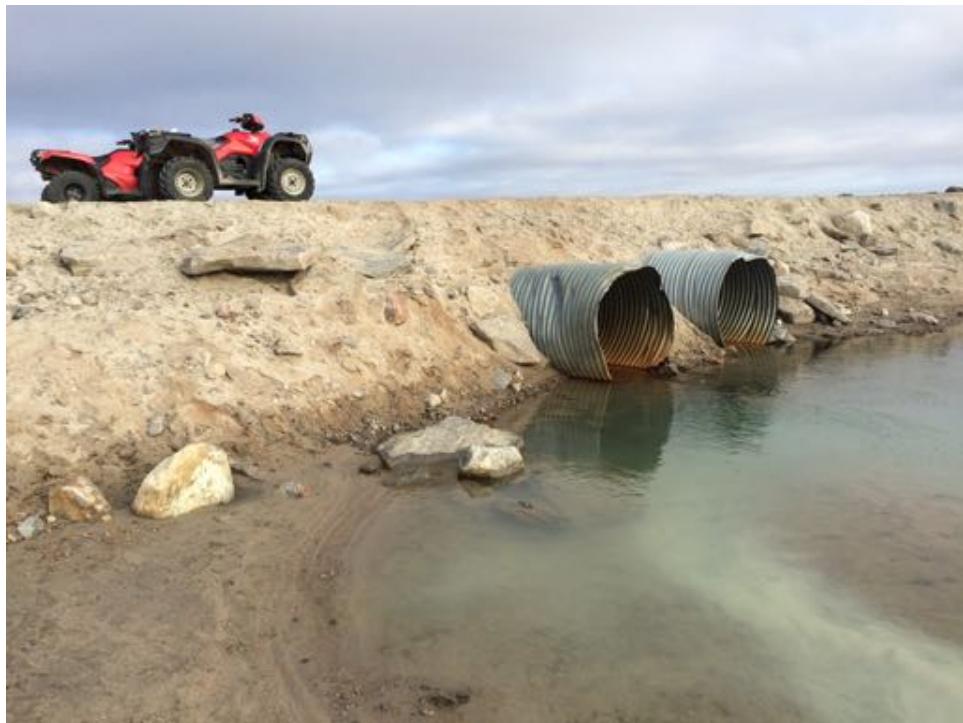
- At Km 0.8, stream crossing #1: For the first time in five years, the backfill material has been washed out in Spring 2014. This suggests the need to add at least one culvert of 1 500 mm.

Photo 3: Stability issue at stream crossing #1, Km 0.8

In Spring 2014, a large amount of rain caused the washed out of the backfill material as the currently installed culverts were insufficient to allow for the water to flow through the road. It is therefore suggested to add at least one culvert of 1500 mm in order to provide sufficient drainage capacity. The culvert should be installed properly using geotextile and riprap on both extremities.

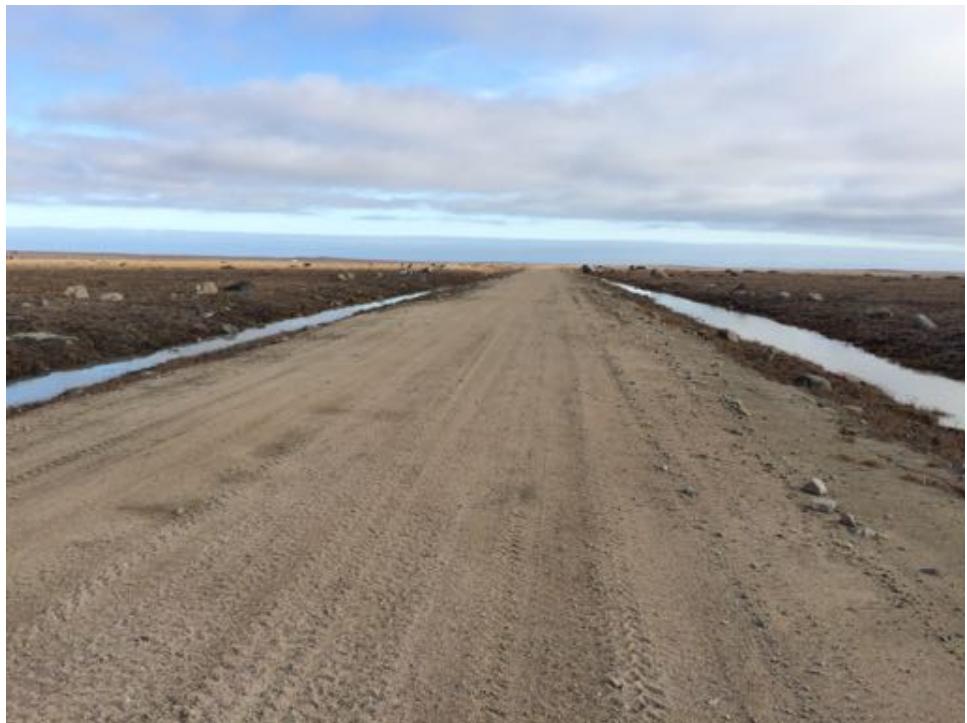
- At Km 3.2: The ditches are full of water. The water level is uneven on either side of the road, suggesting that the water does not flow through it as the road is probably frozen. The road is stable and elevated approximately 0.3 m above natural flat ground, preventing runoff water from overflowing onto the road.

Photo 5: Ditches full of water, Km 3.2

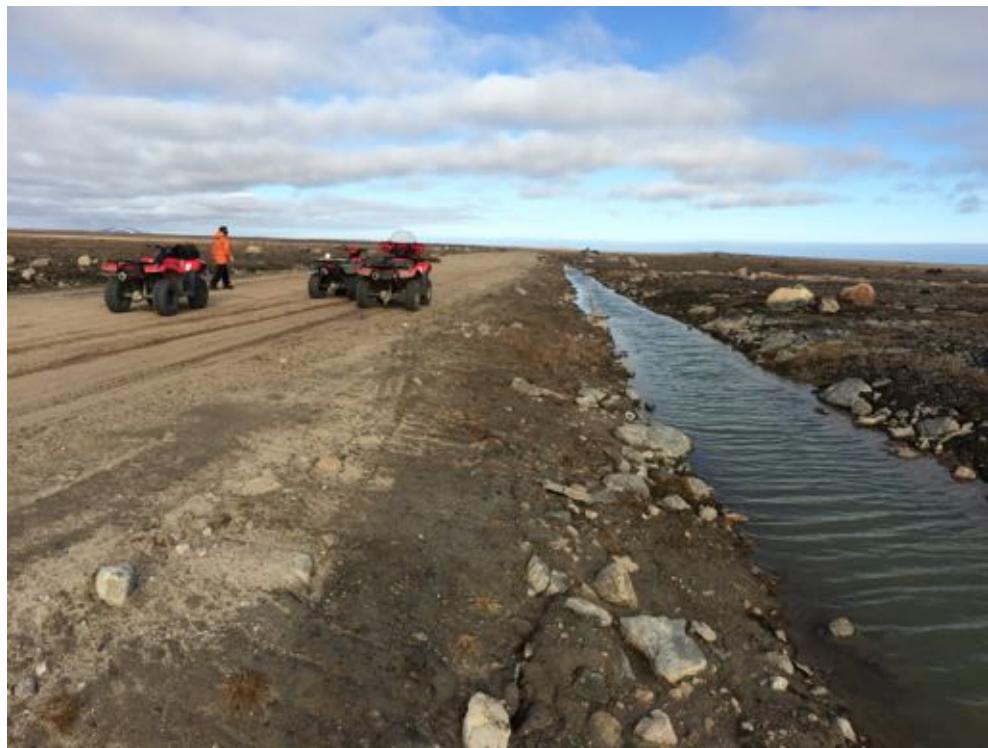
- At Km 4.0: The ditches are full of water. Even if the road is almost at the same level as the natural flat ground, it seems stable.
- At Km 4.7, right before stream crossing #4: According to the local community member, each spring, the hollow of the road is submerged and washed out by a creek coming out from its bed.

Photo 6: Ditches full of water, Km 4.0

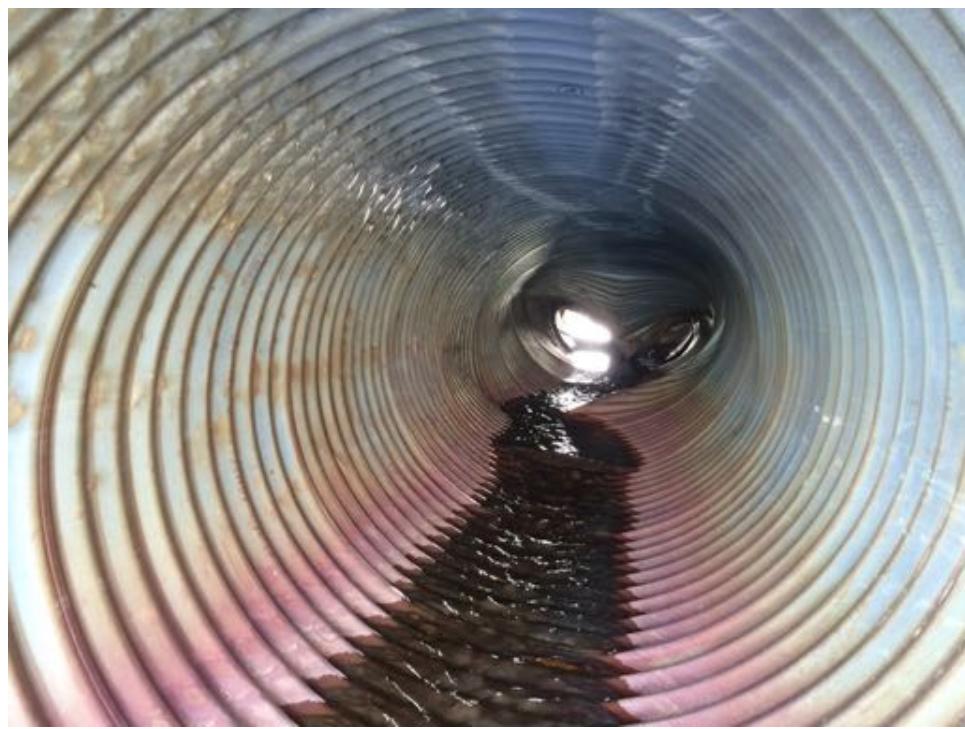
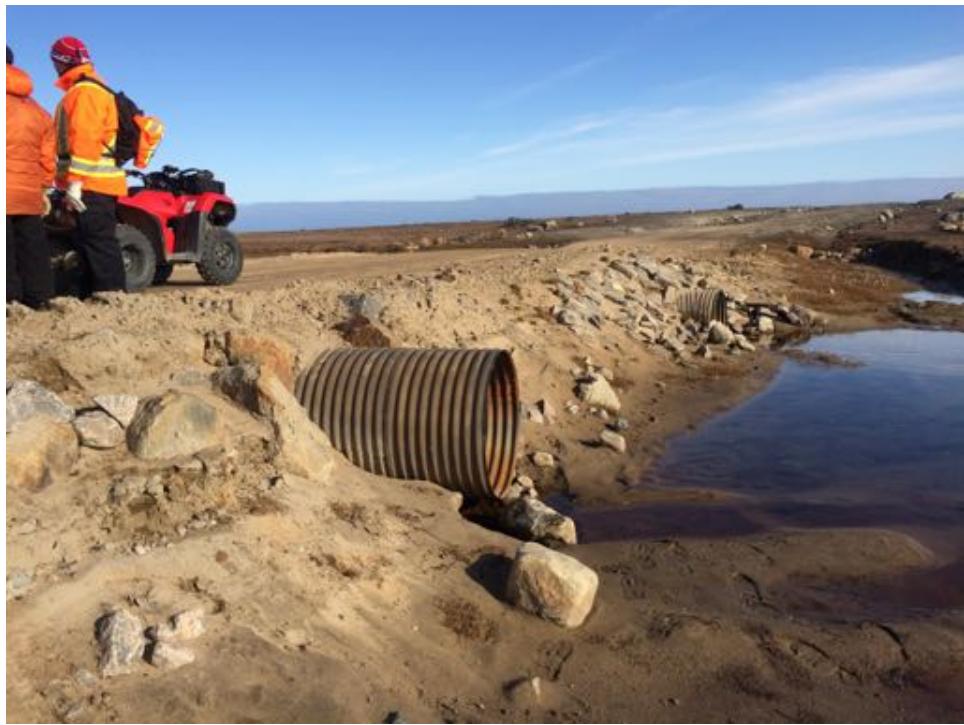
- At Km 4.8, stream crossing #4: One of the culverts is completely deformed and inefficient. The second one is above the natural water flow. However, according to the local community member, there is no issue with the road at this location.

Photo 8: Stream crossing #4, Km 4.8

Photo 9: Stream crossing #4, Km 4.8

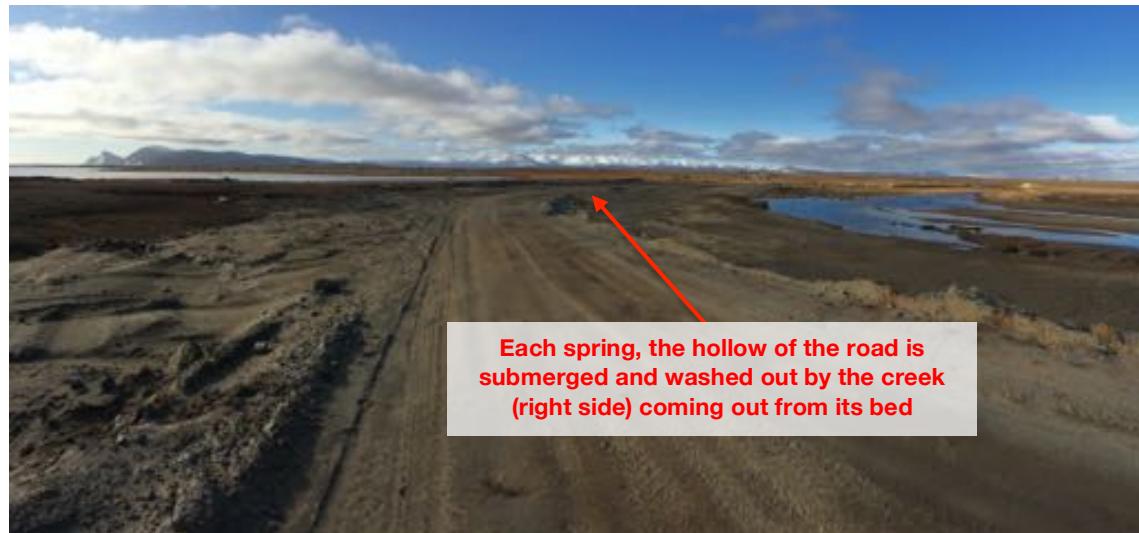
Photo 10: Stability issue near stream crossing #4, Km 4.7

According to the local community member, each spring, the creek beside the road rises, overflows and washes out the backfill material of the road. Therefore, it is recommended to raise the road and install culverts to minimise the impact of the overflows on the road.

To stabilise this portion of the road, it is recommended to fill the natural hollow of the road which is about 50 meters long. To do so, fill of at least 1250 mm high using 500 mm of 100-200 mm riprap or unsorted material has to be placed on the existing road, followed by 500 mm of coarse material (unsorted material) and 250 mm of natural silty sand (see the two first paragraphs of the above section "Backfill Material Available"). A minimum of two to three culverts of 1000 mm should also be installed properly using geotextile and riprap on both extremities.

In the case where the materials mentioned above are not available, it is suggested to use the natural silty sand for the entire thickness. However, this solution is not the one recommended by Alphard and should only be used if the community cannot provide the proper materials.

It is important to note that since this issue involves a creek coming out from its bed and overflowing onto the road, it is quite possible that stabilisation work will be needed on an occasional basis, every spring.

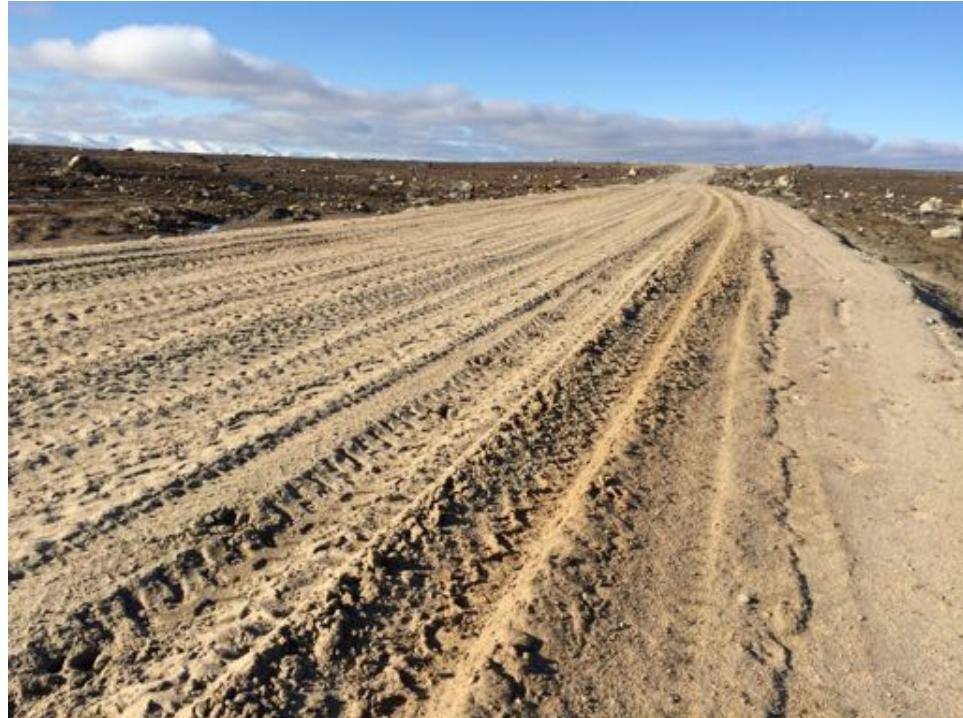
- New road from Km 6.5 to Km 7.2 and Old road from Km 7.2 to Km 8.0: It has been noted that the ruts from the ATV are deeper, which suggests that the backfill material (sand) is loose and of lower quality. The backfill material (coarse sand with rounded grains that is difficult to compact adequately) is of particularly poor quality between Km 7.5 and Km 8.0 (old road portion).

Photo 14: From Km 6.5 to Km 8.0, backfill material (sand) is loose and of lower quality, deeper ruts from the ATV observed

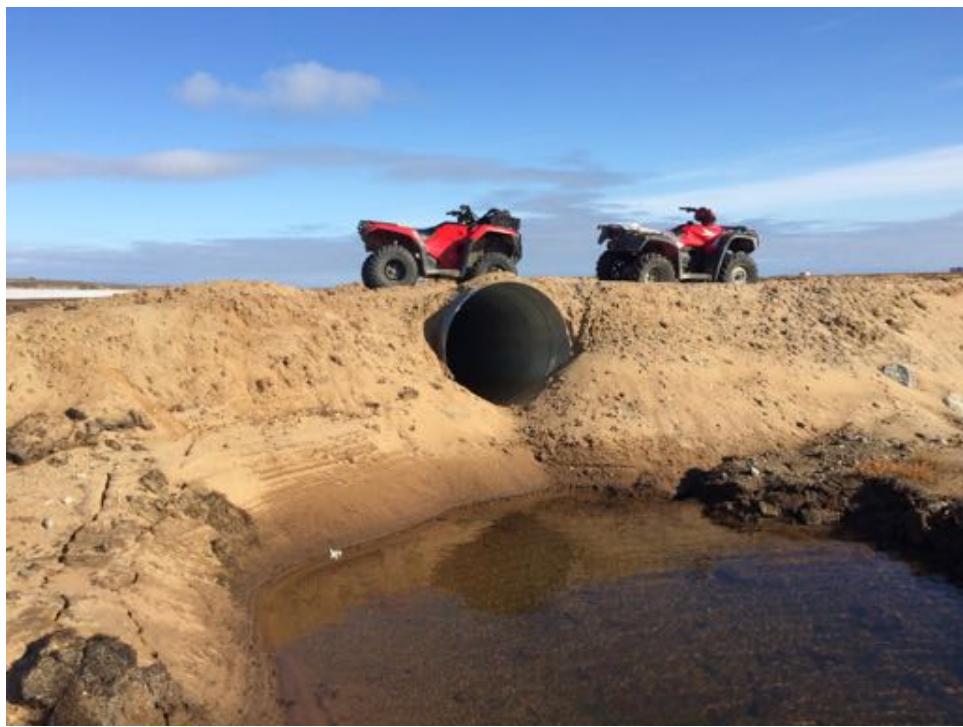
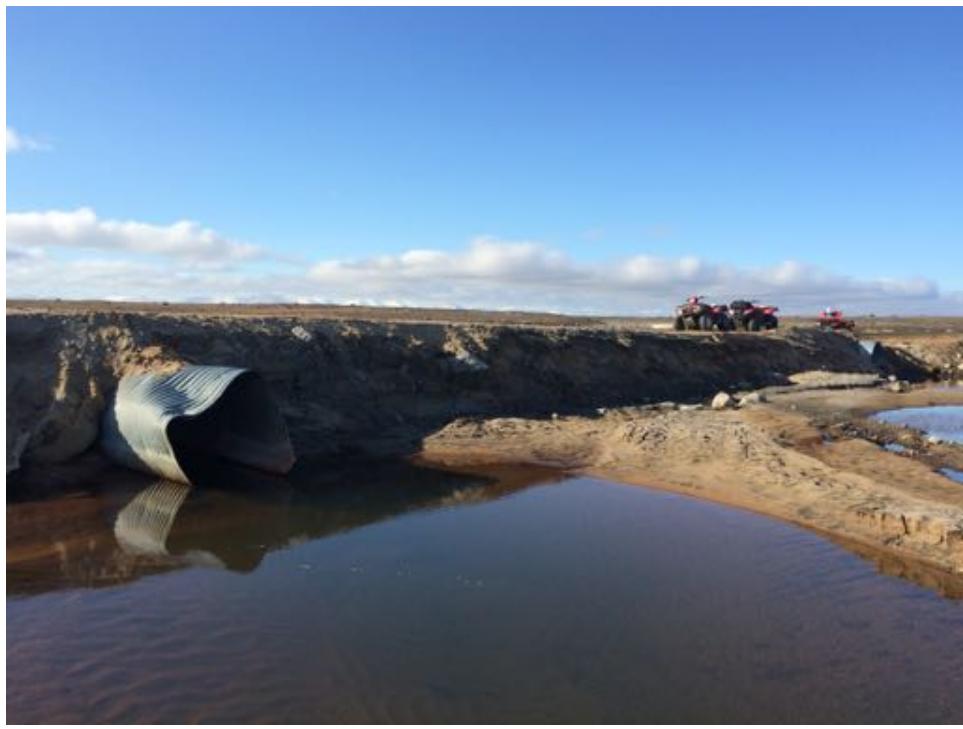
- At Km 7.6 (old road portion), stream crossing #8: One of the culverts is partly deformed and the second one is above the natural water flow. Each spring, the backfill material is washed out, suggesting the need to add at least one culvert of 1 250 mm. The backfill material (coarse sand with rounded grains) is of poor quality, loose and not compactable, and was probably collected from the seashore, 400 meters away, at Km 8.0.

Photo 17: Stability issue at stream crossing #8, Km 7.6

Photo 18: Stability issue at stream crossing #8, Km 7.6

Each spring, the backfill material is washed out. To stabilise the road, it is recommended to re-install properly the two existing culverts as they are currently too high for the water to flow in naturally. It is also recommended to add at least two more culverts of 1250 mm. The culverts should be installed properly using geotextile and riprap on both extremities. The existing backfill material should be completely removed, disposed of properly, and replaced by a proper material such as the ones described in the above section "Backfill Material Available".

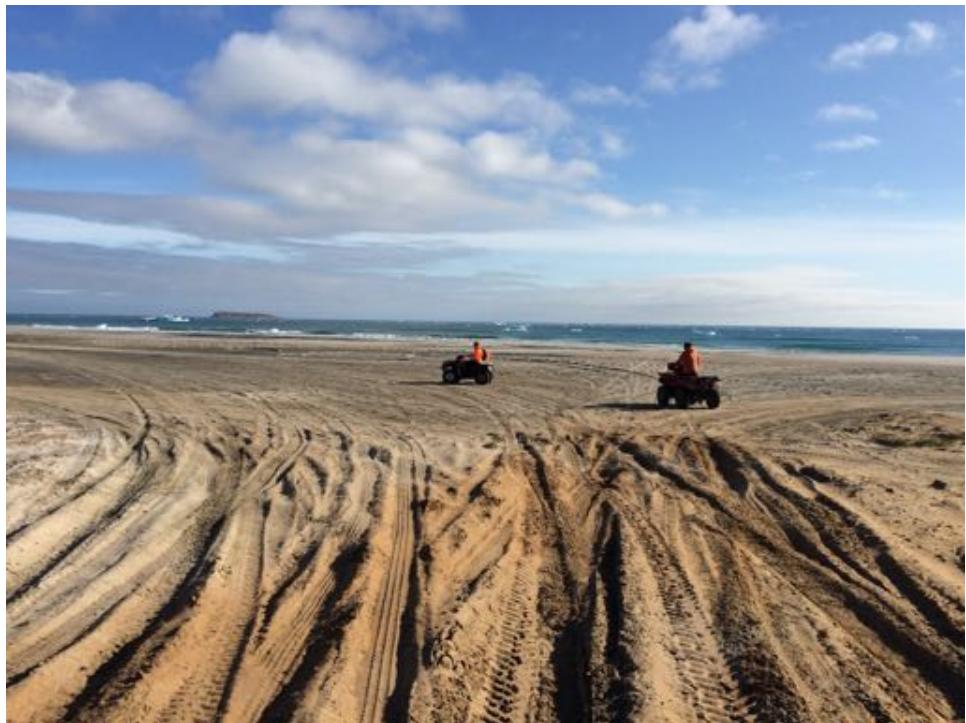
Photo 19: Cape Christian, Km 8.0, deep ruts from the ATV
