Duval River Bridge, Panguirtung, NU

Temporary Repair 2004

Site Photographs

Duval River Bridge, Pangnirtung, NU
Bridge Condition Report, July 2004

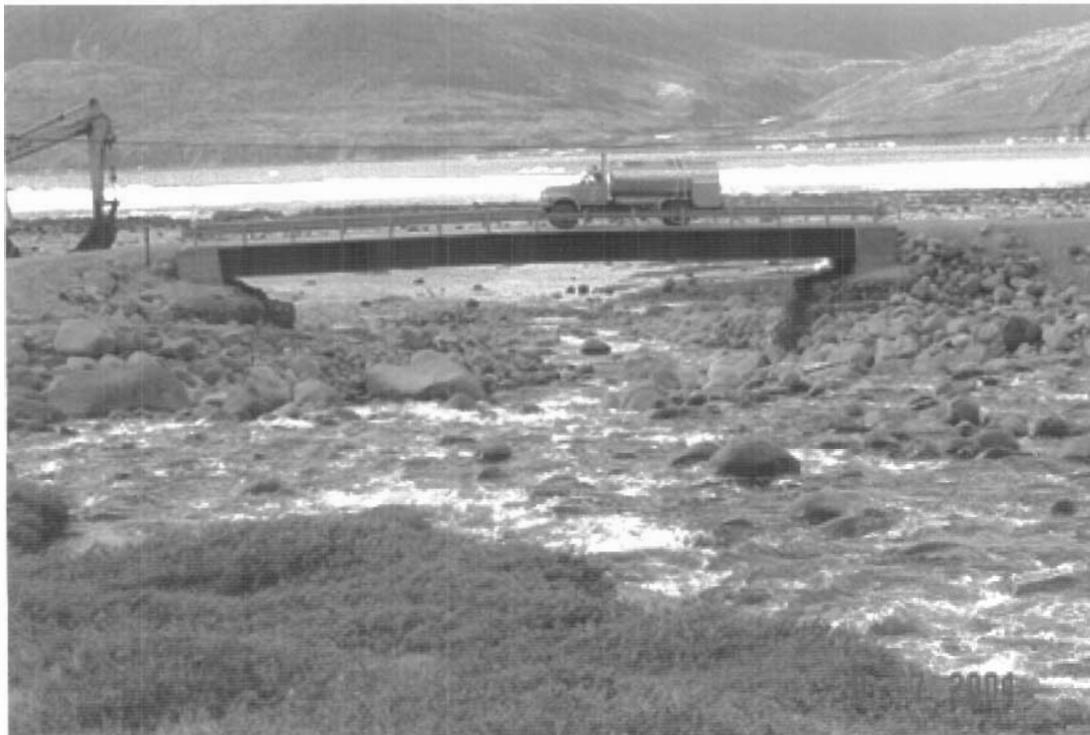
South Elevation of bridge: Reportedly the riverbed was built up to the top of Rock Berms visible in front of both abutments. The rock was placed during previous attempts to stabilize the riverbed.

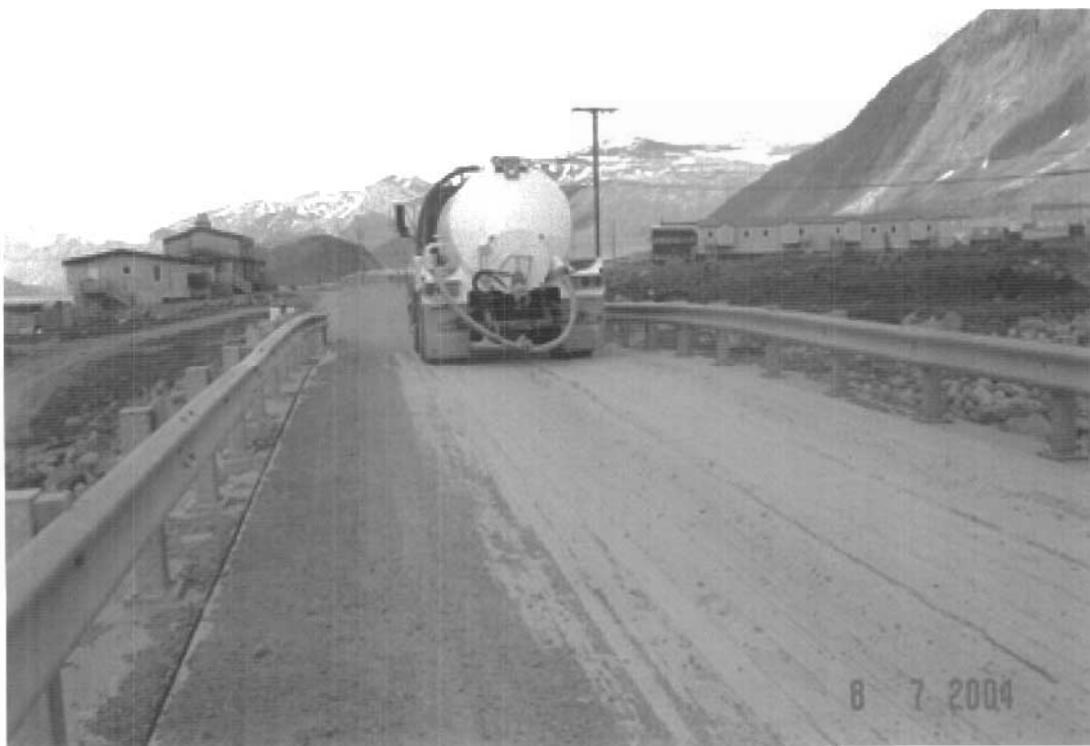
Bridge deck in good condition. Bridge superstructure in excellent condition.

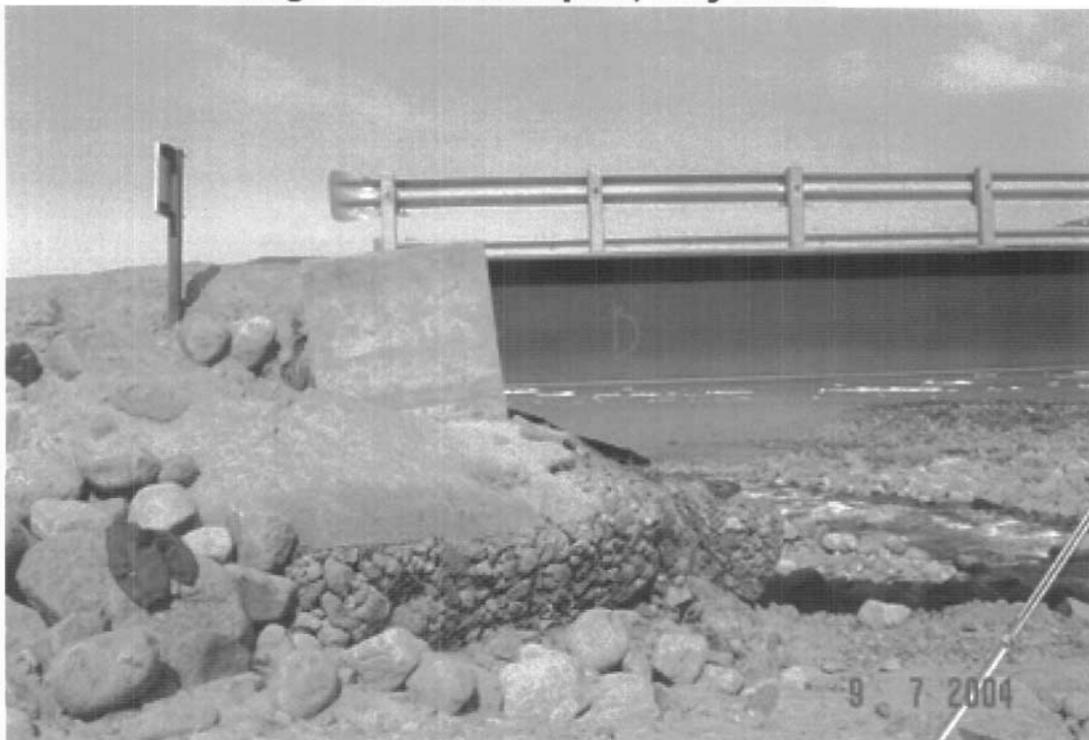
South elevation of west abutment: Evidence of "tilt" of the pile cap. Tilt is due to scour of riverbed under the pile cap; sliding of embankment towards the river; and failure (buckling) of steel piles supporting the cap. Pile cap is being held from sliding down by rebar tie-backs shown on pictures below

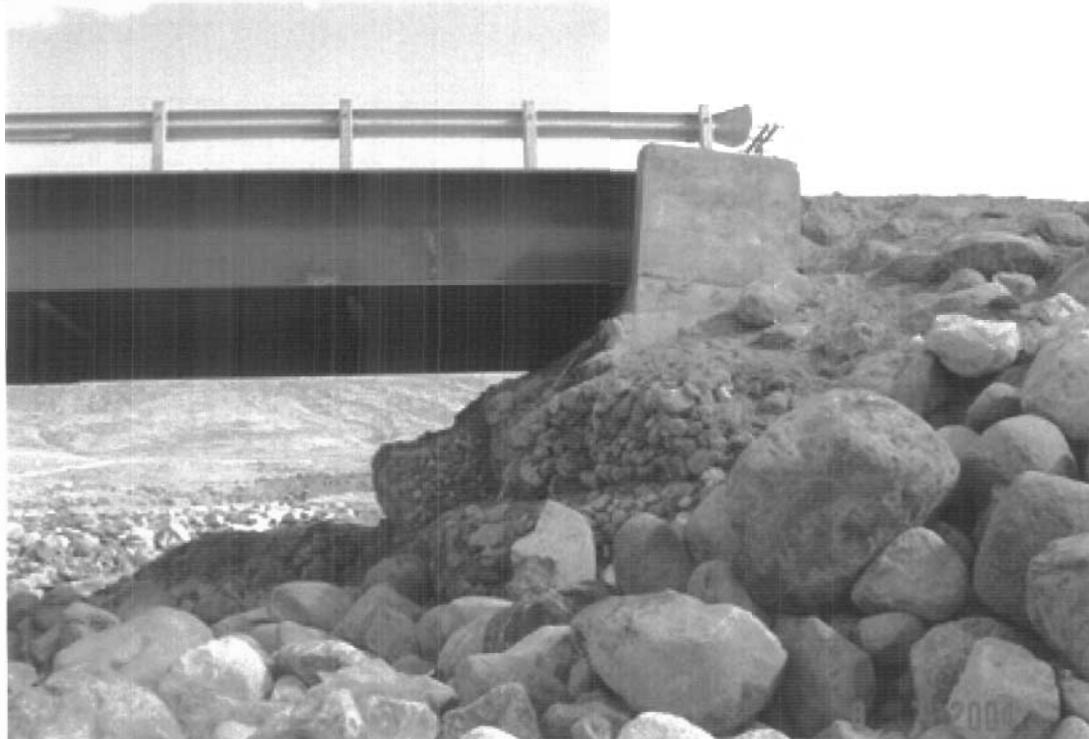
North elevation of west abutment: Evidence of "tilt" of abutment (pile cap); slump of gabions towards the river; and missing (washed out) gabions. Riverbed in front of gabions was washed out near 1992. Rock was placed in attempt to stabilise abutment.

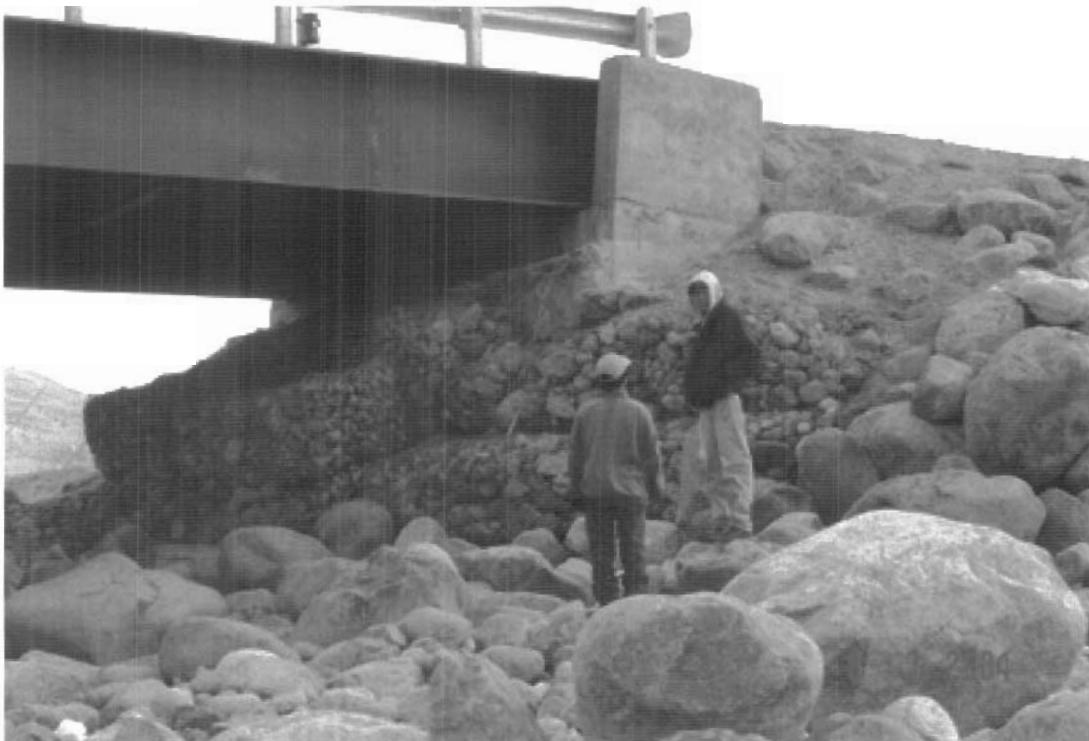
North elevation of west abutment: Evidence of "tilt" of abutment (pile cap); slump of gabions towards the river; and missing (washed out) gabions.

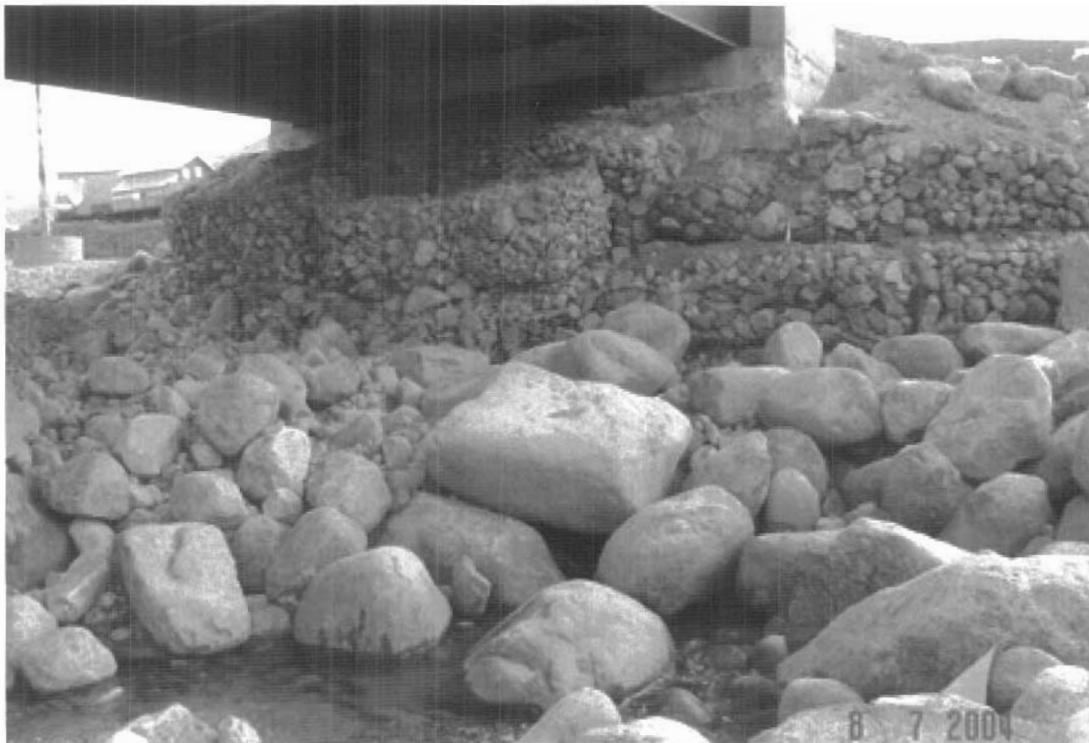
Head slope of west abutment: Riverbed in front of gabions was washed out near 1992. Rock was placed in attempt to stabilise abutment.

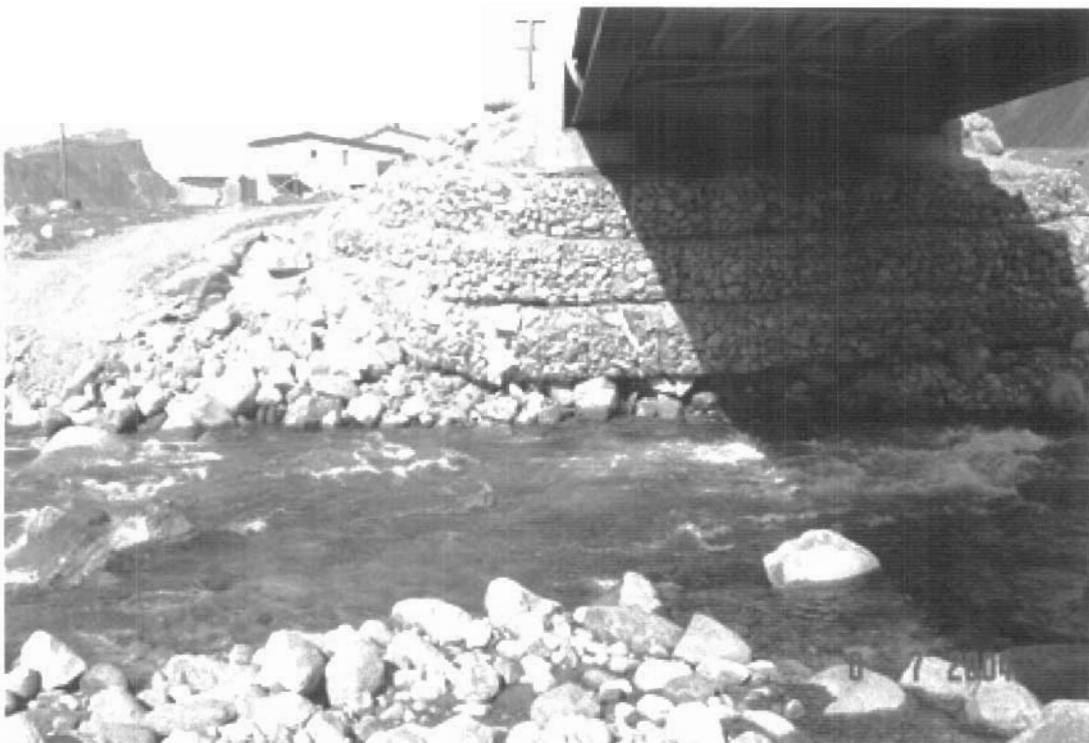
Head Slope of east abutment: 4.0 m section of gabion base is washed out. Gabions are point-supported on few larger boulders, some of which have cracked under the excessive load

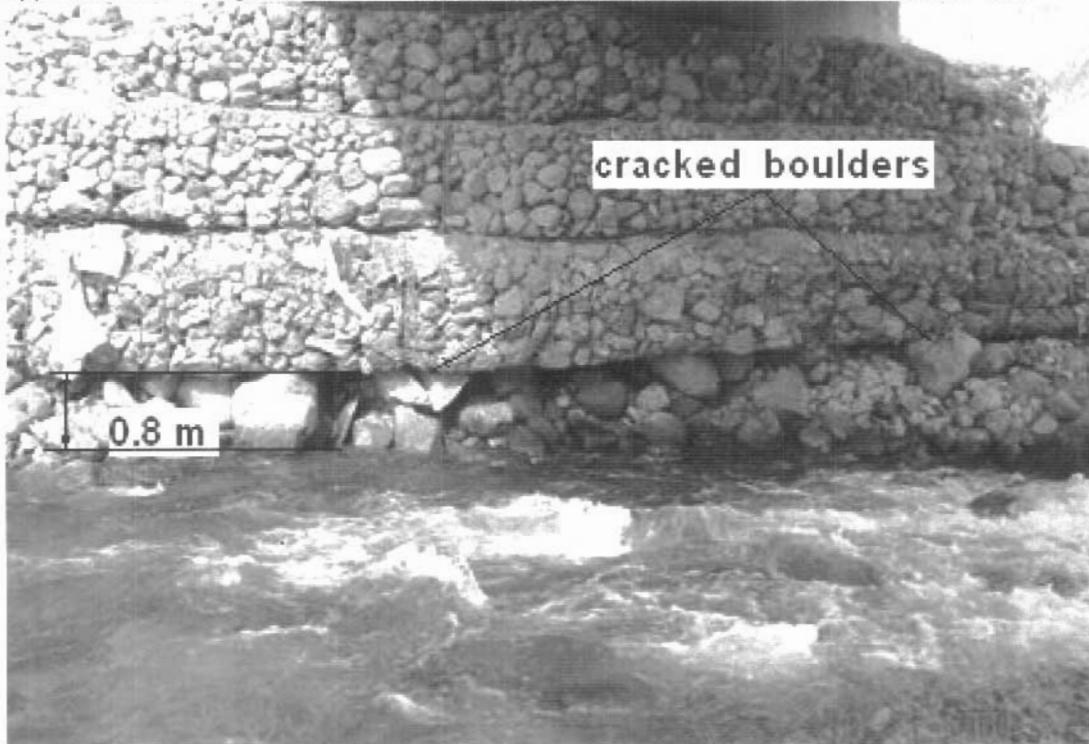
Head Slope of east abutment: 1.3 m layer (0.5 water depth + 0.8 free board) of rock base under gabions is scoured out. After next major flood/ice discharge more rock will be washed out and gabions most likely will collapse and. As a result the fill behind gabions will slide down, the piles supporting cap will buckle and the abutment will tilt as did the one on the west side.

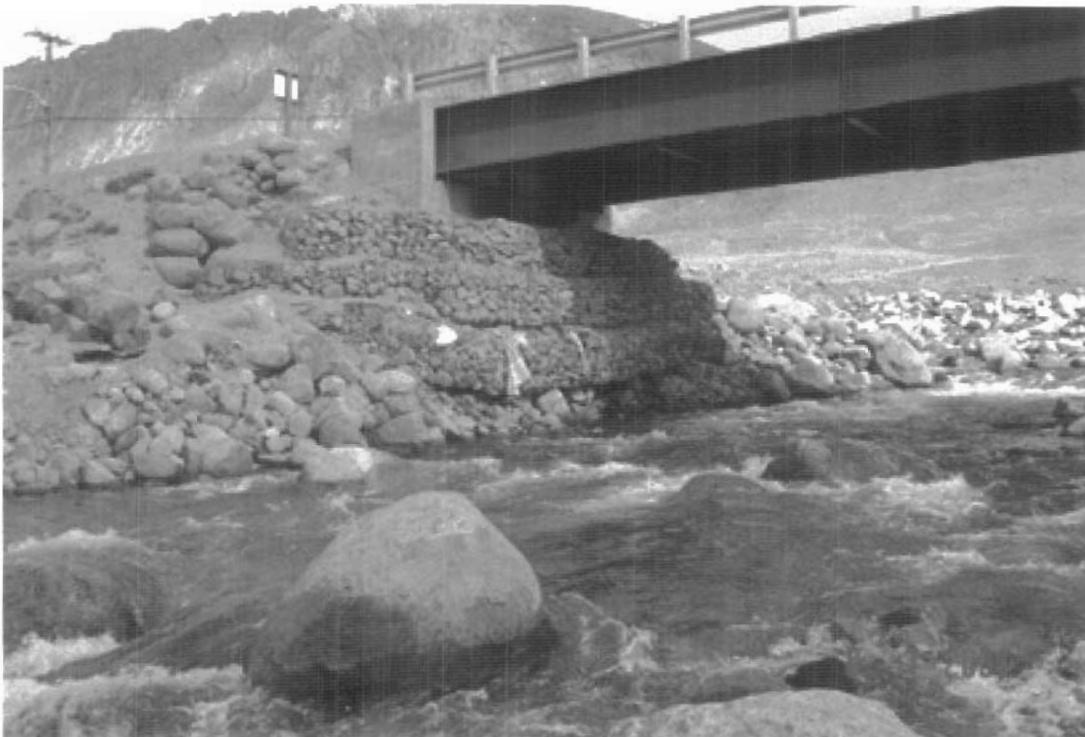
South elevation of east abutment. Evidence of scour under gabions

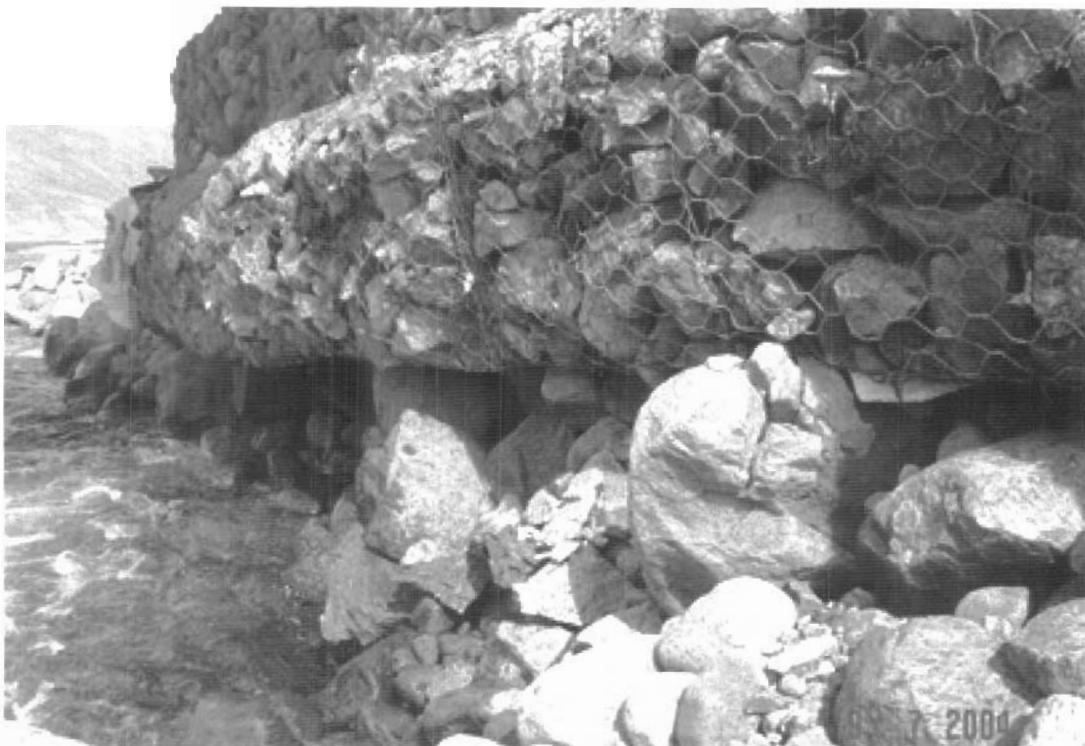
Gabions on east abutment. Boulder cracked under excessive weight (close plan to the right)

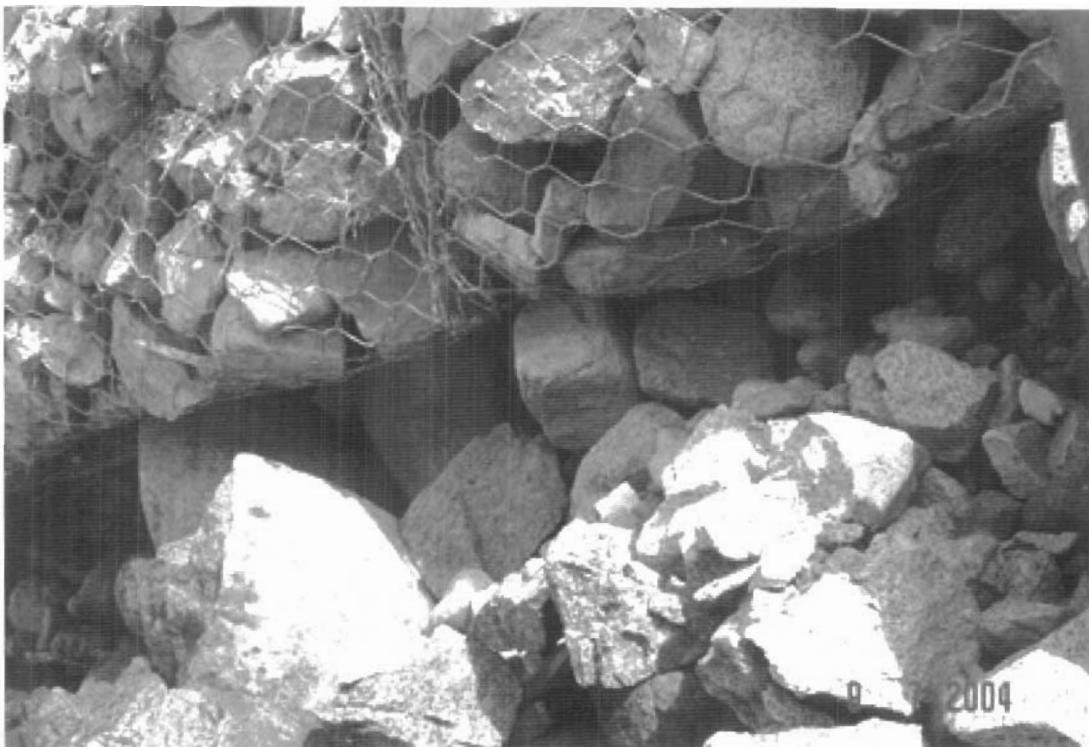
Base of gabions on east abutment. Boulders cracked and split under excessive weight

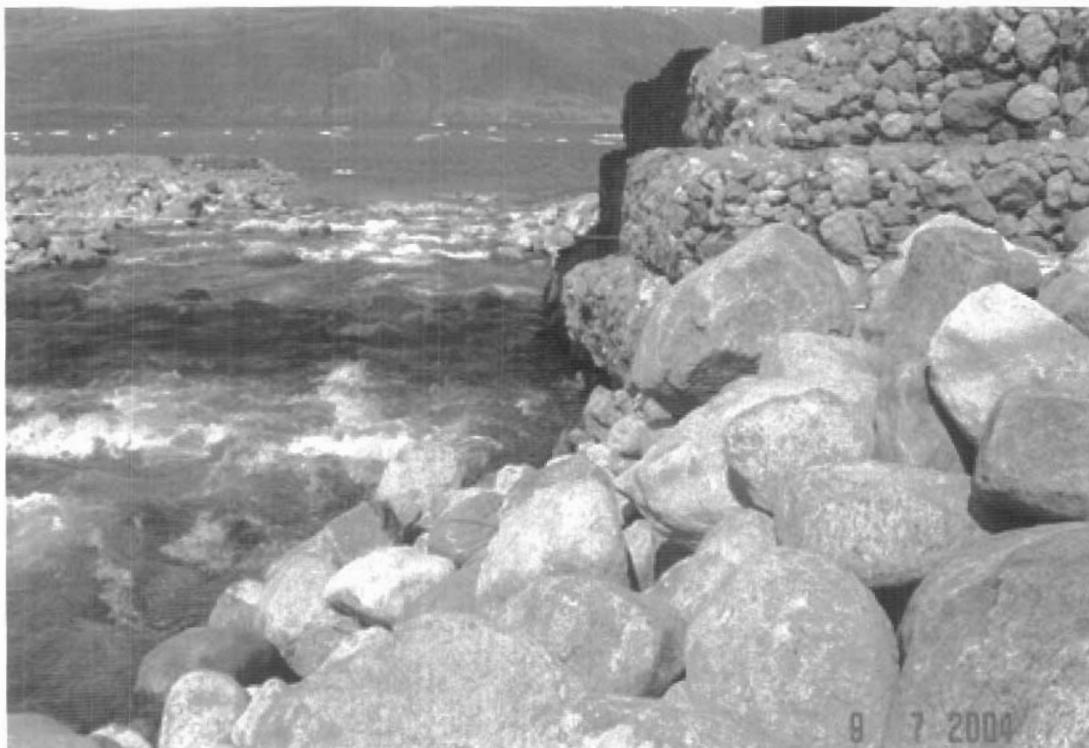
Current undermining the base of gabions on east abutment. In close plan: rock previously placed in attempt to protect abutment

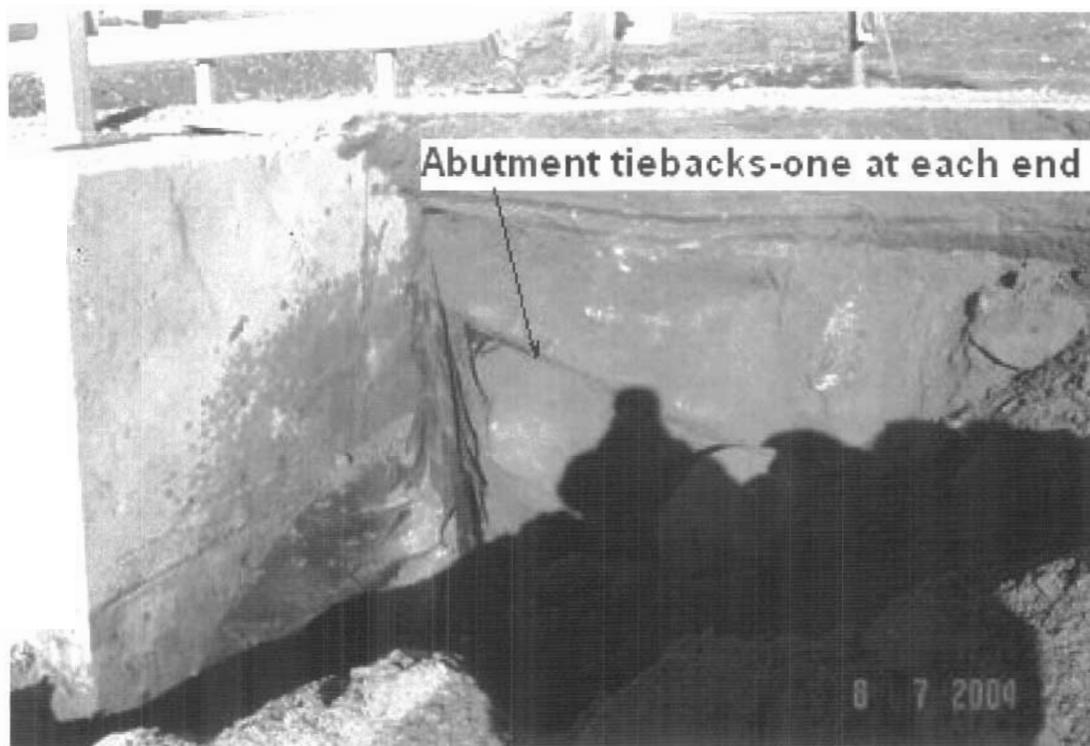
Excavation behind west (tilted) abutment. Note rebar tiebacks anchoring pile cap to dead man behind. Tiebacks are in good condition. Failure of these tiebacks will most certainly cause collapsing of the abutment and decommissioning the bridge.

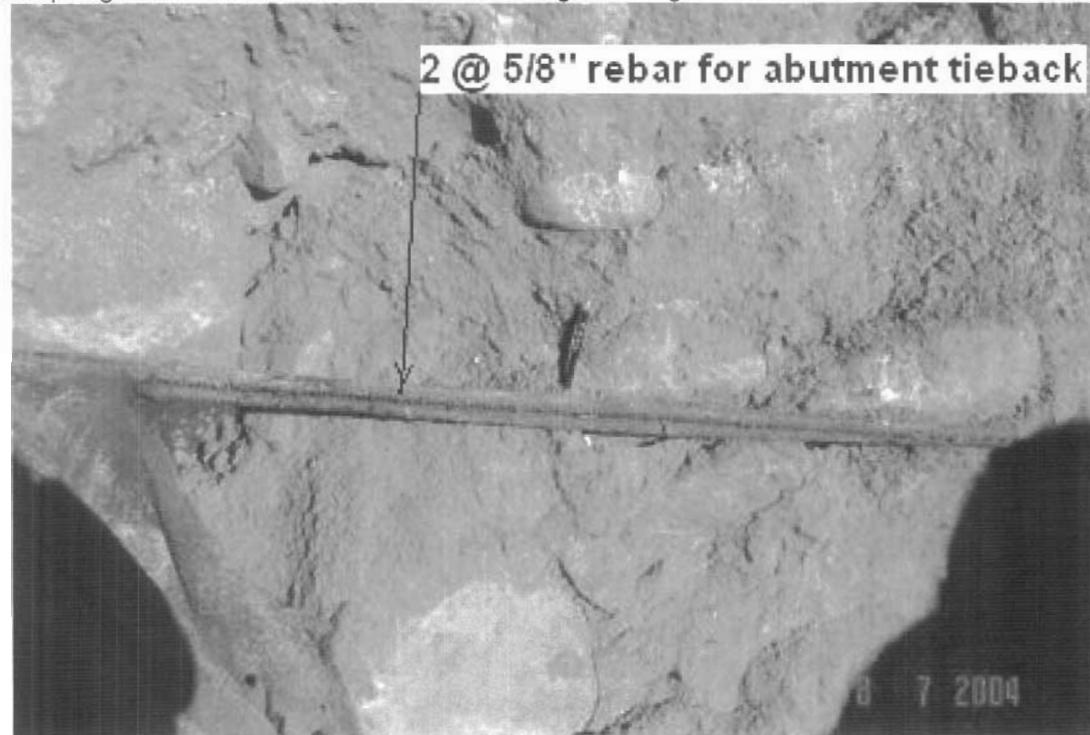
Detail of rebar tiebacks

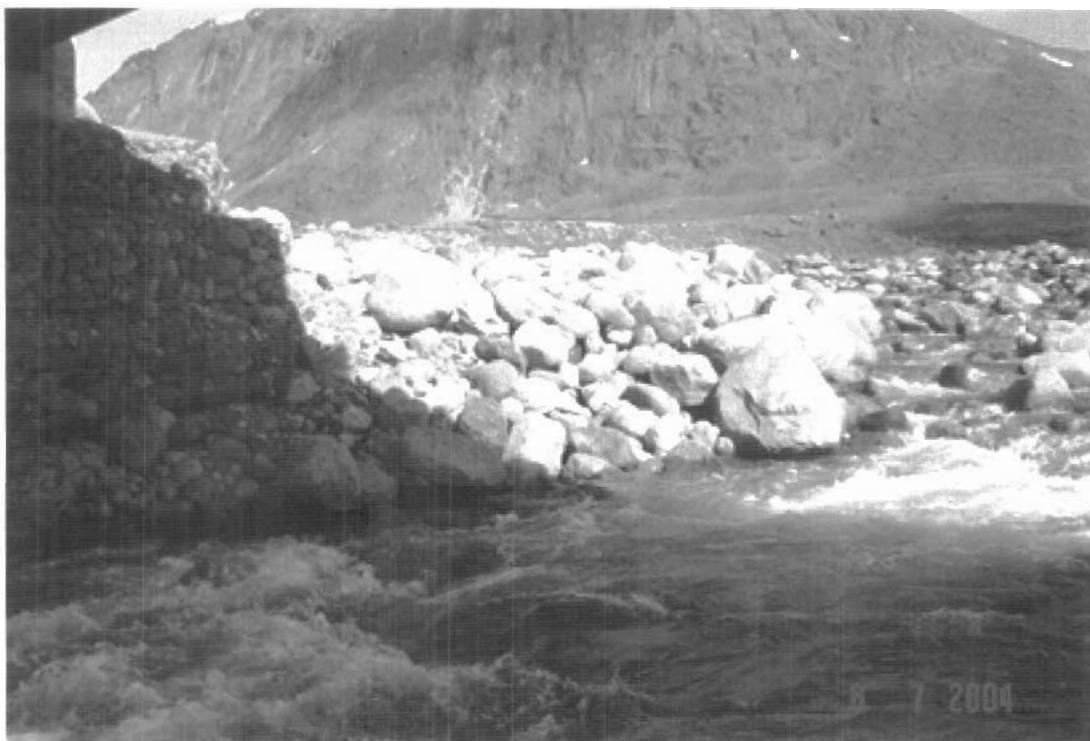
View of upstream part of east abutment. Rock berm placed on the upstream side and between abutments during repair around 1993. River current and ice traffic have washed out not less than one meter layer of rock

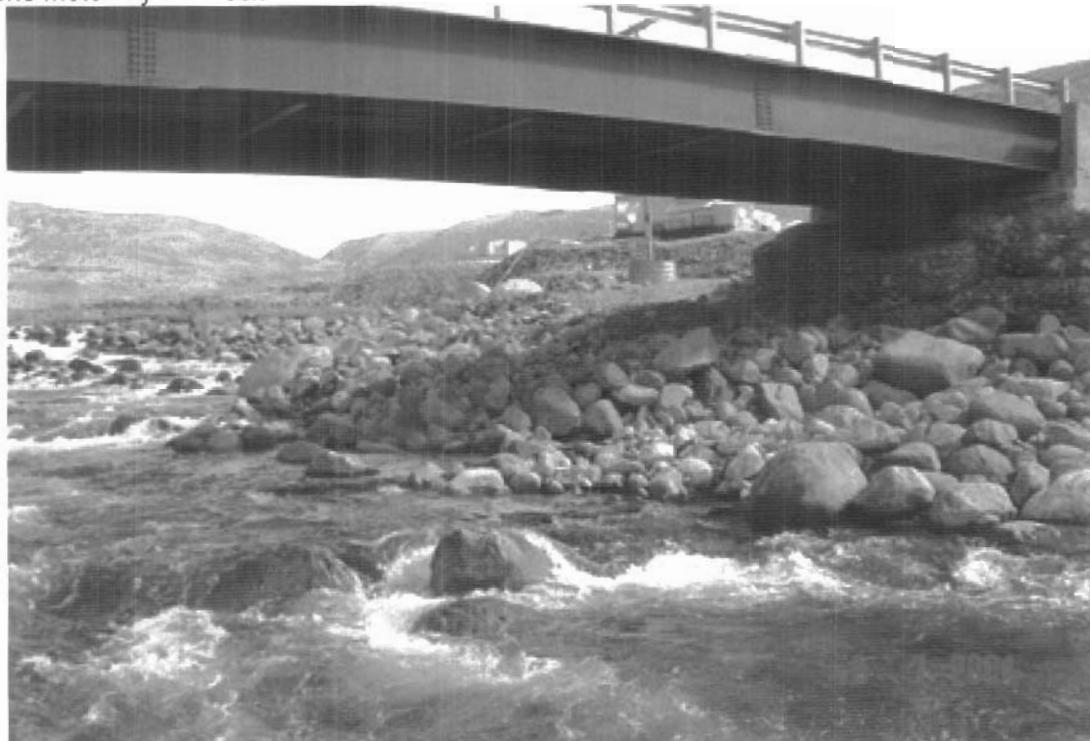
View of upstream part of west abutment. Rock berm placed on the upstream side and between abutments during repair around 1993. River current and ice traffic have washed out not less than one meter layer of rock

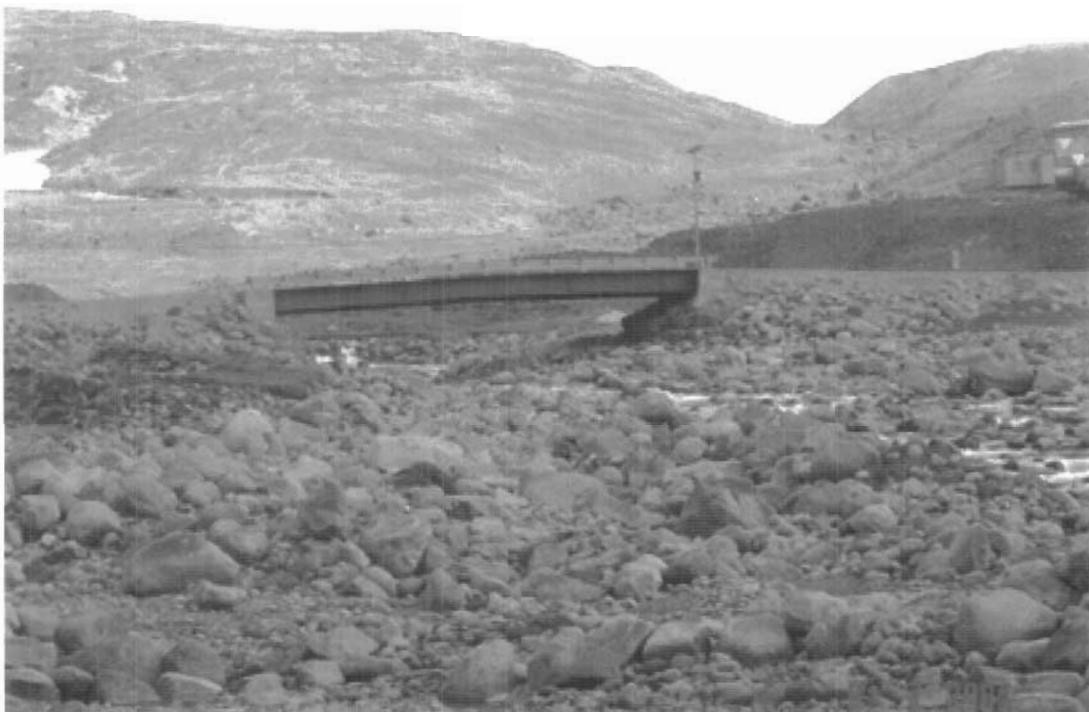
North elevation of bridge. Riverbed width in excess of 80 m immediately downstream from bridge

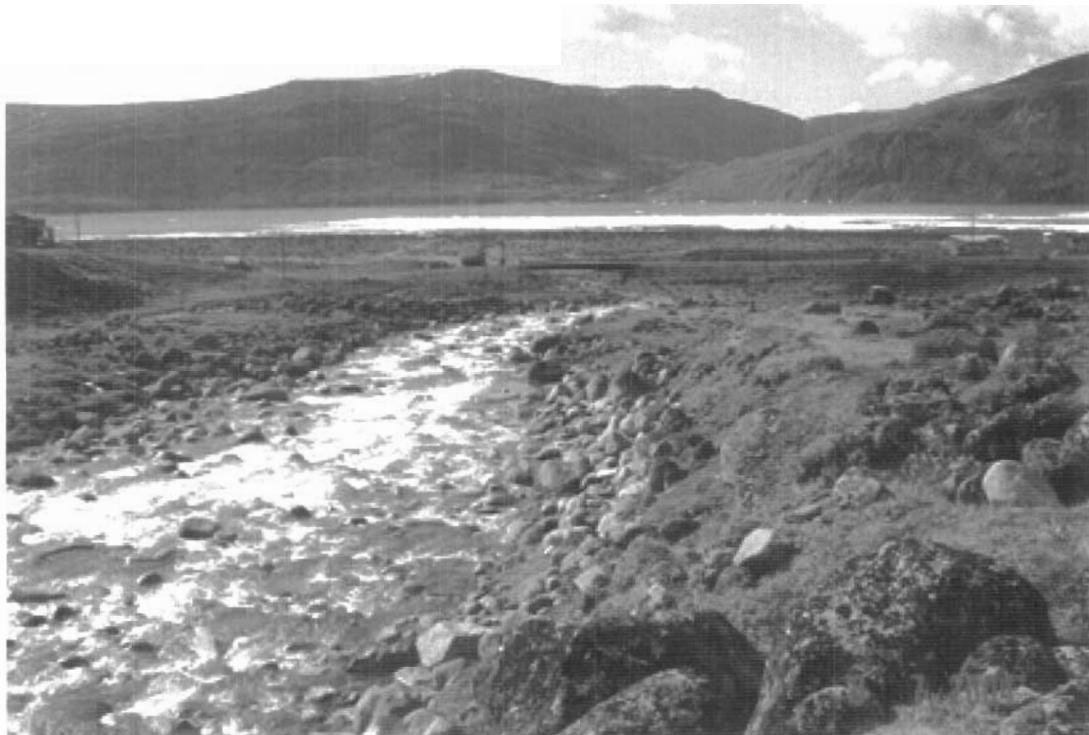
General View of the bridge area towards north. In close plan, rapids between high river banks. Riverbed of appx 45 m width appears to be stable

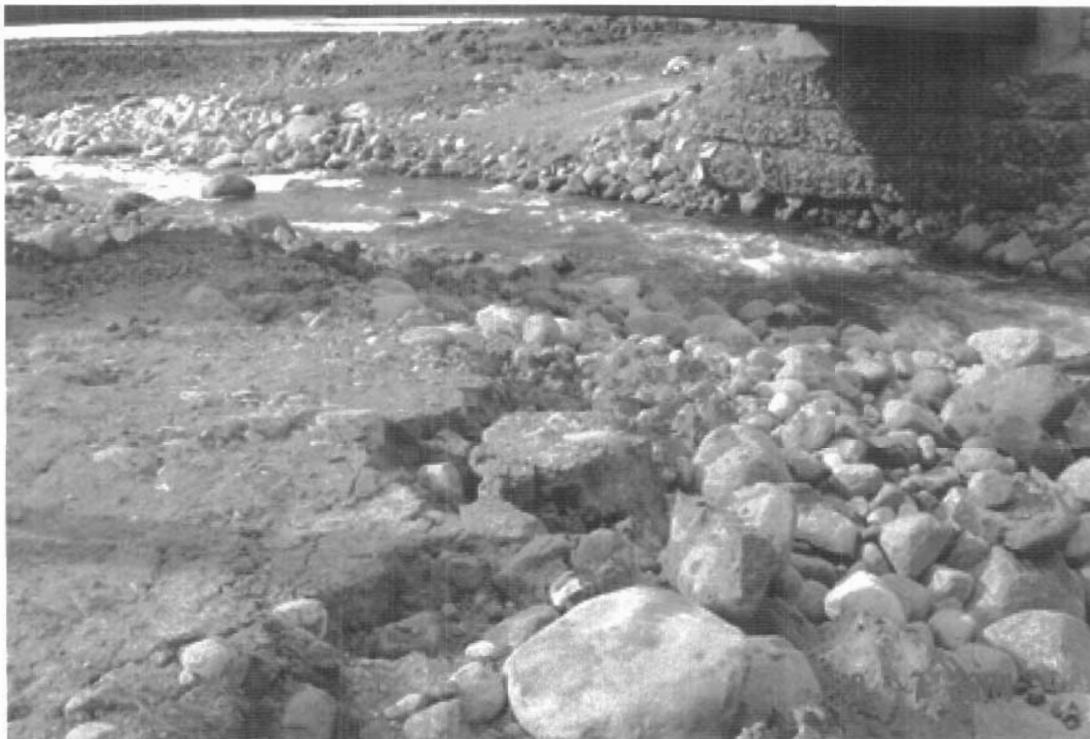
View of upstream side of west abutment. Evidence of failure (cracking and down-sliding) of the embankment due to undermining

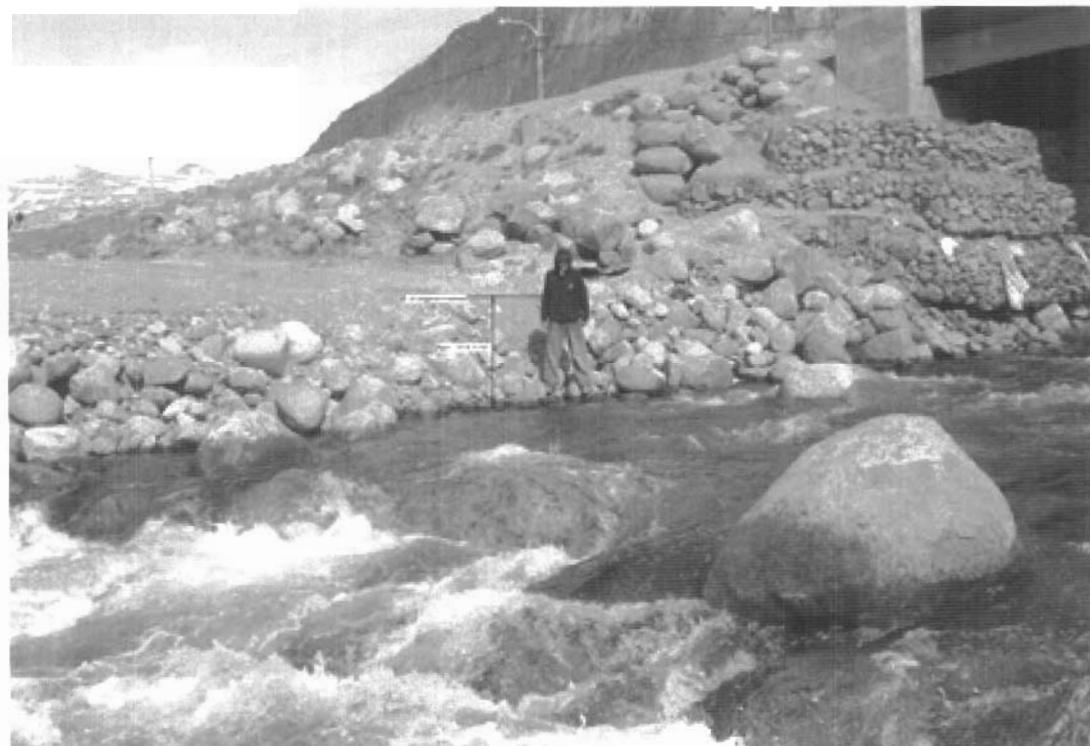
View of downstream side of east abutment on detour (ford) alignment. Evidence of scour of riverbed

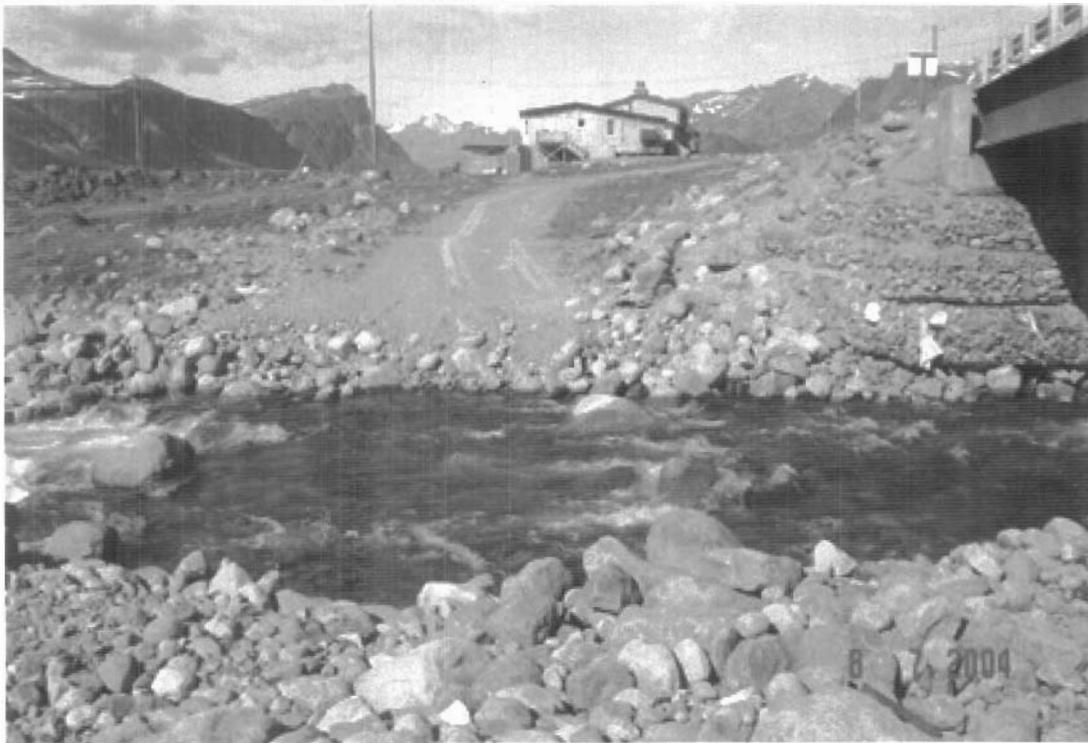
Detour alignment on existing ford. View towards east. Reportedly, 6-8 years ago riverbed at ford was 1.3 m - 1.5 m higher than presently.

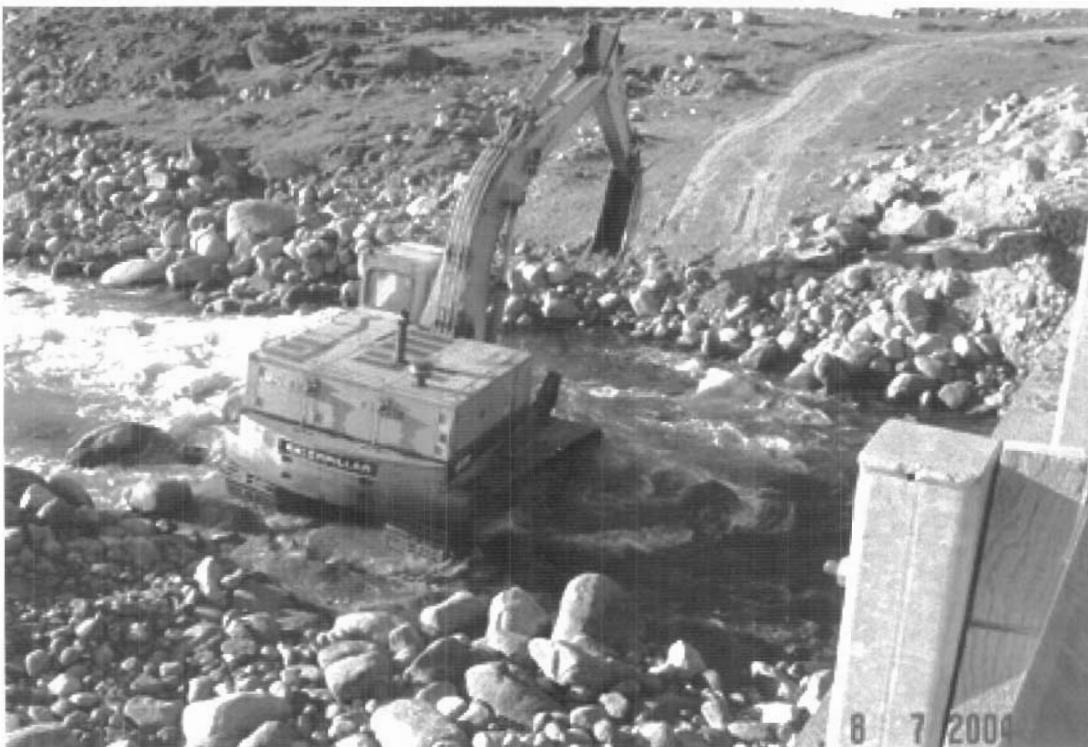
Heavy equipment fording the river. River at ford appx 0.9 m deep. Reportedly heavy equipment on tracks and overload vehicles regularly ford the river. No siltation was noted during the crossing, since the riverbed consists almost exclusively of large boulders
