## WATER LICENCE INSPECTION FORM

Licensee		Licensee Representative	
City of Iqaluit		Navjot Singh	
Licence No. / Expiry 8BW-IGD2123		Representative's Title Consultant inspector	
Land / Other Authorizations		Land / Other Authorizations	
		--	
Date of Inspection August 11, 2021		Inspector Jonathan MESHER	
Activities Inspected		<input type="checkbox"/> Camp <input type="checkbox"/> Drilling <input type="checkbox"/> Mining <input checked="" type="checkbox"/> Construction <input type="checkbox"/> Reclamation <input type="checkbox"/> Fuel Storage <input type="checkbox"/> Roads/Hauling <input type="checkbox"/> Other: _____

The licence 8BW-IGD-2123 was issued to allow for the construction of water crossings and installation of culverts as part of the construction of the access road to the granular site located near the City of Iqaluit within the Qikiqtani Region, Nunavut, generally located at the geographical coordinates as follows:

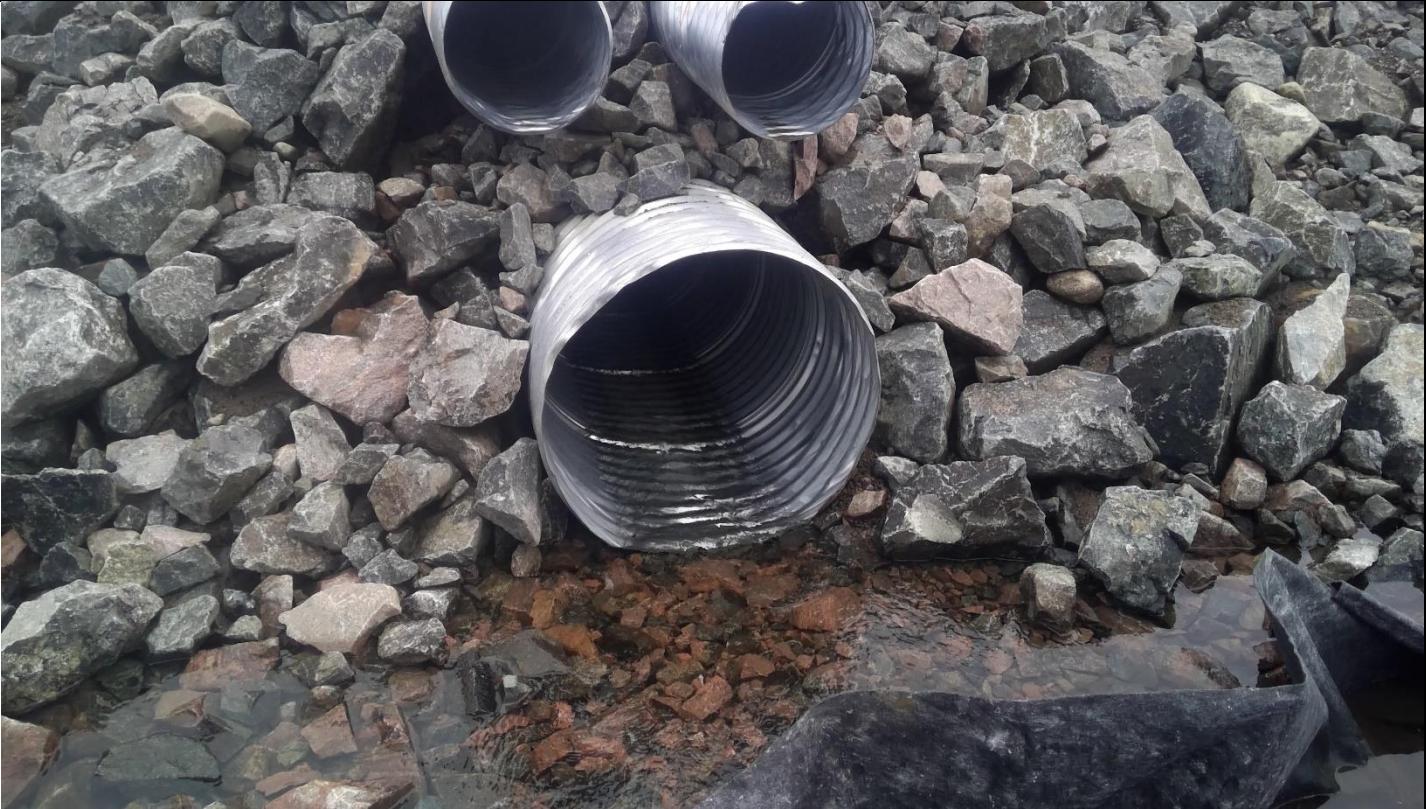
Date	Camera	Inspector	Authorization
	Sony Cyber-shot	J.Mesher	8BW-IGD2123
<b>Photo Log</b>			
Photo 1

1. At the time of the inspection there was little flow in the water crossings.
2. It was noted that water was flowing through the road at the culvert located at approximately N63.802 W68.570, there did not appear to be increased TSS at the downstream side of the road. The same culvert was visited on August 19, 2021, at this time the water levels were higher and the culvert appeared to be operating as intended.
3. During the inspection the ditches along the road described in the For- construction were not yet installed.

Description: culvert installed at N63.802 W68.570, photo taken August 19, 2021.
