WATER LICENCE INSPECTION FORM

Licensee Tower Arctic Ltd.	Licensee Representative Simon-Pier Laberge
Licence No. / Expiry 8BW-PIM1821	Representative's Title Project Manager
Land / Other Authorizations N2019X0012	Land / Other Authorizations 03QN074
Date of Inspection August 11, 2020	Inspector Joseph Monteith
Activities Inspected <input checked="" type="checkbox"/> Camp <input checked="" type="checkbox"/> Roads/Hauling <input type="checkbox"/> Drilling <input type="checkbox"/> Mining <input checked="" type="checkbox"/> Other: Spill Report sites	<input checked="" type="checkbox"/> Construction <input type="checkbox"/> Other: <input checked="" type="checkbox"/> Reclamation <input type="checkbox"/> Fuel Storage

Inspector Statement			
On August 20, 2020, Water License inspections were conducted at the site of the Pond Inlet Infrastructure Project, Pond Inlet, Qikiqtani Region, Nunavut, to verify compliance with the terms and conditions of the Water Licence 8BW-PIM1821.			
General Condition

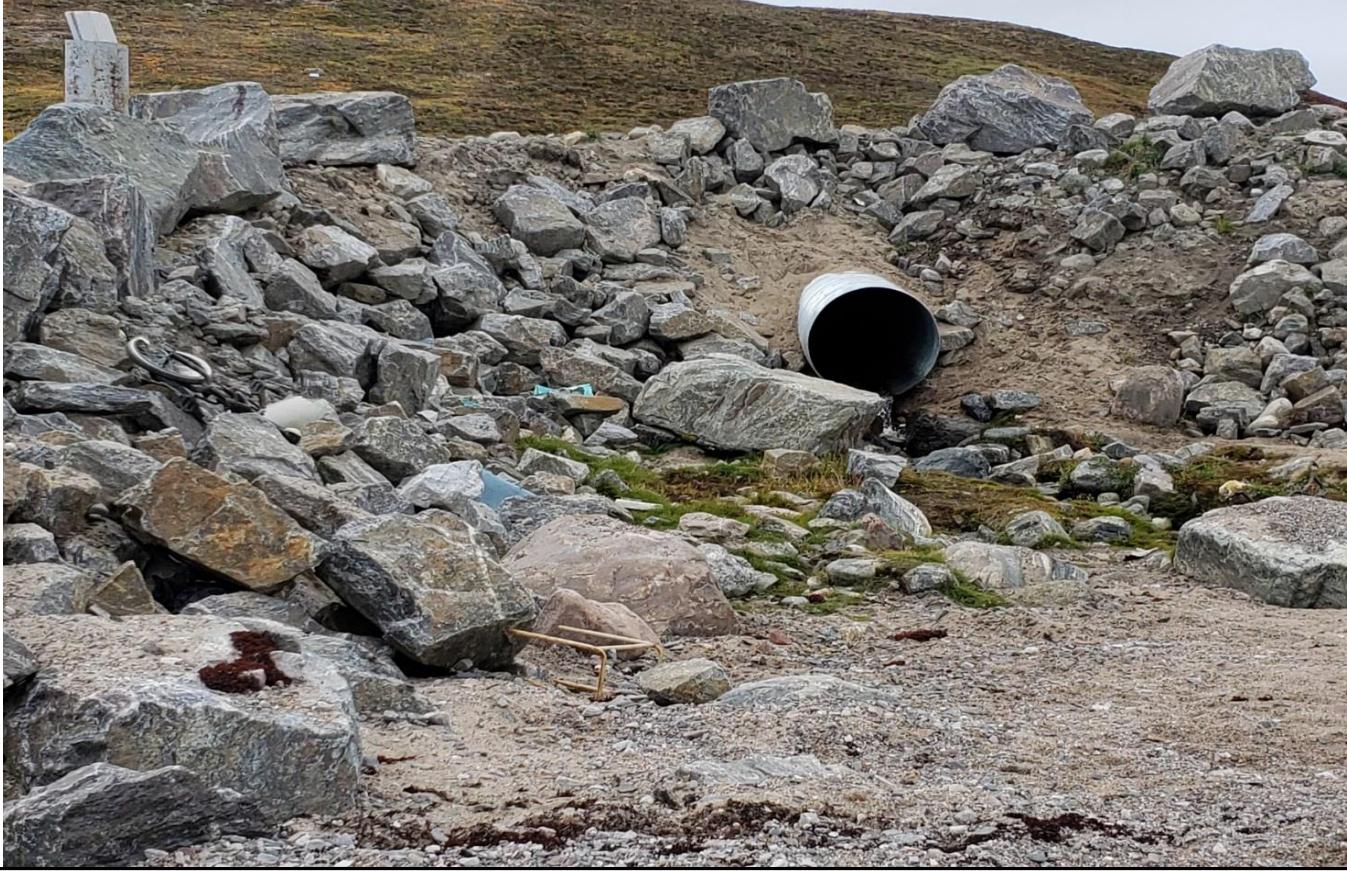
Photo 3

Description: Culvert CS-07. The last culvert between the quarry and the construction site.

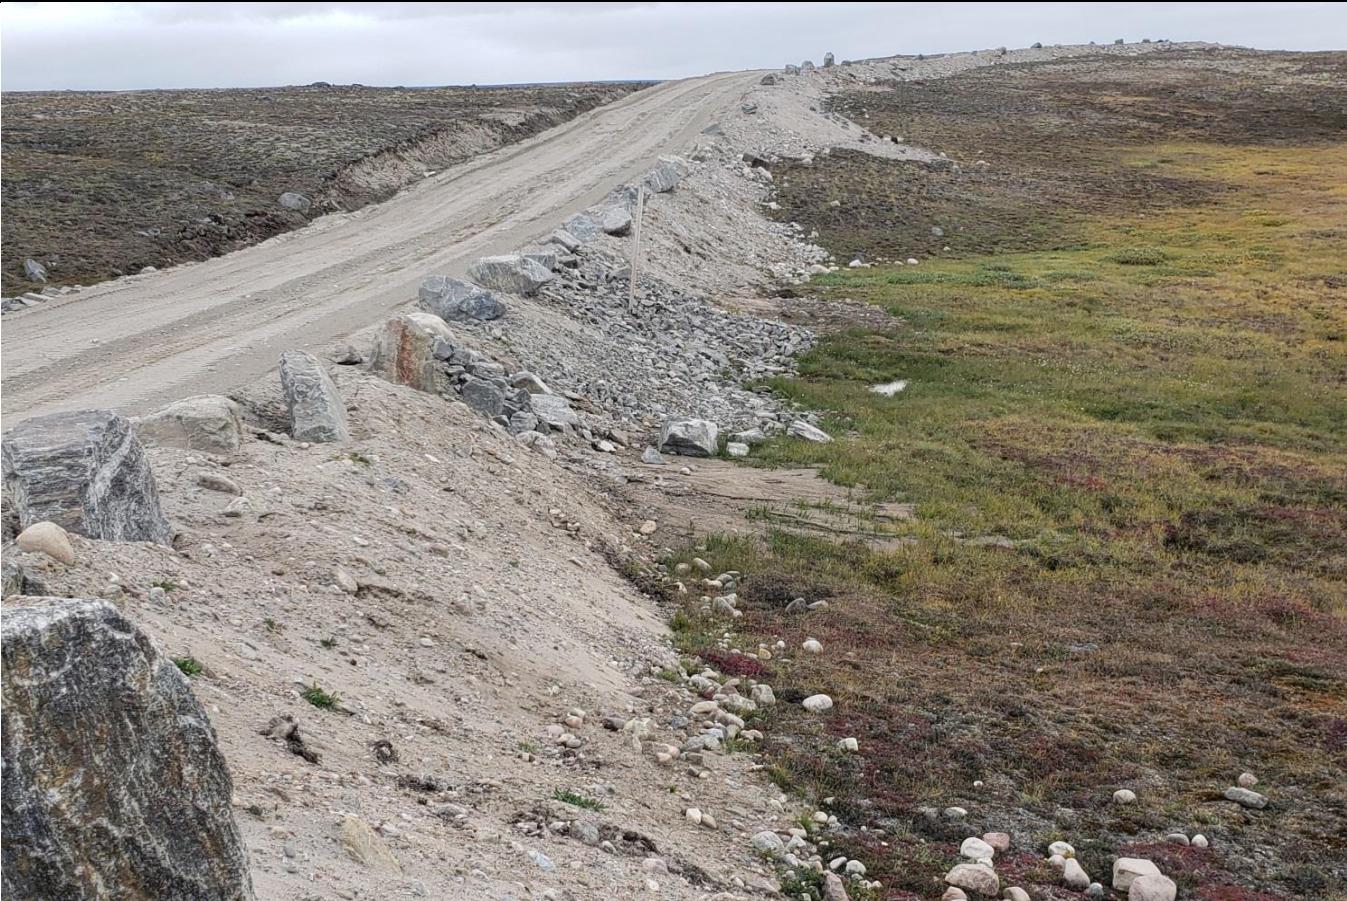
Photo 4

Description: CS-06 Culvert on haul road. Stick protruding out of side of road is location of culvert. No Parallel ditches on downward slope side of road. Parallel ditches observed on higher elevated road. Culvert covered with Rip Rap to protect it if vehicle goes over the side of road, and to stop warm air from melting permafrost.

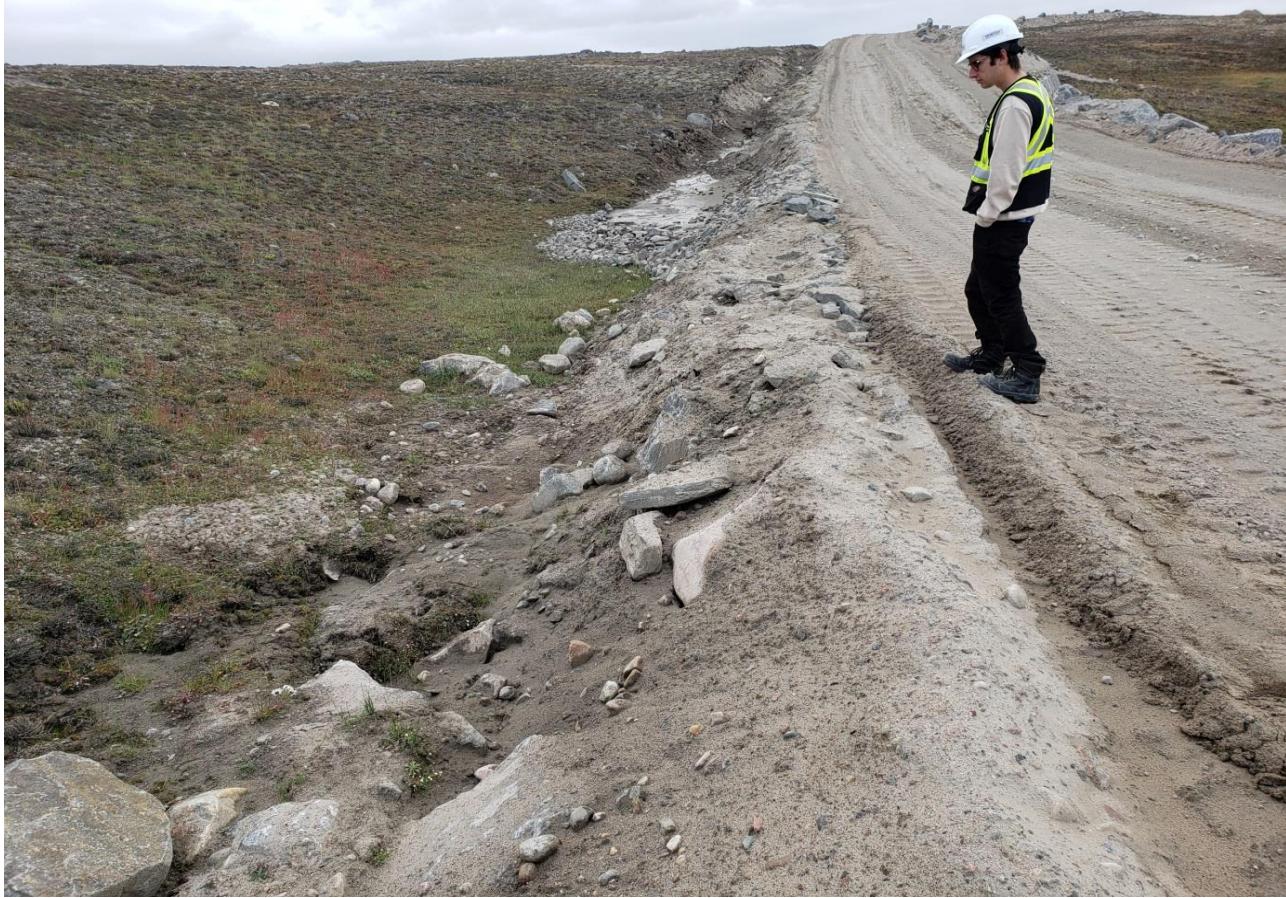
Photo 5

Description: Parallel Ditch only goes from top of the hill to culvert. CS-06 Culvert

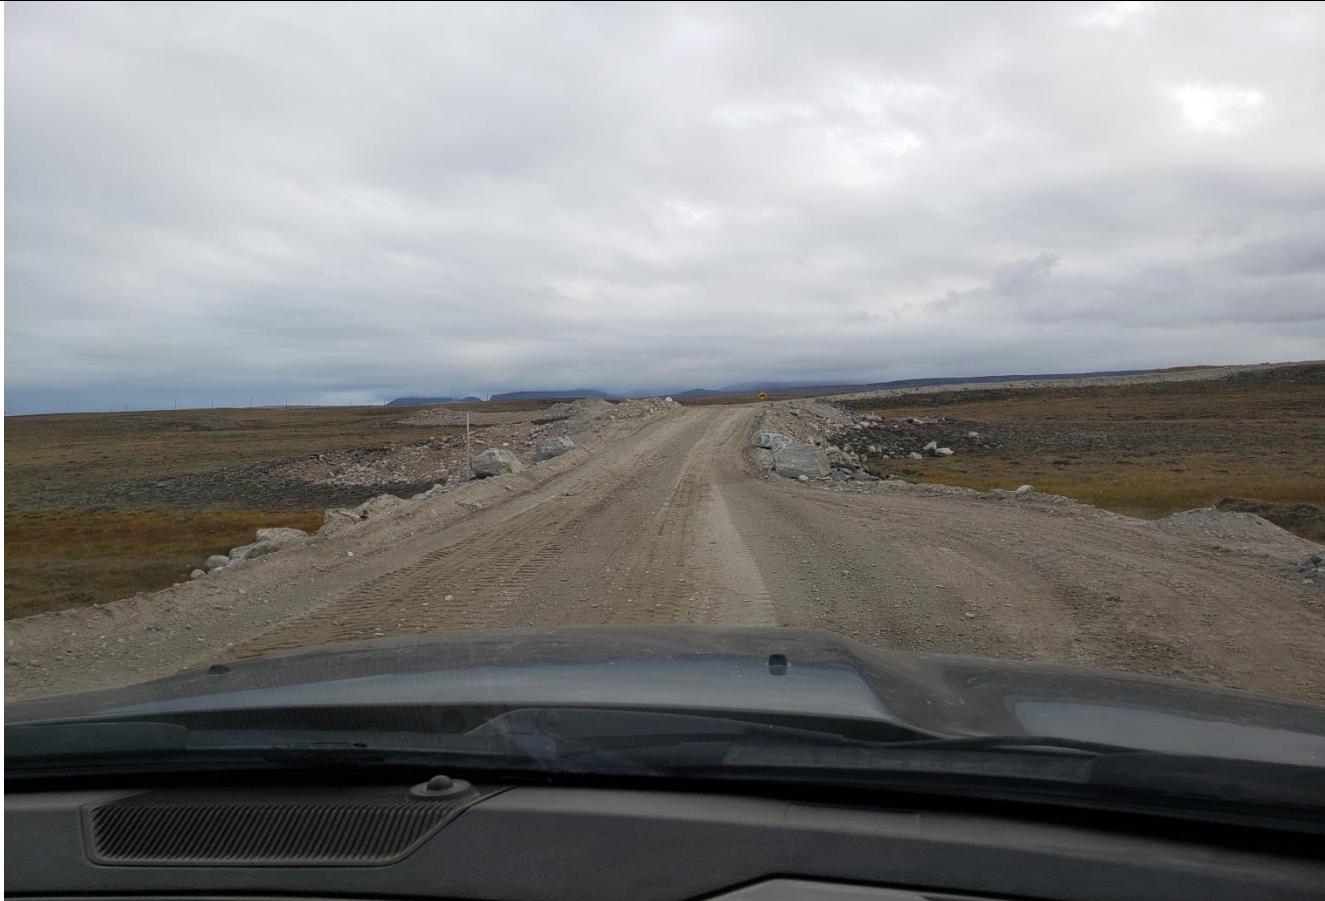
Photo 6

Description: CS-05 Culvert located where the stick is protruding up from the road. Road widened, possibly to allow other heavy equipment to pass. Widened road width approximately 9 metres wide. Culvert is covered by Rip Rap to mitigate any damage to the culvert, and to mitigate warm air melting permafrost.

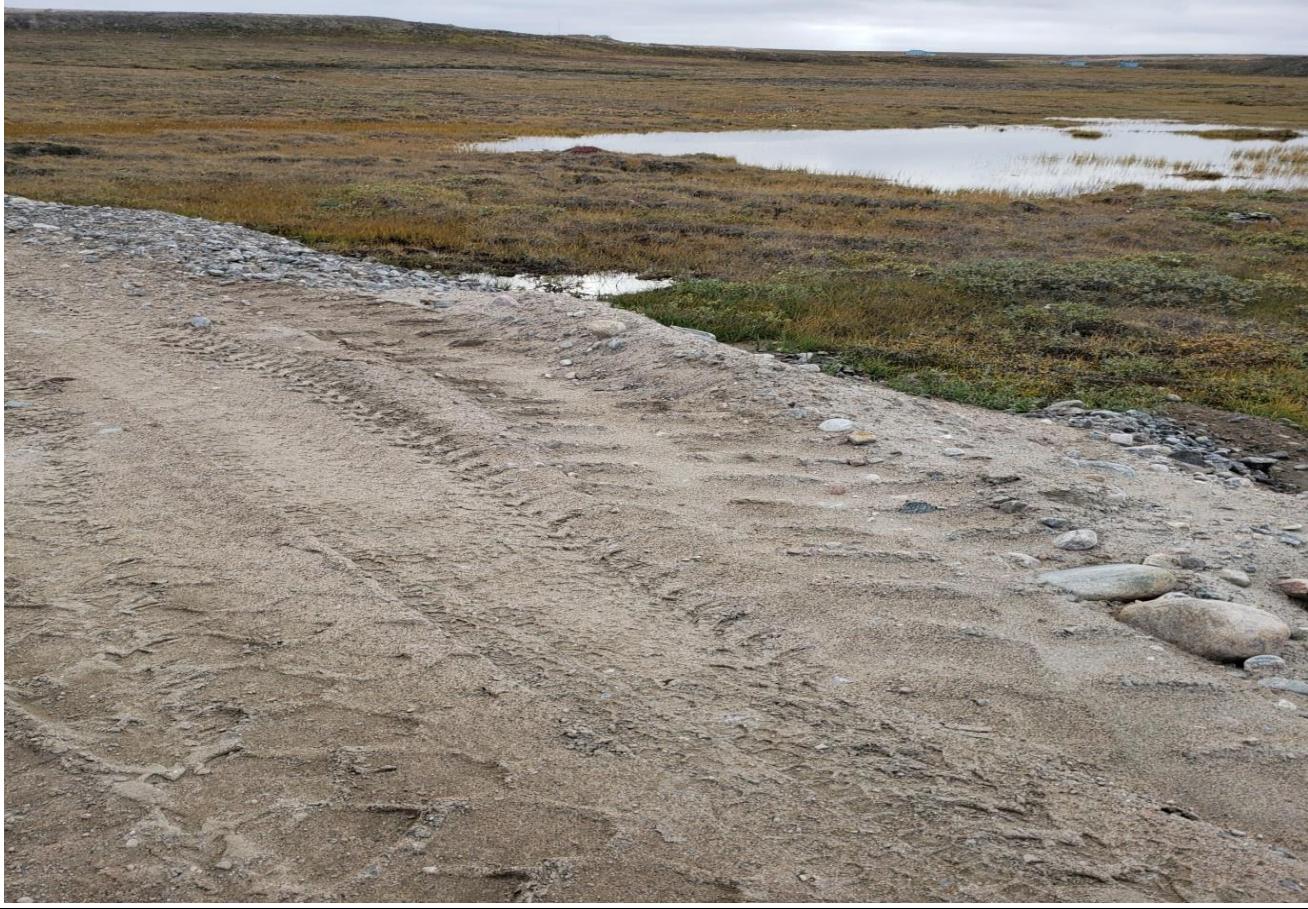
Photo 7

Description: CS-04 Culvert. Culvert is covered by Rip Rap to mitigate any damage to the culvert, and to mitigate warm air melting permafrost.

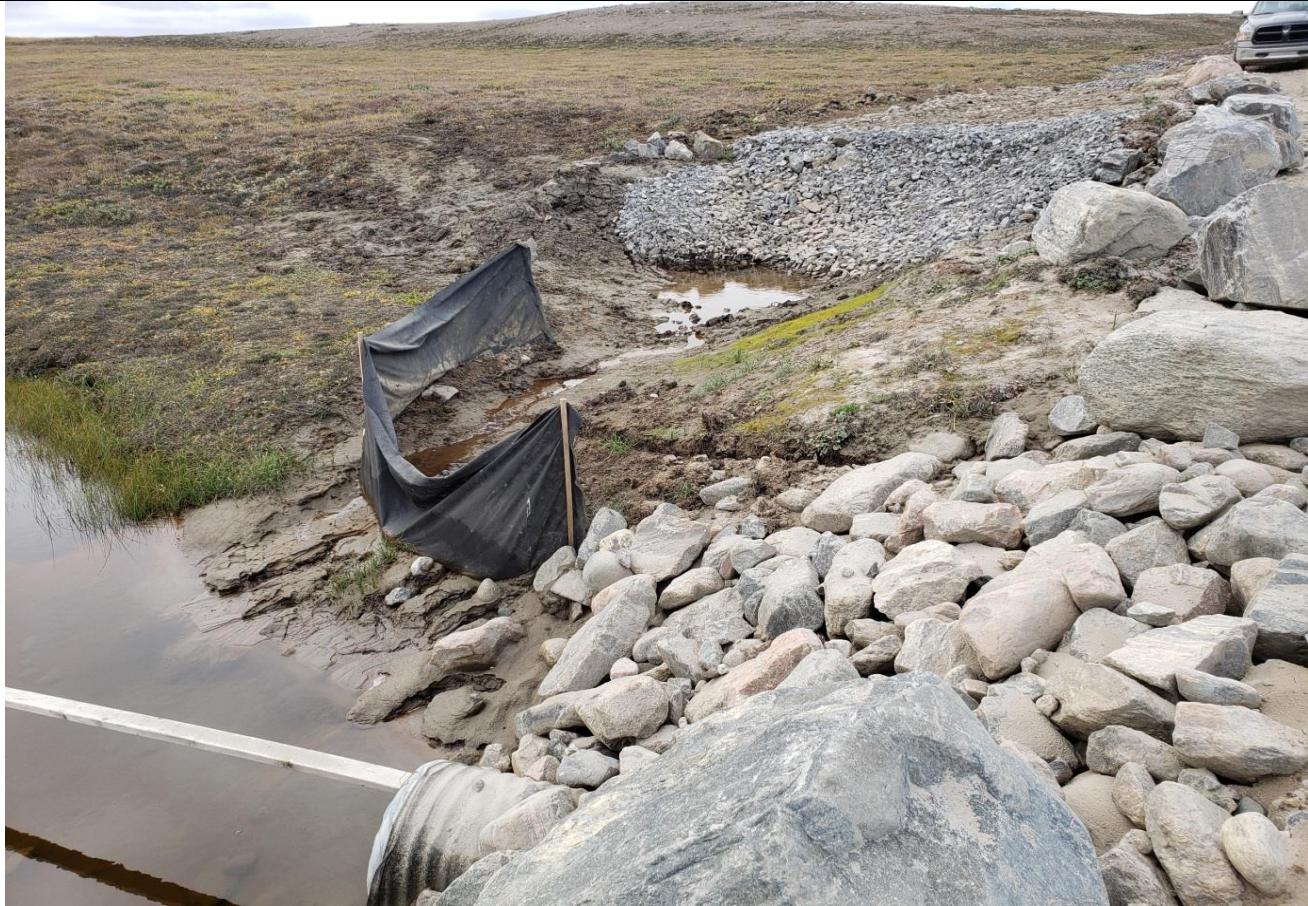
Photo 8

Description: The first Culvert between the Quarry and the construction site. CS-03, with Rip Rap and silt fencing appear to have been put down to help mitigate sedimentation.

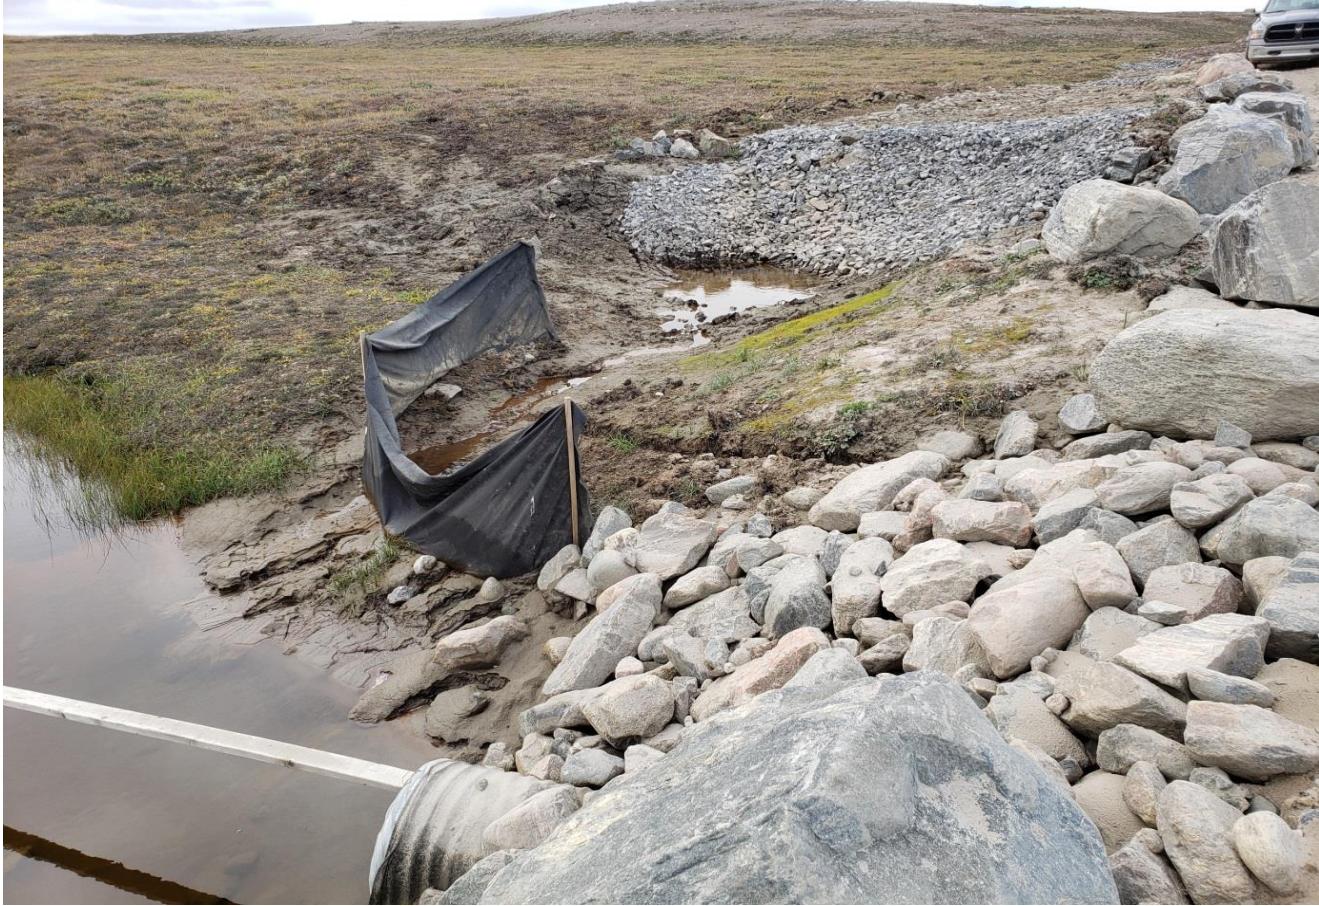
Photo 9

Description: The first Culvert between the Quarry and the construction site. CS-03, with Rip Rap and silt fencing appear to have been put down to help mitigate sedimentation.

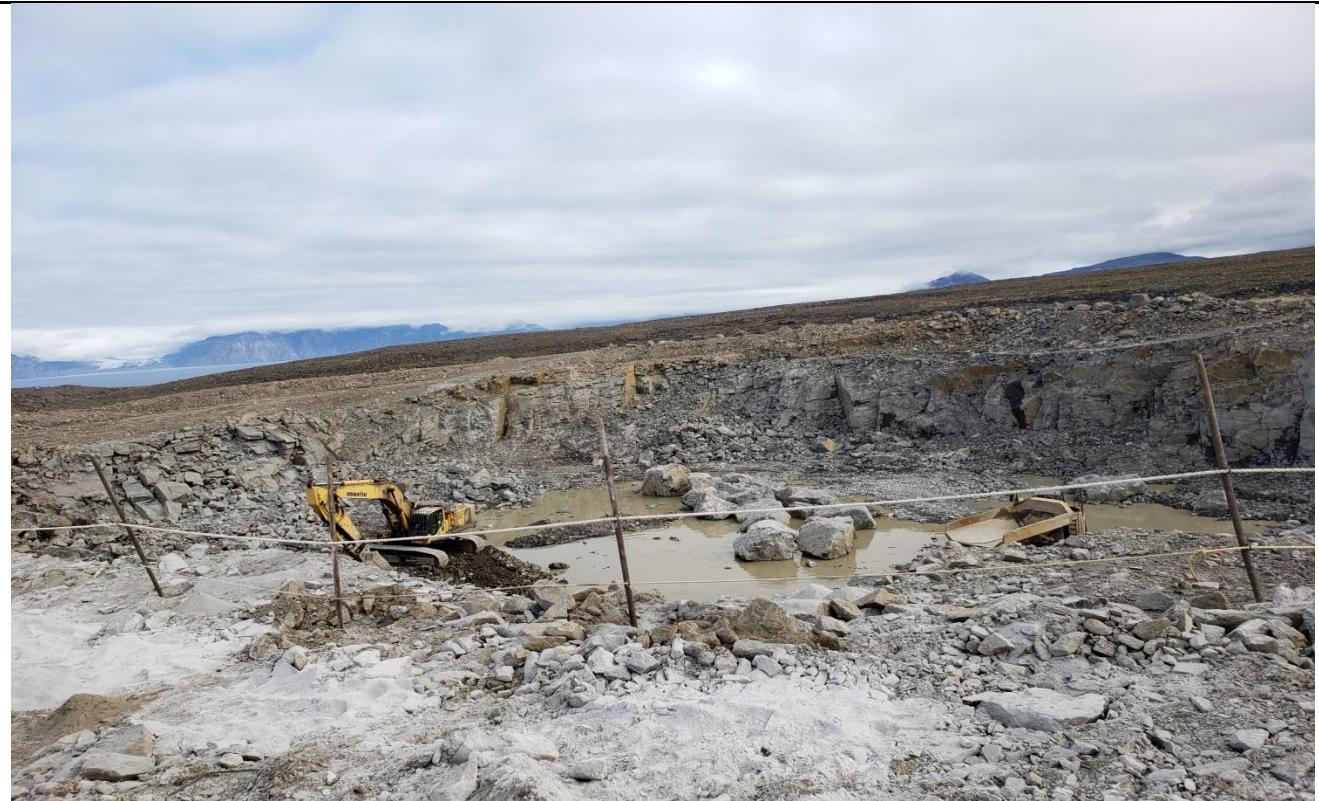
Photo 10

Description: Quarry Pit. Fresh Water interaction in

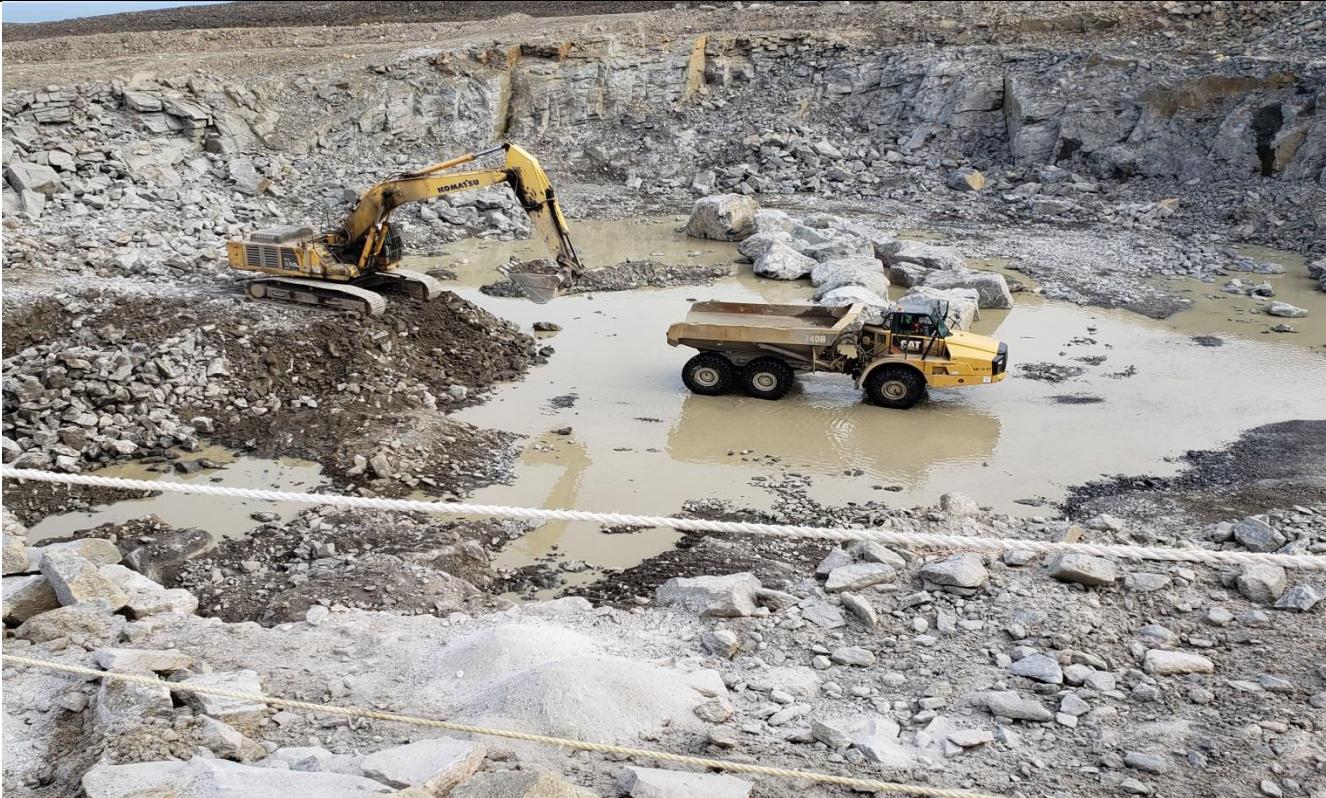
Photo 11

Description: At the bottom of the Quarry Pit. Active site of excavation and hauling. Naturally gravity would accumulate raw water in the depression, and interact with heavy equipment. The water undergoes month testing, if water exceeds particular parametres . Tower Arctis is also bound to monitor run off and discharges from the quarry sites.

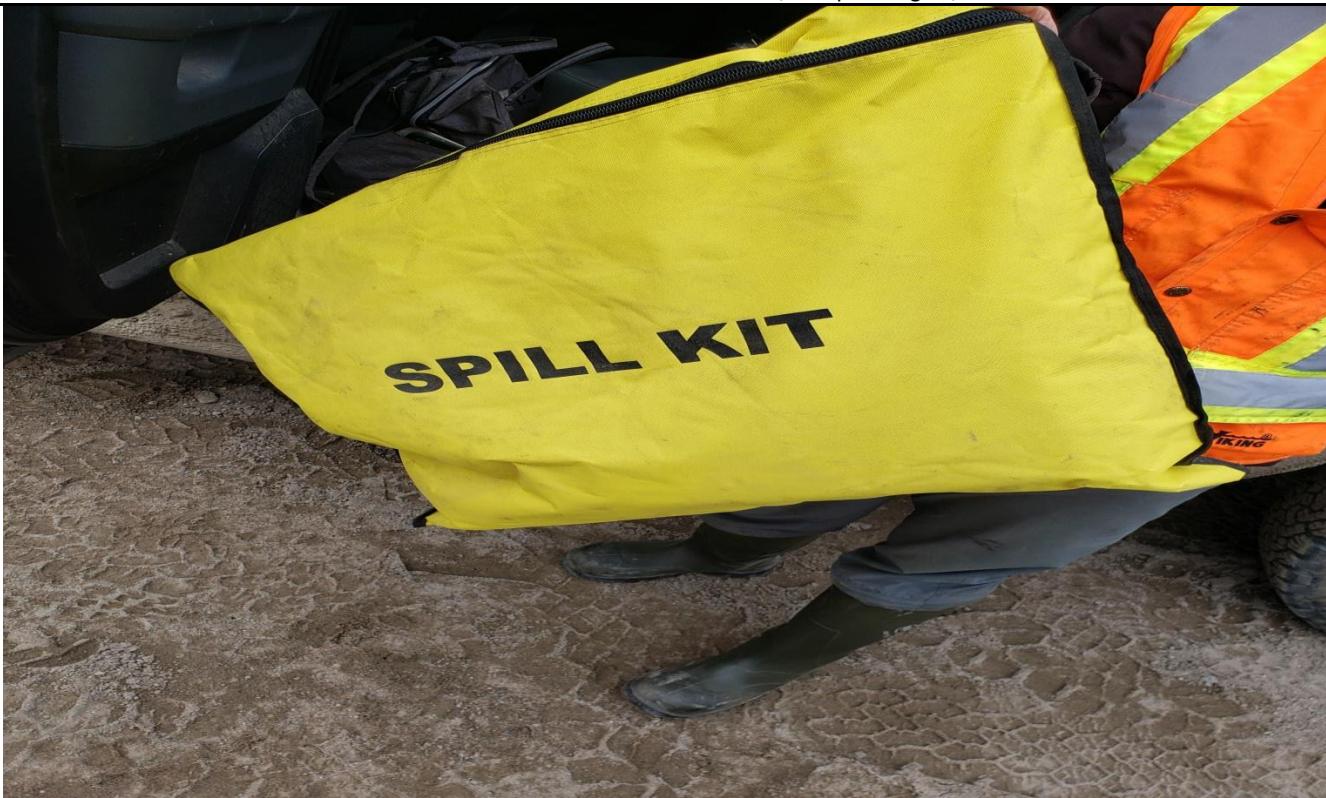
Photo 12

Description: mobile spill kits in all the vehicles.

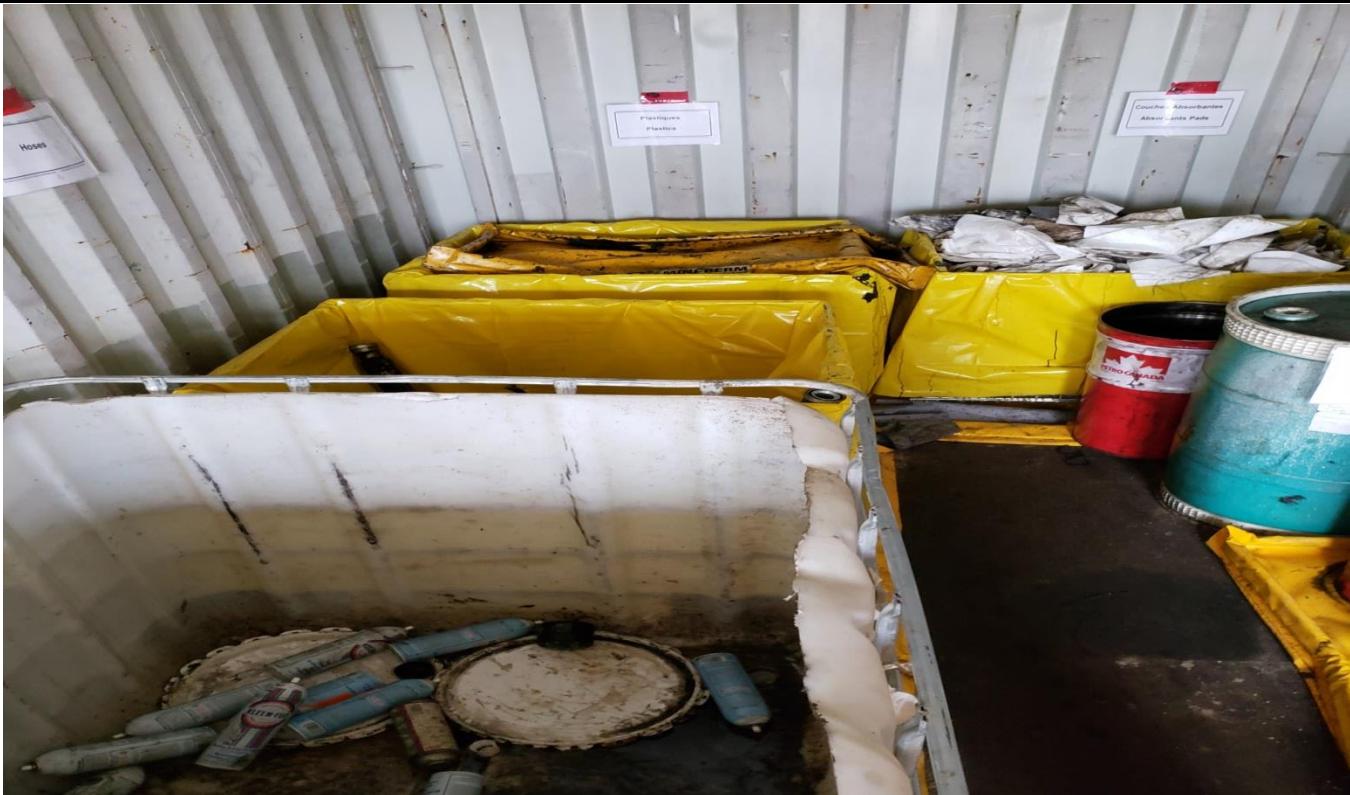
Photo 13

Description: Hazardous Waste in sea can, in secondary containment. Stored at the Garage area sea can lay down area.

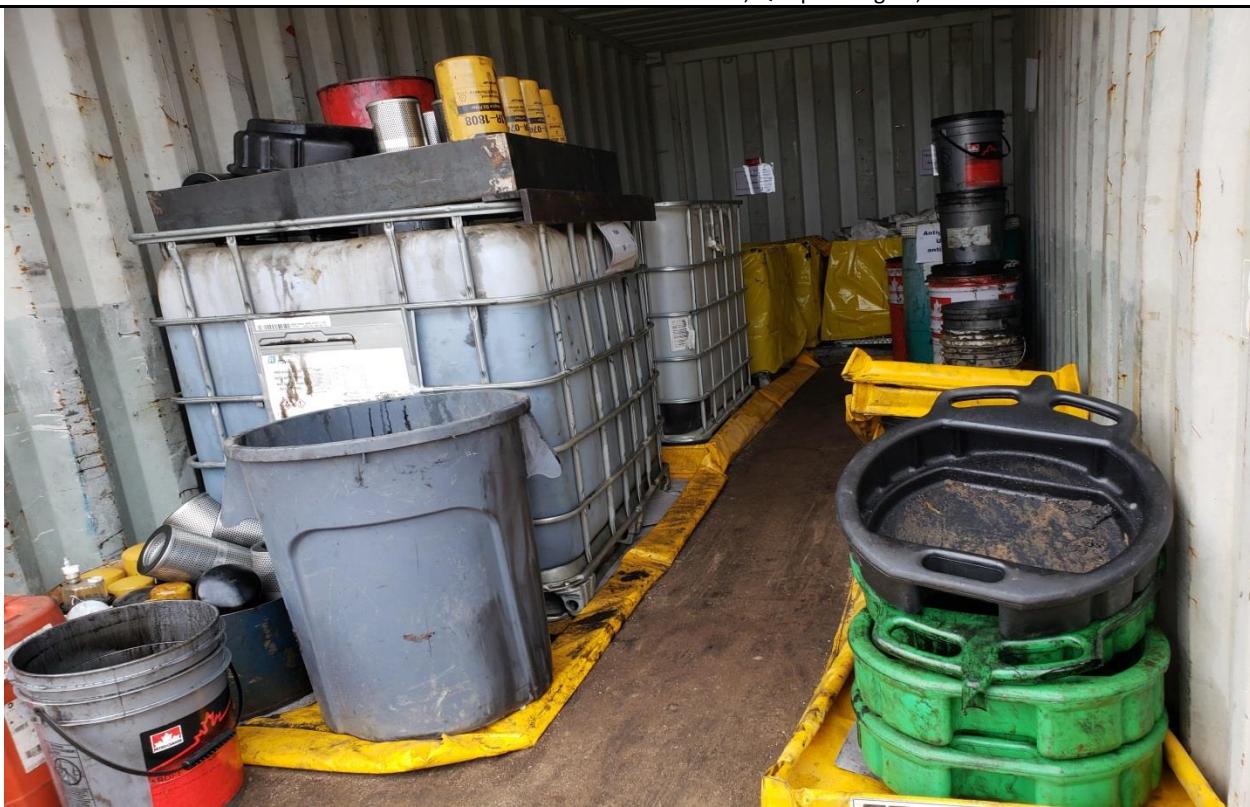
Photo 14

Description: hazardous waste sea can, drip pans, and waste oil storage in secondary containment.

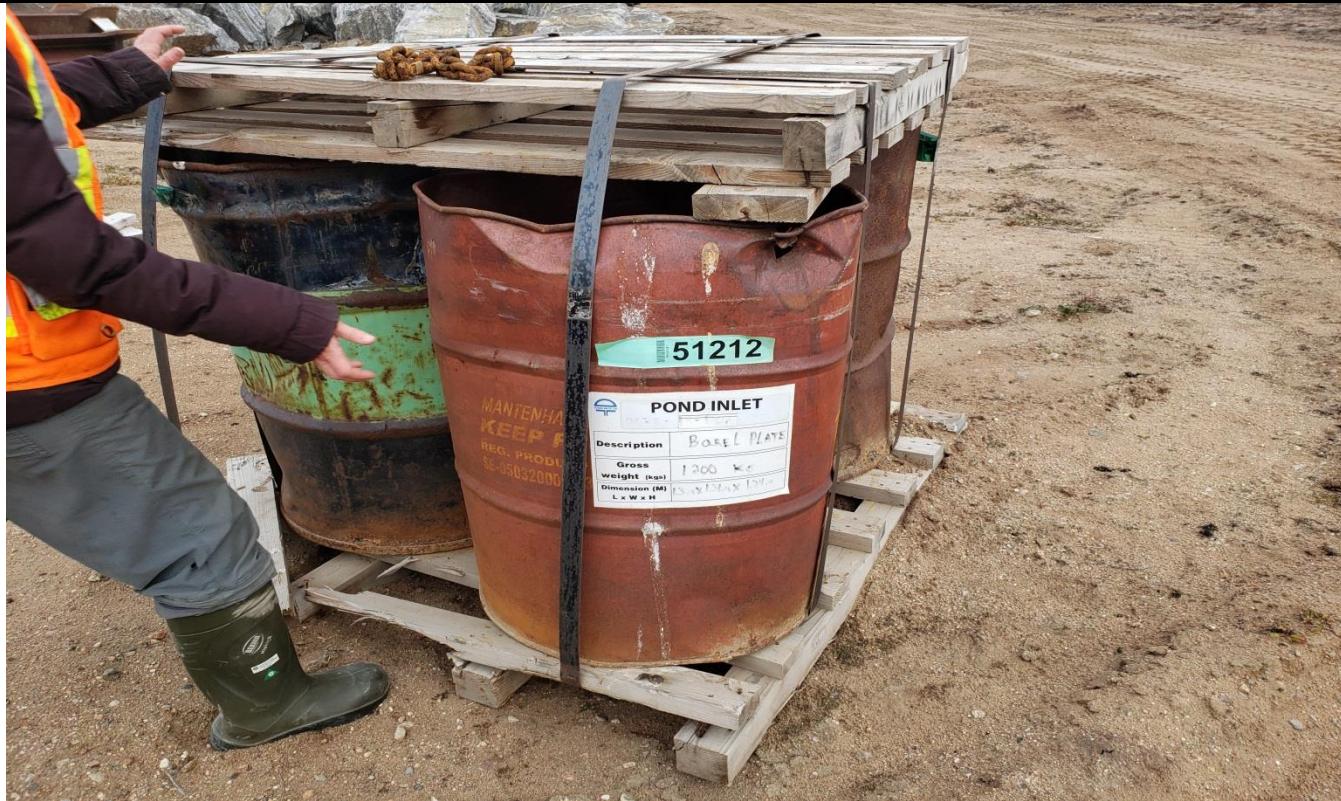
Photo 15

Description: palletized bulk metal waste. Ready to be disposed with in the municipal landfill.

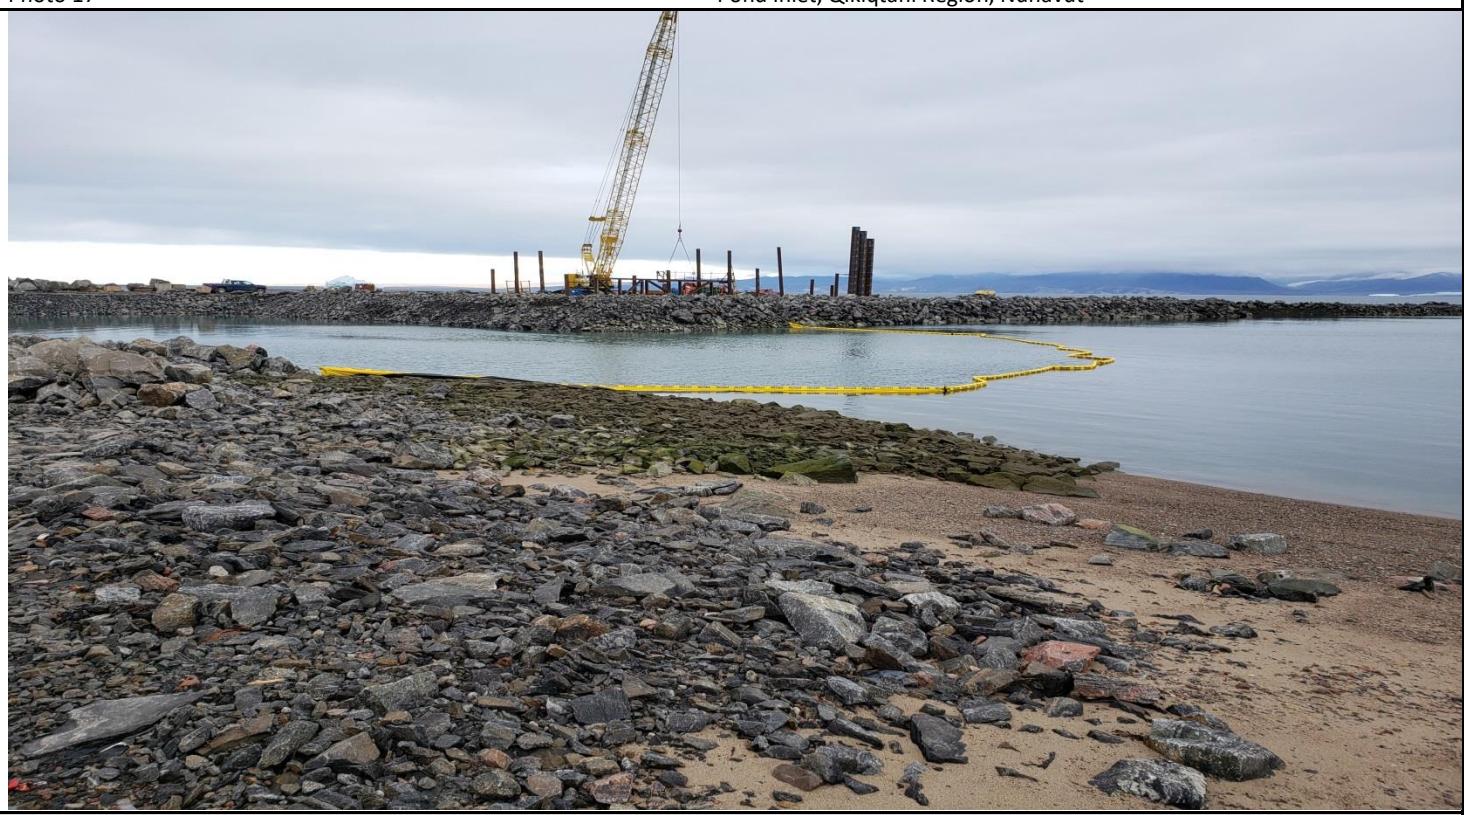
Photo 17

Description: Boom to mitigate the impact of construction.
