WATER LICENCE INSPECTION FORM

Licensee Tower Arctic Ltd.	Licensee Representative Simon-Pier Laberge
Licence No. / Expiry 8BW-PIM2122	Representative's Title Project Manager
Land / Other Authorizations N2019X0012	Land / Other Authorizations 03QN074
Date of Inspection July 23, 2021	Inspector Joseph Monteith
Activities Inspected <input checked="" type="checkbox"/> Camp <input checked="" type="checkbox"/> Roads/Hauling	<input type="checkbox"/> Drilling <input checked="" type="checkbox"/> Other: Spill Report sites <input type="checkbox"/> Mining <input type="checkbox"/> Construction <input type="checkbox"/> Other: <input checked="" type="checkbox"/> Reclamation <input checked="" type="checkbox"/> Fuel Storage

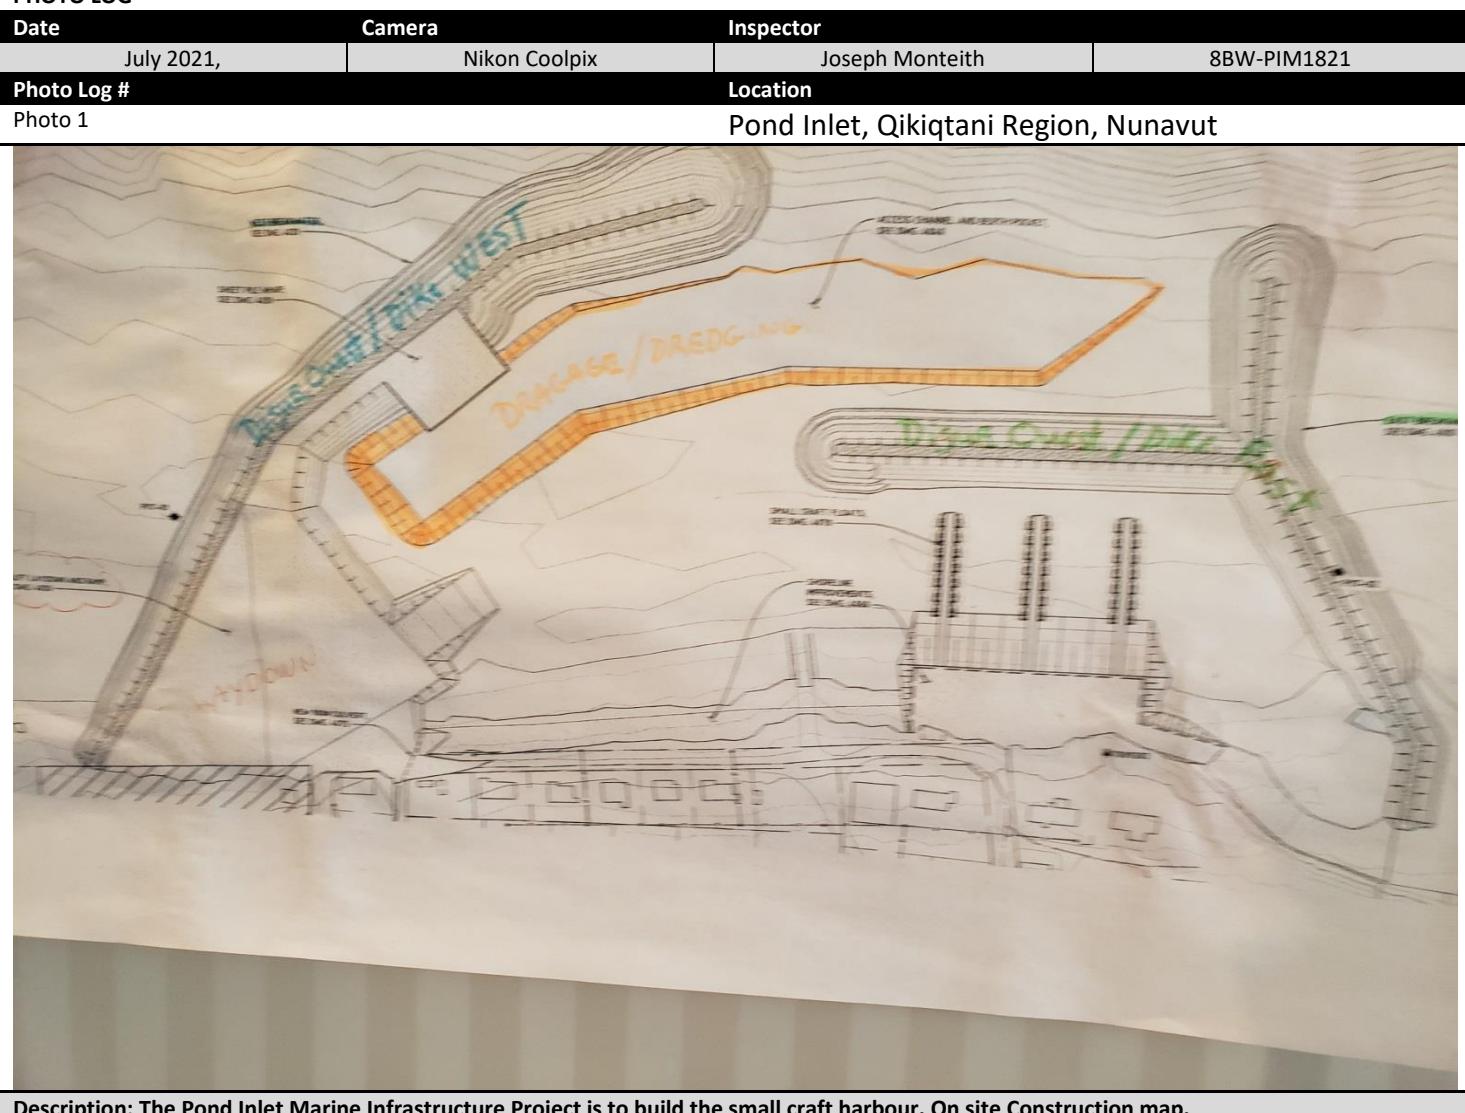
Description: The Pond Inlet Marine Infrastructure Project is to build the small craft harbour. On site Construction map.

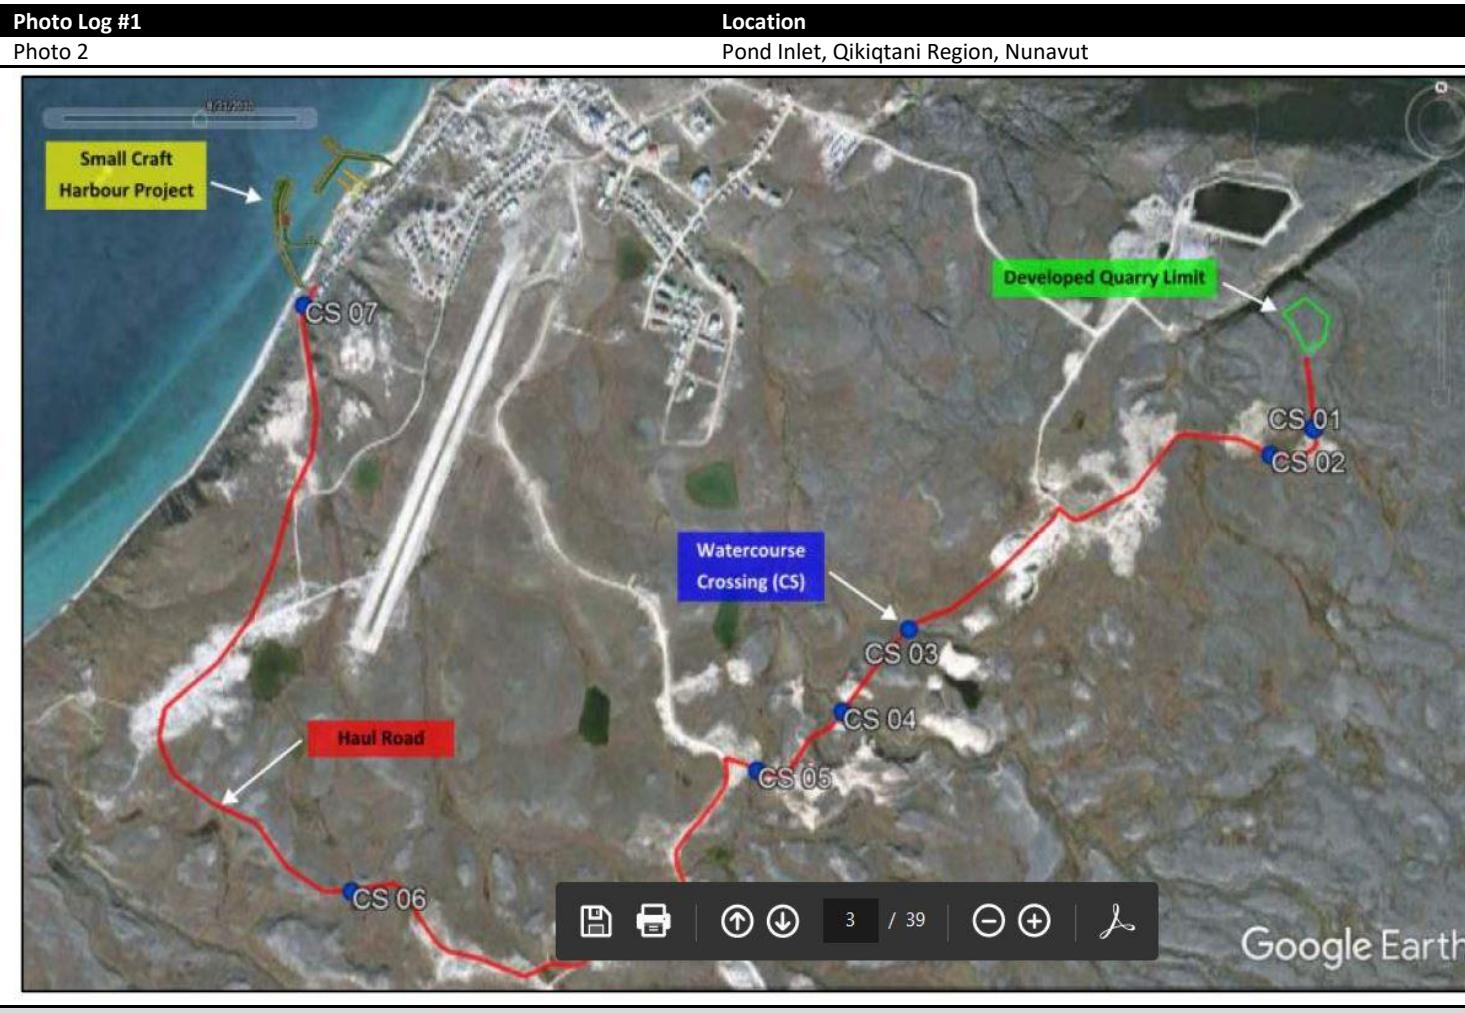
A map of the Stream Crossings – (See photo 2)

3. A total of 7 water crossings along the hauling road from the municipal quarry to the site of the Pond Inlet Infrastructure Project (Photo 2).
4. CS-07 Water Crossing (Photo 3)
5. CS-06 Water Crossing (Photo 4)
6. CS-05 Water Crossing (Photo 5)
7. CS-01 Water Crossing (Photo 6)
8. CS-02 Water Crossing (Photo 7)

Description: CS-01, and CS-02 were not observed in the 2020 inspection. They were inspected in 2021.

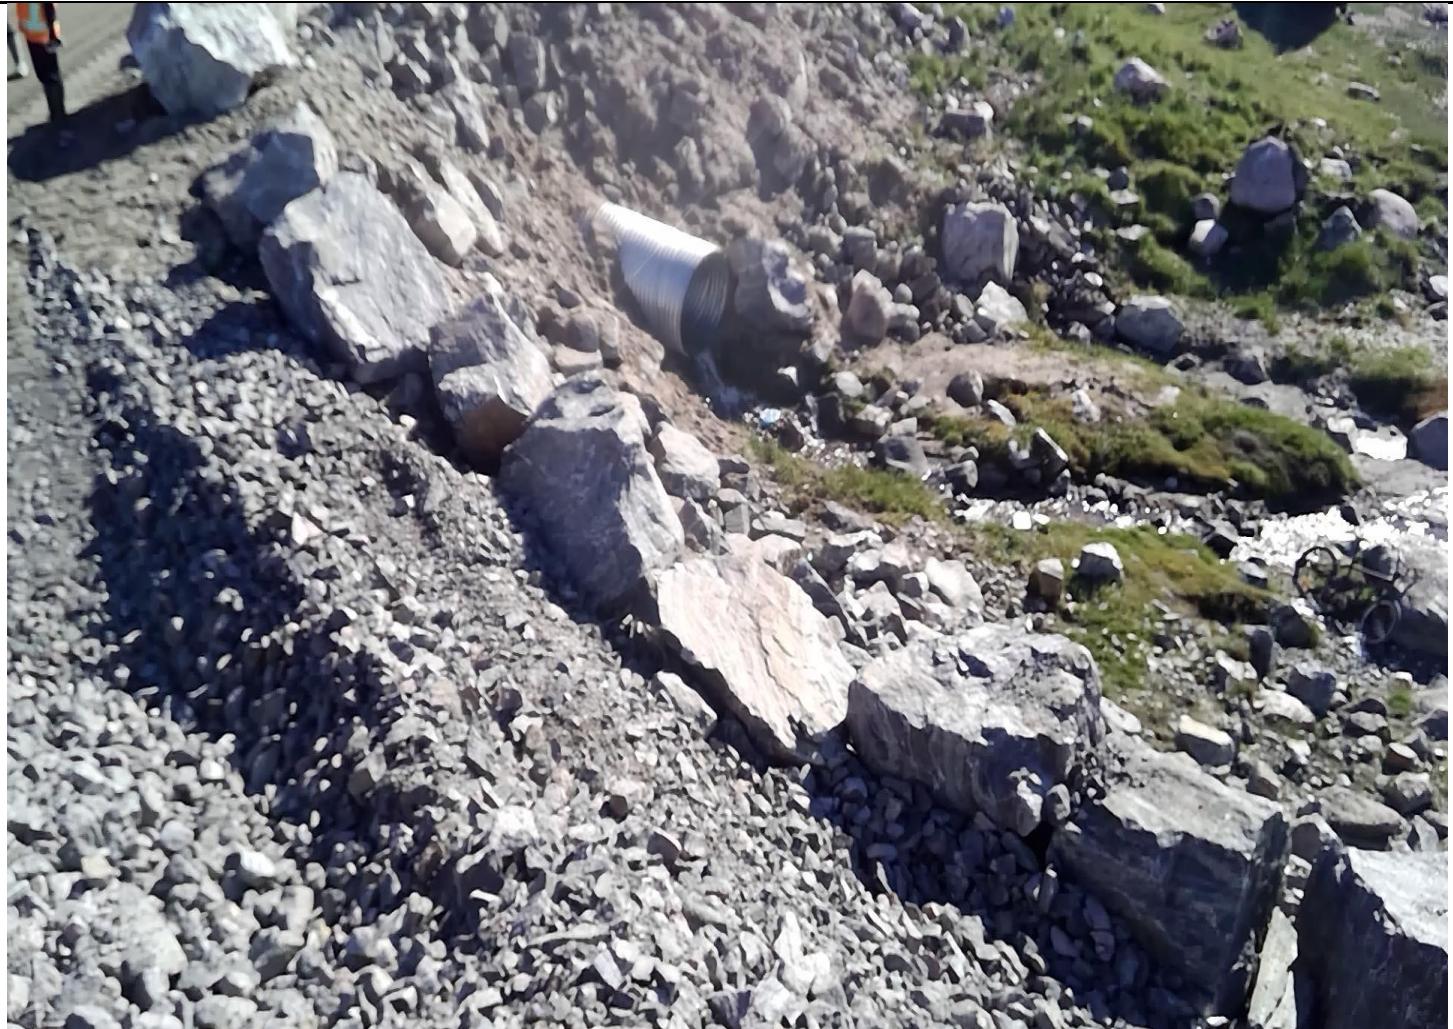
Photo 3

Description: Culvert CS-07. The last culvert between the quarry and the construction site.

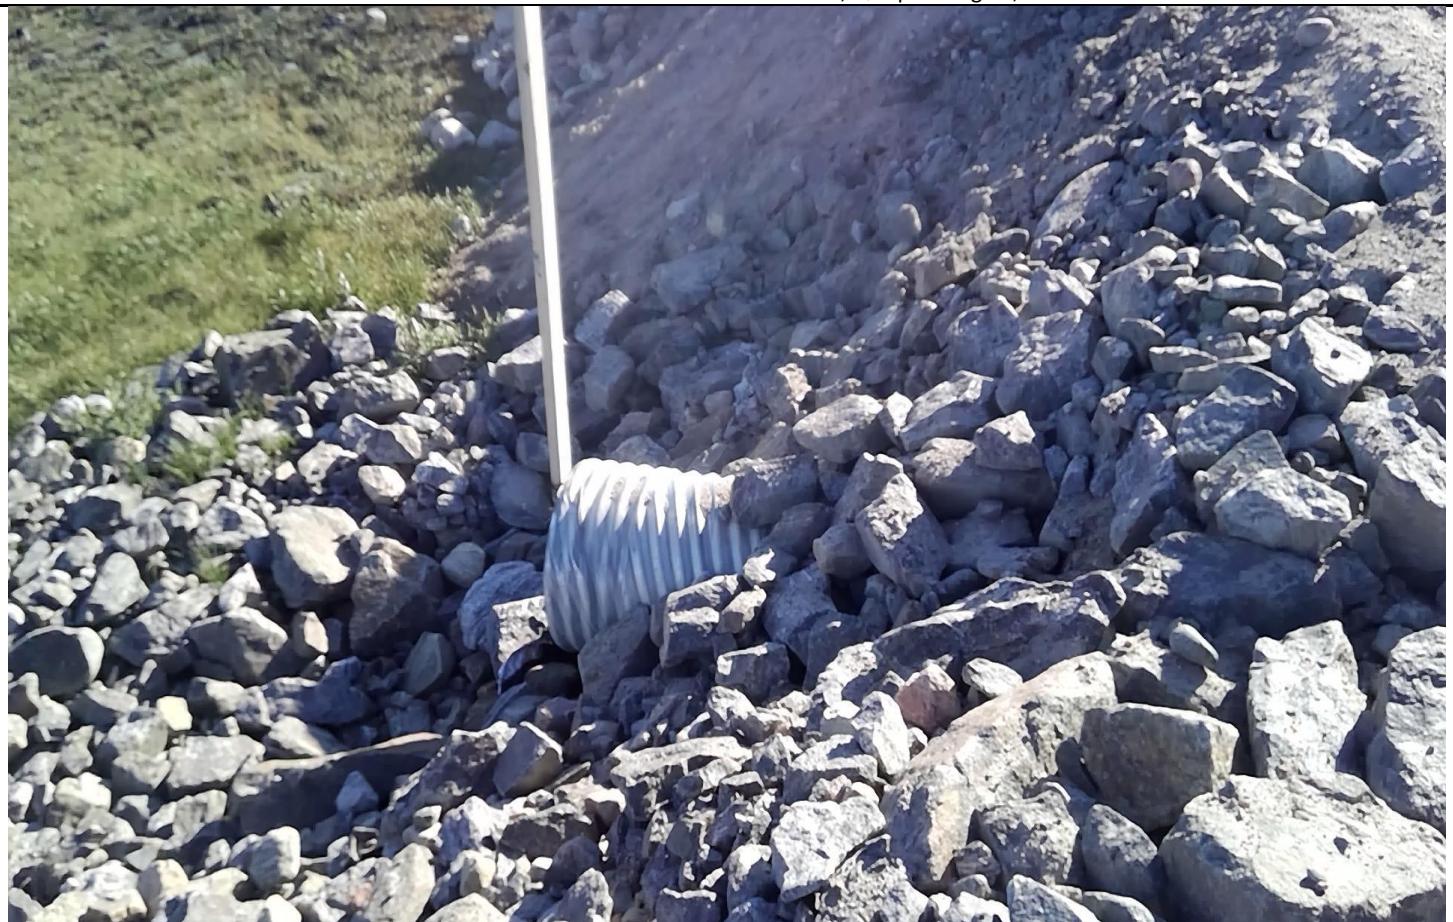
Photo 4

Description: CS-06 Culvert on haul road. Stick protruding out of side of road is location of culvert. No Parallel ditches on downward slope side of road. Parallel ditches observed on higher elevated road.

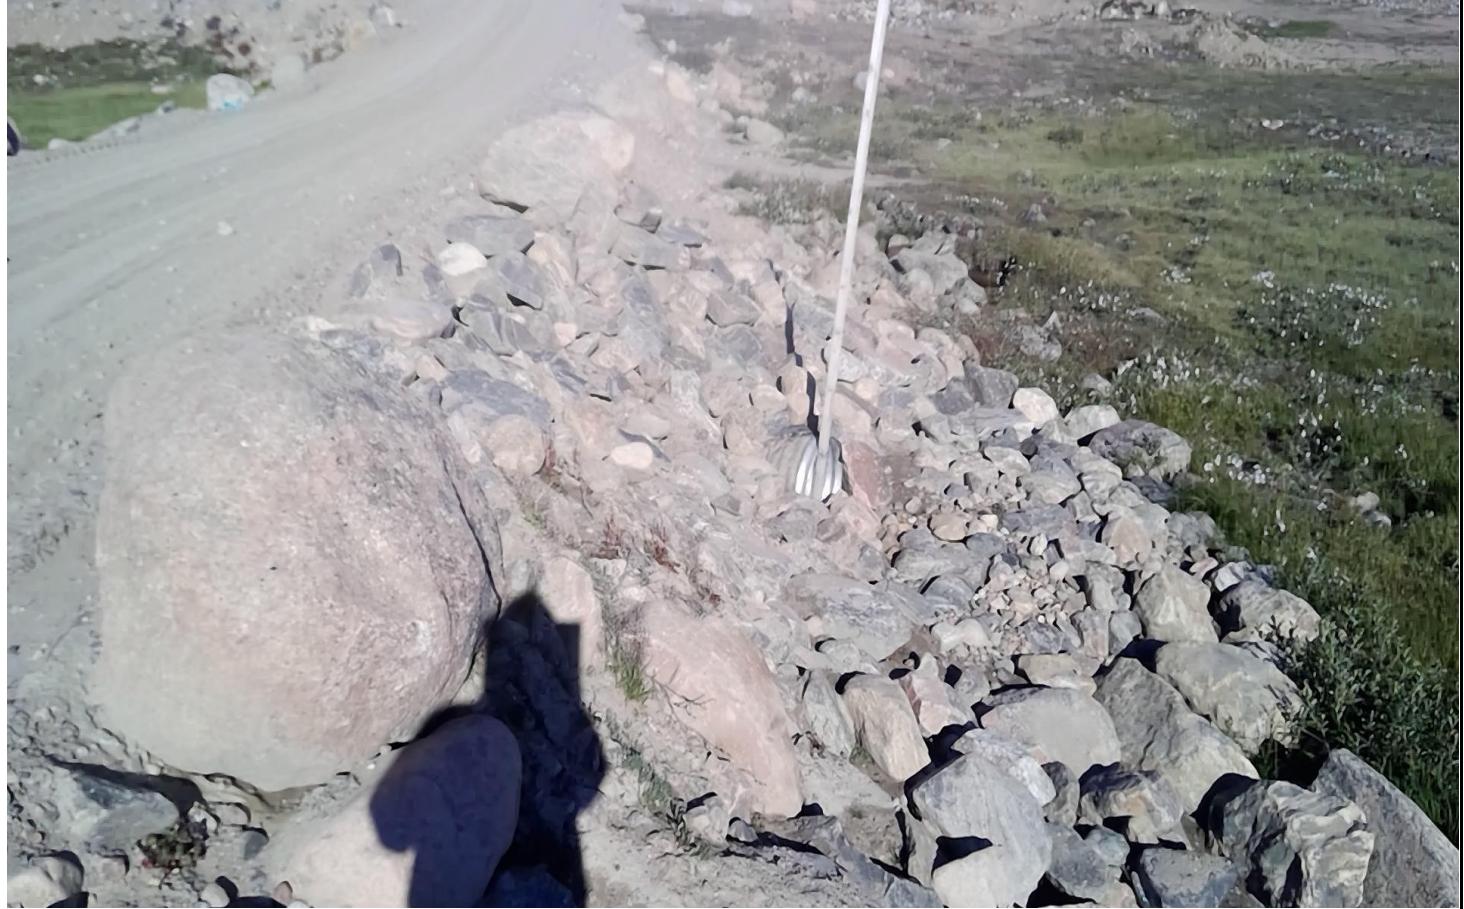
Photo 5

Description: CS-05 Culvert located where the stick is protruding up from the road. Road widened, possibly to allow other heavy equipment to pass. Widened road width approximately 9 metres wide. Culvert is covered by Rip Rap to mitigate any damage to the culvert, and to mitigate warm air melting permafrost.

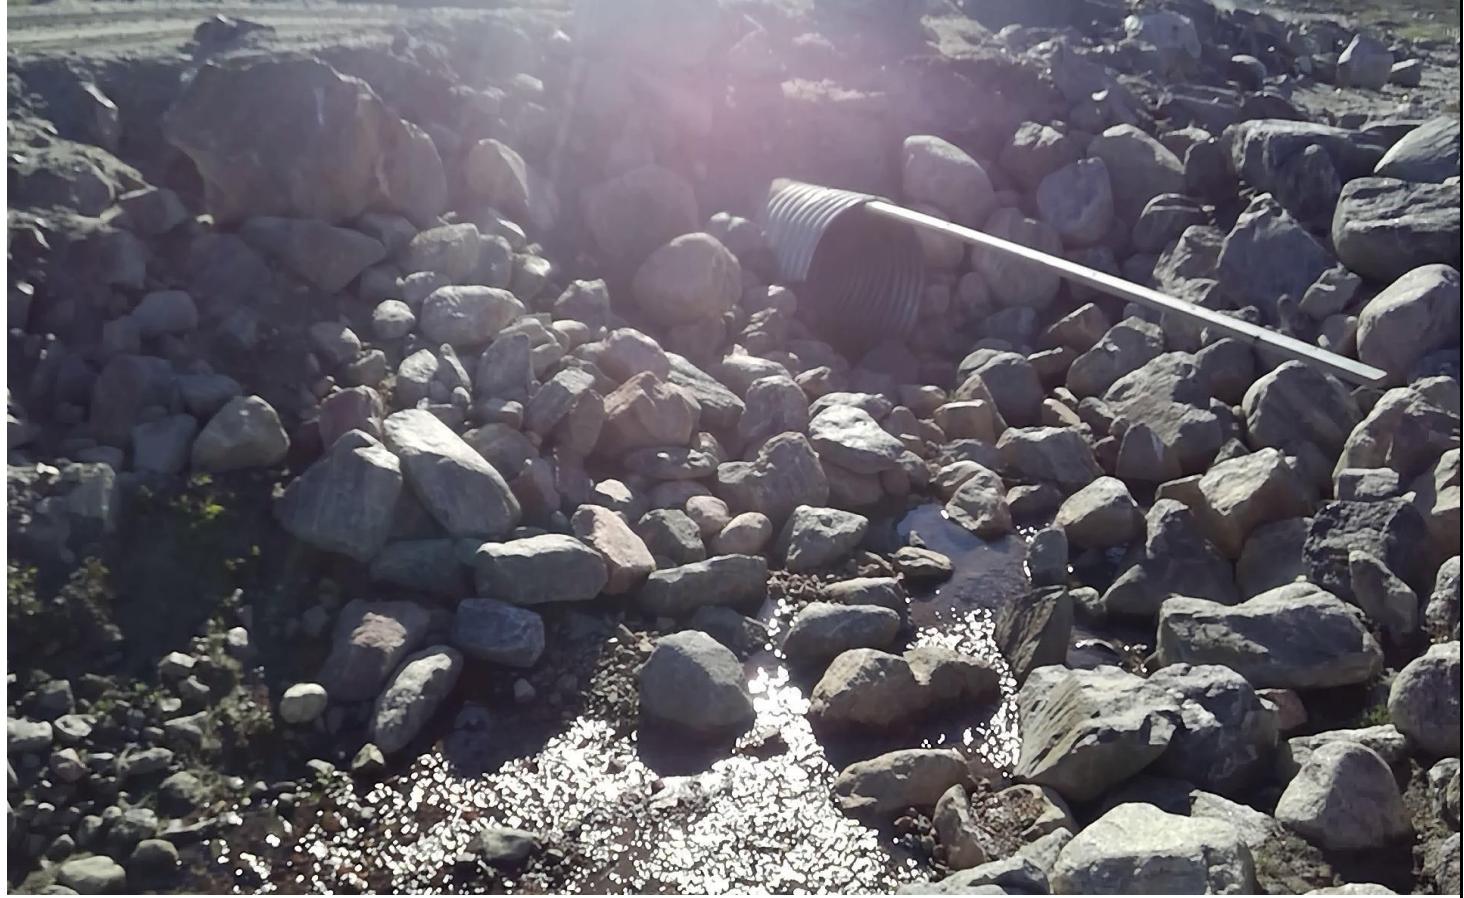
Photo 6

Description: CS-02

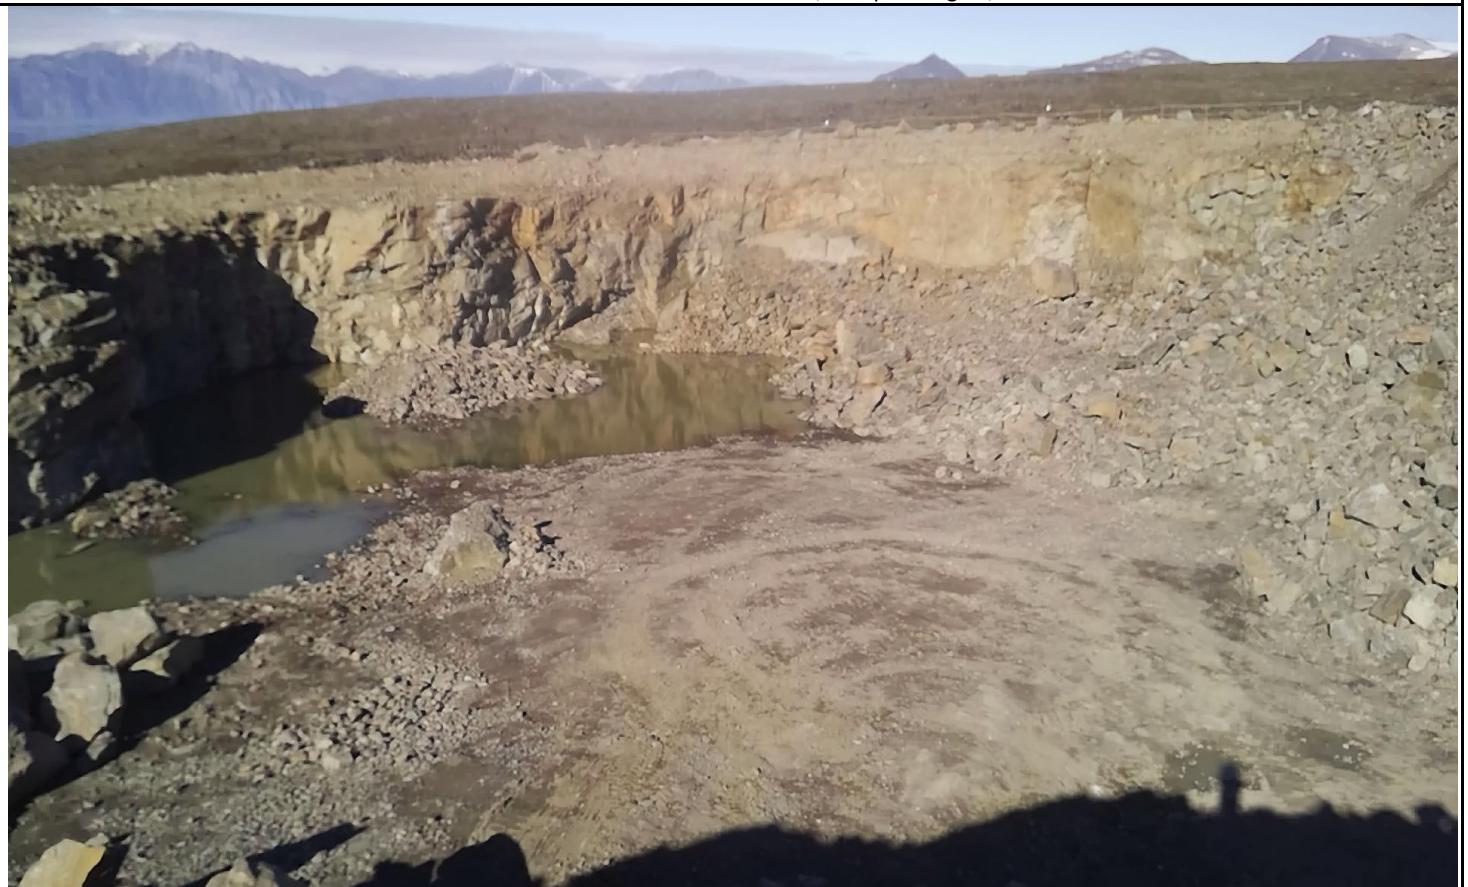
Photo 8

9. Top of the Quarry Pit, looking in (photo 8,9)
10. Inside the Quarry Pit (Photo 8, 9)
11. Quarry Stock Pile, was observed to be inland and 31 metres away from any water body. Located between CS-07 and CS-06 (Photo 13).

Description: Quarry Pit. Raw Water interaction in the pit.

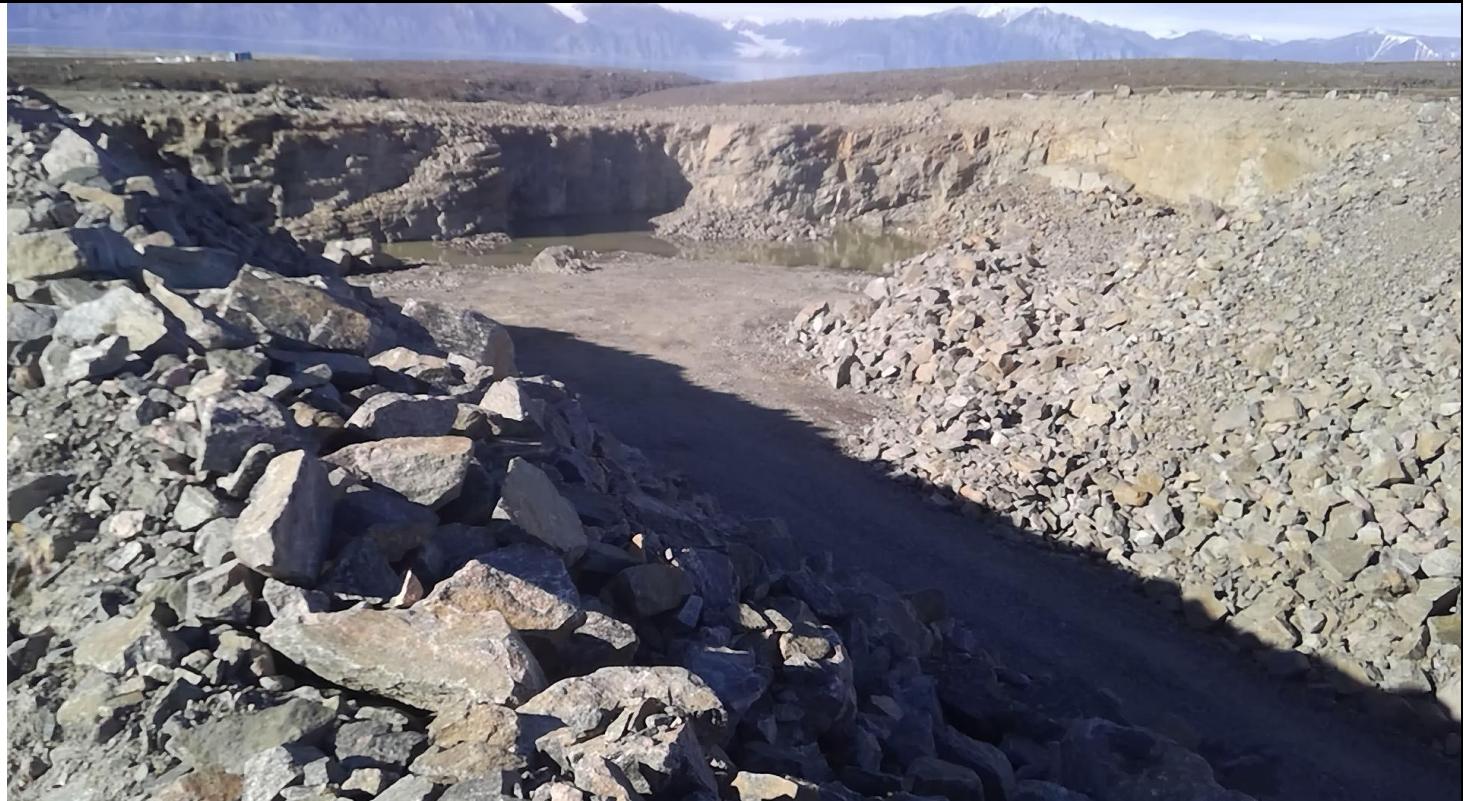
Photo 9

Description: At the bottom of the Quarry Pit. Active site of excavation and hauling. Naturally gravity would accumulate raw water in the depression, and interact with heavy equipment. The water undergoes monthly testing, if water exceeds certain parameters . Tower Arctic is obligated to monitor run off and discharges from the quarry sites.

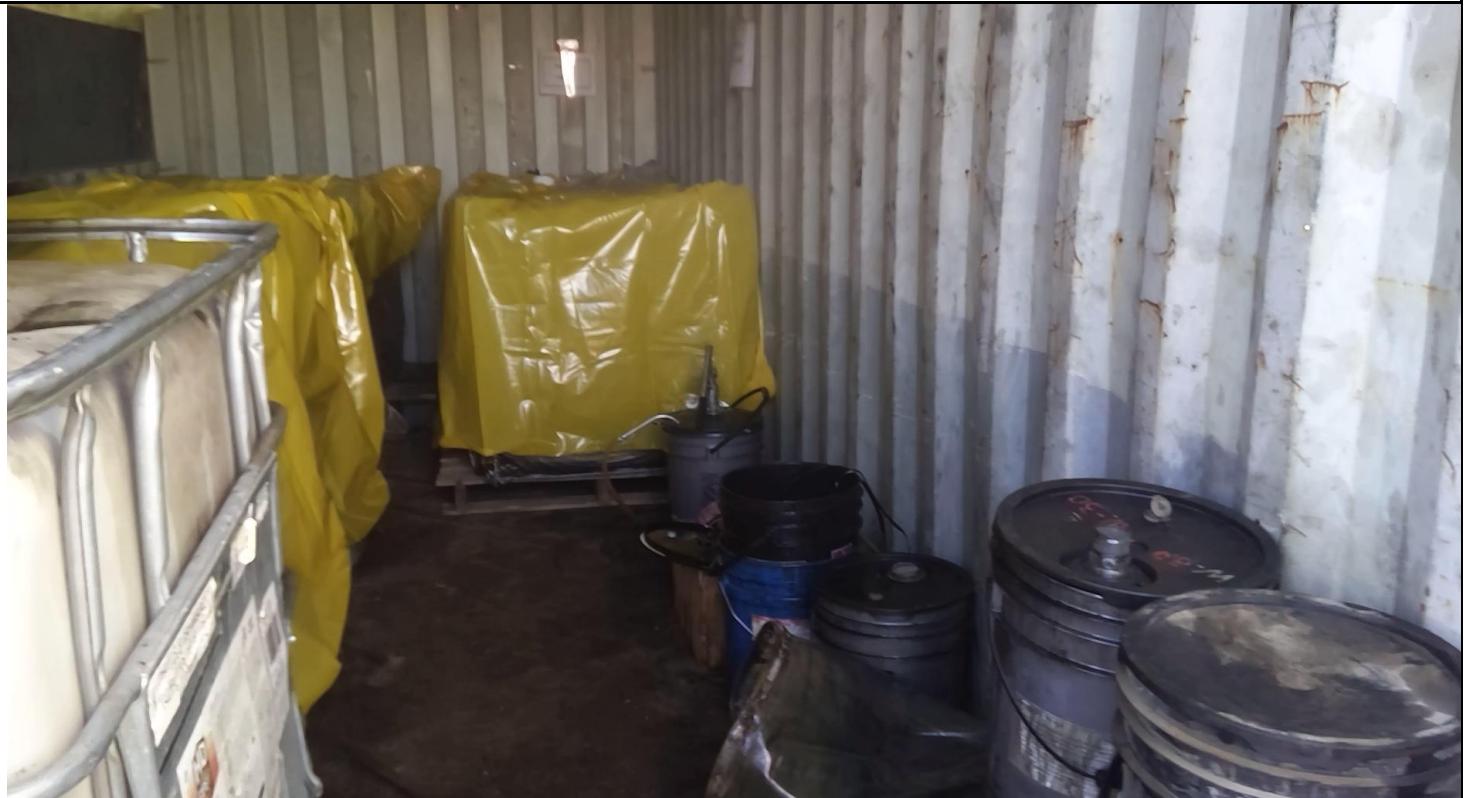
Photo 10

12. An agreement with the community of Pond Inlet was struck to receive all waste from the construction to the community landfill
13. All hazardous waste is contained in sea cans, in secondary containment. To be shipped to an approved Hazardous Waste Storage Facility (Photos 10, 11).

Description: Hazardous Waste Disposal facility

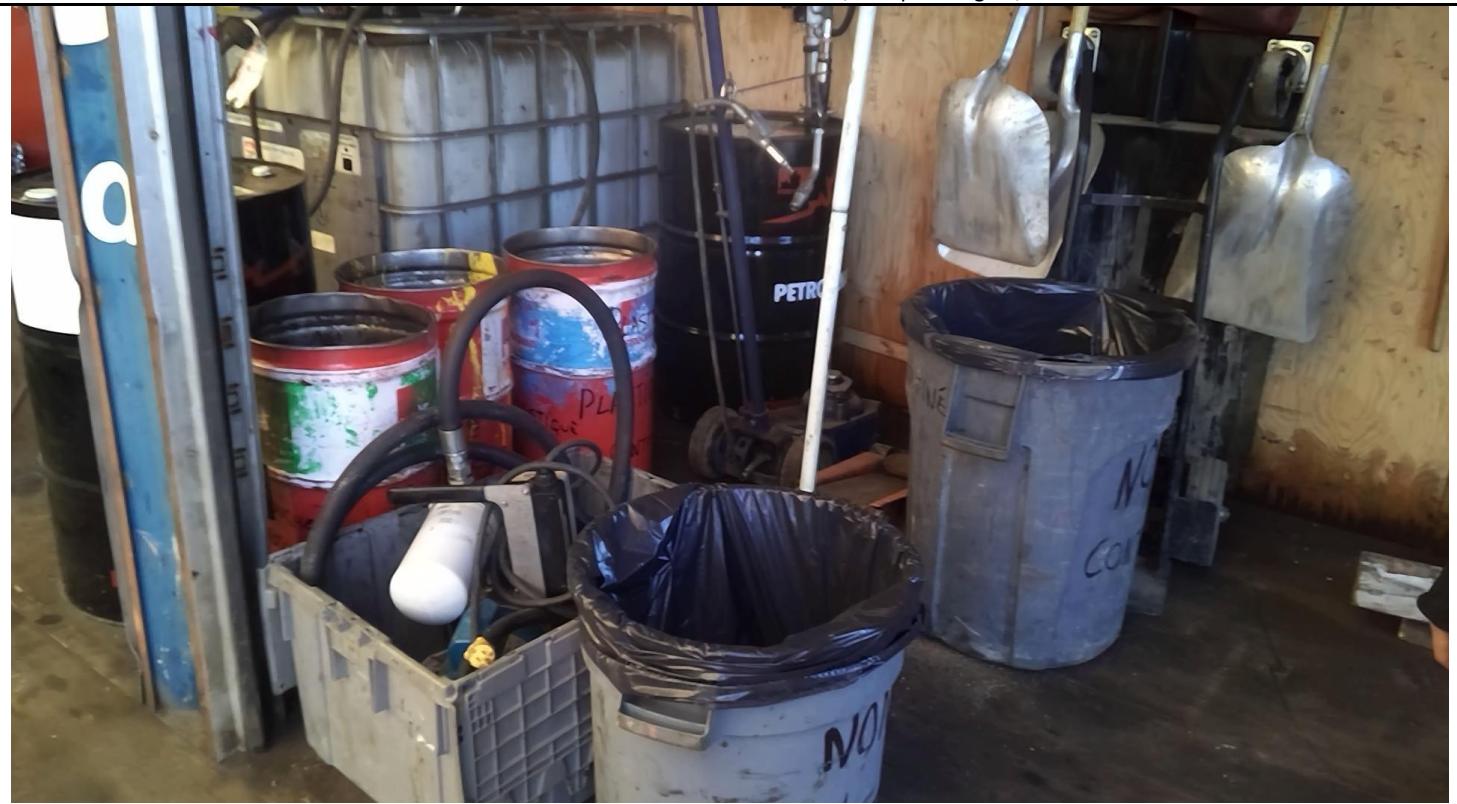
Photo 11

Description: Hazardous Material transfer station, and temporary storage location.

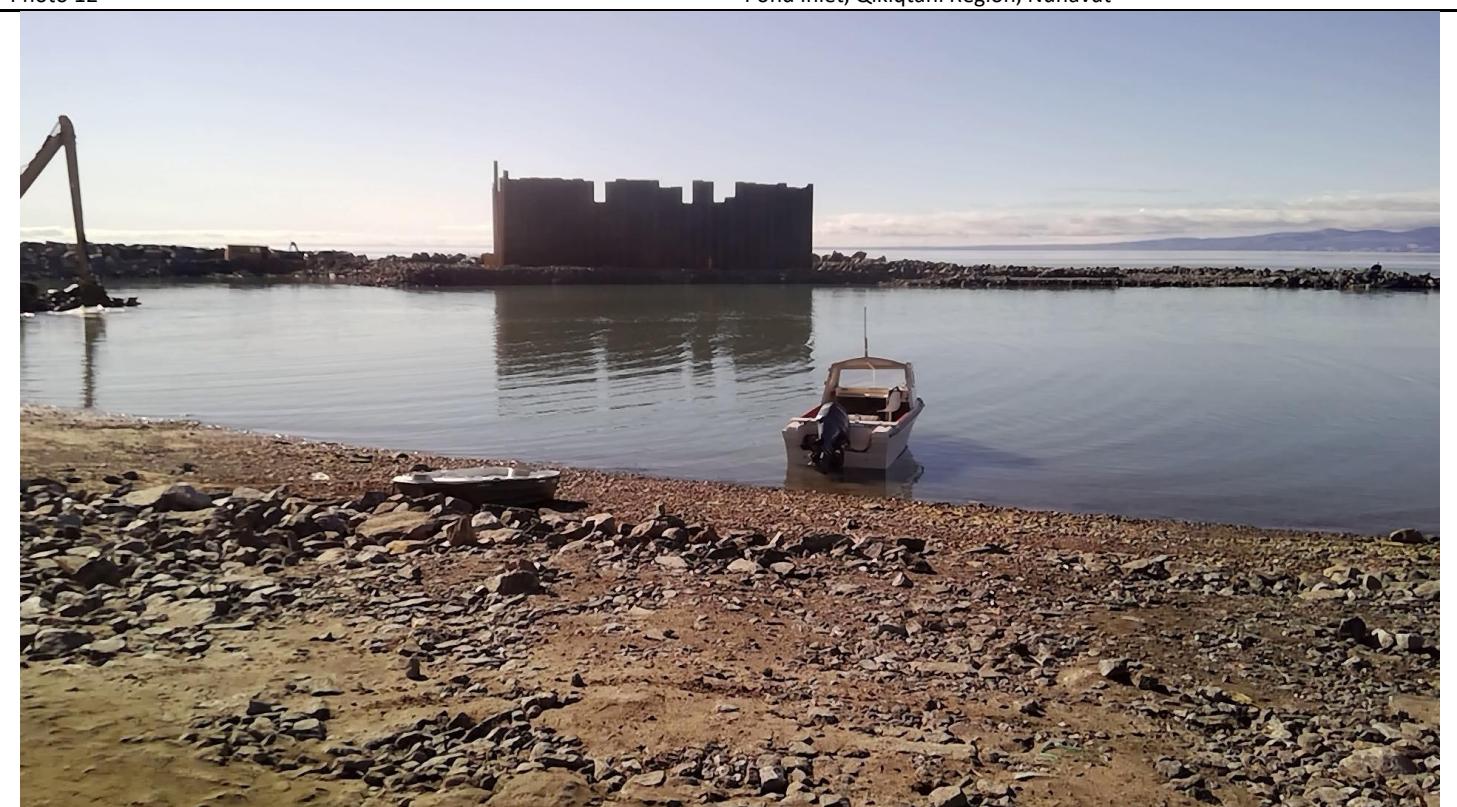
Photo 12

Description: Boom not visible, but installed to mitigate the impact of construction.

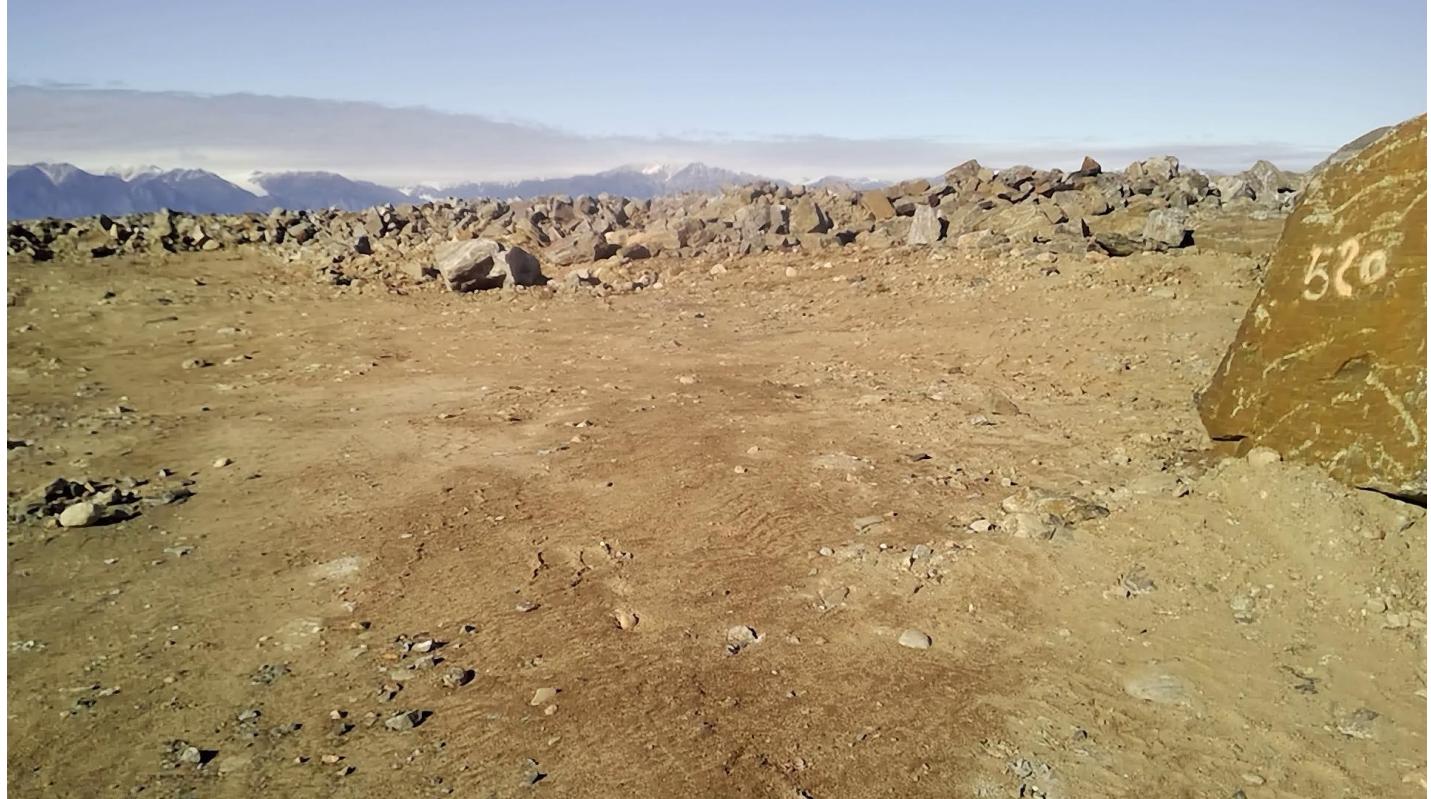
Photo 13

Description: Quarry Pitt Stock Pile
