POND INLET MARINE  
INFRASTRUCTURE  
PROJECT

NUNAVUT WATER BOARD  
ANNUAL REPORT 2020

**DOCUMENT NUMBER:** TA\_NWB\_POND INLET MARINE INFRA  
PROJECT\_ANNUAL\_REPORT\_2020

## WATER LICENCE INSPECTION FORM

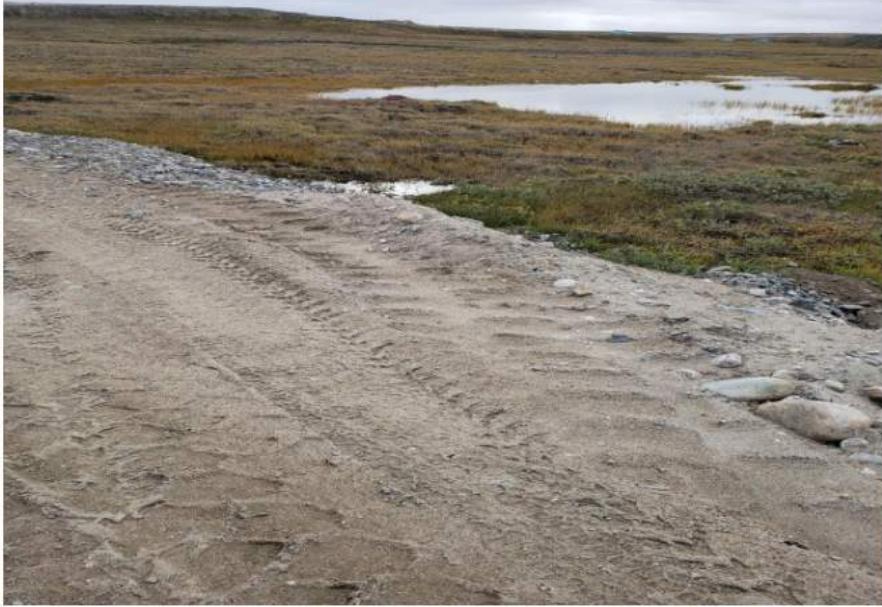
Photo Log #1	Location
Photo 7	Pond Inlet, Qikiqtani Region, Nunavut

<p>Description: CS-04 Culvert. Culvert is covered by Rip Rap to mitigate any damage to the culvert, and to mitigate warm air melting permafrost.</p>

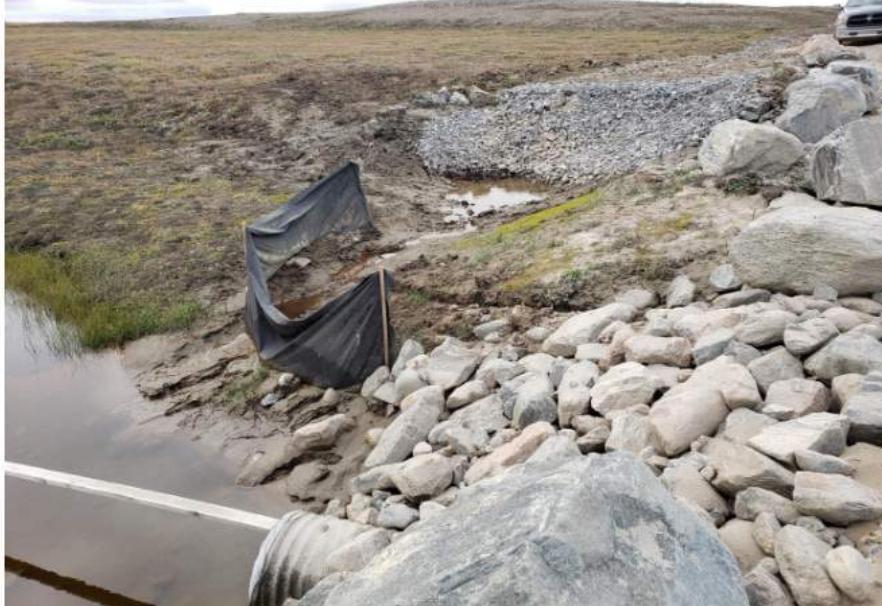
Photo Log #1	Location
Photo 8	Pond Inlet, Qikiqtani Region, Nunavut

<p>Description: The first Culvert between the Quarry and the construction site. CS-03, with Rip Rap and silt fencing appear to have been put down to help mitigate sedimentation.</p>

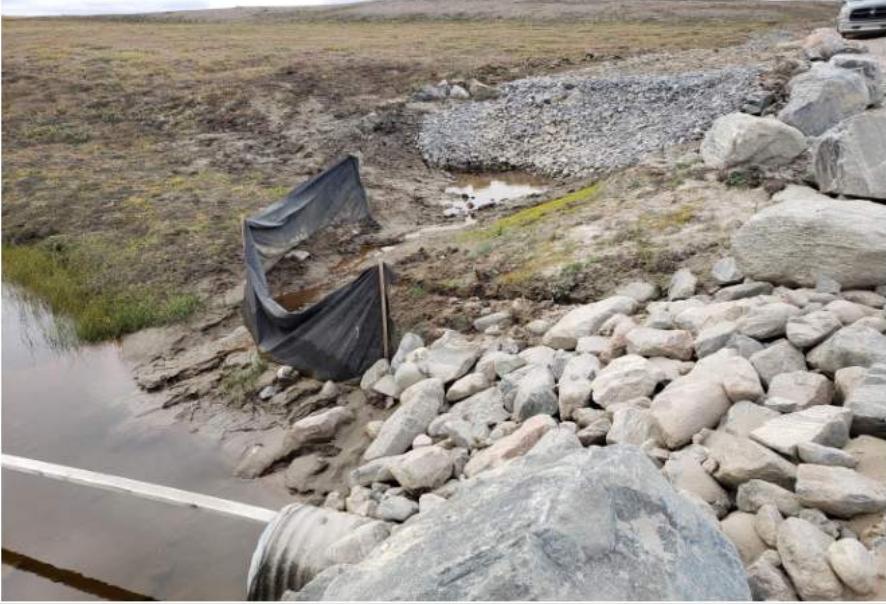
Photo Log #1	Location
Photo 9	Pond Inlet, Qikiqtani Region, Nunavut

<p>Description: The first Culvert between the Quarry and the construction site. CS-03, with Rip Rap and silt fencing appear to have been put down to help mitigate sedimentation.</p>

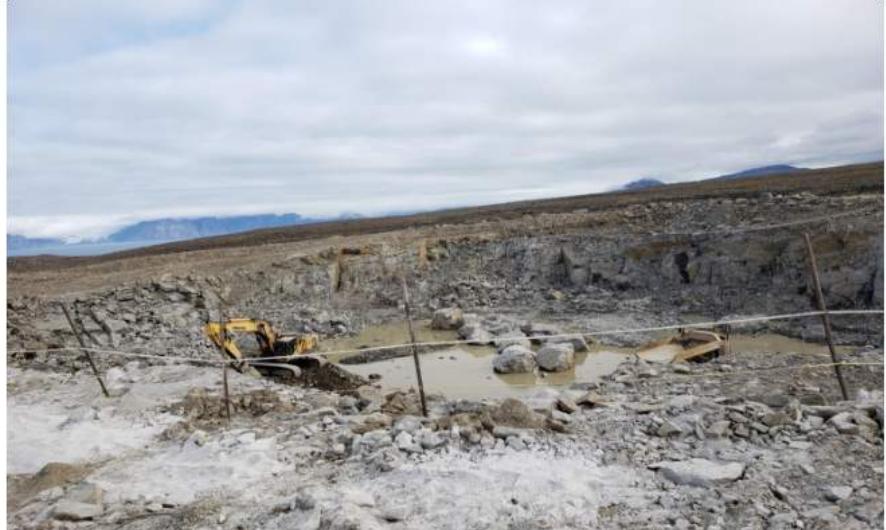
Photo Log #1	Location
Photo 10	Pond Inlet, Qikiqtani Region, Nunavut

<p>Description: Quarry Pit. Fresh Water interaction in</p>
