POND INLET MARINE
INFRASTRUCTURE
PROJECT

NUNAVUT WATER BOARD
ANNUAL REPORT 2021

8BW-PIM2122

DOCUMENT NUMBER: TA_NWB_POND INLET MARINE INFRA
PROJECT_ANNUAL_REPORT_2021

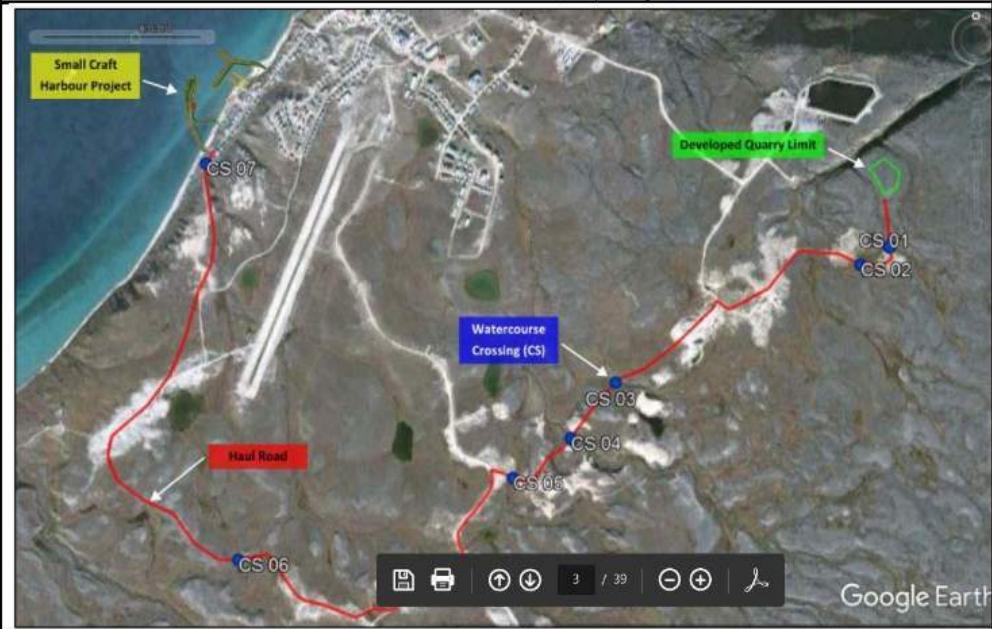
Photo Log #1
Photo 2Location
Pond Inlet, Qikiqtani Region, Nunavut

3. A total of 7 water crossings along the hauling road from the municipal quarry to the site of the Pond Inlet Infrastructure Project (Photo 2).
4. CS-07 Water Crossing (Photo 3)
5. CS-06 Water Crossing (Photo 4)
6. CS-05 Water Crossing (Photo 5)
7. CS-01 Water Crossing (Photo 6)
8. CS-02 Water Crossing (Photo 7)

Description: CS-01, and CS-02 were not observed in the 2020 inspection. They were inspected in 2021.
