## Appendix B      Waterbody Crossing Photographs

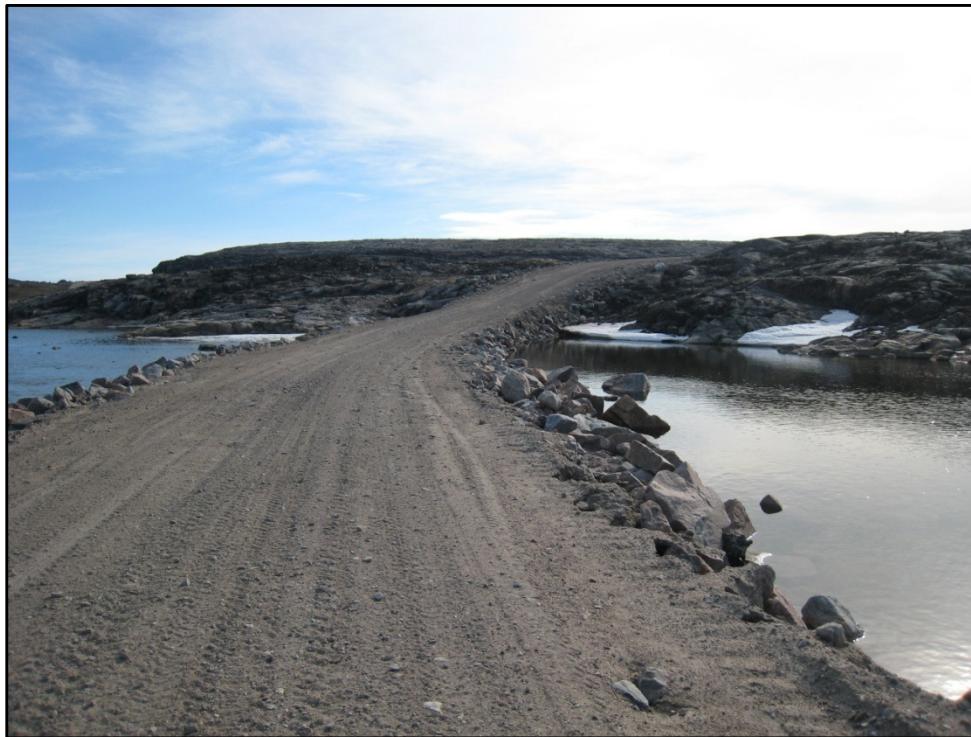
**Photo 1**

**West aspect of constructed CRS-1 crossing at Km 0 of the access road, marine Tariuraq Inlet on the left side of photo and the freshwater lake on the right side; no culverts installed.**

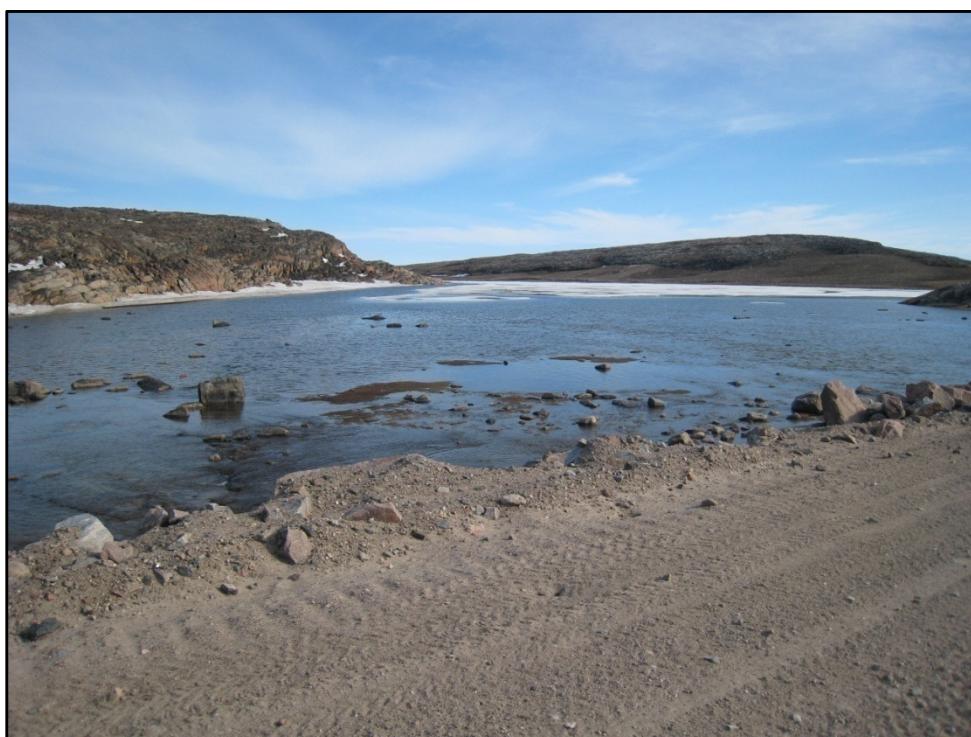
**Photo 2**

**South aspect from the constructed CRS-1 crossing; marine Tariuraq Inlet in background.**

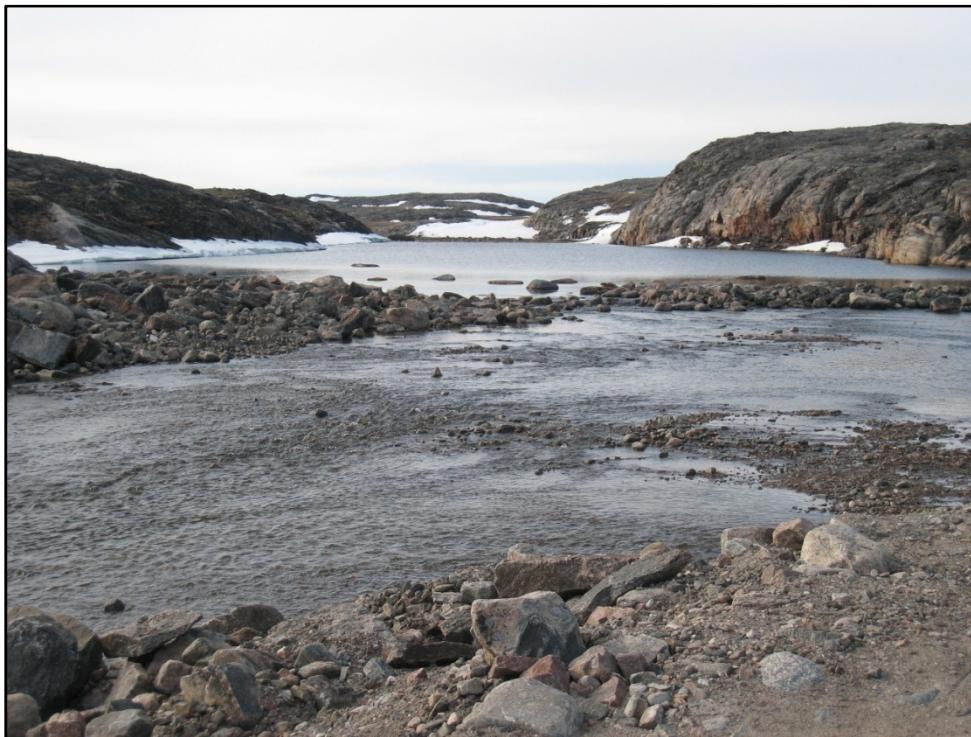
**Photo 3** North aspect from constructed CRS-1 crossing; the freshwater lake in background.

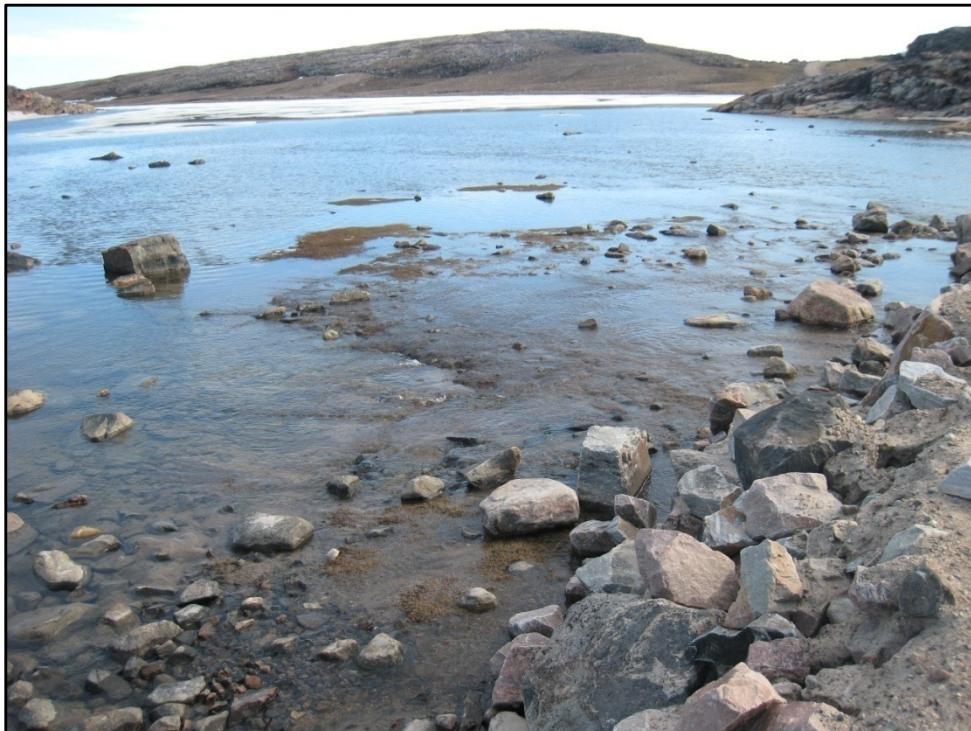
**Photo 4** Substrate and large riprap on south shore of CRS-1 crossing, the marine Tariuraq Inlet in background; south aspect.

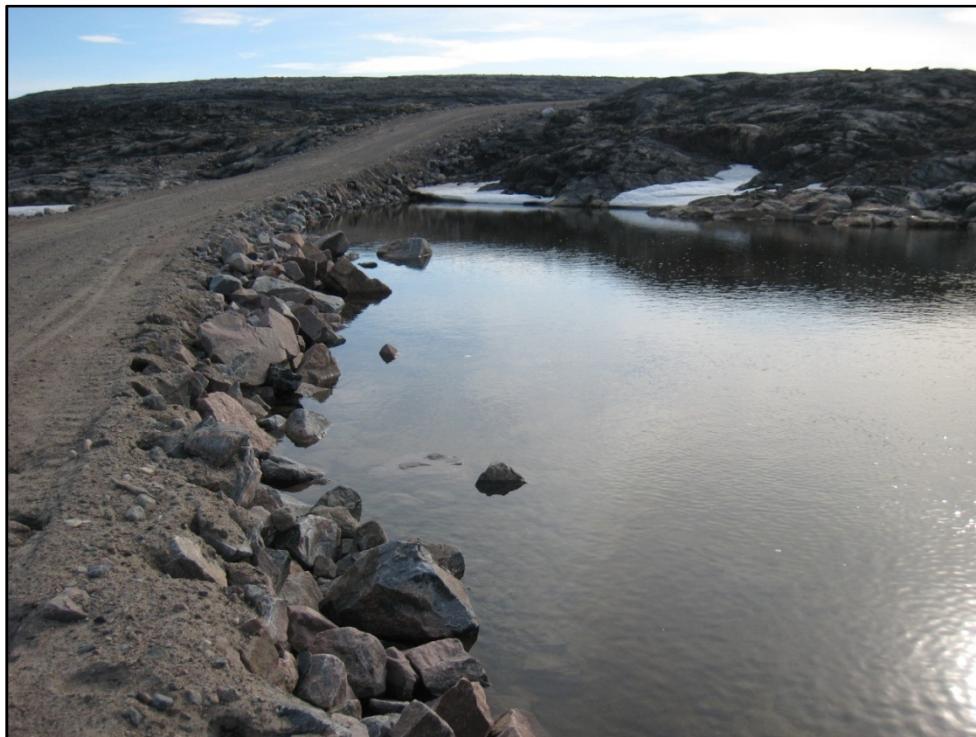
**Photo 5**

**Substrate and large riprap of north shore of CRS-1 crossing, the freshwater lake on right side of photo; west aspect.**

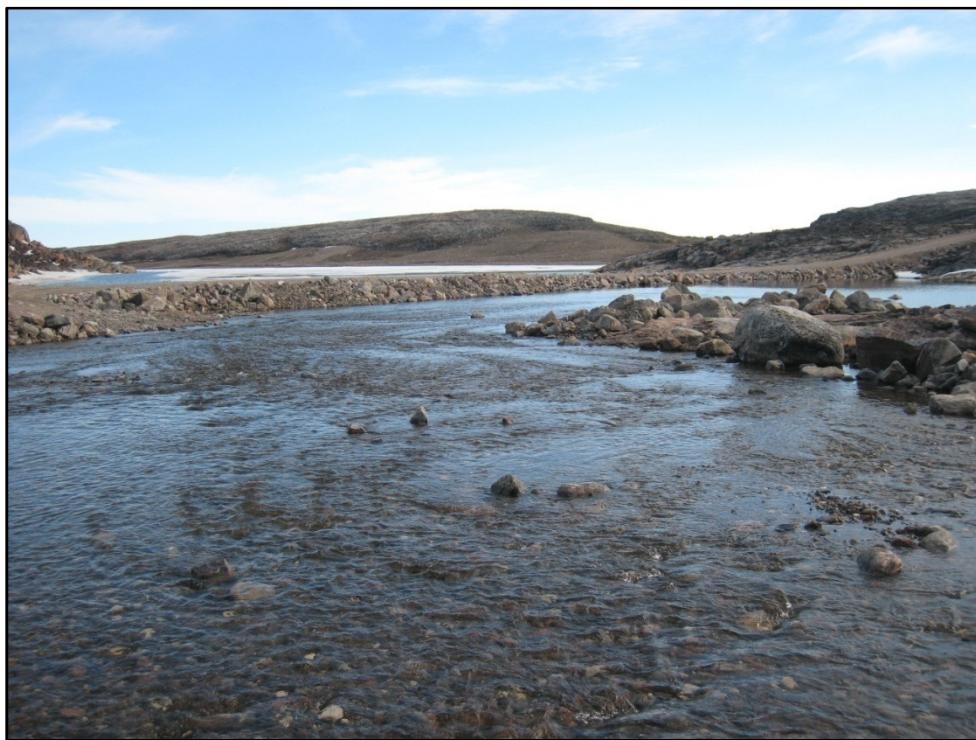
**Photo 6**

**South aspect from the freshwater lake with CRS-1 crossing and Tariuraq Inlet in background.**

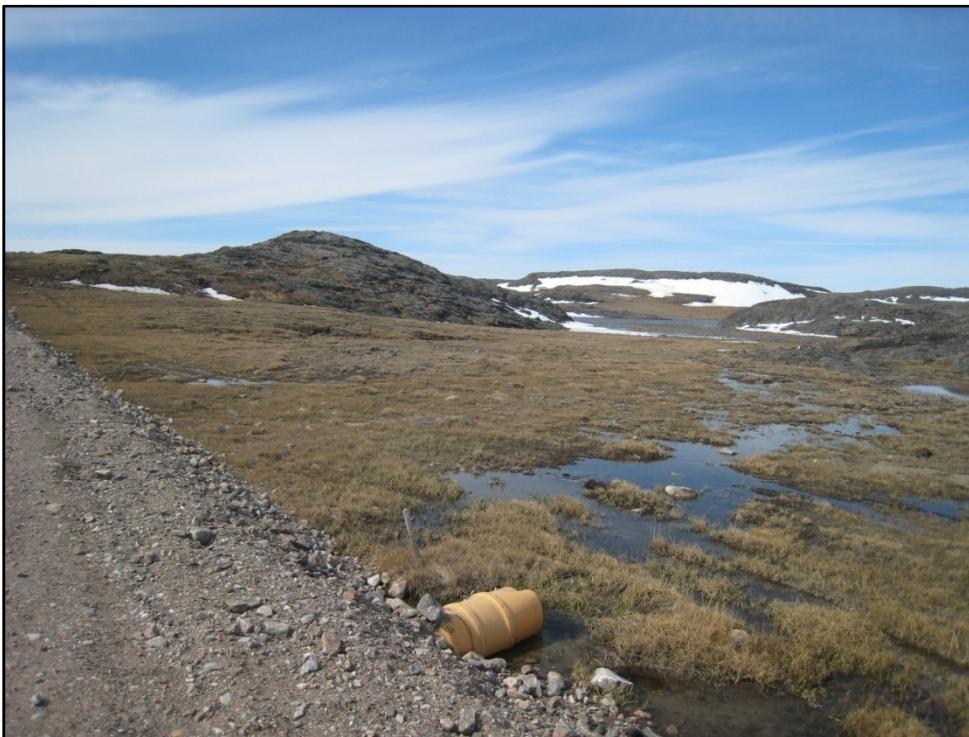
**Photo 7** CRS-2 crossing at Km 1.8 of the access road, north aspect with installed culvert and downstream flow pattern.

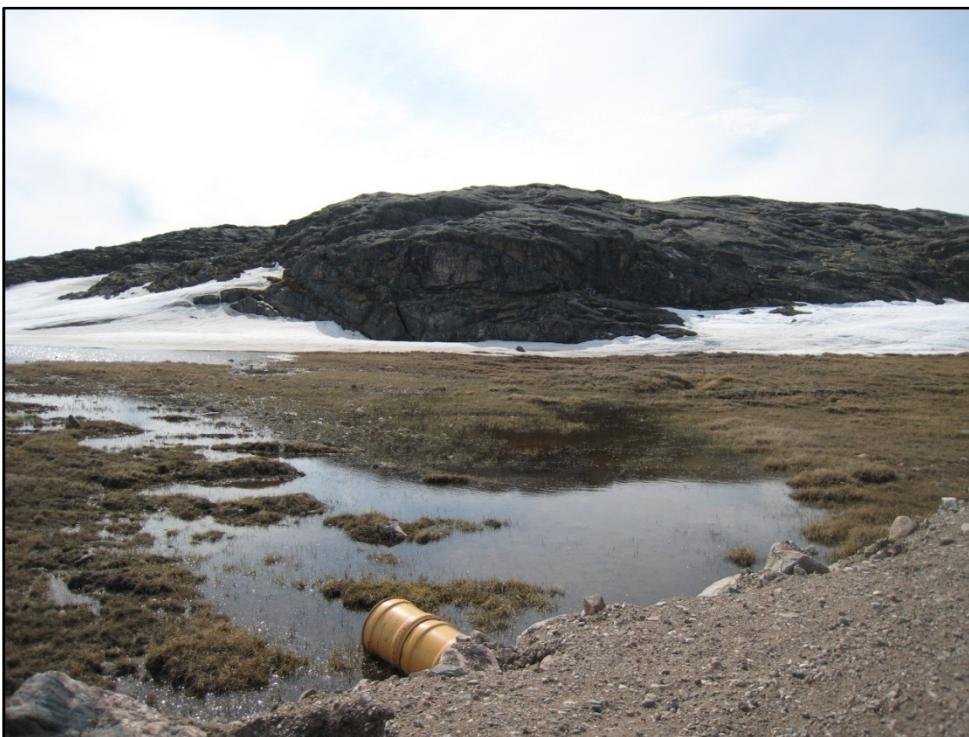
**Photo 8** CRS-2 crossing west aspect with installed culvert and upstream pond flow pattern.
