FEASIBILITY REVIEW OF CROSSINGS ALTERNATIVES UNDER AIRPORT ROAD, CORAL HARBOUR

**Kivalliq Region, Community and Government Services -
Government of Nunavut**

JANUARY 2015
ISSUED FOR USE
FILE: 704-C31103153

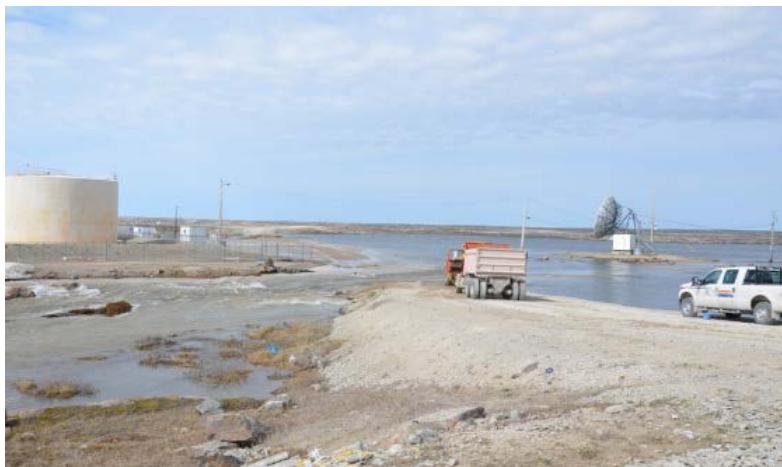
Tetra Tech EBA Inc. (operating as Tetra Tech) was initially hired by the CGS in November 2012 to prepare a report specifying remediation options for the culvert crossings near the fuel farm facility. The impetus behind this project was a road washout which had occurred in June of 2012, closing the Airport Road for approximately one week and also causing damage to the supports of the fuel line feeding the Hamlet (See Figures 1-1 and 1-2). The Hamlet of Coral Harbour reported that the road washout and flooding had occurred four times over the previous six or seven years and requested assistance to repair the damage and improve the drainage system to prevent this from happening again.

Figure 1-1. June 2012 Washout

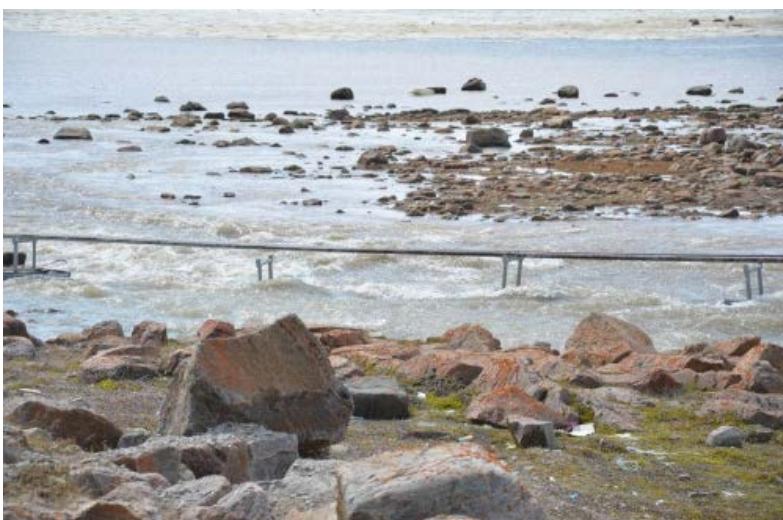
Figure 1-2. June 2012 Impact on Fuel Line

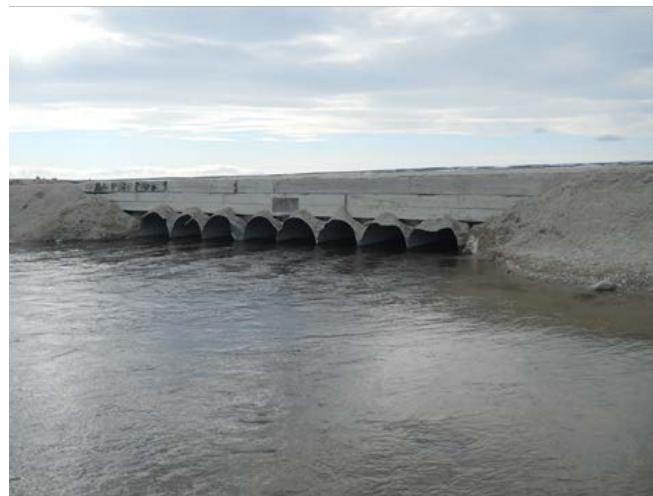
Crossing 4 is located in the central basin and consists of eight corrugated metal culverts. Based on the photographs provided (Figures 2-1 to 2-4), it appears that the culverts at Crossing 4 are nearing the end of their operational life. The lower portions (inverts) of the culverts are rusted out. The culverts also appear to be damaged and warped, which is indicative of reduced structural strength.

Figure 2-1: Culvert Crossing 4

Although the eight culverts at Crossing 4 may be able to convey water over the next few years, it would be more cost effective to consider the replacement of the eight culverts with a new structure. All the approaches presented in this report include the replacement of these culverts as integral to the proposed improvements.

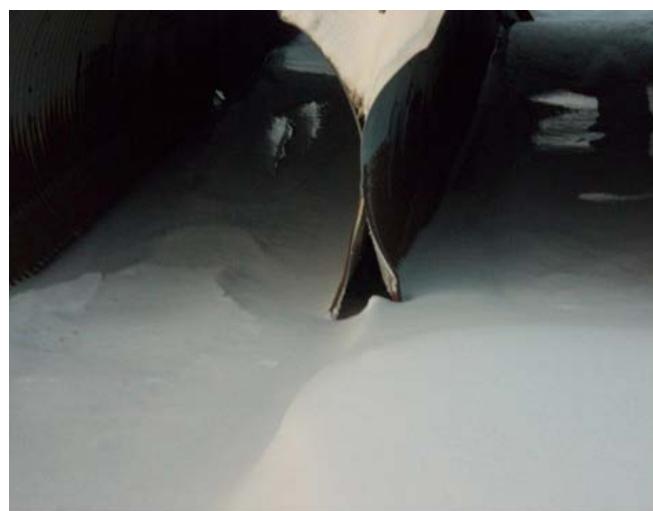
Figure 2-2: Culvert Crossing 4

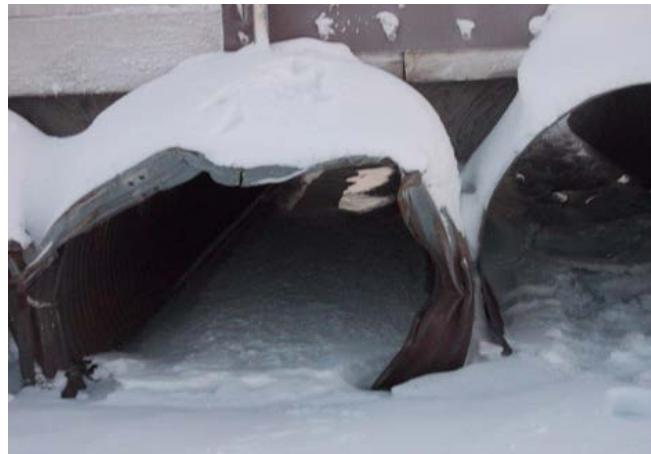
Figure 2-3: Culvert Crossing 4

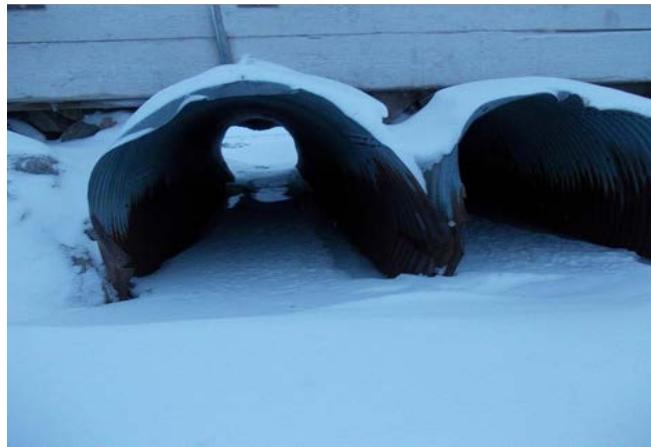
Figure 2-4: Culvert Crossing 4

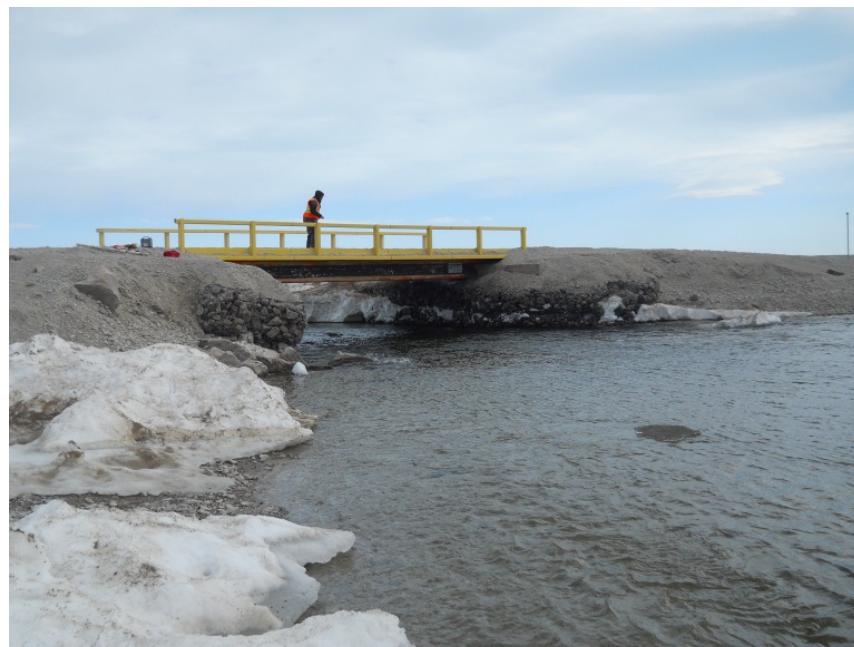
Crossing 7 is located in the central basin. Based on the pictures and comments provided by Mr. Saviakjuk, the bridge was built in the early 1980s. Tetra Tech was partially able to confirm this information when an attempt was made to contact the company who had supplied the original girders, TRI-Northern Steel Ltd. Based on information provided by other competitors, TRI-Northern has been out of business for several decades. Tetra Tech is unable to fully assess the condition of the bridge without a site visit or as-built drawings. However, some deterioration of the rock gabion baskets forming the abutments of the bridge were observed (Figures 2-5 to 2-7). As detailed in the pictures, the rock gabions have started to “fall” into the river and are no longer vertical. It was noticed that some of the wire links are also broken suggesting it may be time to consider the replacement/repair of the abutments.

Figure 2-5: Bridge Crossing 7

Although showing some signs of deterioration, the superstructure of this bridge still has several years of service life available. It should be noted that the bridge deck was recently replaced (2010). Service life of the entire crossing could be extended by completing remediation work on both of the bridge's abutments. Approach 2 was developed to include the remediation and continued use of this bridge. Approaches 3 and 4 include the removal of this bridge crossing and the replacement with one or two new structures respectively.

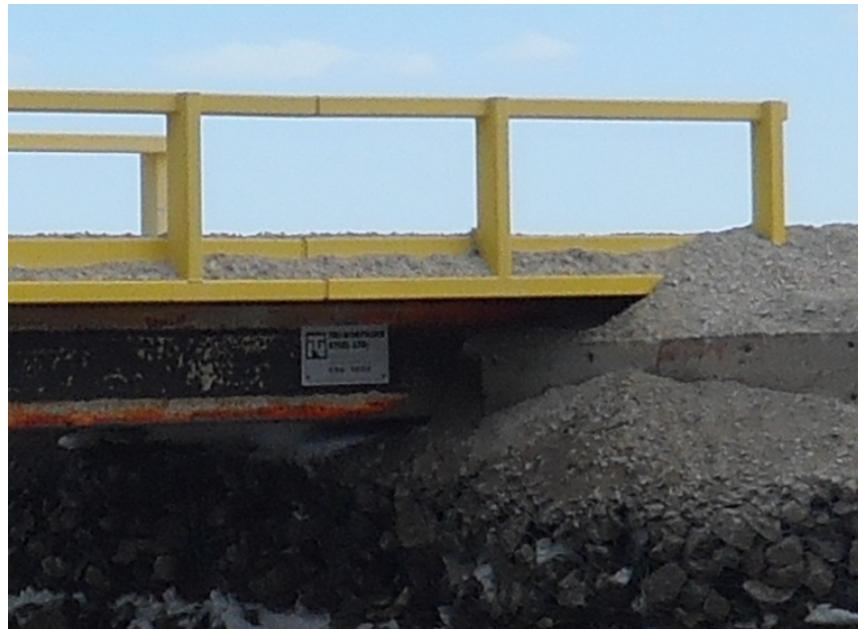
Figure 2-6: Bridge Crossing 7

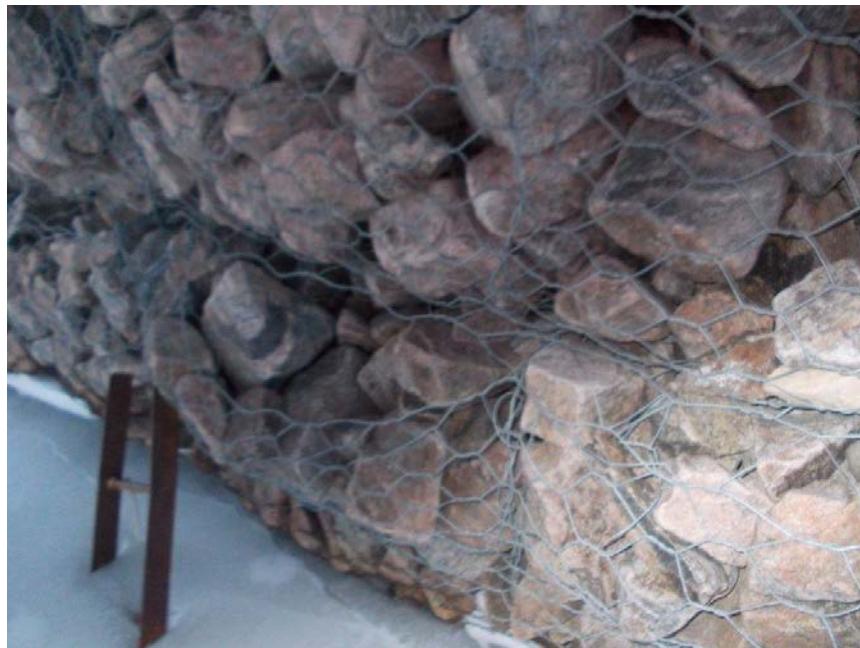
Figure 2-7: Bridge Crossing 7 – Gabions
