2.1.3 Geotechnical Site Investigation (September 25th through 28th, 2015)

2.3 Bridge Inspection (October 9th, 2015)

Airport Community Road Washout Rehabilitation - Coral Harbour Project Schedule (11/17/2015 Update)

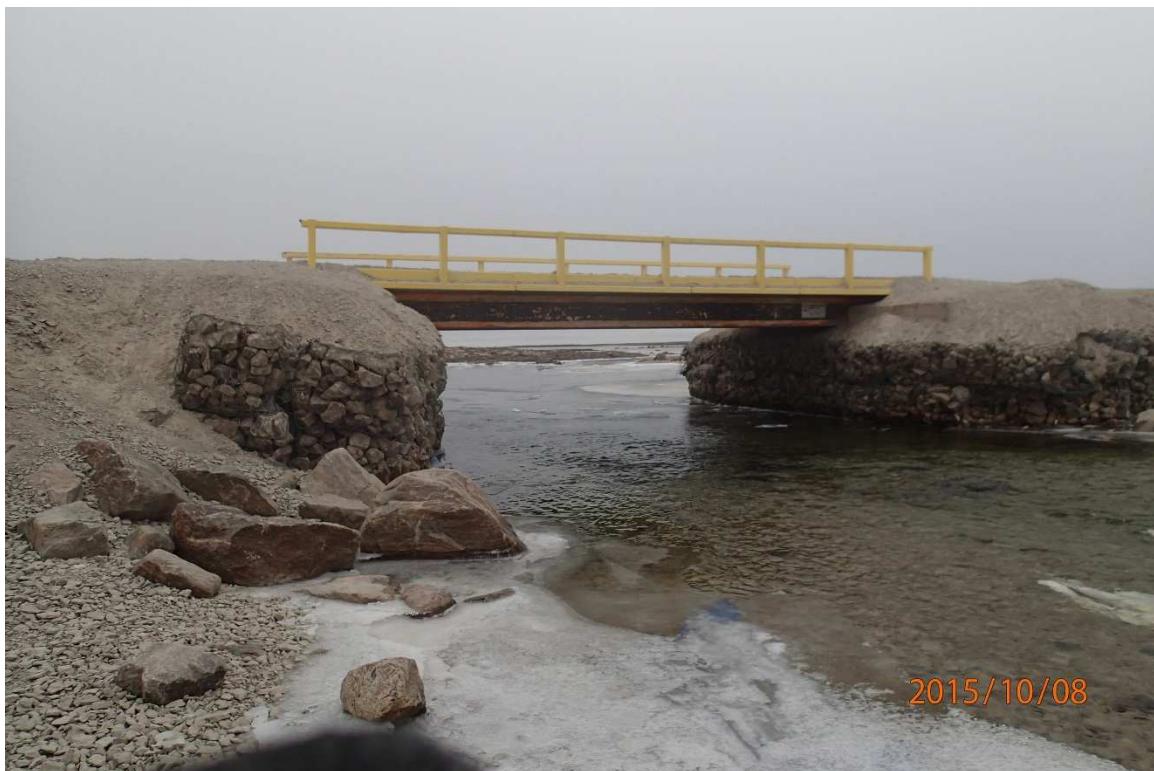
Crossing 7 is located on Airport Road and crosses the Post River in Coral Harbour. Figure 1, in Appendix A, shows a general view of the bridge at Crossing 7. The single lane 13.6 m long bridge spans an approximately 8 m wide channel. The bridge head slopes are supported by vertical gabion basket walls and precast concrete wingwalls at each corner of the bridge. Bridge foundations and bearings, if they exist, are buried in the approach fills. The bridge superstructure consists of two sets of joined pairs of W610X155 steel girders, with a center to center spacing between the pairs of girders of 2.3 m. The girders support a timber deck that provides a clear width of 4.55 m. The timber deck is comprised of 3"X10" (actual dimensions) timbers spanning transversely over the girders and topped by 3"X10" timbers running longitudinal along the bridge deck. Bridge railings are supported independently of the timber deck by what appear to be steel W shape members running transversely over the girder tops between every third transverse deck timber. The W shapes support barriers consisting of vertical posts with top and bottom rails all constructed from steel HSS members. No approach barriers or guard railings are present on the approaches to the structure. No drawings of the bridge are available and all reported dimensions are based on measurements obtained during the inspection.

Figure 1 – General view of bridge at Crossing 7 looking downstream.

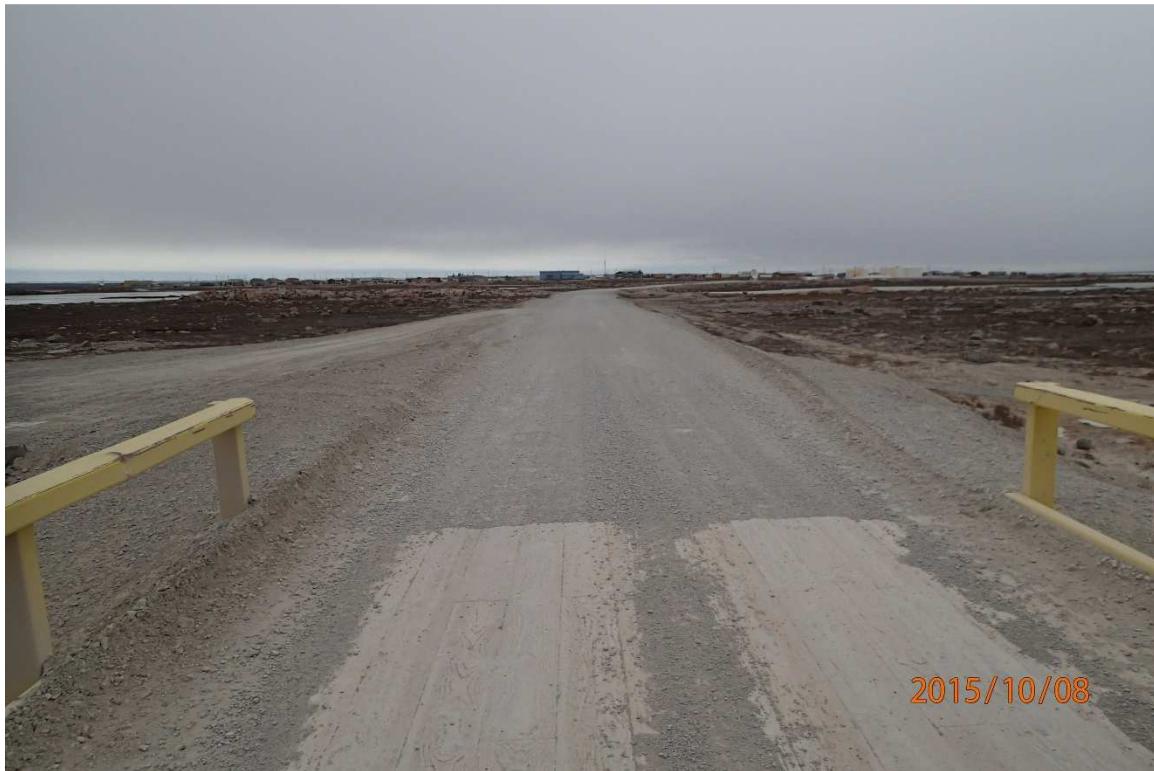
The approach roadway embankments were observed to be in good condition with no significant signs of erosion or slope instabilities, as shown in Figures 2 and 3.

The bridge deck timbers were observed to be in good condition and no nail heads protruded above the deck surface. See Figures 2 and 3. Hamlet staff indicated that the bridge deck timber were replaced two years ago.

Figure 2 – Approach roadway embankment looking east towards Coral Harbour.

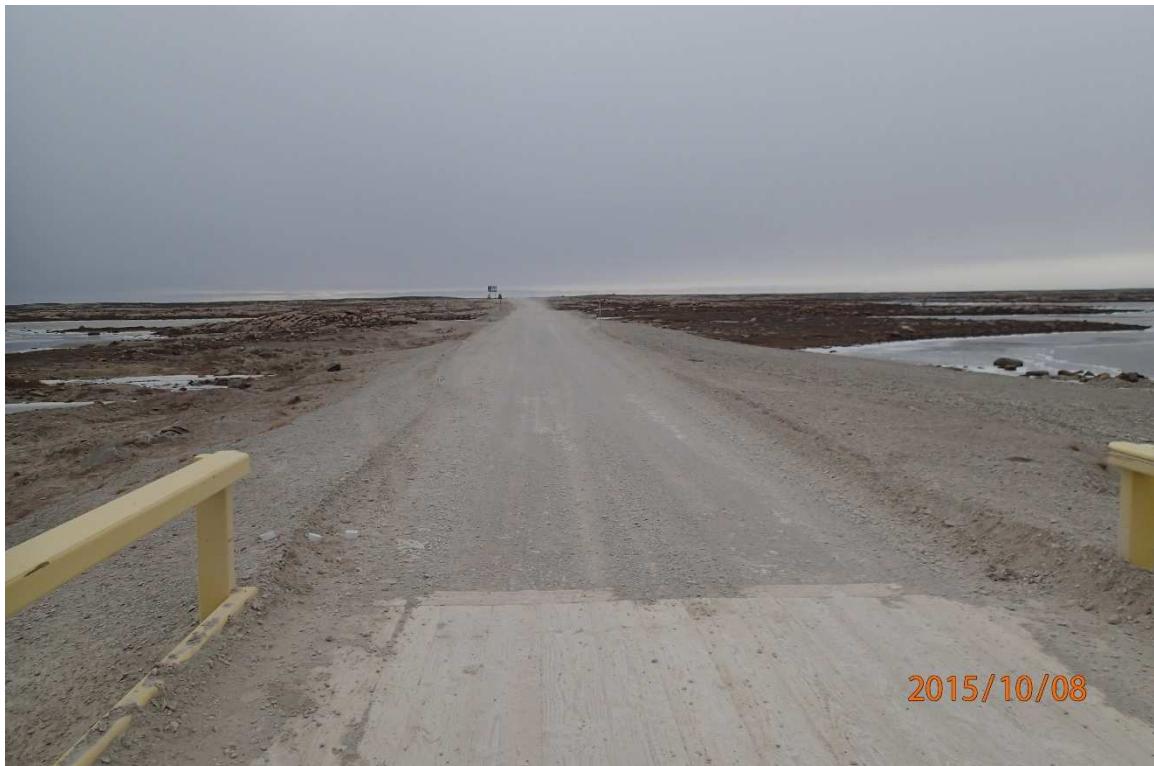
Figure 3 – Approach roadway embankment looking west towards Airport.

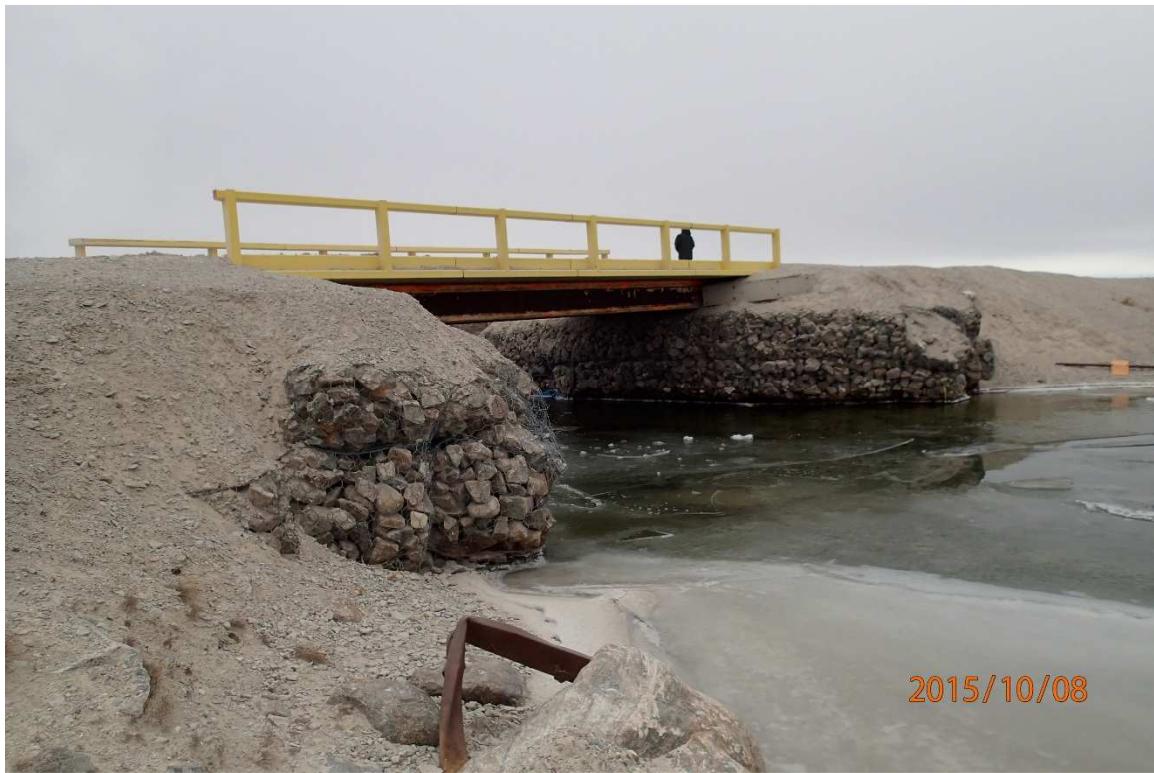
Gabion baskets walls that support the approach fills at the bridge abutments were observed to be in fair to good condition. The east and west gabion basket walls are shown in Figures 4 and 5, respectively. The walls appear to be in nearly vertical positions with possibly very slight forward leans and small bulges on the front faces of some individual gabion baskets. One gabion basket on the upstream edge of the west abutment is ruptured, likely due to ice forces, with some loss of filler stone, as shown in Figure 6. The damage to this basket does not currently appear to be impacting the stability of the approach fill but ongoing deterioration of the basket could eventually result in loss of fill material or slips in the embankment slope. No significant loss of section was observed on the wire mesh forming the gabion baskets but the galvanized coating on the wire mesh is now gone from the base to just above the current water level.

Figure 4 – East abutment gabion basket wall looking east from downstream side of bridge.

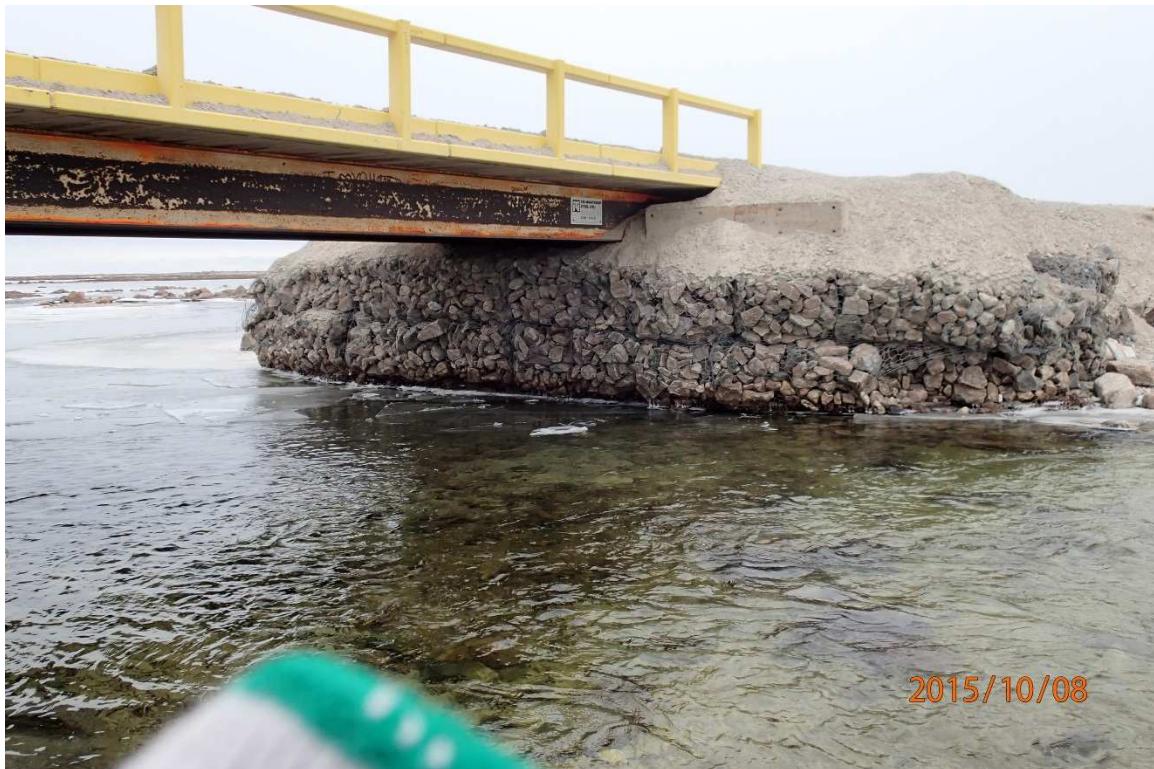
Figure 5 – West abutment gabion basket wall looking west from upstream side of bridge.

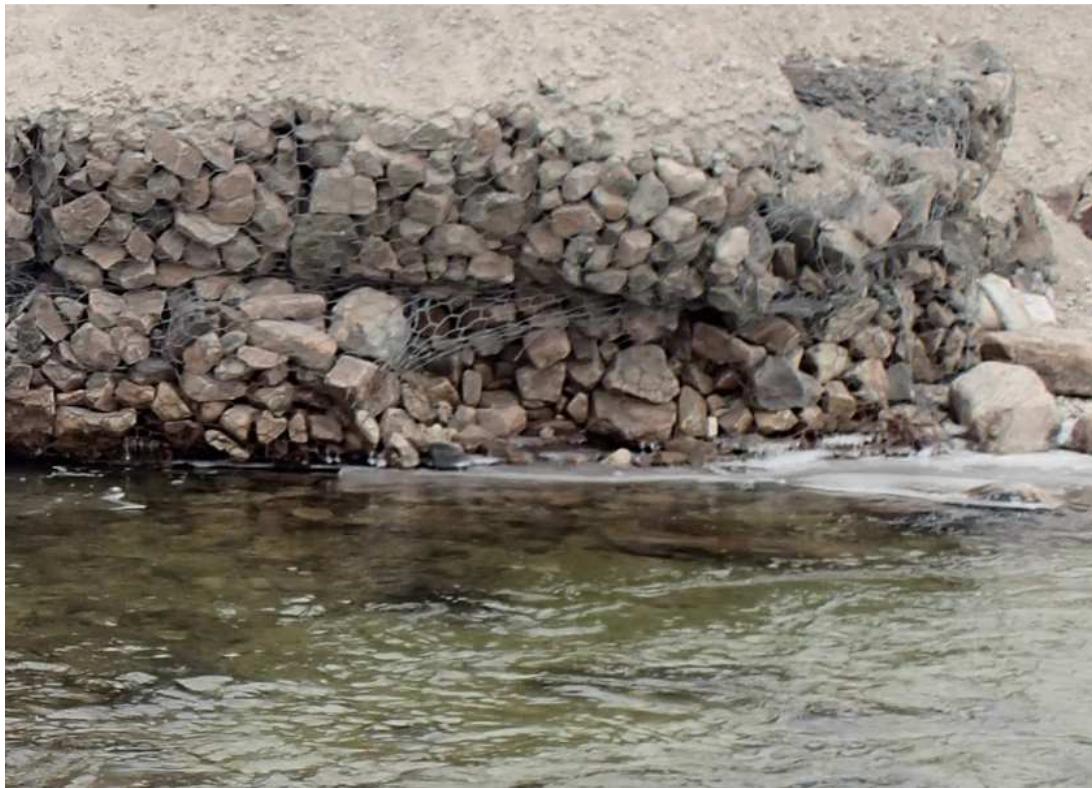
- Near vertical gabion basket walls protect both abutments; however, some were observed to have ruptured and lost some stone, likely due to ice forces;

Figure 6 – Ruptured gabion basket on upstream corner of west abutment fill.

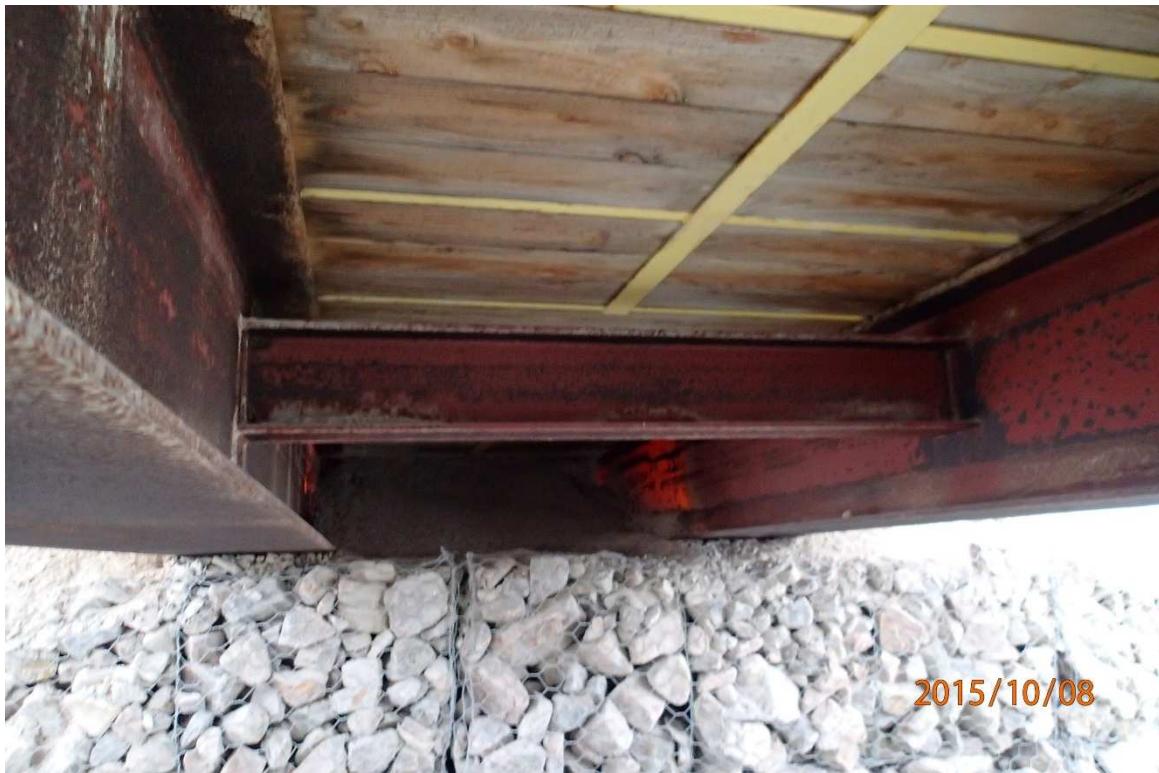
The steel girders were found to be in good condition with no significant defects observed, see Figures 7 and 8. Paint coatings on the girders have almost completely failed and surface corrosion is present on all visible surfaces, as shown in Figure 9. However, no significant loss of steel section was observed which indicates a low rate of corrosion to date. No signs of more advanced corrosion were observed when the approach fill was removed from small areas of the buried girder ends.

Figure 7 – Steel girders looking east from near midspan.

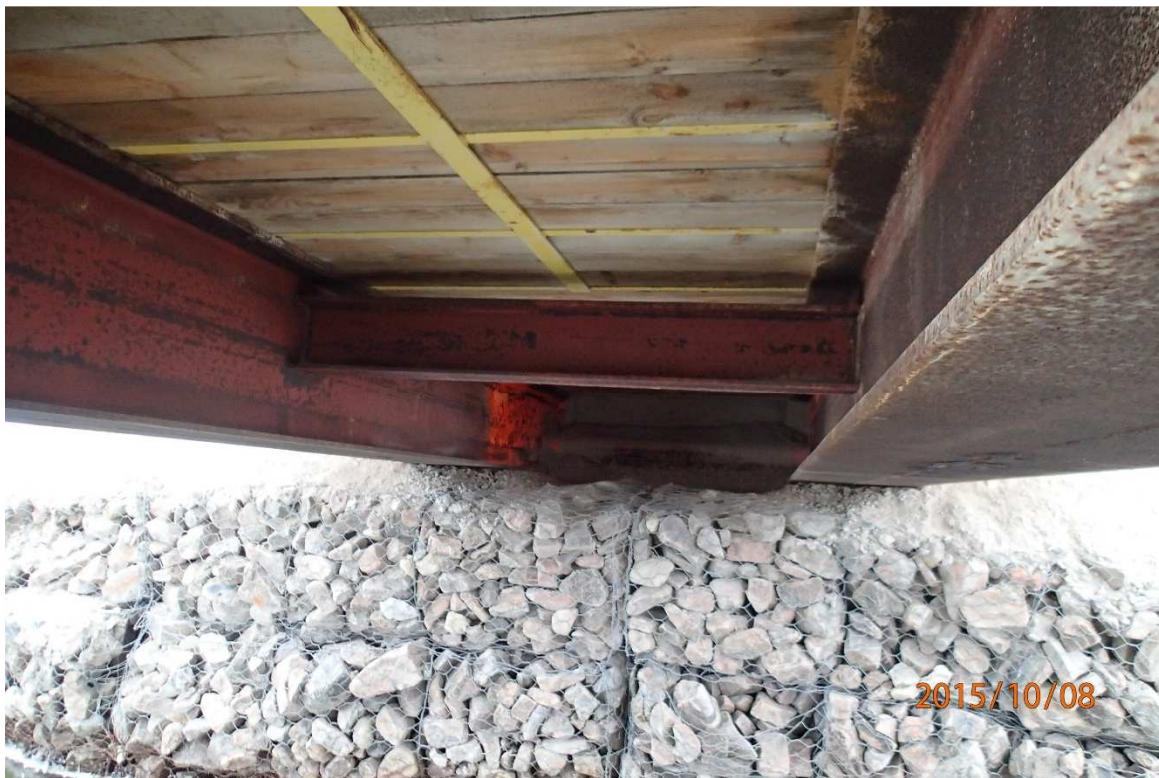
Figure 8 – Steel girders looking west from near midspan.

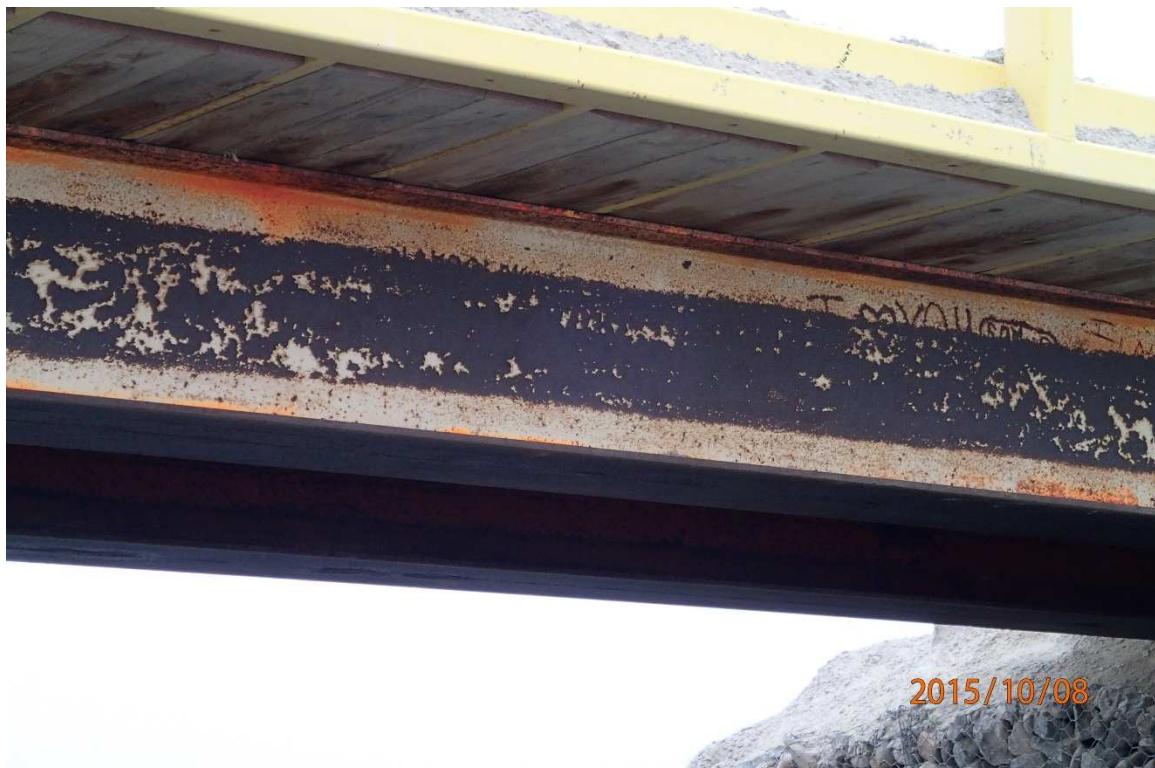
- The bridge superstructure consists of two steel girders. Paint coatings on both girders have almost completely failed and surface corrosion is present on all visible surfaces; however, no significant loss of steel was observed. The girders are deemed to be in good condition with no significant defects;

Figure 9 – Typical condition of paint coating on steel girders.

- The bridge deck timbers were observed to be in good condition. These were replaced two years ago (2013). It is expected that with the repainting of the girders, the bridge service life could be extended by 30+ years. The bridge deck timbers will likely need replacing every 10 to 15 years once replaced. Barrier railing could also last 30 years if painted when required and baring significant vehicle impact damage;

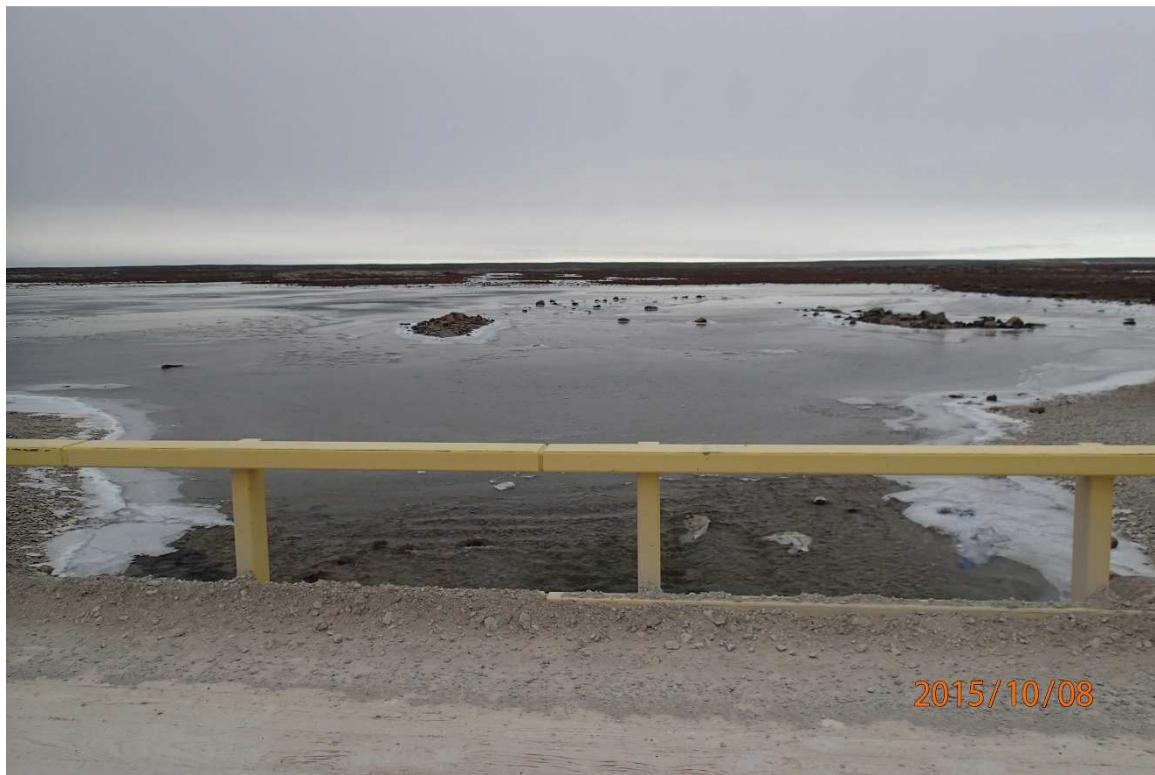
- Minor impact damage was observed to the east end of the south barrier rail; otherwise, barrier railings, including the paint coatings, were observed to be in good condition; and,

Figure 10 – General view of bridge barrier rail.

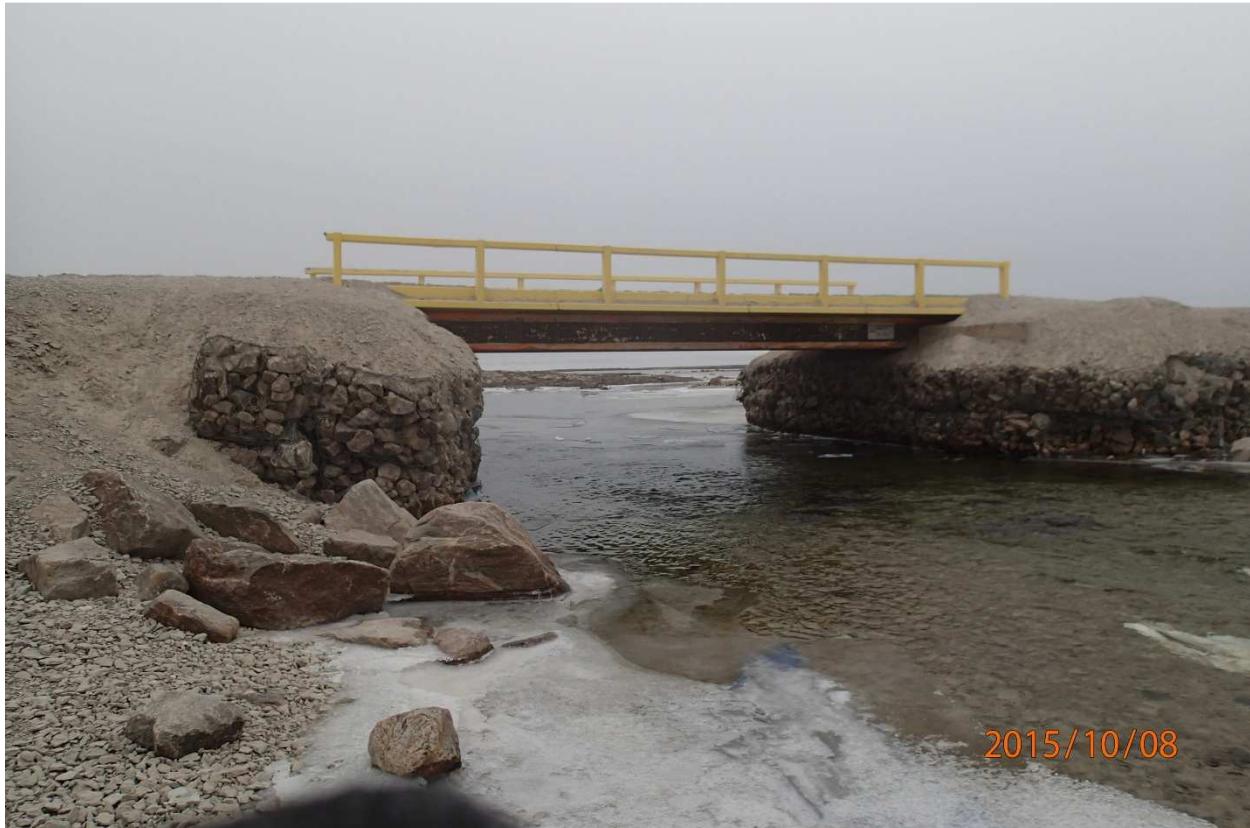
Figure 1 – Existing bridge at Crossing 7 Airport Road, Coral Harbour, NU
