WATER LICENCE INSPECTION FORM

Licensee	Licensee Representative
University of Exeter	Thomas Brody
Licence No. / Expiry	Representative's Title
8WLC-FDI1415	Researcher
Land / Other Authorizations	Land / Other Authorizations
N2014N0006	
Date of Inspection	Inspector
July 5, 2022	Joseph Monteith
Activities Inspected	
<input checked="" type="checkbox"/> Camp	<input type="checkbox"/> Drilling
<input type="checkbox"/> Roads/Hauling	<input type="checkbox"/> Mining
	<input type="checkbox"/> Construction
	<input checked="" type="checkbox"/> Reclamation
	<input type="checkbox"/> Fuel Storage
	<input type="checkbox"/> Other:

Background			
A water license application was submitted on			
Inspector Statement			
On July 5, 2022, a Water License inspection was conducted by Water Resource Officer(WRO) Joseph Monteith at the site where 8WLC-FDI1415 was located in Schei Peninsula, Axel Heiberg Island,NU.			
Water Use

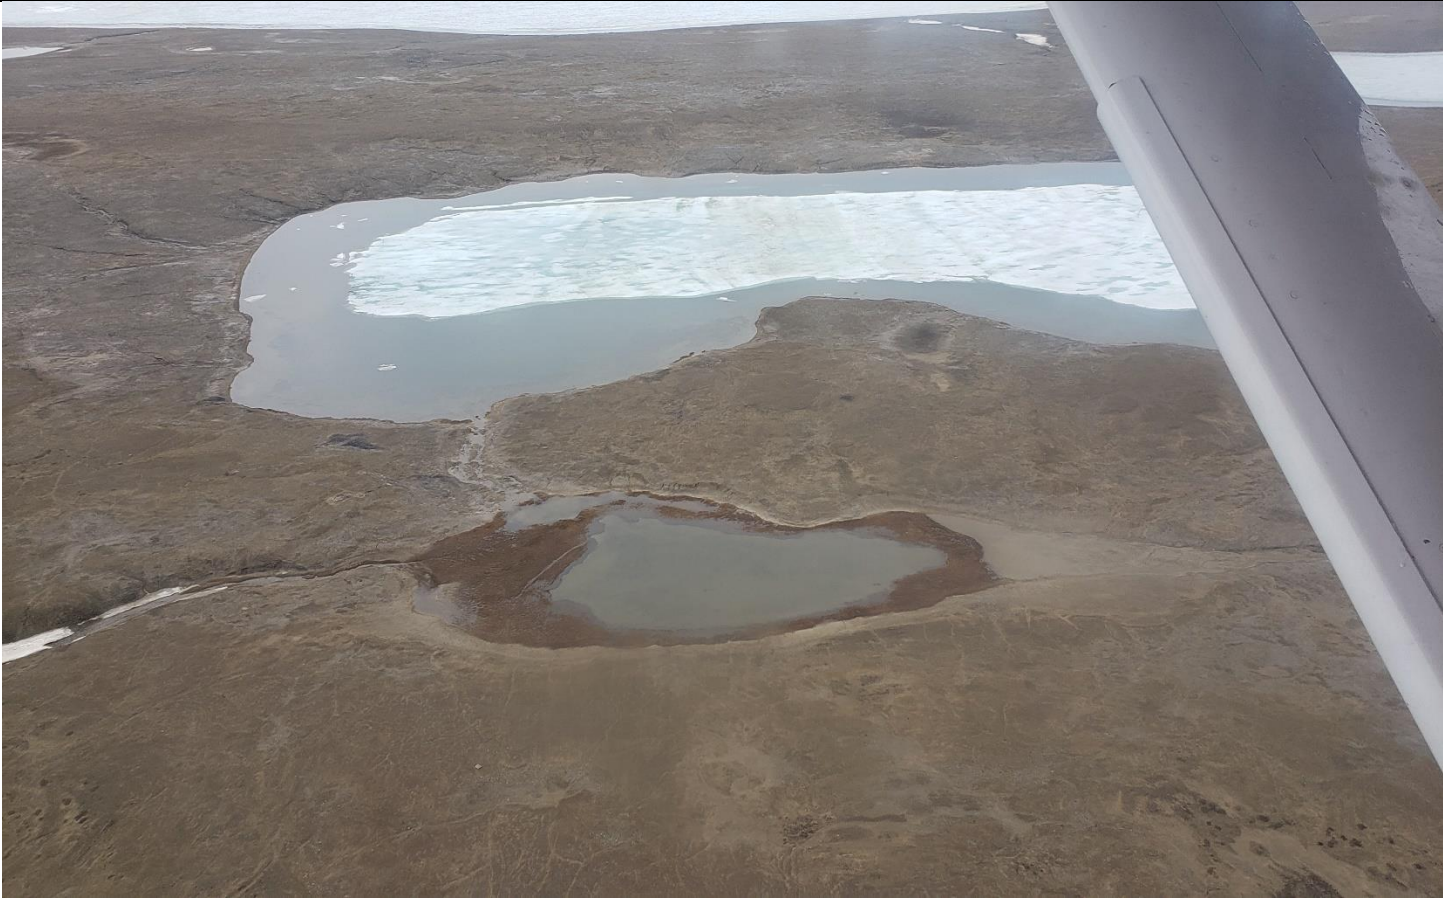
Photo 2

Description: Campsite was located at the top right hand side of the lake.

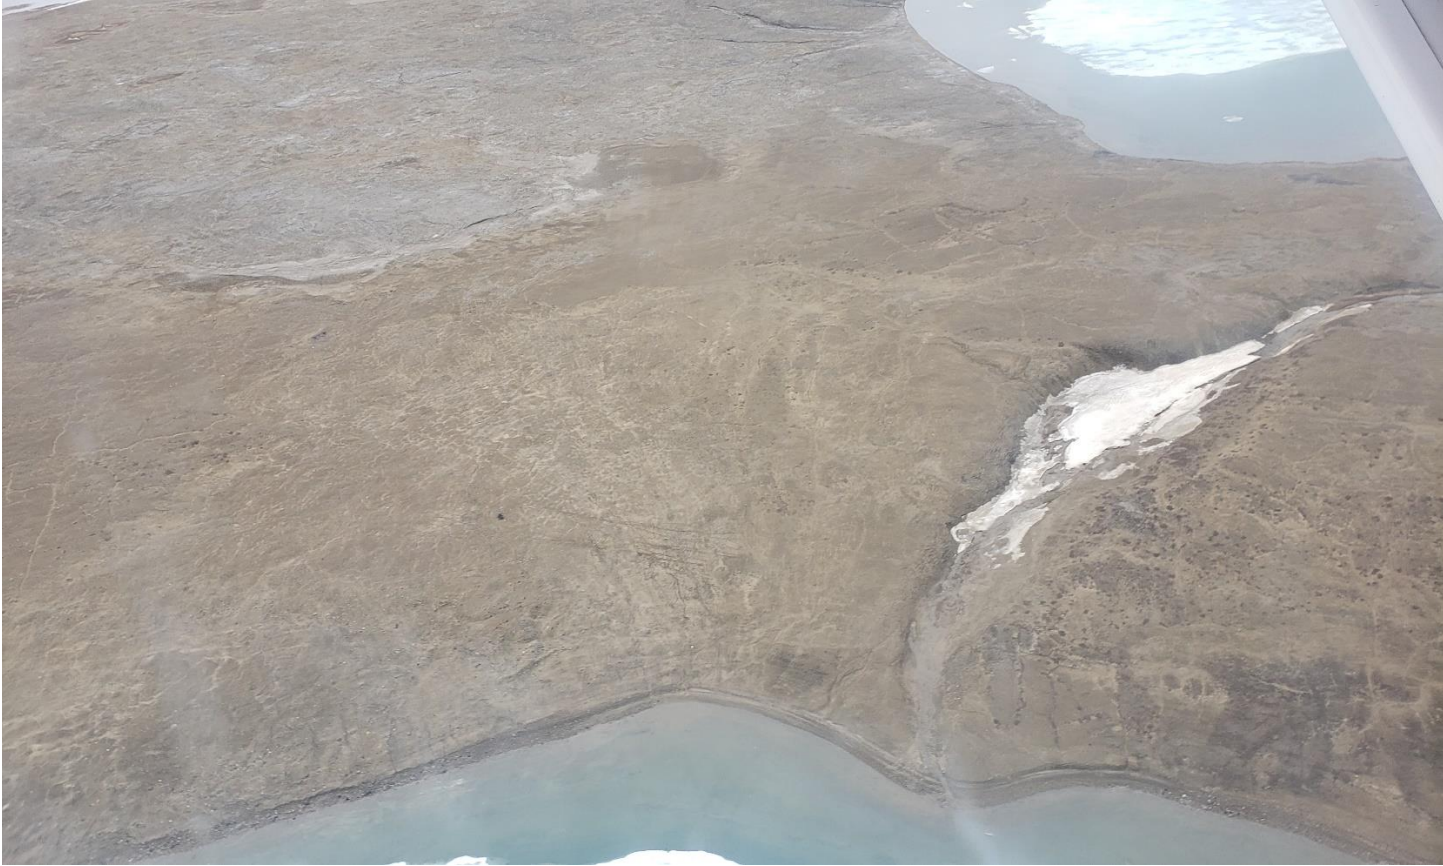
Photo 3

Description: No signs of structures, equipment or spills in the general vicinity of the camp site.

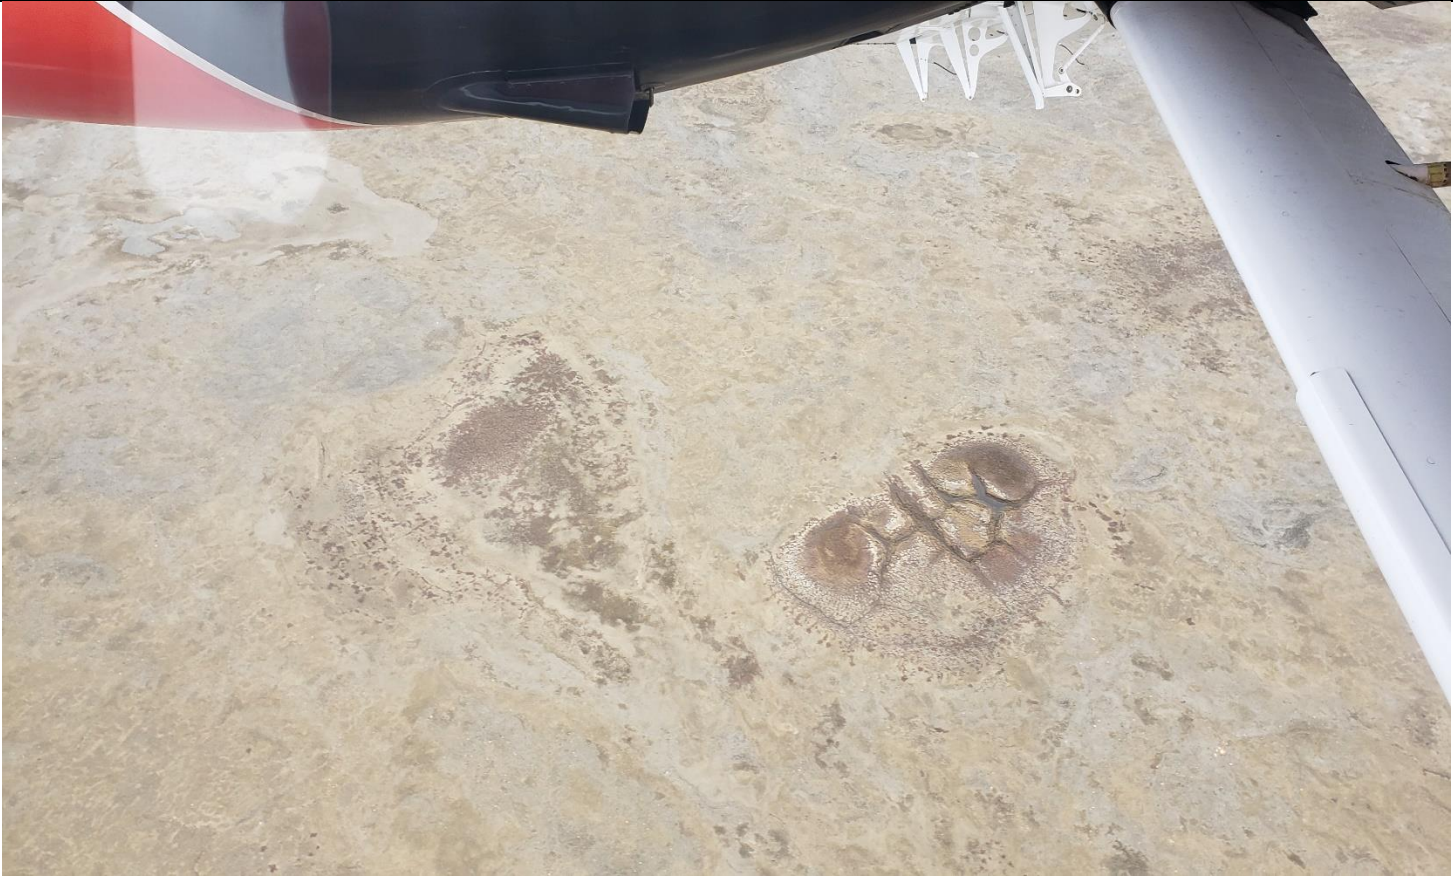
Photo 4

Description: No signs of structures, equipment or spills in the general vicinity of the camp site.
