INSPECTION FORM

Licensee				Licensee Repre	Sentativ	-				
Mars Society			srupert@marssociety.org							
Licence No. / Expiry				Representative	e's Title					
8WLC-LHA1718										
Land / Other Authorizations										
N2012N0018, 58H	1 7-2									
Date of Inspection				Inspector						
30 June 2017	0 June 2017 Justin HACK									
Activities Inspected	_			_						
	Drilling Other: Cam	מו	☐ Mining ☐ Construc ☐ Other:			ion Reclamation		☐ Fuel Storage		
<u>-</u>		-		_						
	ceptable	C	C - Concern	U - Unacceptab			Not Applicable		Not Insp	ected
Water Use	Condition	Comment	Site Condition	ns	Condit ion	Comme nt	Haz/Mat Manager	nent	Condition	Comment
Intake/Screen			Water Manag	ement Structures			Storage		Α	
Flow Measure. Device			Culverts / Brid	dges			Spills			
Source:			Drainage		А		Spill Plan			
Water Use:			Erosion / Sedi	ment	Α					
Recirculation (y /n)			Mitigation Me	easures			Administrative			
			Reclamation A	Activities			Records

SECTION 1 Background

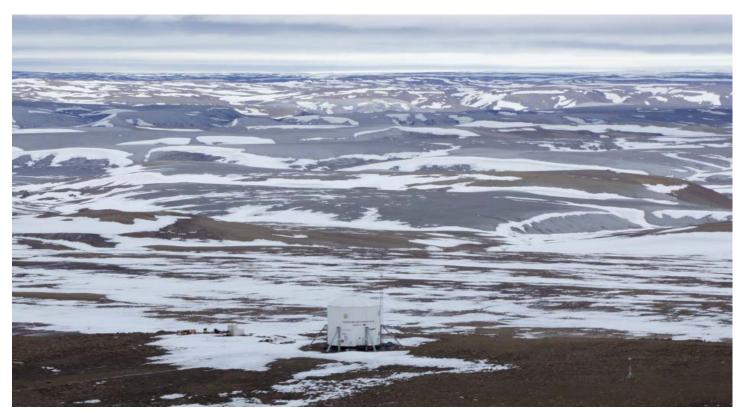
Figure #1: Overview of camp

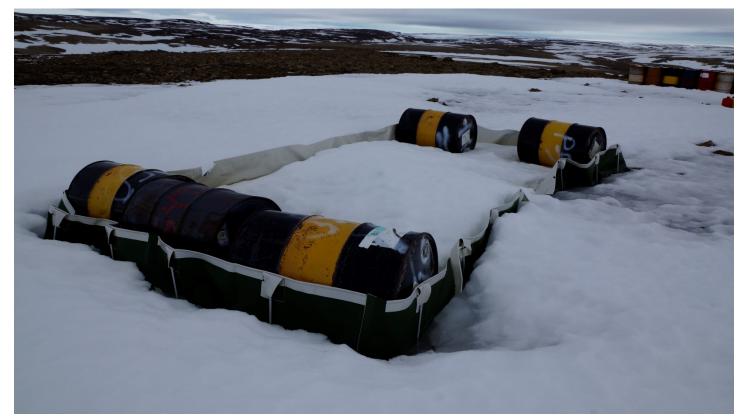
No sewage was being discharged on site. There was evidence on site that all waste was being contained in barrels. Secondary containment

Figure #2: 5 Barrels of Fuel in secondary containment.
