WATER LICENCE INSPECTION FORM

| 3BC-NET1520 | | Head, Aquatic Unit | |
| August 11, 2020 | | Joseph Monteith | |

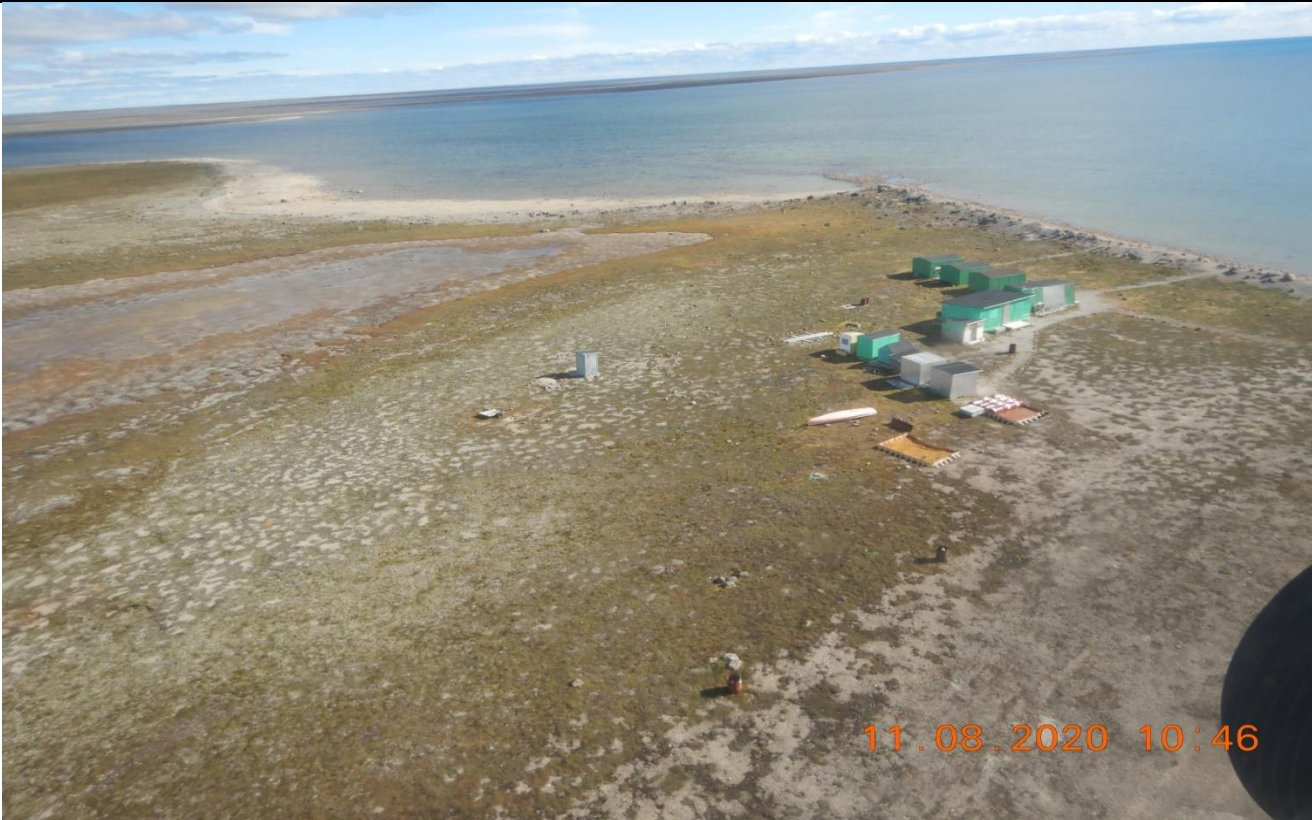
| Date | Camera | Inspector | |
|---|---|---|--|
| Photo 1 | Nikku Island, Nettling Lake, Qikiqtani Region, NU | | |

| Date | Camera | Inspector | |
|---|---|---|--|
| Description: Nikku Camp – Nettling Lake 11 structures, and 2 fuel caches | | | |

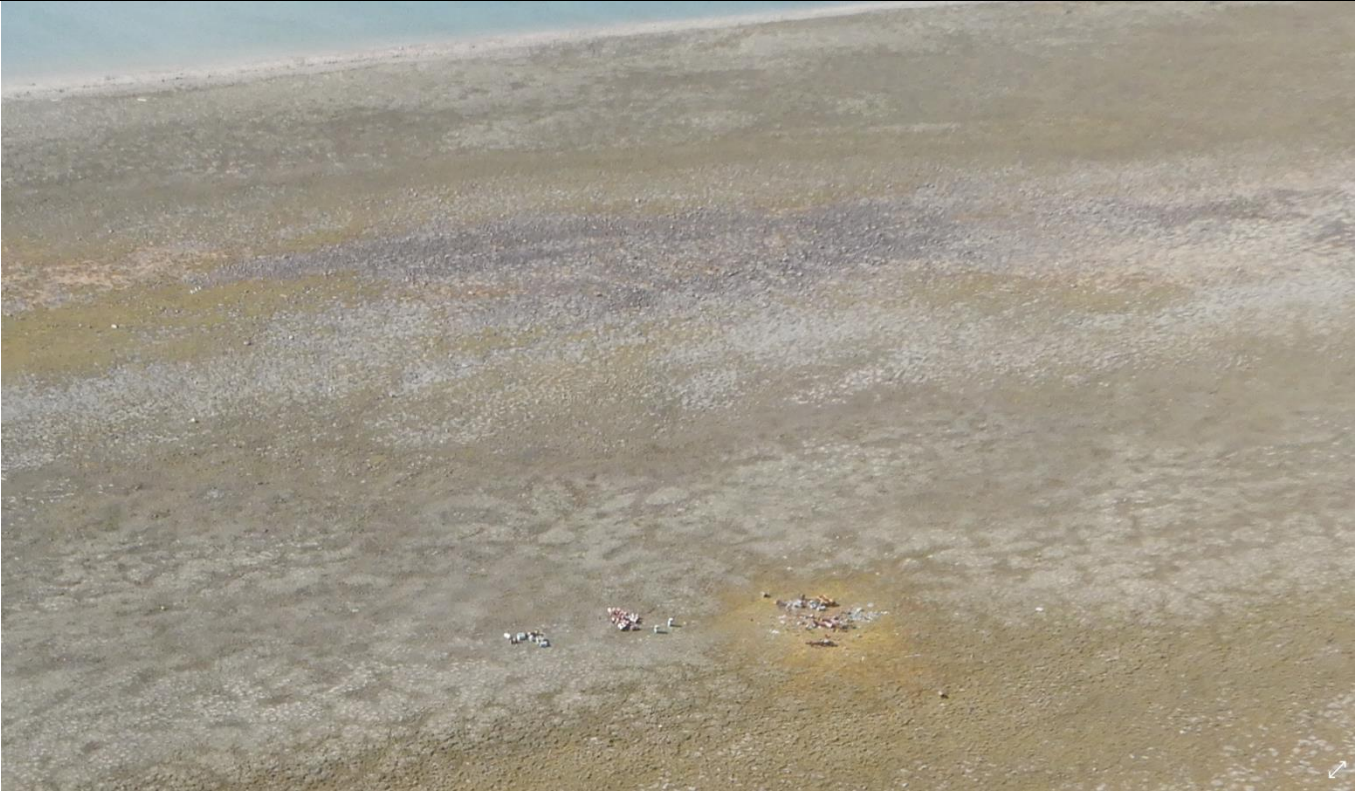
| Photo Log #1 | Location |
|---|---|
| Photo 2 | Nikku Island, Nettling Lake, Qikiqtani Region, NU |

3. Latrine (photo 4) and covered Latrine hole (photo 4)
4. Bulk metal Part D: Item 1 (photo 2 & 3)
5. Incinerator. No sign of incinerator at campsite, but another project to reclaim old drums appears to be on the other side of the island.
6. Non-combustible material has been removed on an annual basis for disposal and recycling

| Photo Log #1 | Location |
|---|---|
| Description: Drums bulk metal at the other end of Nikku Island, | |

Remove any bulk metal waste away from the 31 metres from the ordinary high water mark.

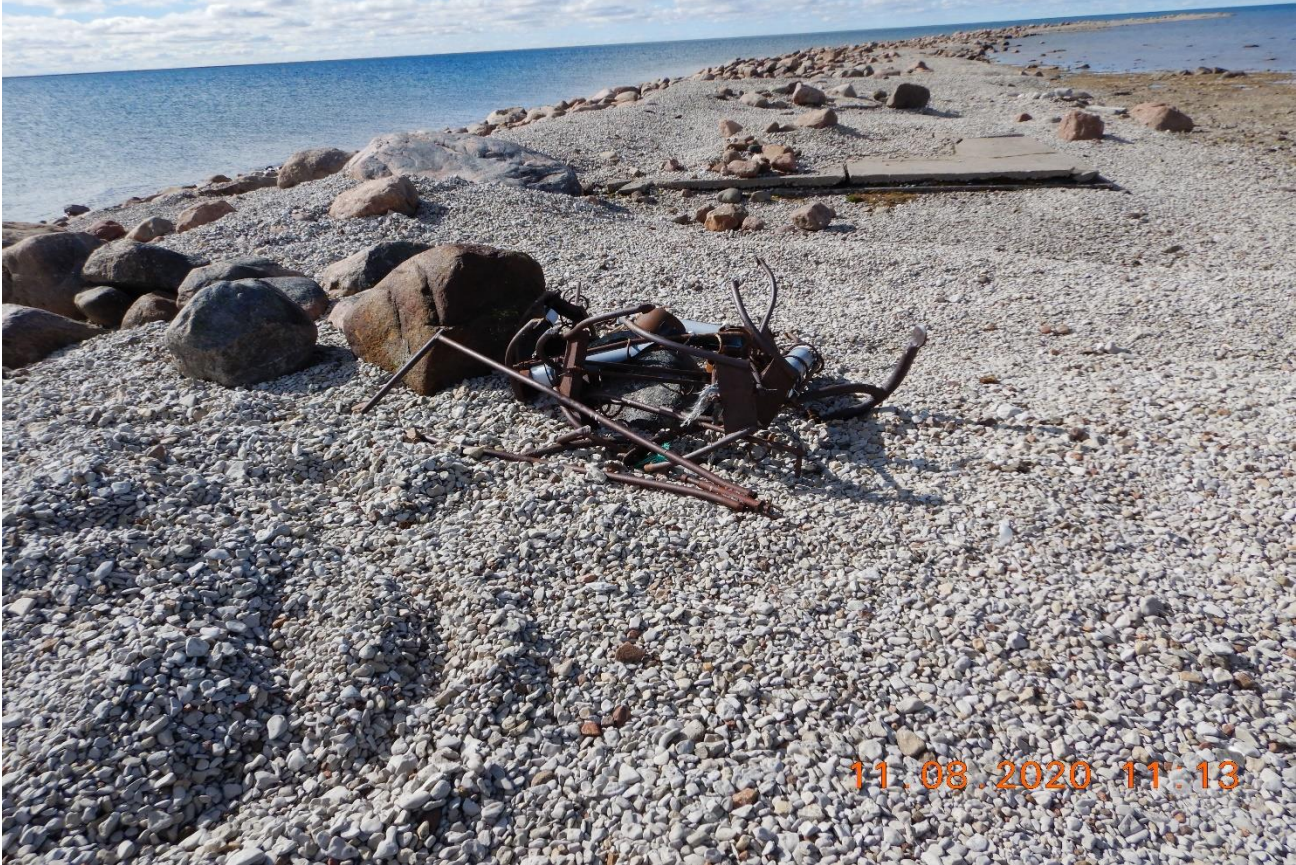
| Photo Log #1 | Location |
|---|---|
| Photo 3 | Nikku Island, Nettling Lake, Qikiqtani Region, NU |

| Photo Log #1 | Location |
|---|---|
| Description: Bulk Metal Waste, and concrete base. | |

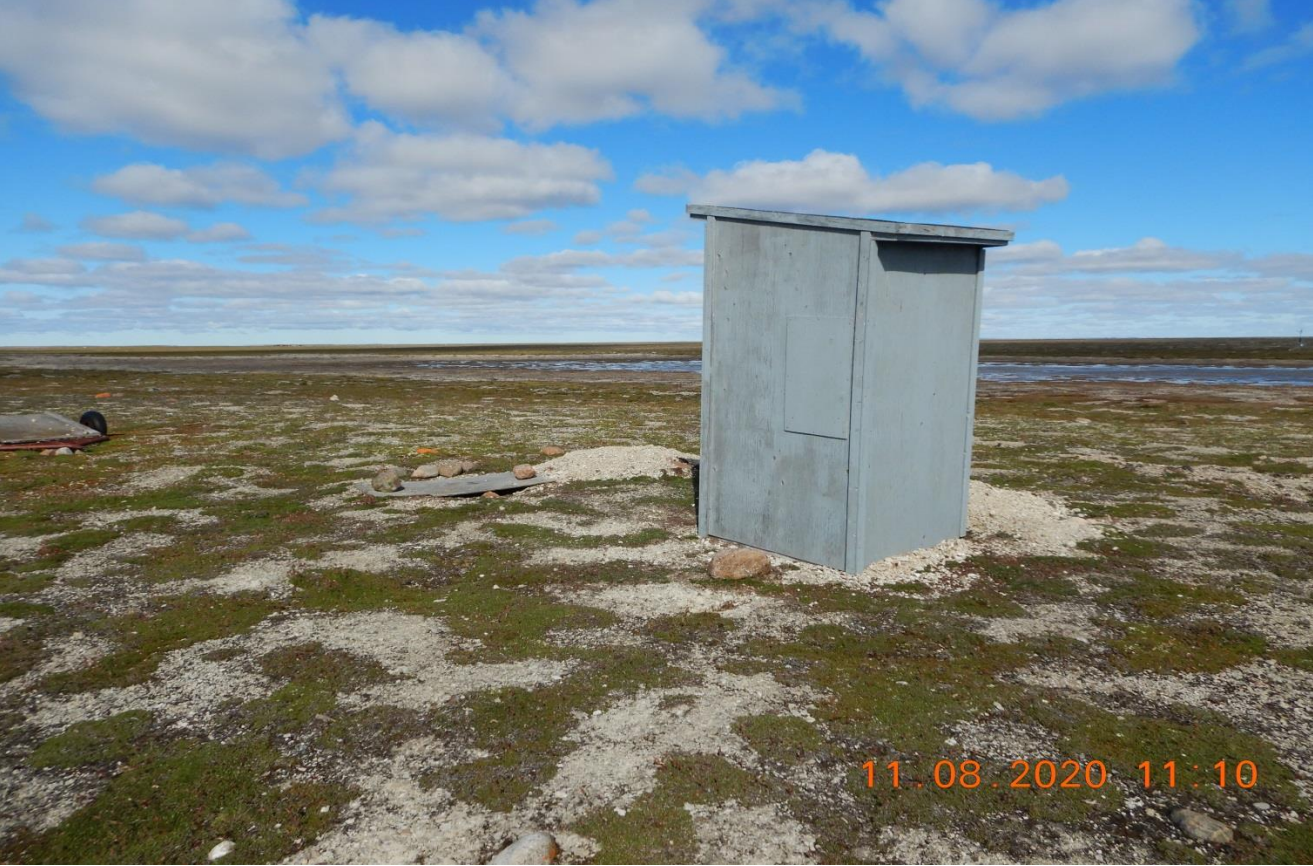
| Photo Log #1 | Location |
|---|---|
| Photo 4 | Nikku Island, Nettling Lake, Qikiqtani Region, NU |

Description: Latrine – Backfilled latrine hole covered with plywood.

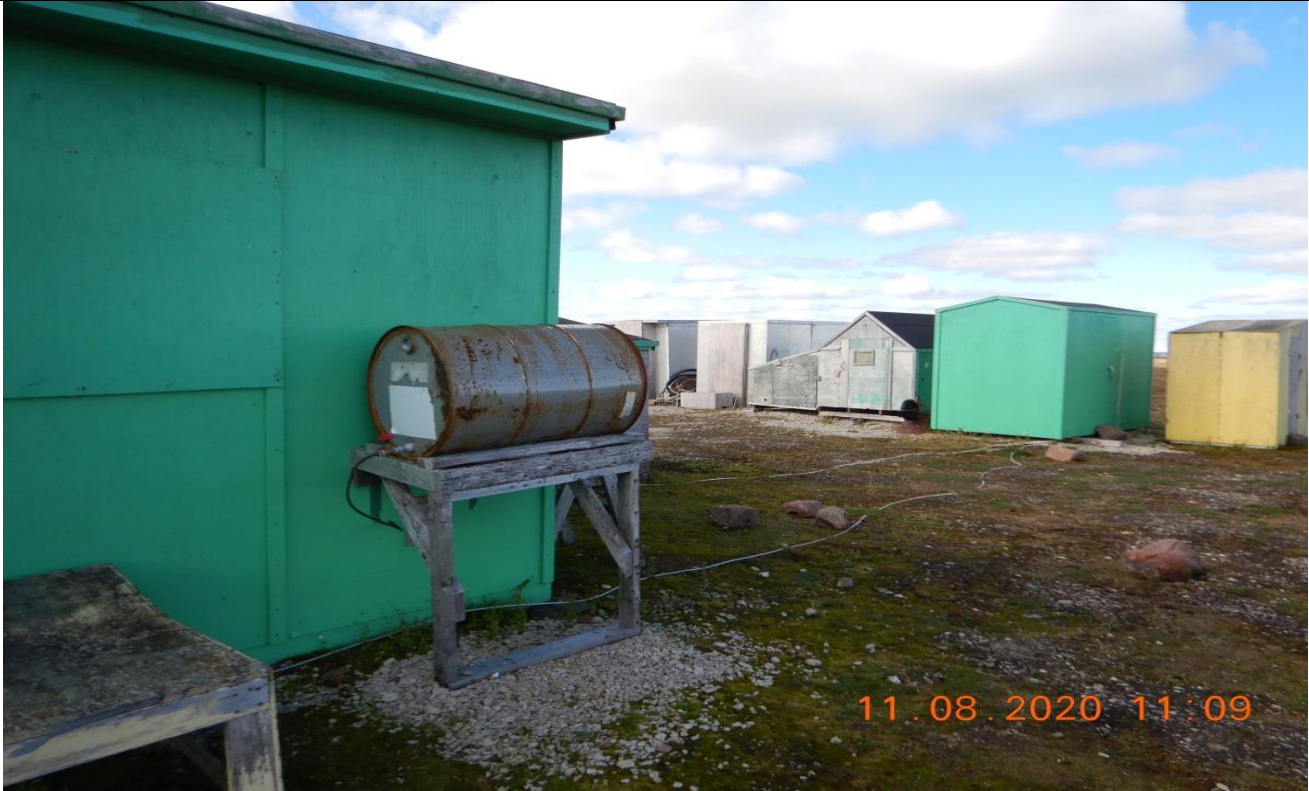
| Photo Log #1 | Location |
|---|---|
| Photo 6 | Nikku Island, Nettling Lake, Qikiqtani Region, NU |

Description: No secondary containment under heating storage tank

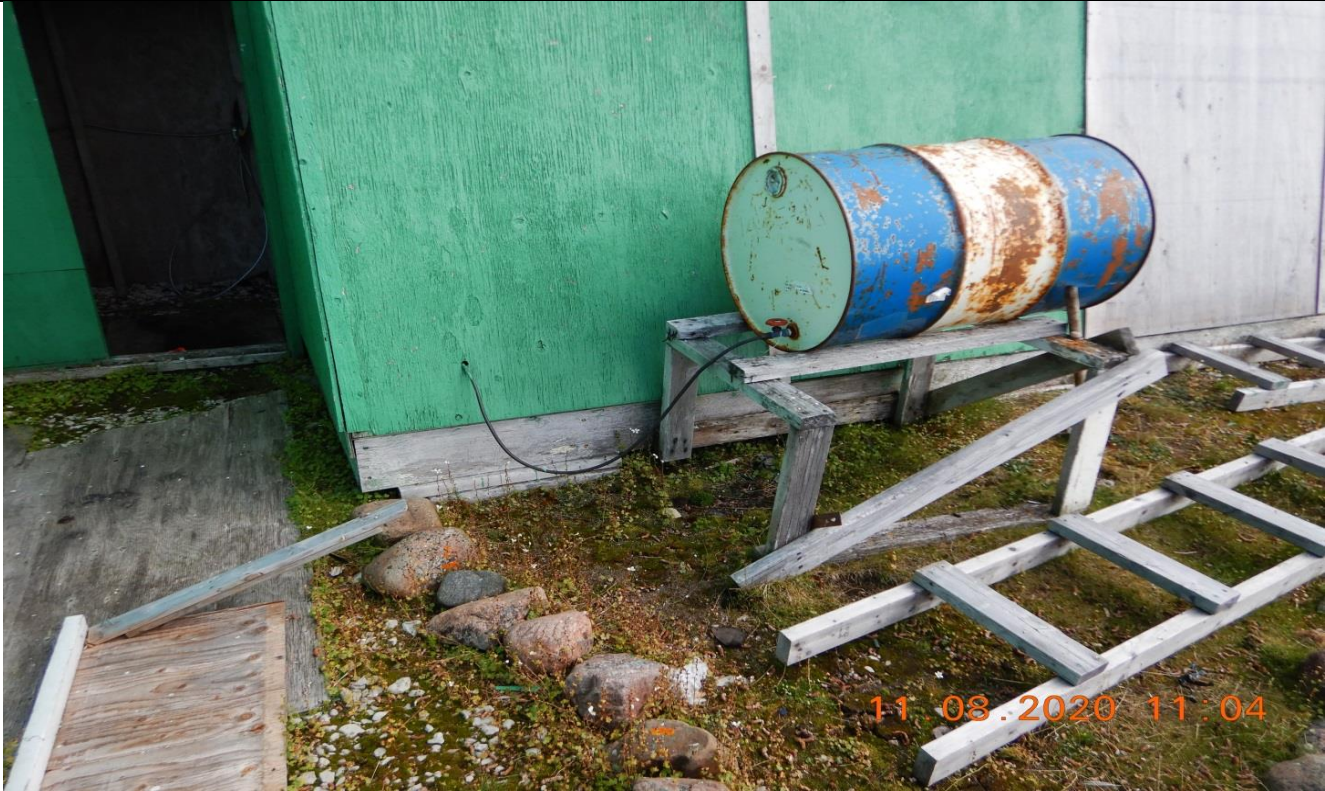
| Photo Log #1 | Location |
|---|---|
| Photo 7 | Nikku Island, Nettling Lake, Qikiqtani Region, NU |

Description: No secondary containment under heating storage tank

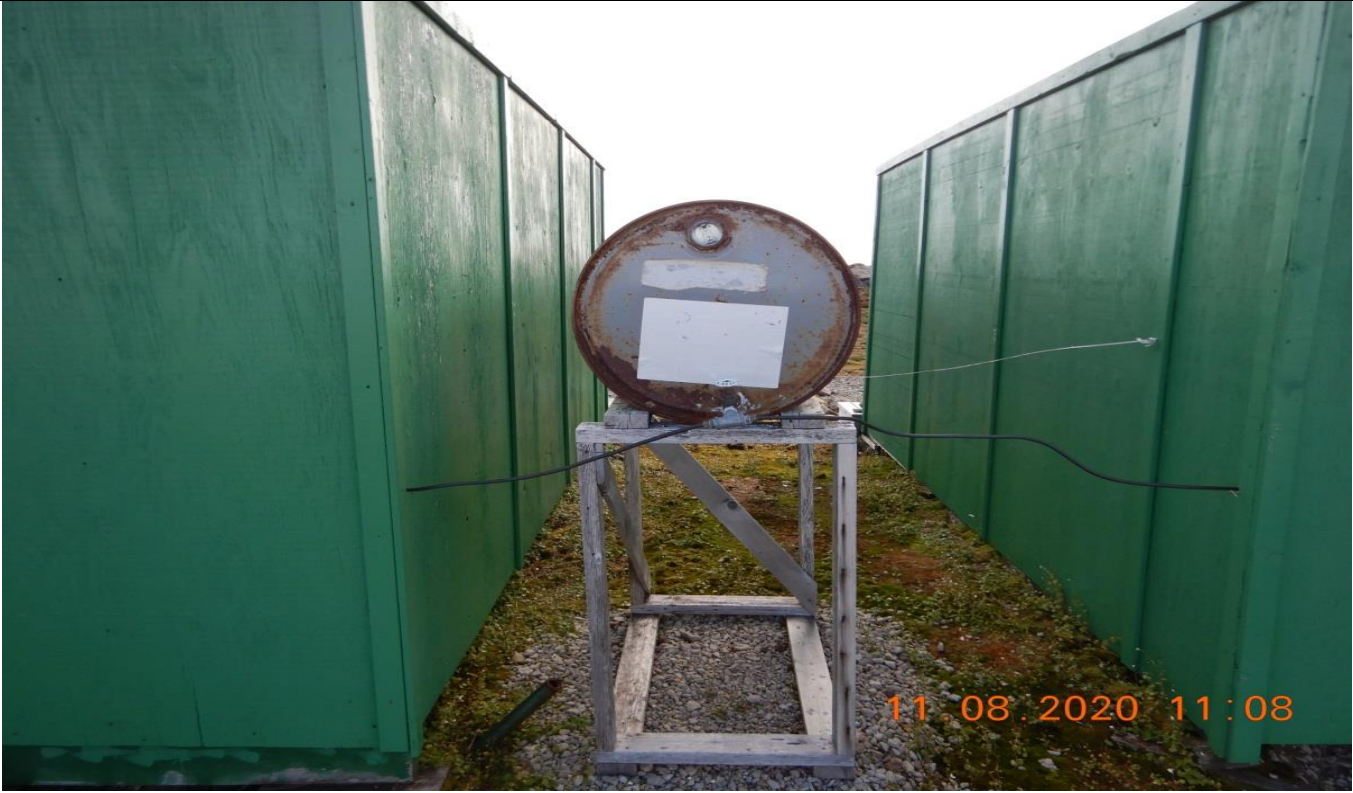
| Photo Log #1 | Location |
|---|---|
| Photo 8 | Nikku Island, Nettling Lake, Qikiqtani Region, NU |

Description: No secondary containment under heating storage tank

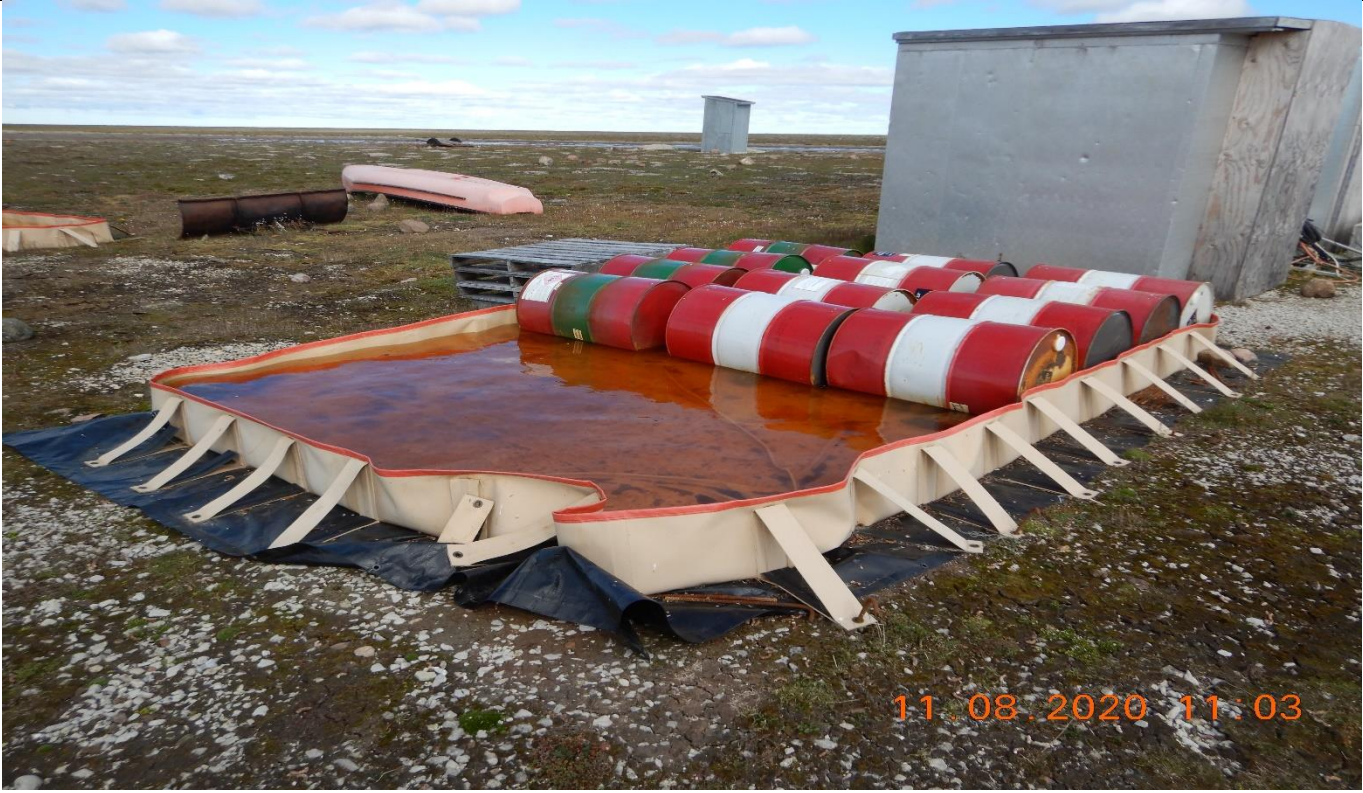
| Photo Log #1 | Location |
|---|---|
| Photo 9 | Nikku Island, Nettling Lake, Qikiqtani Region, NU |

Description: 12 drums of fuel in Secondary Containment. Secondary containment full of water.

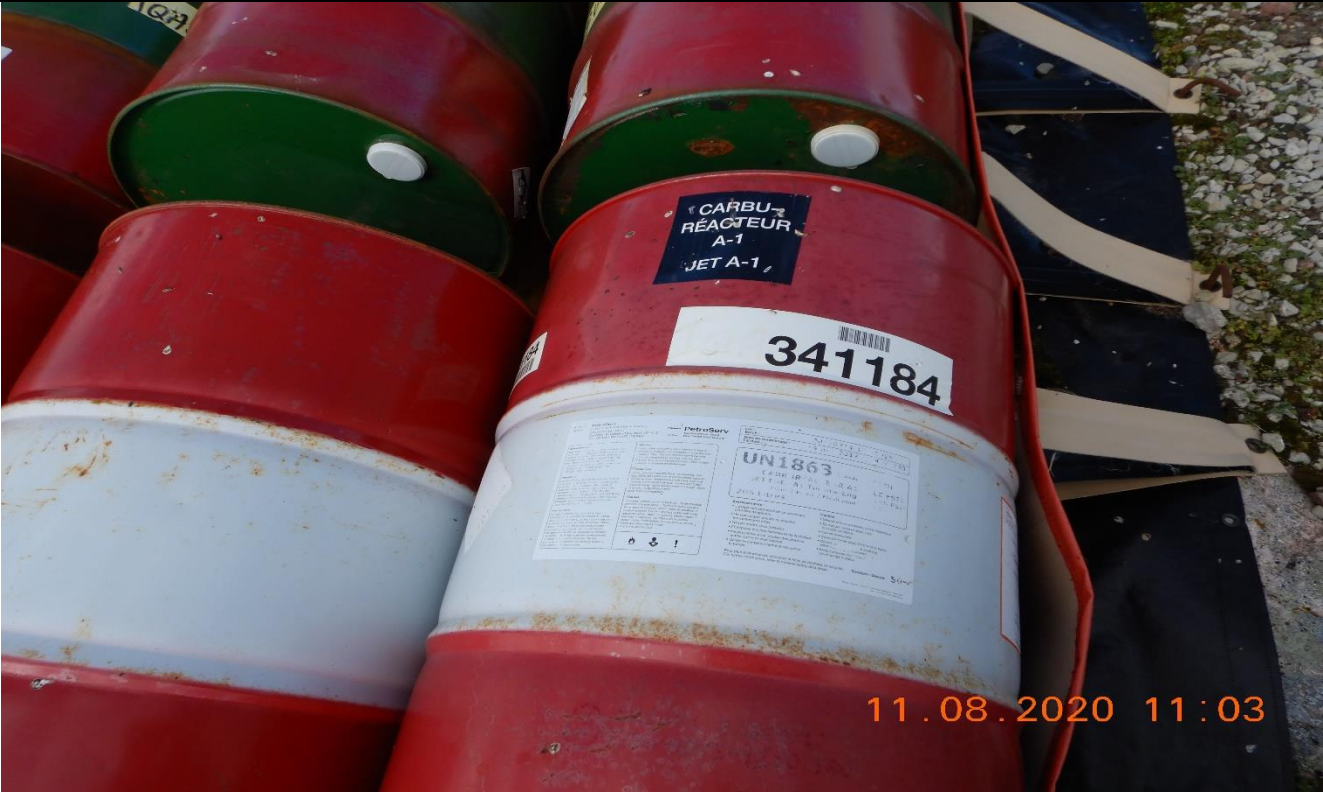
| Photo Log #1 | Location |
|---|---|
| Photo 10 | Nikku Island, Nettling Lake, Qikiqtani Region, NU |

Description: Jet A-1.
