WATER LICENCE INSPECTION FORM

The CWS Nikko Island Goose Research Camp Project, located approximately 270 km West of Pangnirtung, 350 km northeast of Cape Dorset and 425 km north-northwest of Iqaluit within the Qikiqtani Region, Nunavut (photo 1). The site was inactive due to COVID-19 Travel Restrictions.

On August 20, 2021, Water License inspections were conducted at Nikko Island, Nettling Lake, Qikiqtani Region, Nunavut, to verify compliance with the terms and conditions of the Water Licence 3BC-NET2122.

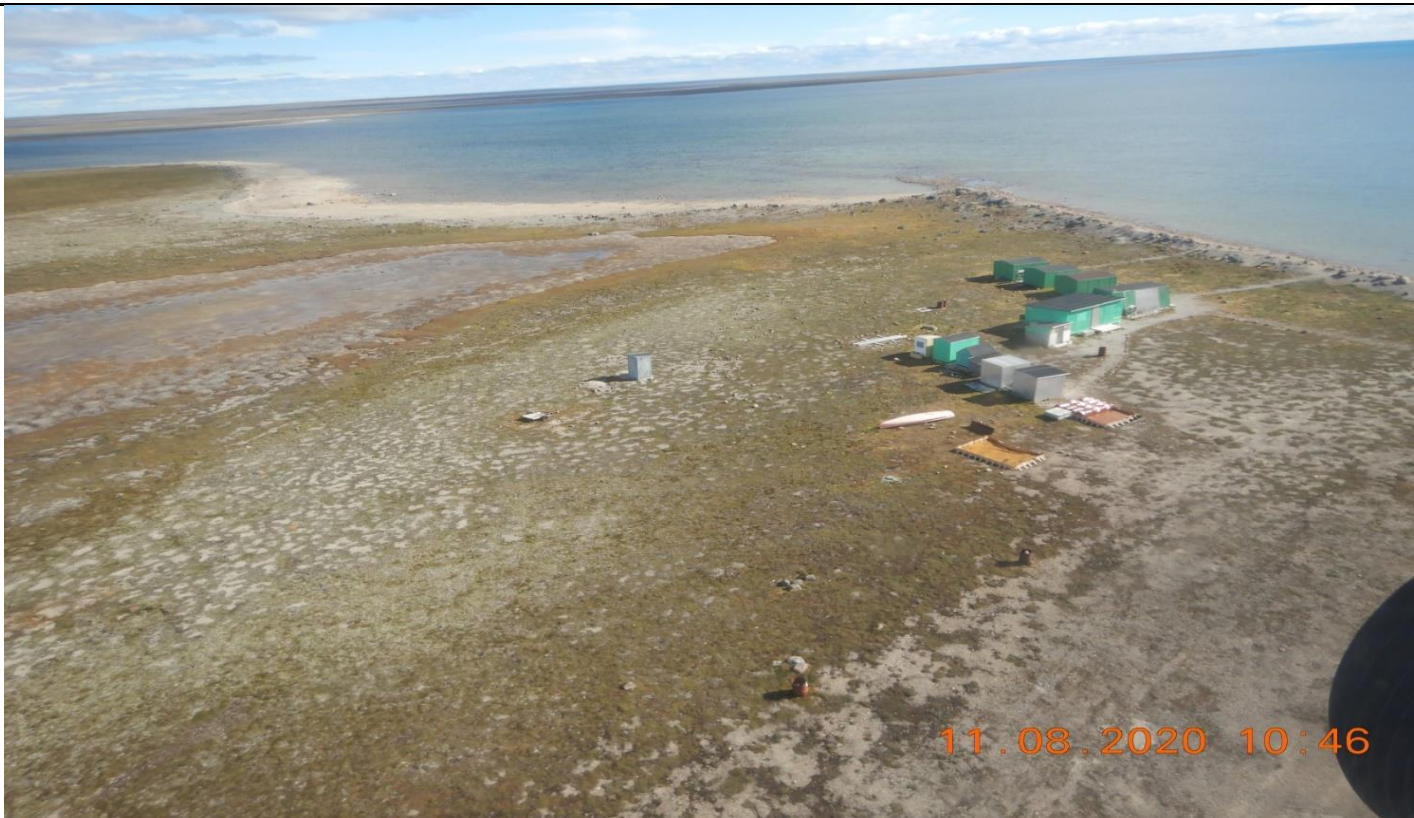
| Date | Camera | Inspector |
|---|---|---|
| Photo 1 | Nikku Island, Nettling Lake, Qikiqtani Region, NU | |

1. Nettling Lake – Water Source (See photo 1 and 2) 5 cu.m/day (photo 1). 2020 photo

| Date | Camera | Inspector |
|---|---|---|
| Description: Nikku Camp – Nettling Lake 11 structures, and 2 fuel caches. This photo is from November 8, 2020. | | |

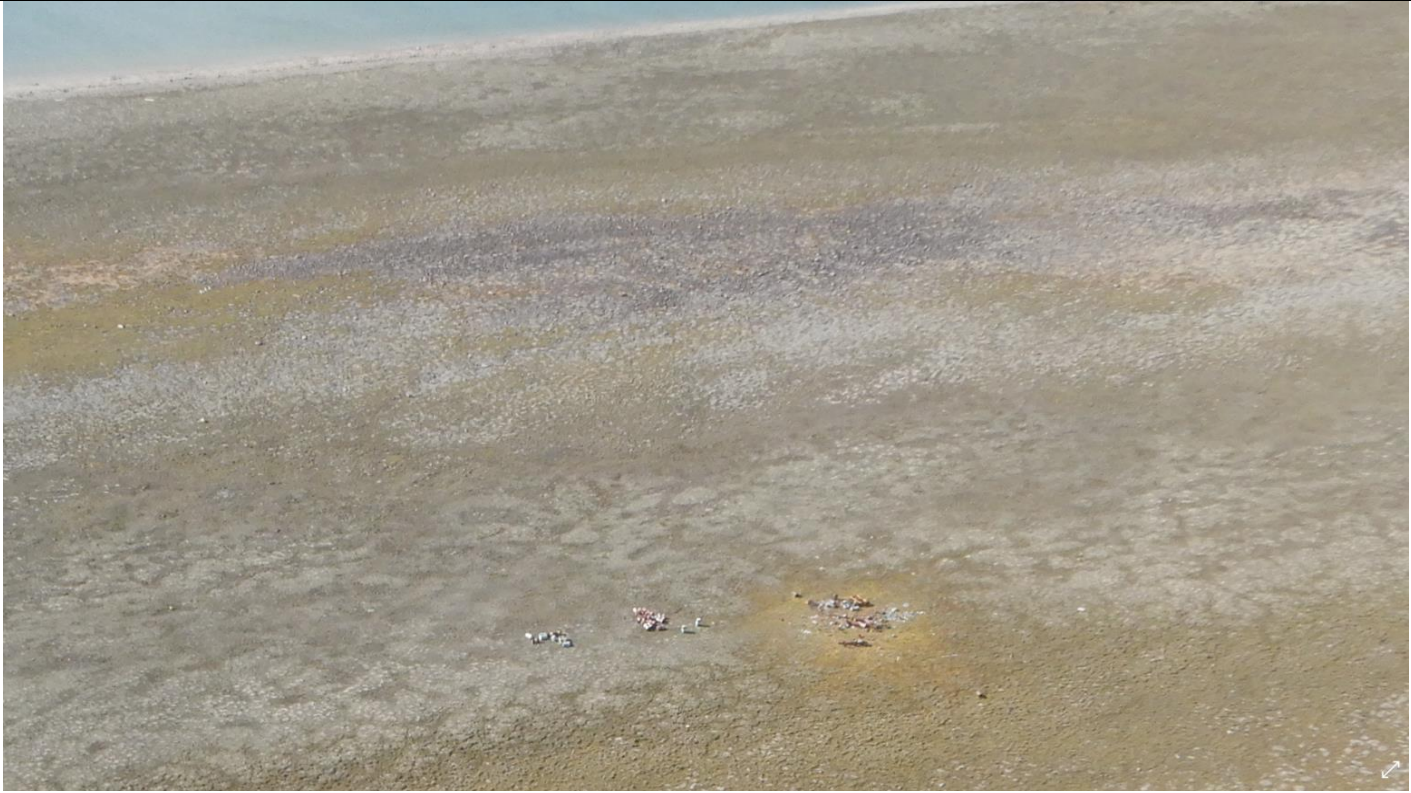
| Photo Log #1 | Location |
|---|---|
| Photo 2 | Nikku Island, Nettling Lake, Qikiqtani Region, NU |

6. Old drum disposal or storage site (photo 2).

8. Bulk metal Part D: Item 1 (photo 2 & 3)

9. Incinerator. No sign of incinerator at campsite, but another project to reclaim old drums appears to be on the other side of the island (photo 2).

Description: Drums bulk metal at the other end of Nikku Island,

Schedule 1: Item 3  
The Authorized Entity shall not deposit Waste to surface water or within thirty-one (31) metres of the ordinary High Water Mark of any body of water.

Remove any bulk metal waste away from the 31 metres from the ordinary high water mark.

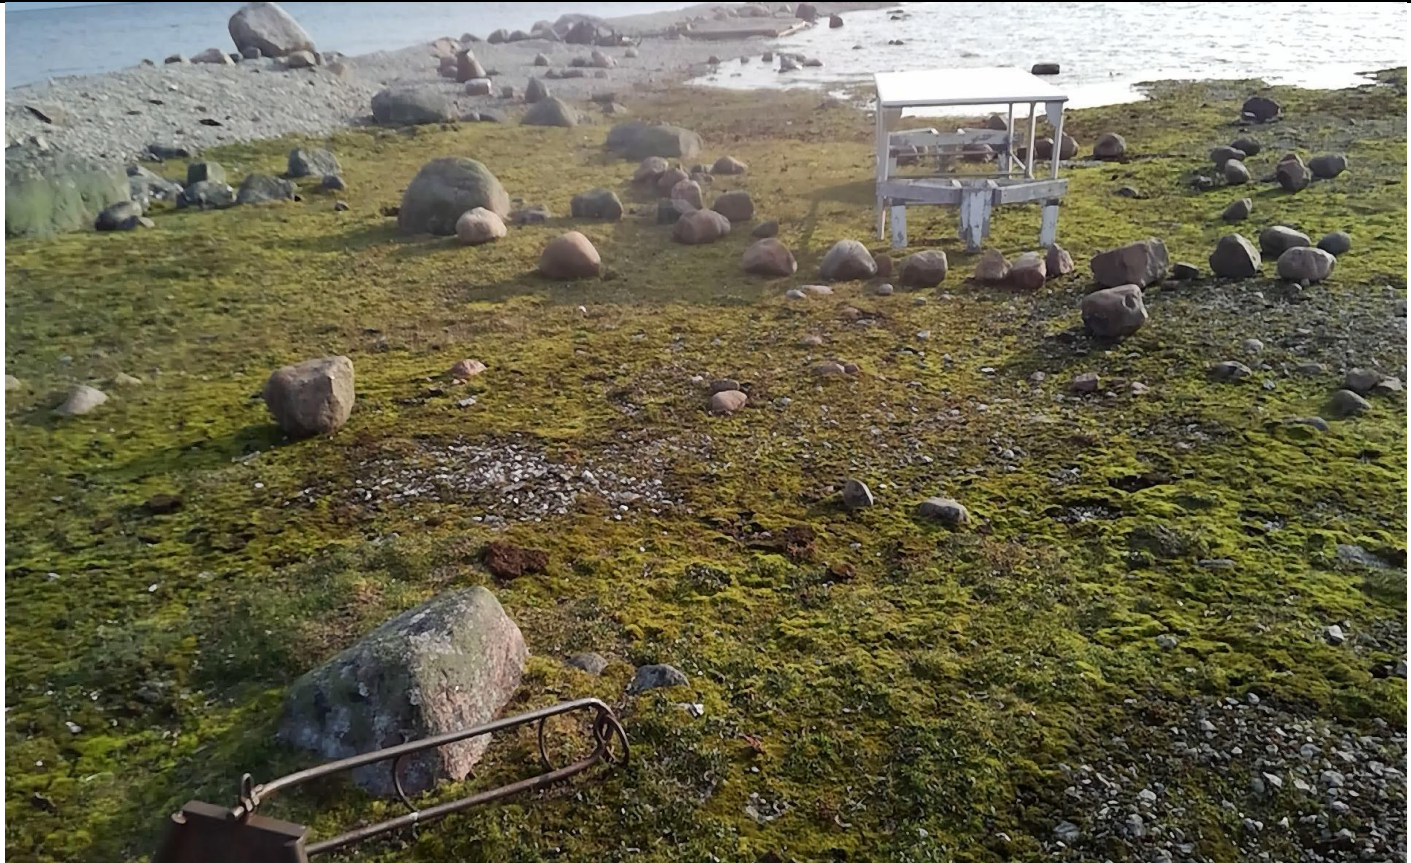
| Photo Log #1 | Location |
|---|---|
| Photo 3 | Nikku Island, Nettling Lake, Qikiqtani Region, NU |

Description: Bulk Metal Waste in the foreground and background. Concrete base in the background.

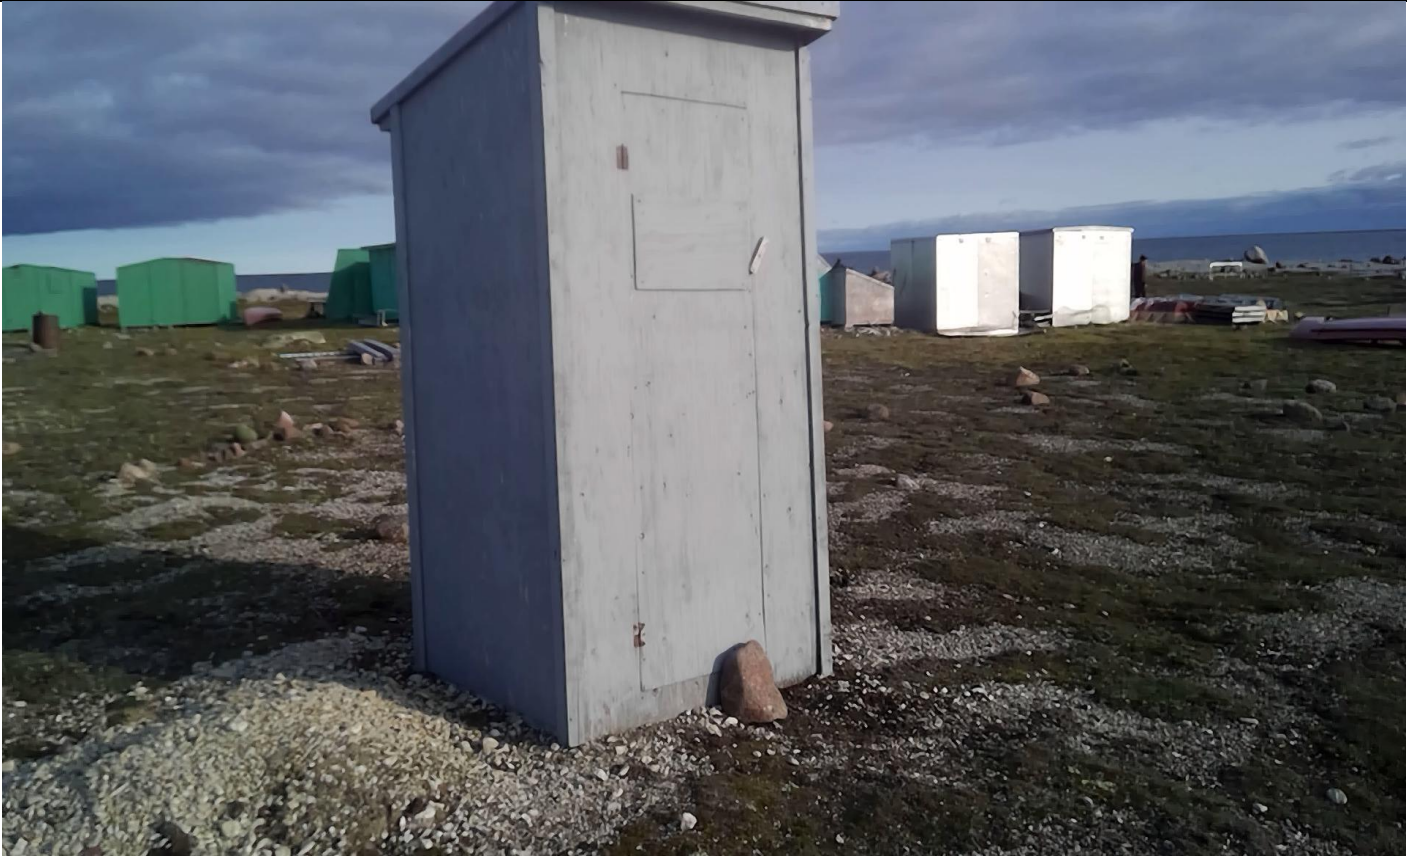
| Photo Log #1 | Location |
|---|---|
| Photo 4 | Nikku Island, Nettling Lake, Qikiqtani Region, NU |

7. Latrine (photo 4) and covered Latrine hole (photo 4)

Description: Latrine – Backfilled latrine hole covered with plywood.

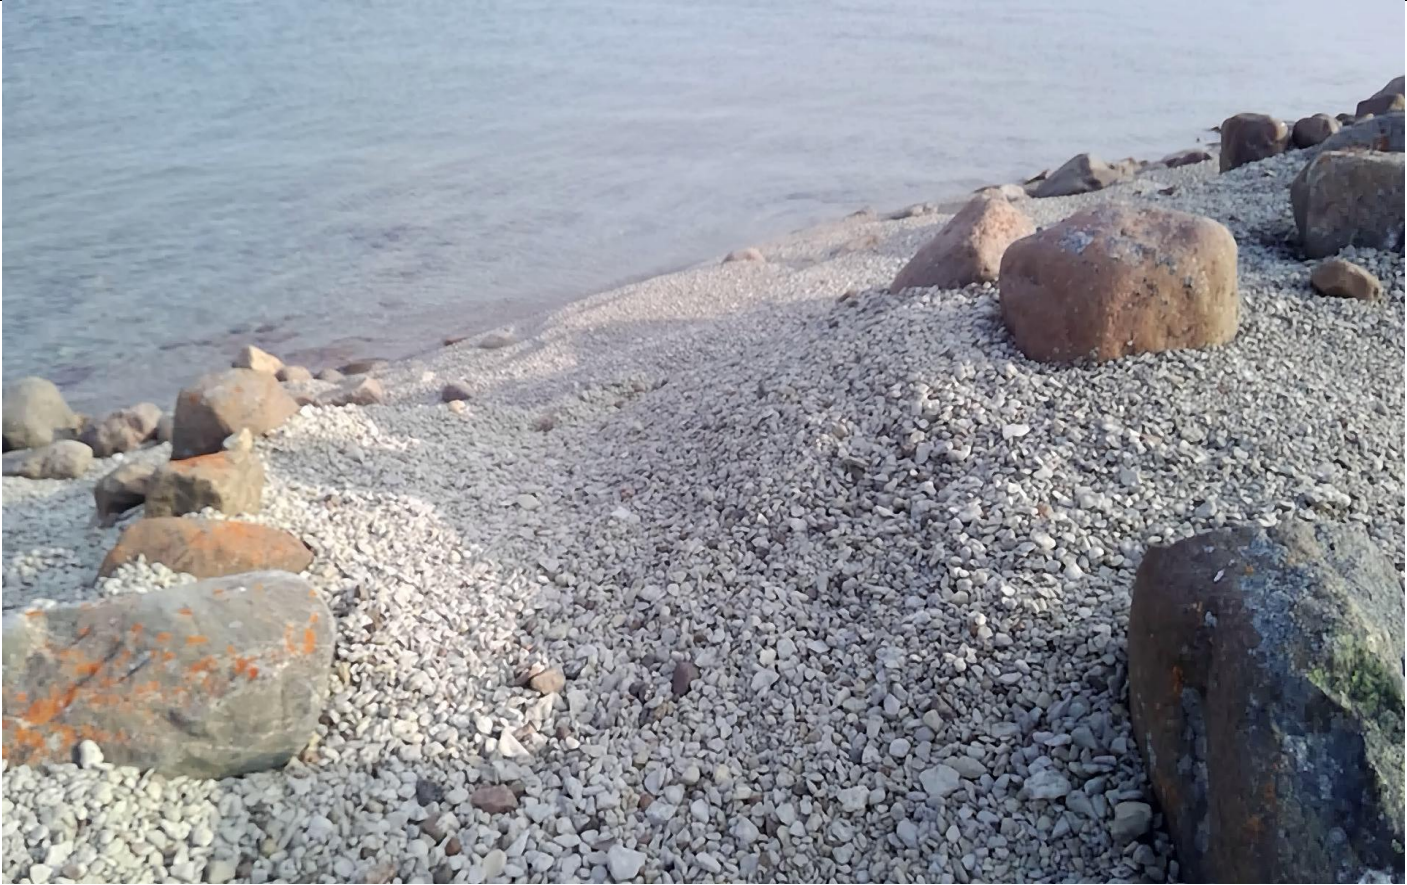
| Photo Log #1 | Location |
|---|---|
| Photo 5 | Nikku Island, Nettling Lake, Qikiqtani Region, NU |

Description: path to Nettling River may be site of water withdrawal. No observations of pumps, hoses for water withdrawal.

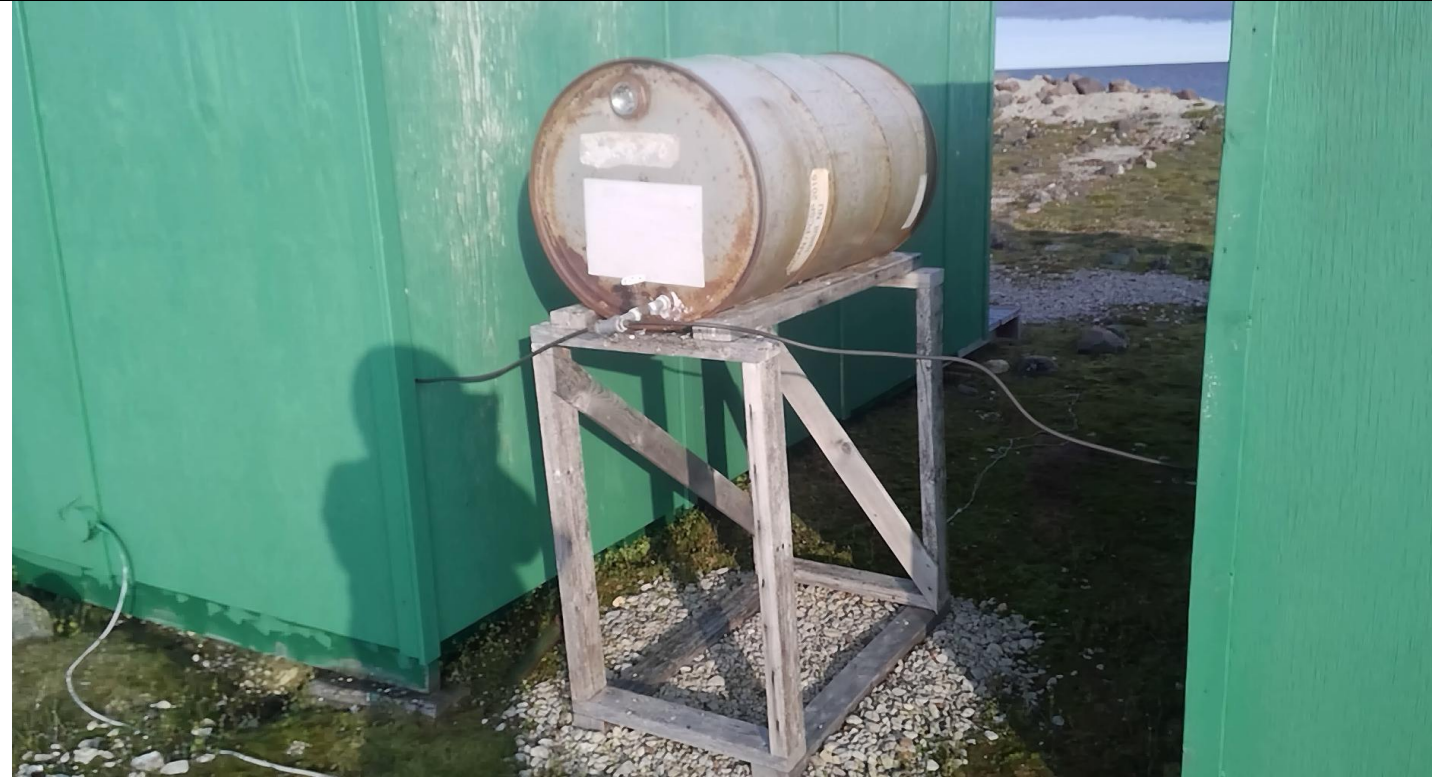
| Photo Log #1 | Location |
|---|---|
| Photo 8 | Nikku Island, Nettling Lake, Qikiqtani Region, NU |

5. Storage tanks for heating. No secondary containment (photo 6,7,8).

| Photo Log #1 | Location |
|---|---|
| Description: No secondary containment under heating storage tank | |

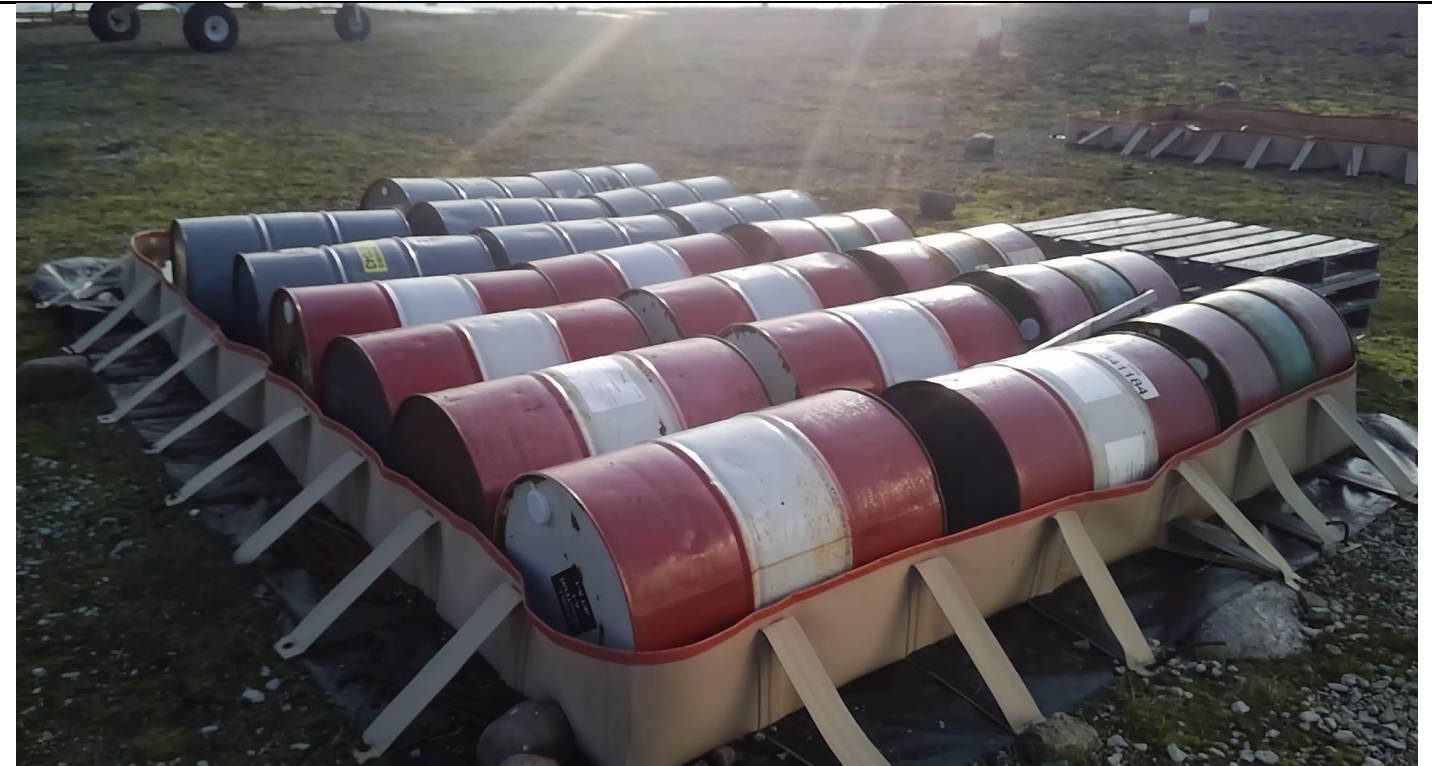
| Photo Log #1 | Location |
|---|---|
| Photo 9 | Nikku Island, Nettling Lake, Qikiqtani Region, NU |

3. Fuel cache 1, holds 20 drums. Water in berms (Photo 9).

| Photo Log #1 | Location |
|---|---|
| Description: 20 drums of fuel in Secondary Containment. Secondary containment full of water. | |

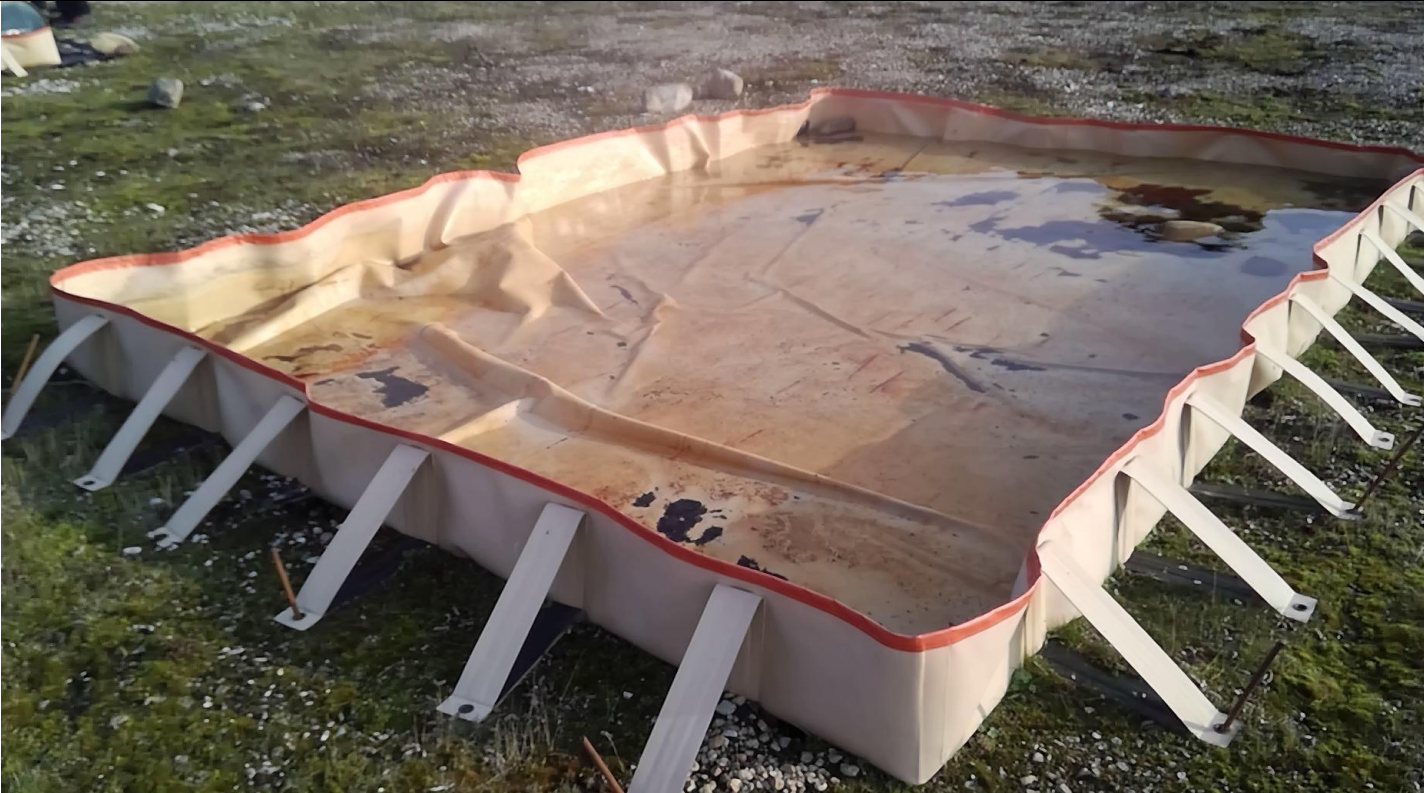
Photo 10

4. Fuel cache 2, hold zero fuel containers. Water in berm (photo 10).

Description: drums left for storage in 2020 in this berm were moved to the other berm. Water in berm.
