WATER LICENCE INSPECTION FORM

| 3BC-NWT1113 Exp. Sept 30, 2013 | | NA | |
| 09/07/2014 | | A.Keim | |

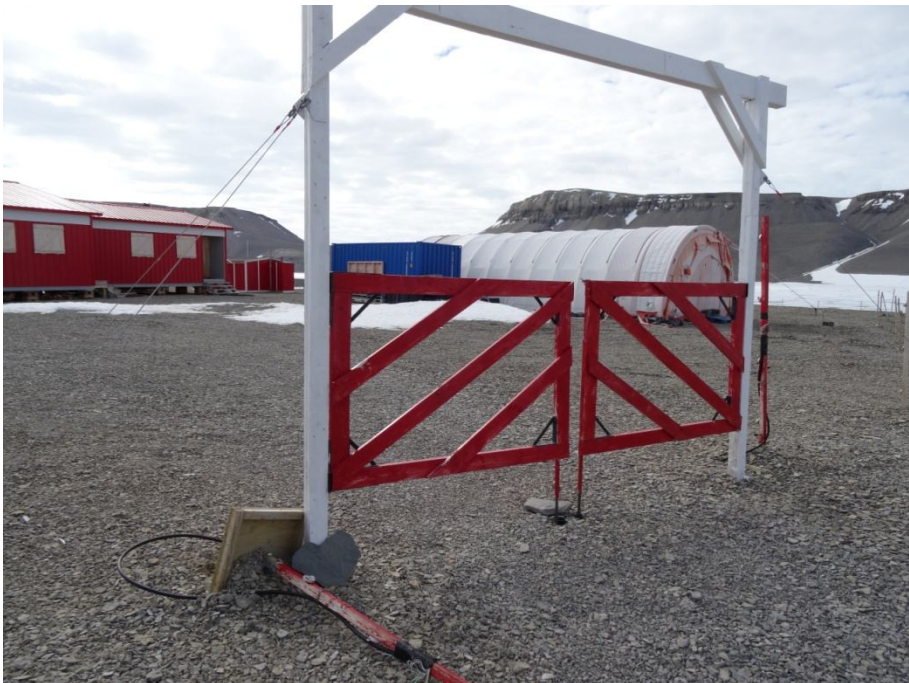
Figure 1Main gate at facility

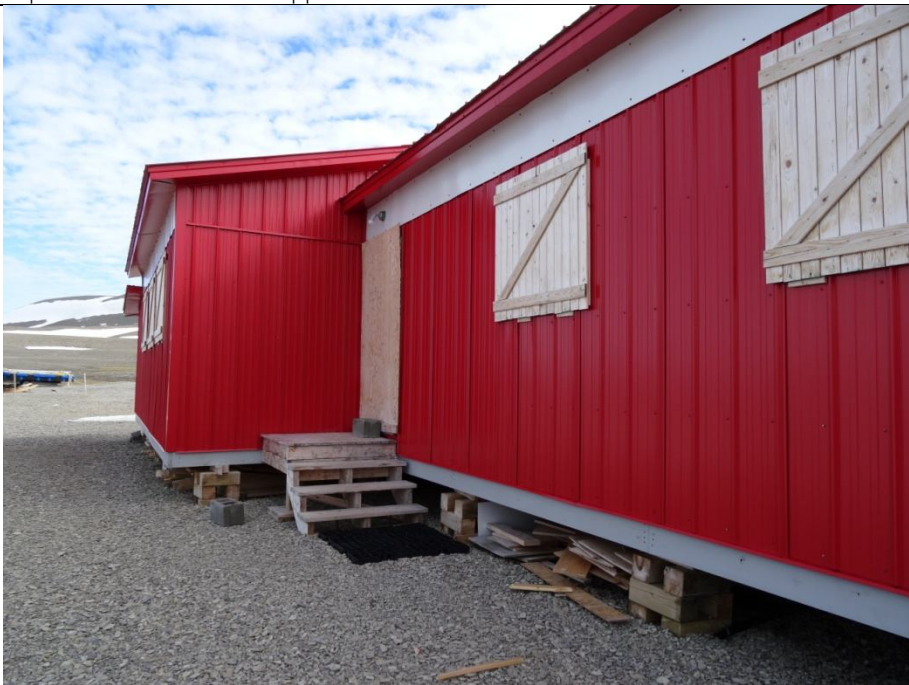
Figure 2 Main hall or mess building

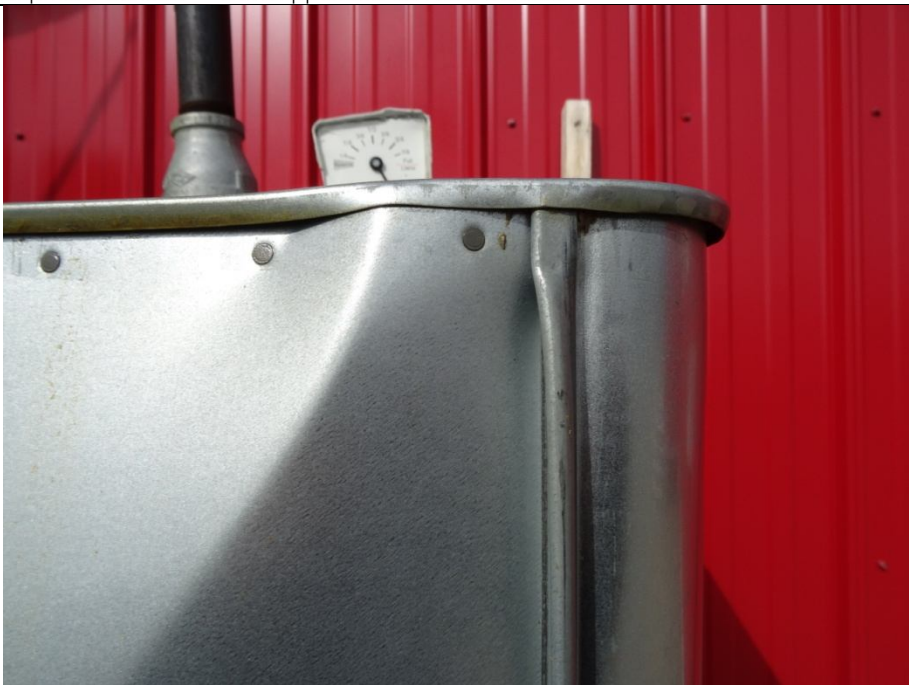
During the period of inspection each of the buildings was checked for security and to determine if any damage or fuel leaks had occurred since the last inspection. Upon going to the North (island Facing) side of the large main building the Inspector found that a large tank containing fuel had (it appears) buckled under the weight of the fuel and had leaked 10-30 l of heating fuel onto the ground below the tank and possibly under the building. This was reported to the contact listed in the annual report on July 17<sup>th</sup>, 2014 at the first opportunity of the Inspector. It is unclear when the last inspection of the site by the operator/owner was. Given that fuel is to be kept on site a system of monitoring of this fuel should be put in place to prevent and detect leaks.

Contrary to Section 12 (1b) of the Nunavut Water and Nunavut Surface Rights Tribunal Act, the Licensee did deposit waste (fuel oil) in any other place in Nunavut under conditions in which the waste, or any other waste that results from the deposit of that waste, may enter waters in Nunavut.

Figure 5 Fuel tank note buckled top Note rivets not welds

The Licensee shall ensure compliance with the issued Water License by employing the conditions set out in Part G Conditions applying to Spill Contingency Planning and implementation of Item 4 of that Part. Specifically;

1. Implement the Spill Contingency Plan, dated March 1<sup>st</sup> , 2011 as per Part G item 2 of the Water License.

2. Report the Spill as detailed in the Plan

3. Within 30 days provide the Inspector;

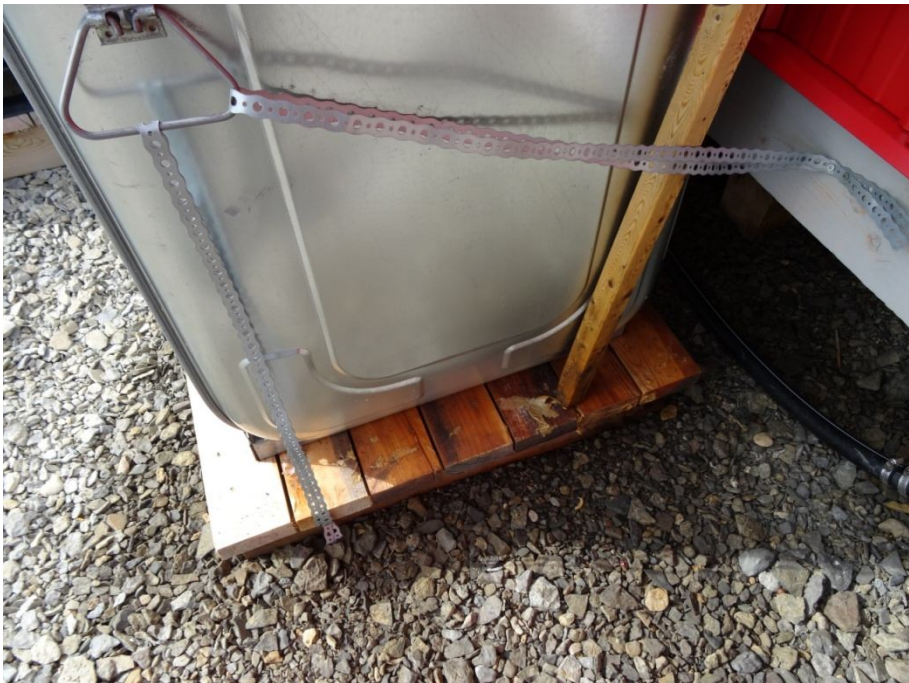
Figure 6 Tank secured to building using metal round ,, note fuel staining

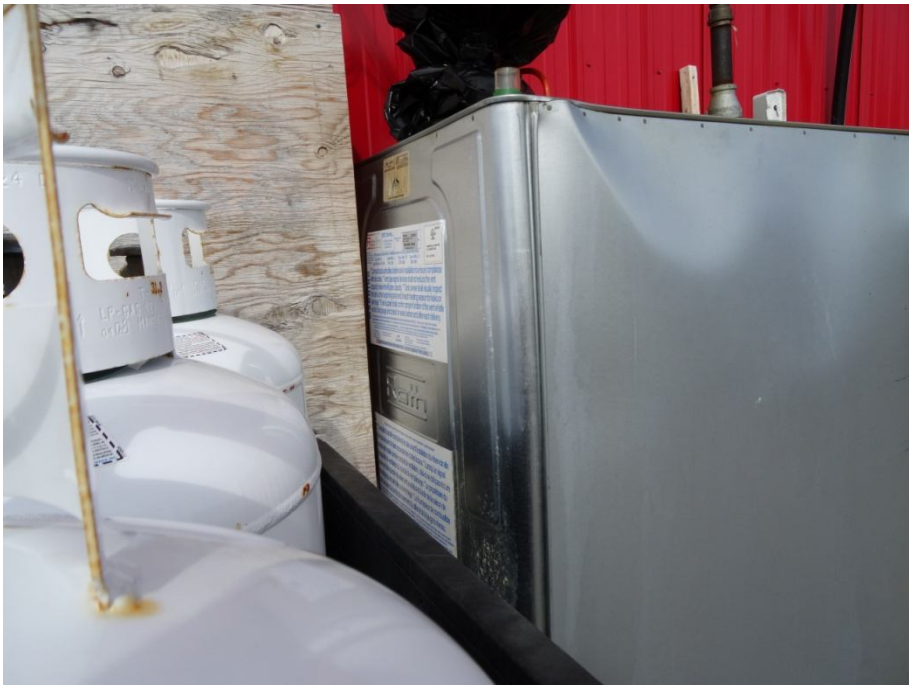
Figure 7 Buckling at opposite end

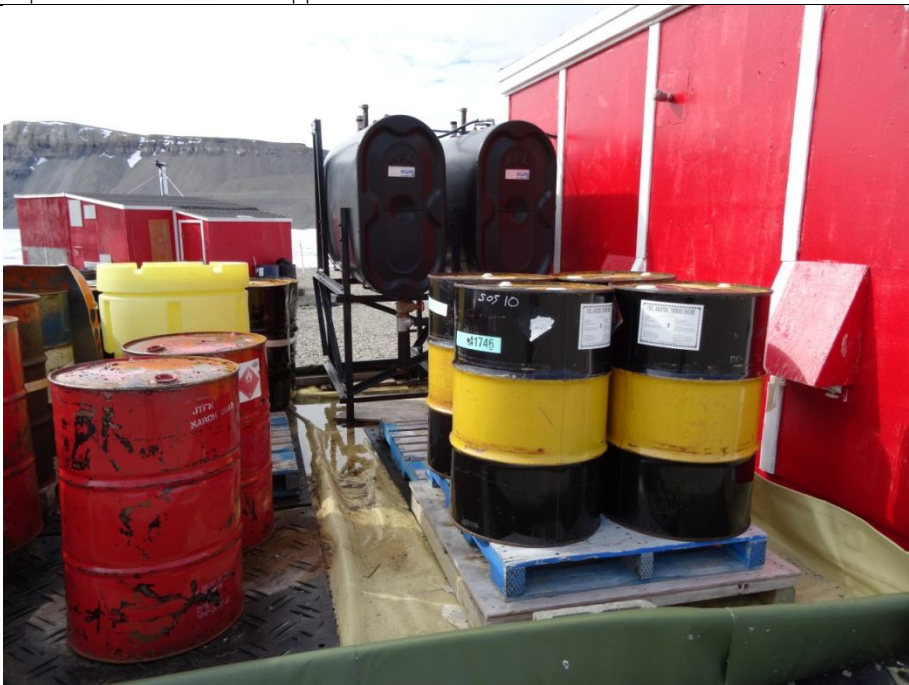
Figure 8 Fuel storage in secondary containment

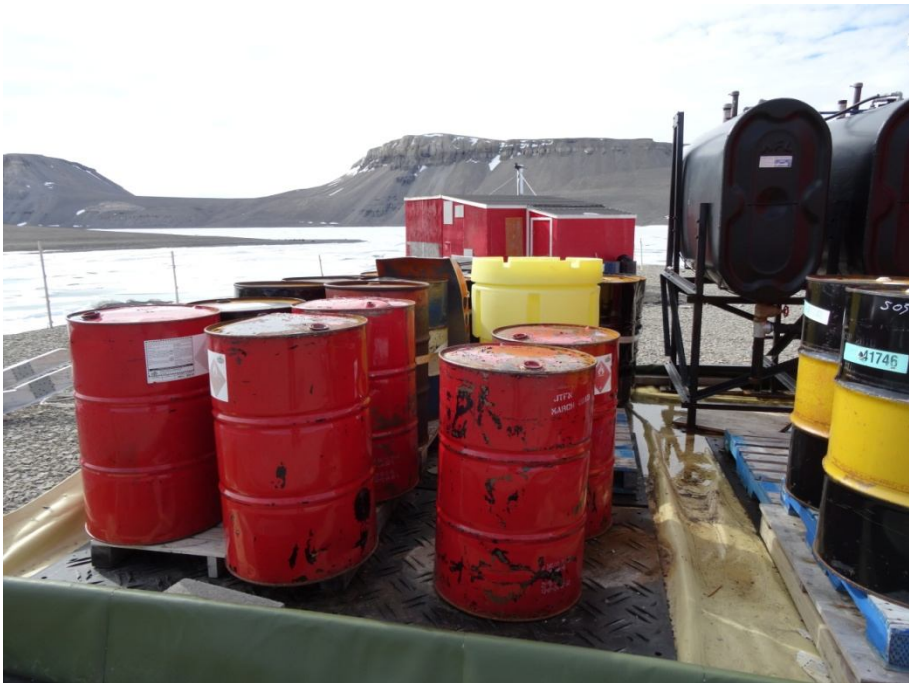
Figure 9 Secondary containment

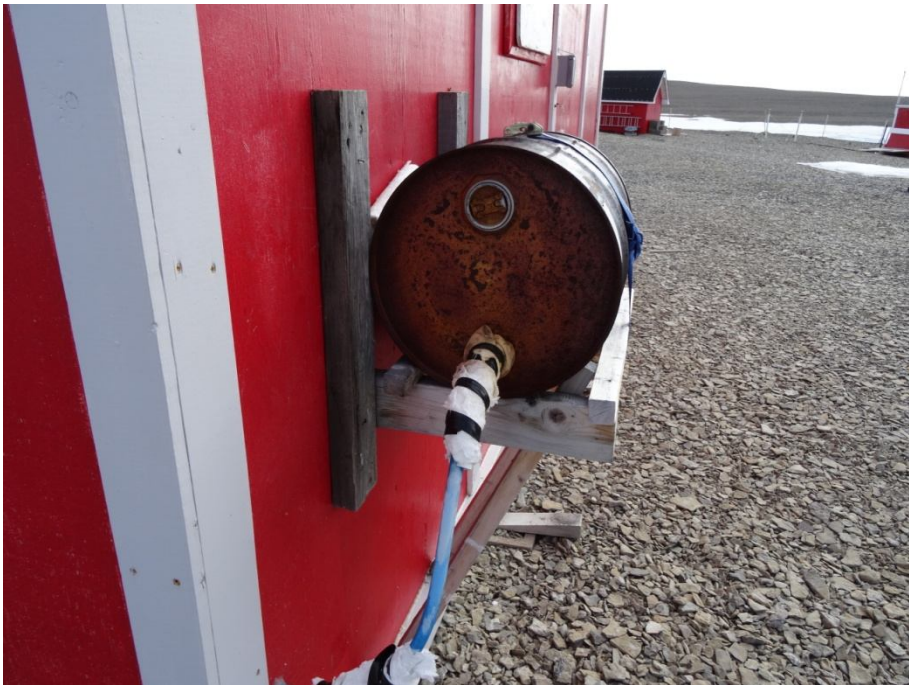
Figure 10 Fuel tank outside one of the buildings. Joints are wrapped
