**11 September 2014**

**Report of Fuel Spill Assessment and Corrective/Remediation Work**

Photographs – DRDC Arctic Deployment to Gascoyne Inlet Camp 2014

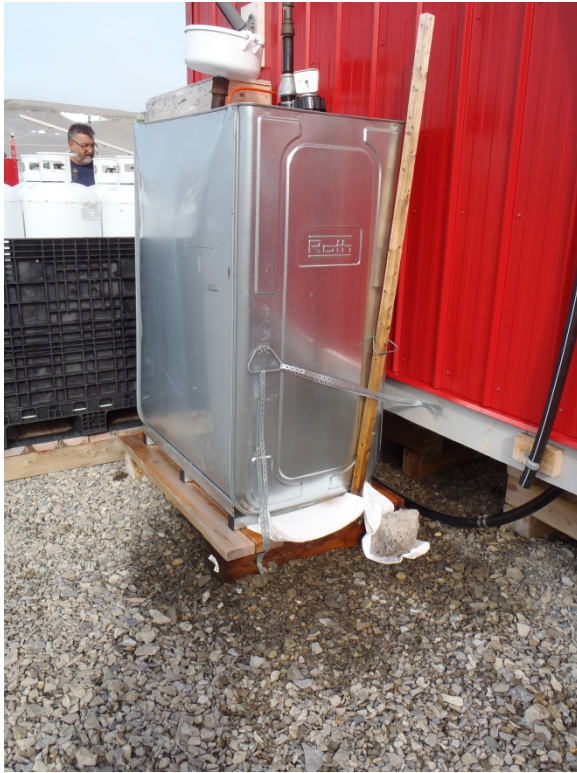
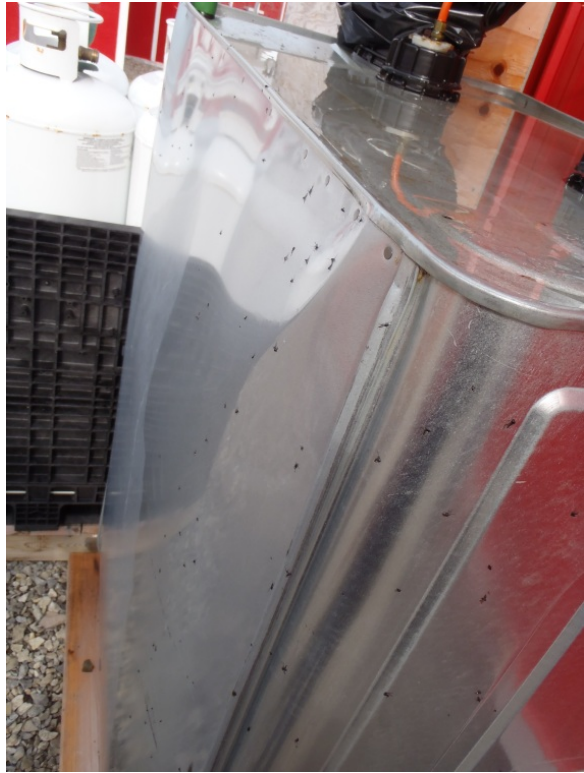
bulged the outer tank skin and compressed the inner tank. The upper seam of the tank had one small rupture, otherwise the inner and outer tanks were intact and without leaks.

Roth tank showing bowing to outer skin

- a) Replace the tank with a standard double steel bottom tank which we use for the main generator(s). Ensure that the tank is placed in a filtered berm. We currently utilize this type of berm in our main camp berm next to the generator building.
