**Deployment of environmental instrumentation in Greiner Lake
watershed, Cambridge Bay, Victoria Island
(NRI Licence #: 04 015 18R-M; NIRB File No: 15YN032)**

Annual Report for 2018

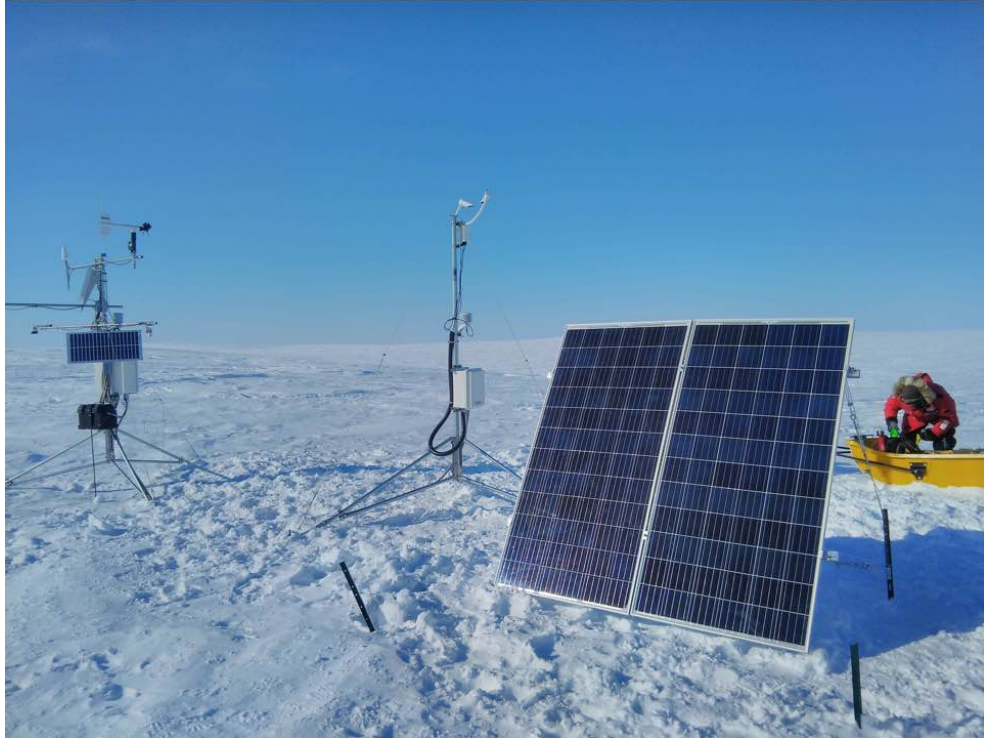
Figure 2. Disdrometer (background centre) and its solar panel array (foreground) installed in April 2018 as part of the Université de Sherbrooke weather station (background left).

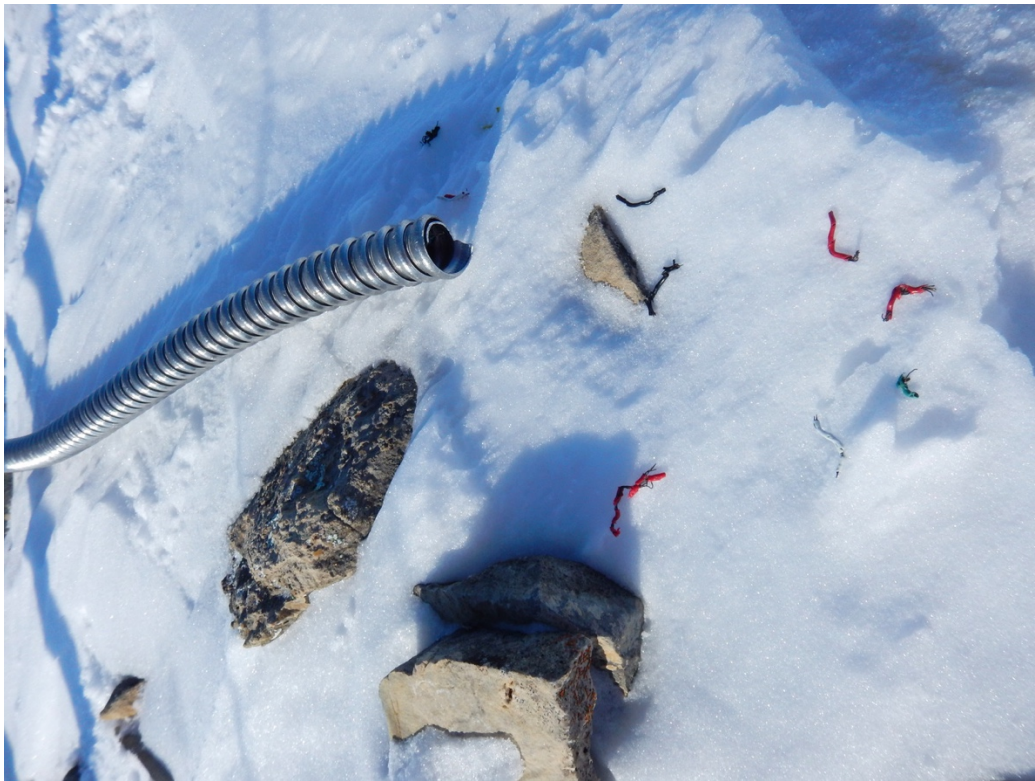
Figure 3. Cable damage caused by arctic foxes on the Université de Sherbrook weather station in April 2018

The Université de Sherbrooke group conducted snow research in the vicinity of the station (licence # 04 010 15R-M) in order to analyze the impact of weather on snow conditions. The work was conducted in April 2018 with the installation of a disdrometer that measures precipitation phase and rate (Figure 2). The data has been linked and archived to our website and available to the public at <https://grimp.ca/>. The data from the station also allowed a good model parameterization for snow simulations that can now account for wind slab formation. At the same time the station was maintained, and minor cable damage due to arctic foxes (Figure 3) was repaired.

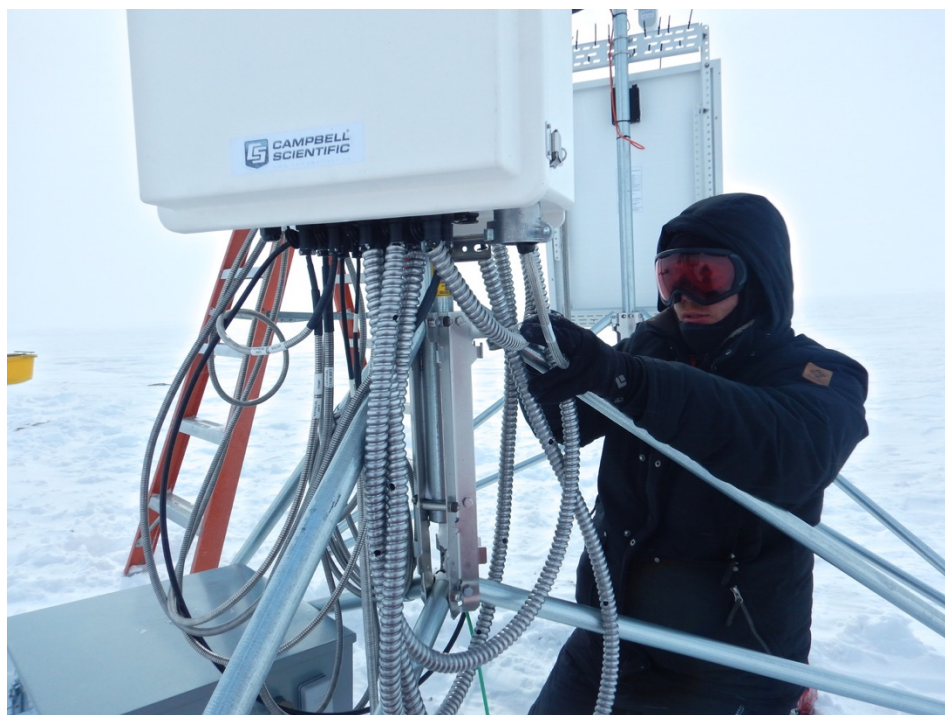
Figure 4. Armoured cables on the POLAR weather station in May 2018

In May 2018, all the cables damaged by arctic foxes in the previous years have been replaced with cables encased in metallic conduits, obtained from Campbell Scientific. The remaining undamaged cables were placed in metallic armour that has been sealed at both ends with duct seal, with additional drainage holes drilled in the metallic conduit (Figure 4). Most of the sensors have been reinstalled on the station, and the station has been started up (Figure 5). The snow depth sensor was not installed, one of the temperature sensors proved to be faulty, and the two digital cameras installed on the station are not transmitting images. The rest of the sensors of the station are operating normally, and Campbell Scientific is able to access remotely the station every day for data download and maintenance.

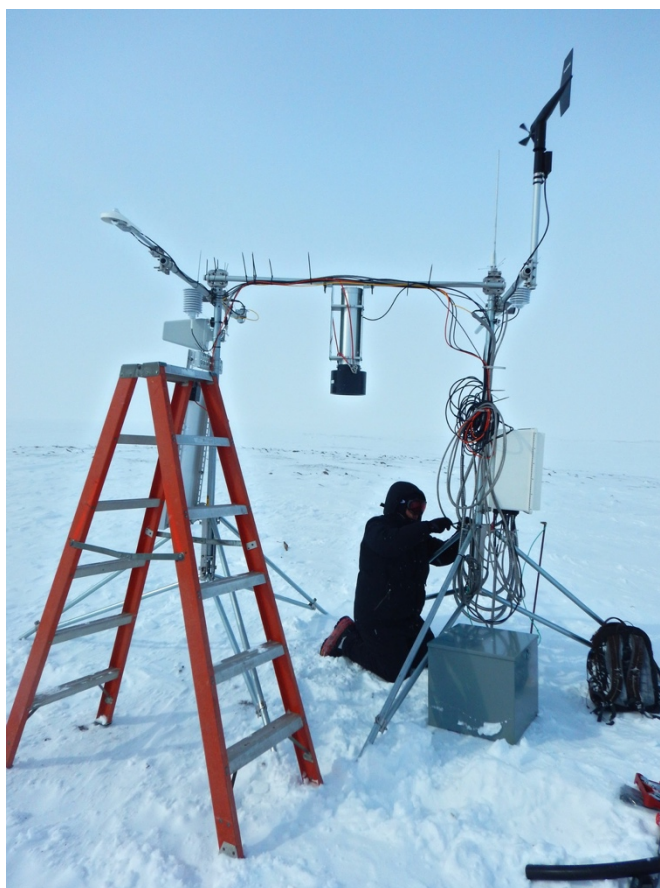
Figure 5. The POLAR weather station in May 2018
