## **City of Iqaluit Sewage Lagoon Iqaluit, Nunavut Dam Safety Inspection**

*October 29, 2009*

*REPORT*

**Concentric Project Reference Number:**  
09-2930

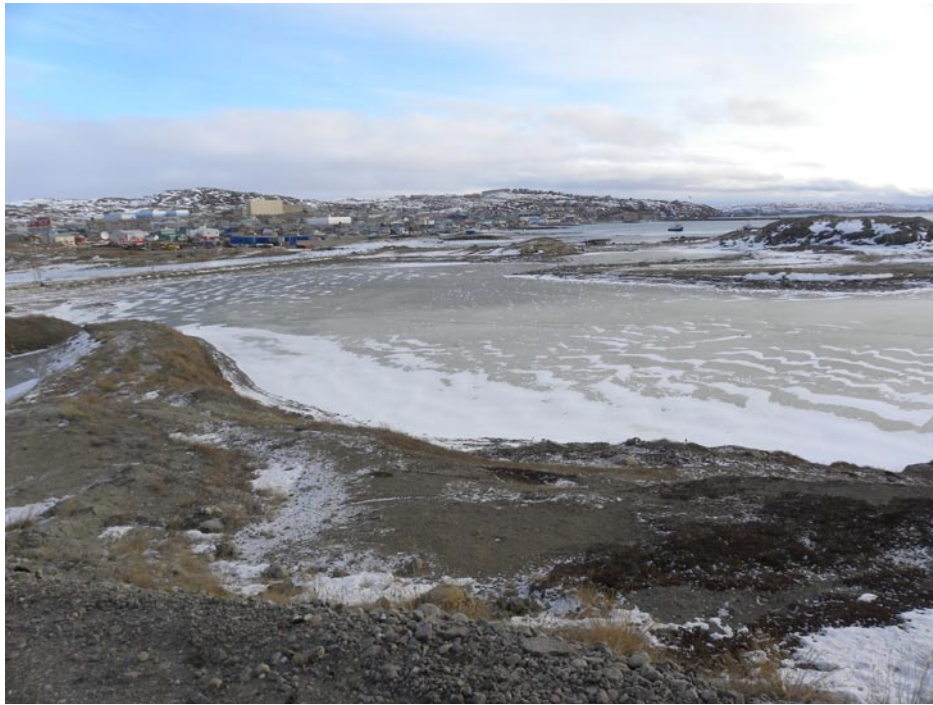
Photograph 1  
Overview looking East.

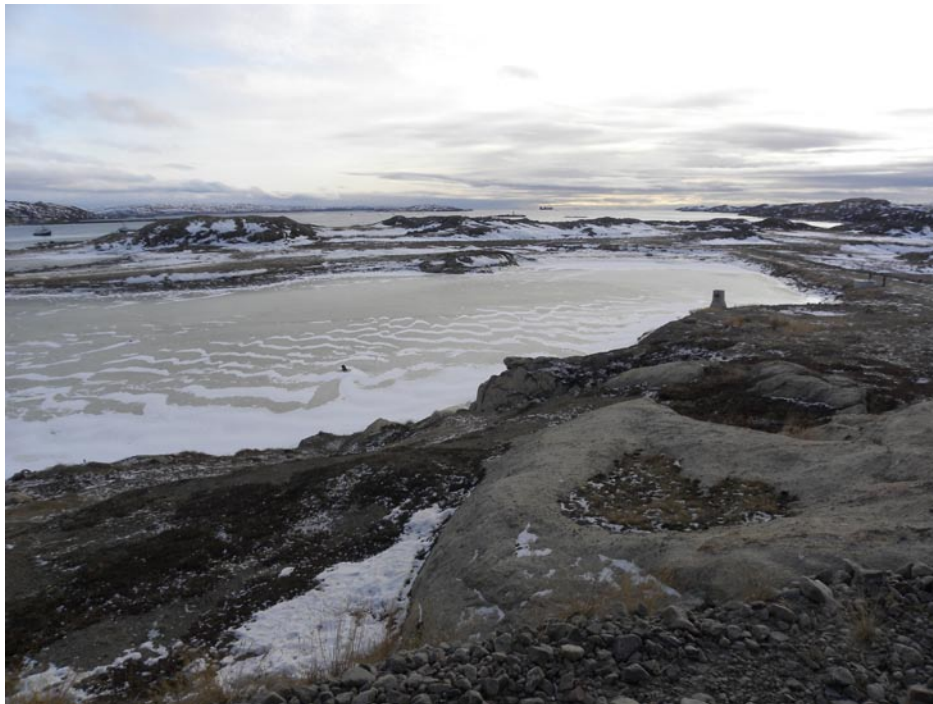
Photograph 2  
Overview looking West
