City of Iqaluit Sewage Lagoon Iqaluit, Nunavut Dam Safety Inspection

September 21, 2011

REPORT

Concentric Project Reference Number:
11-3999

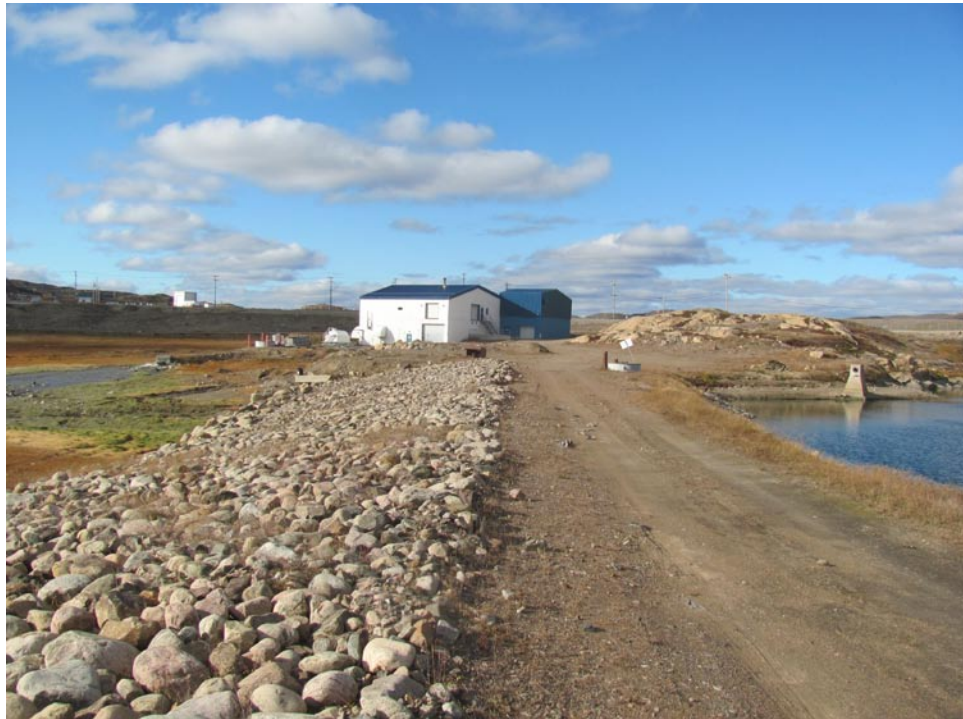
Photograph 1
Overview of West berm.

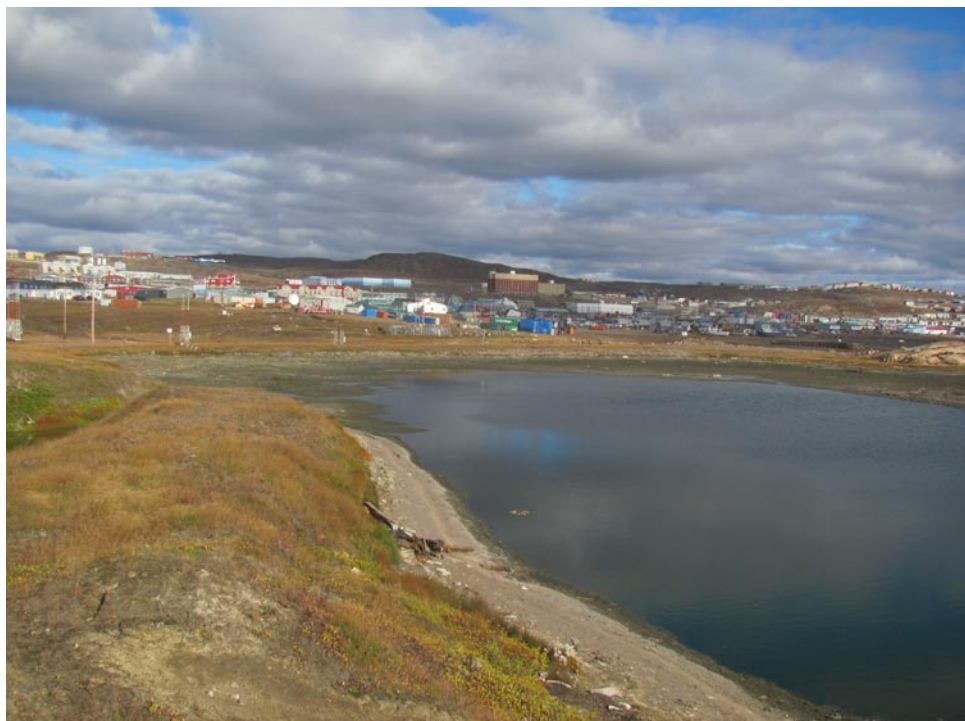
Photograph 2
Overview looking East; note lagoon level and sludge accumulation.

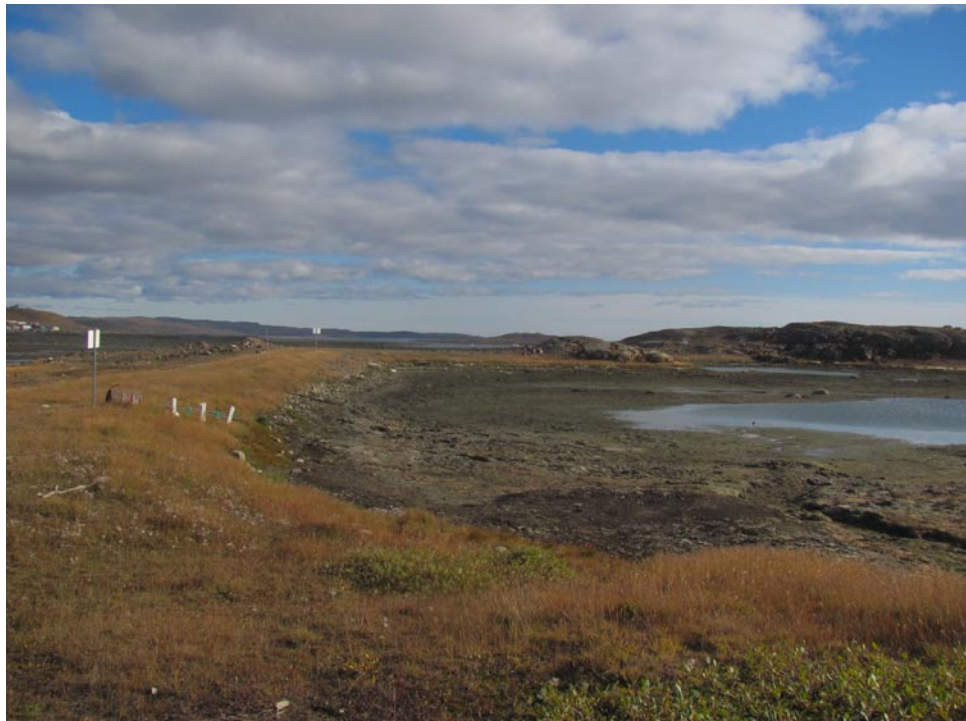
Photograph 3
Overview, Northeast berm.

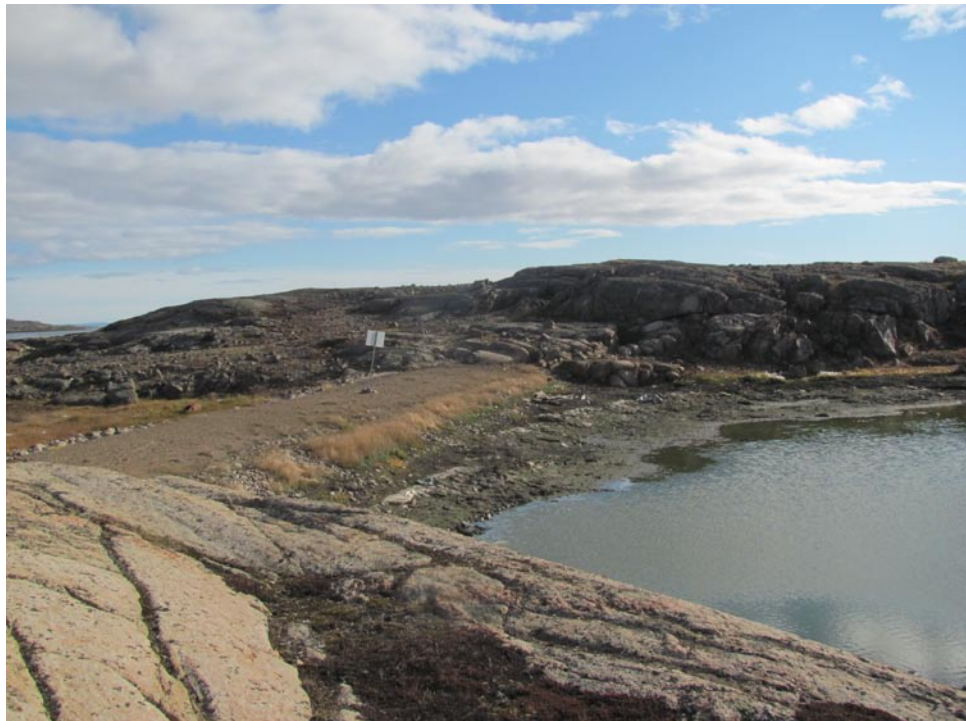
Photograph 4
Overview, Southeast berm.
