SUBMITTED FOR THE CONFIDENTIAL INFORMATION OF OUR CLIENT FOR A SPECIFIC PROJECT AND					SCALE: N/A DATE: February, 2002		III BOO ENGINE		Preliminary Spillway Design			
					DRAWN:	GKC	BGC	AN APPLIED EARTH SO Calgary, AB	NEERING INC. RTH SCIENCES COMPANY Phone (403) 250-5185	Selected Photos of Ground Conditions		
					DESIGNED:	GKC		Calgary, Ab				
					CHECKED:	JWC	CLIENT:	Nanisivik Mine		PROJECT No.	FIGURE. No.	REV.
RE	/. DATE	REVISION	DRAWN CHECKED	APPROVED	APPROVED:	JWC				0255-004-01	Figure 6	0.

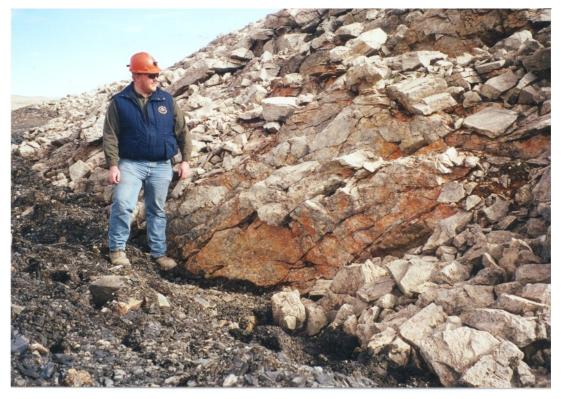
Photo #6
View of dolostone bedrock outcrop at south abutment.
Note the high degree of fracturing.

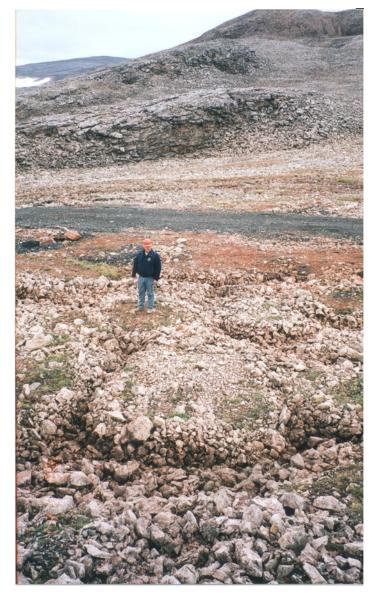
Photo #7
View of ground conditions in proposed spillway alignment.
Note the raised polygrounds indicative of permafrost conditions.
