Appendix **B**

Design Quantities

APPENDIX D: PHOTOGRAPHS			
Client Name: Public Services and Procurement Canada		Site Location: PIN-C Bernard Harbour	Project Number: 60688145
Photo No. 1	Date: 07/30/2022

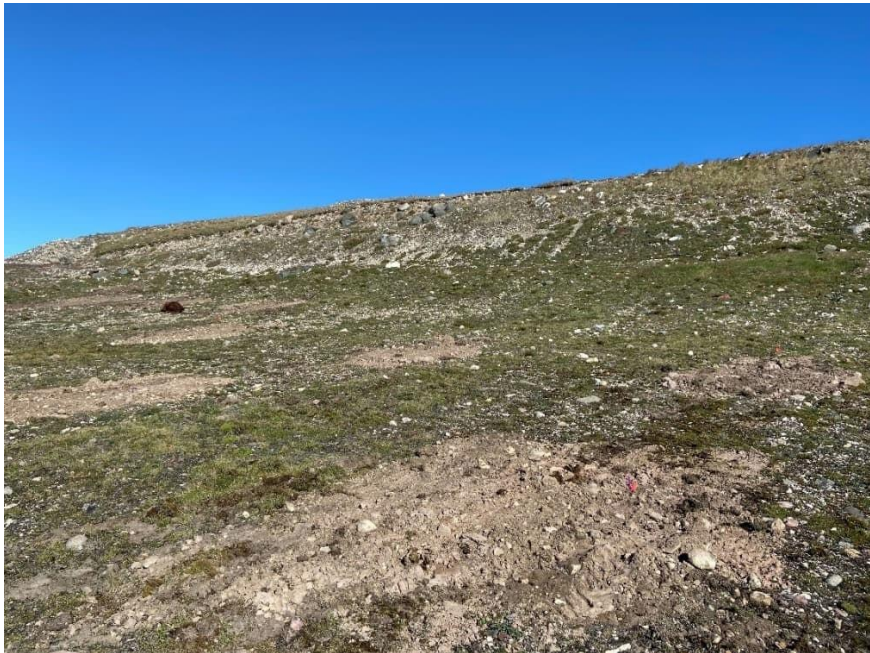
Direction Photo Taken: Northwest			
Description: BDA-1.			
Photo No. 2	Date: 07/30/2022

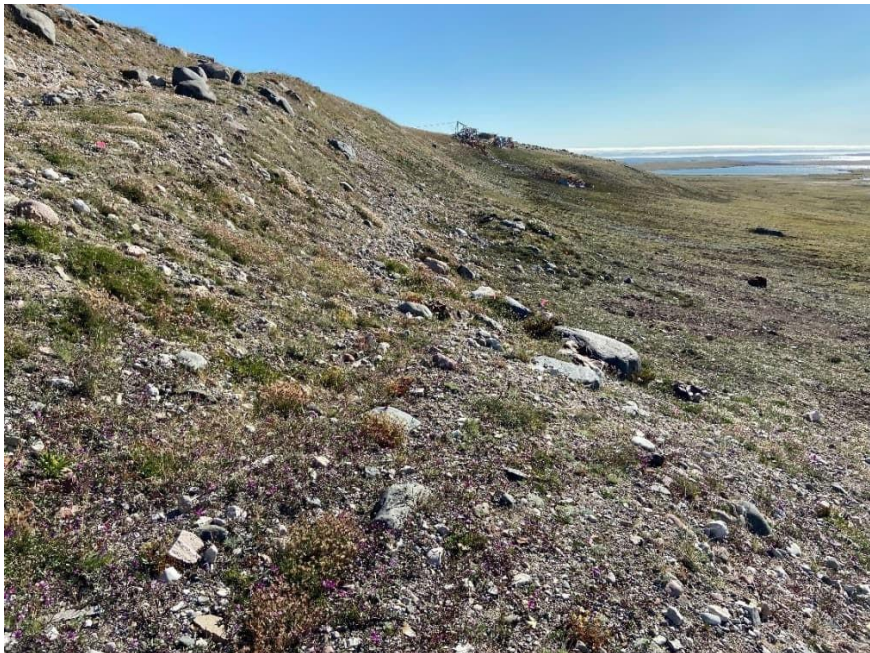
Direction Photo Taken: Southeast			
Description: BDA-1d and BDA-1e. At the toe of the slope.
