Appendix E – Photographs

Remediation of the Old Town Site, Clyde River, Nunavut
Environmental Screening
Final
Appendix E – Photographs

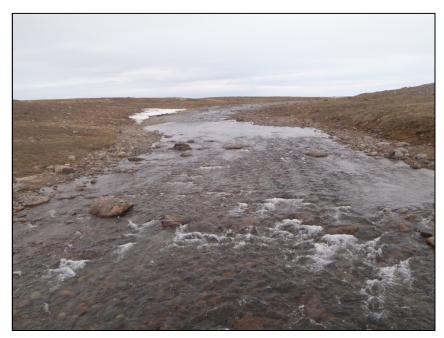
Photo 1: Clyde River from the bridge in July 2011; east aspect

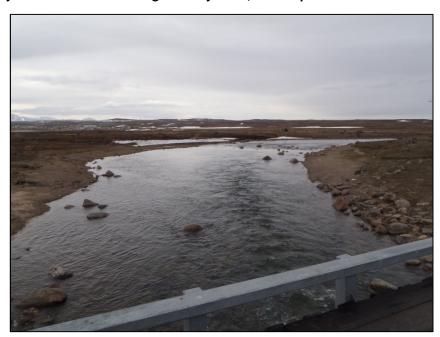
Photo 2: Clyde River from the bridge in July 2011; west aspect.

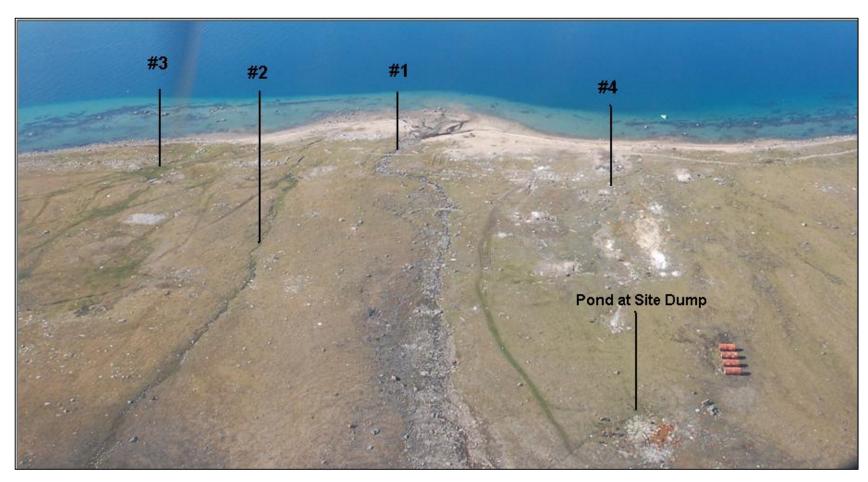
Photo 3: Aerial photograph depicting locations of the four drainage channels and pond located at the Old Town Site in August 2010; west aspect.

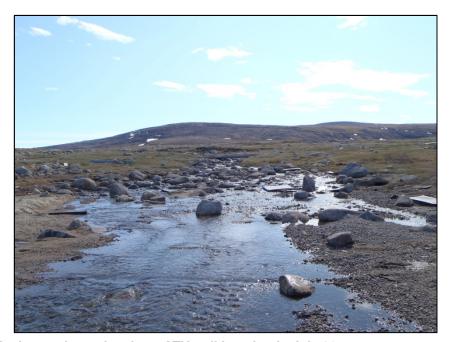
Photo 4: Drainage channel #1 from ATV trail location in July 2011; east aspect.

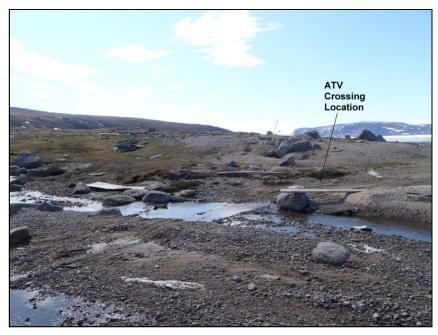
Photo 5: ATV crossing location at drainage channel #1 in July 2011; south aspect.

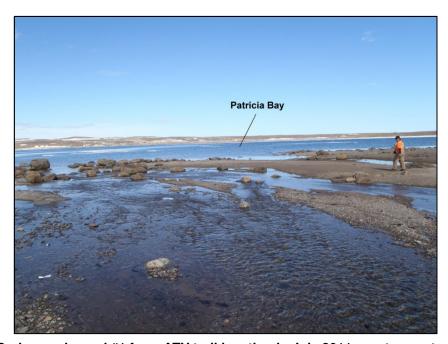
Photo 6: Drainage channel #1 from ATV trail location in July 2011; west aspect.

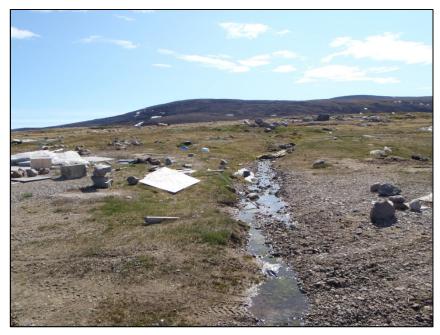
Photo 7: Drainage channel #2 from ATV trail location in July 2011; east aspect.

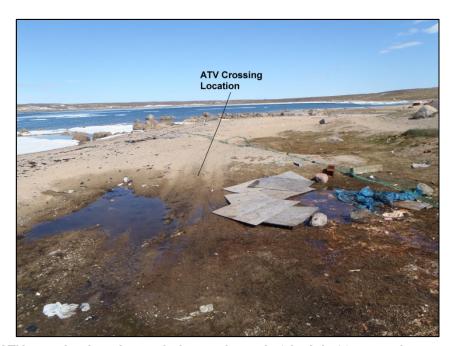
Photo 8: ATV crossing location at drainage channel #2 in July 2011; north aspect.

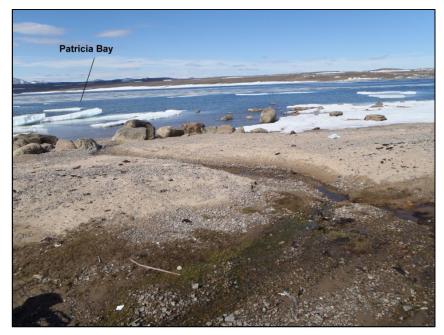
Photo 9: Drainage channel #2 from ATV trail location in July 2011; west aspect.

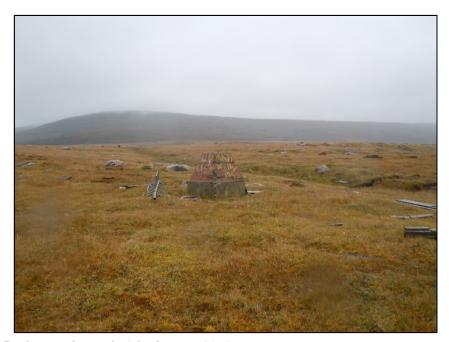
Photo 10: Drainage channel #3 in August 2010; east aspect.

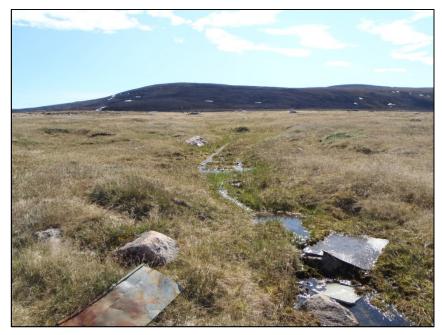
Photo 11: Drainage channel #3 from ATV trail location in July 2011; east aspect.

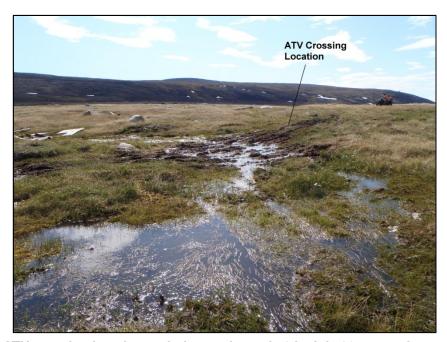
Photo 12: ATV crossing location at drainage channel #2 in July 2011; southeast aspect.

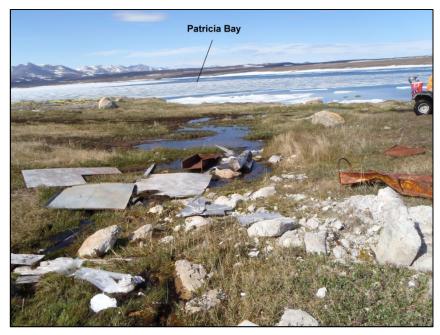
Photo 13: Drainage channel #3 in July 2011; west aspect.

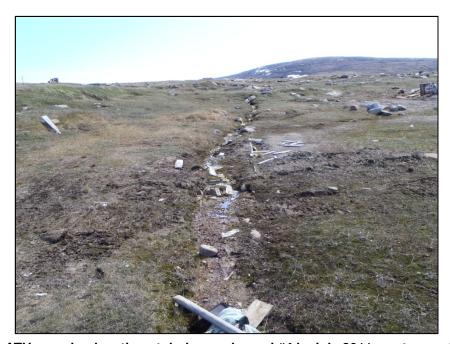
Photo 14: ATV crossing location at drainage channel #4 in July 2011; east aspect.

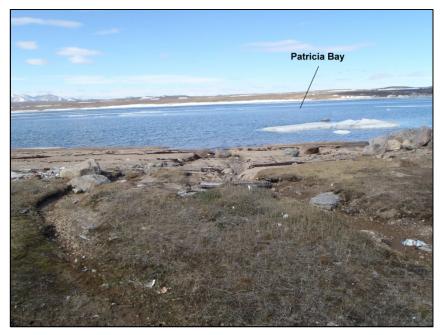
Photo 15: Drainage channel #4 from ATV trail location in July 2011; west aspect.

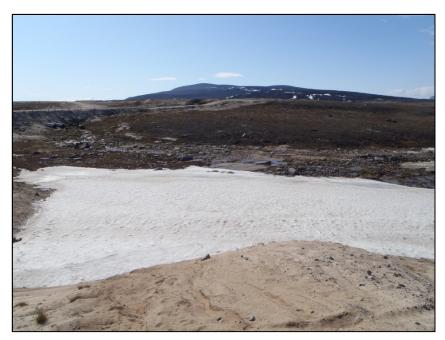
Photo 16: Watercourse adjacent to potential borrow sources deposits 1, 2 and 3 in July 2011; east aspect.

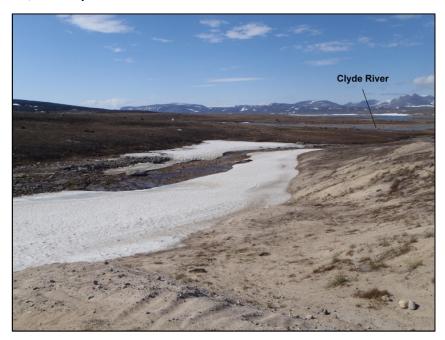
Photo 17: Watercourse adjacent to potential borrow sources deposits 1, 2 and 3 in July 2011; southwest aspect with Clyde River in the background.

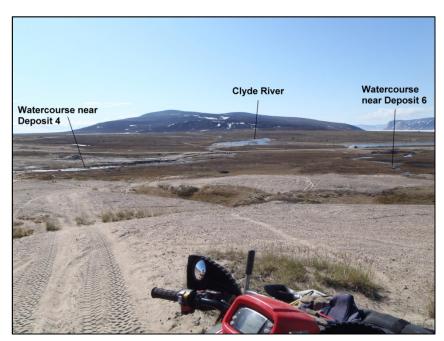
Photo 18: Watercourses near borrow source deposits 4 and 6 in July 2011; southeast aspect.

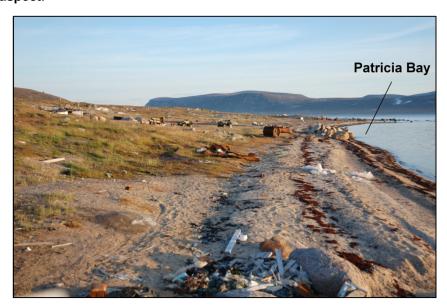
Photo 19: Nearshore area at the Old Town Site in August 2010; south aspect.

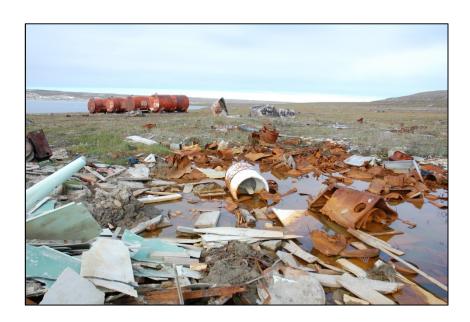
Photo 20: Ponded surface water at the Site Dump located at the Old Town Site; north aspect.
