Cullaton Lake Mine

Closure and Reclamation Plan

PECG Project #
14054

August 10, 2018

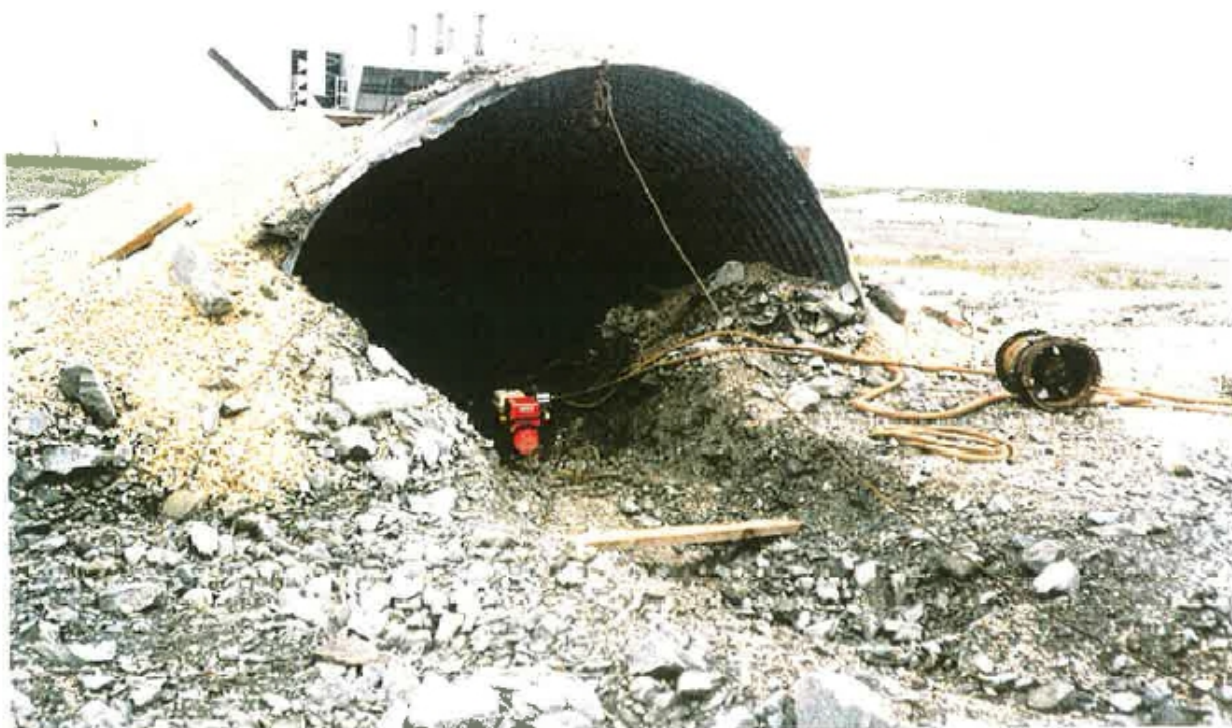
Photograph 5-1 shows the B-Zone mine portal and is believed to be representative of the portal conditions at the time of closure. Although no information is available to determine whether the stopes were backfilled during mining, the mine drawings show that the stopes were all at depth and that their extent was rather limited.

Photograph 5-1. B-Zone mine portal at the time of closure.

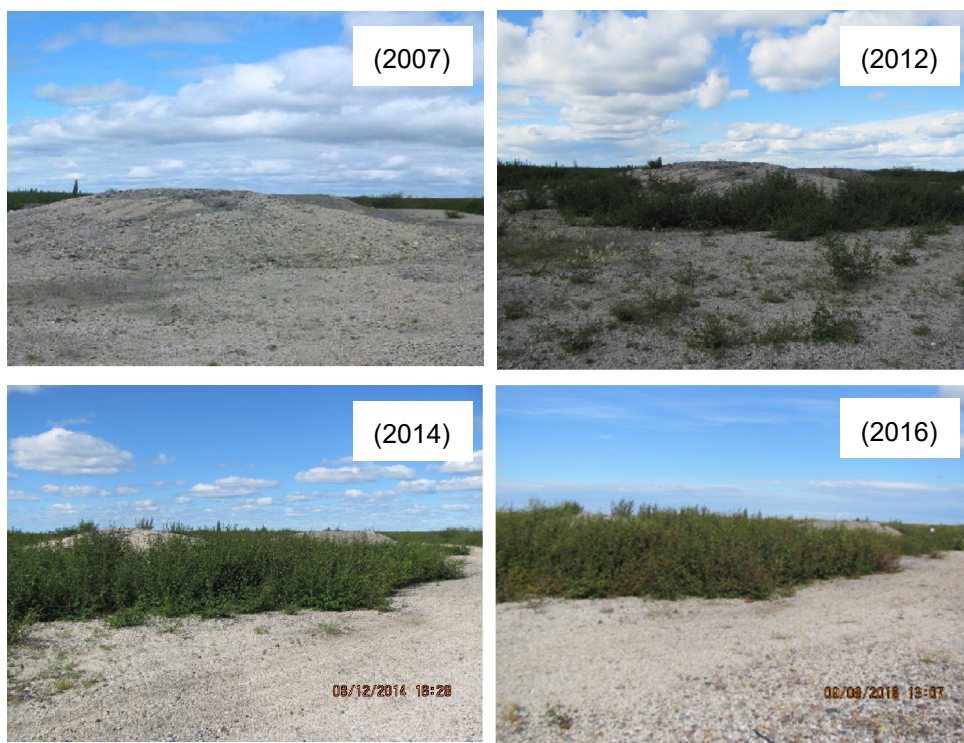
The photos of the B-Zone mine portal and ventilation raise taken during the annual inspections after the 2001 reclamation works show that the area reclaimed around the portal and ventilation raise has gradually become covered in shrubs (Photograph 5-2).

Photograph 5-2. Former B-Zone portal and ventilation raise in post-reclamation conditions

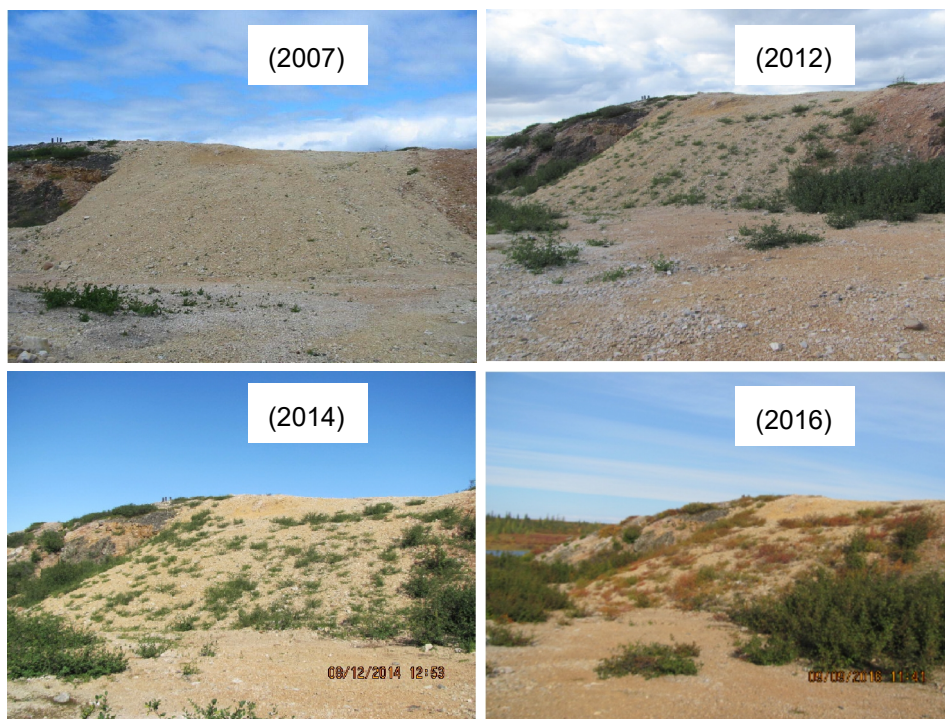
With regard to the integrity of the backfill at the mine portals, settlement of the fill occurred in the Shear Lake portal, as observed during the DIAND site inspection in August 2006. Minor subsidence was observed in the 2009 annual inspection and was refilled in August 2009 (Brugger, 2010). No further settlement has been noted in subsequent annual inspections (Brugger, 2011; 2012; 2013; 2014; 2015; 2016; 2017; 2018).

Photograph 5-3. Former Shear Lake Zone portal in post-reclamation conditions

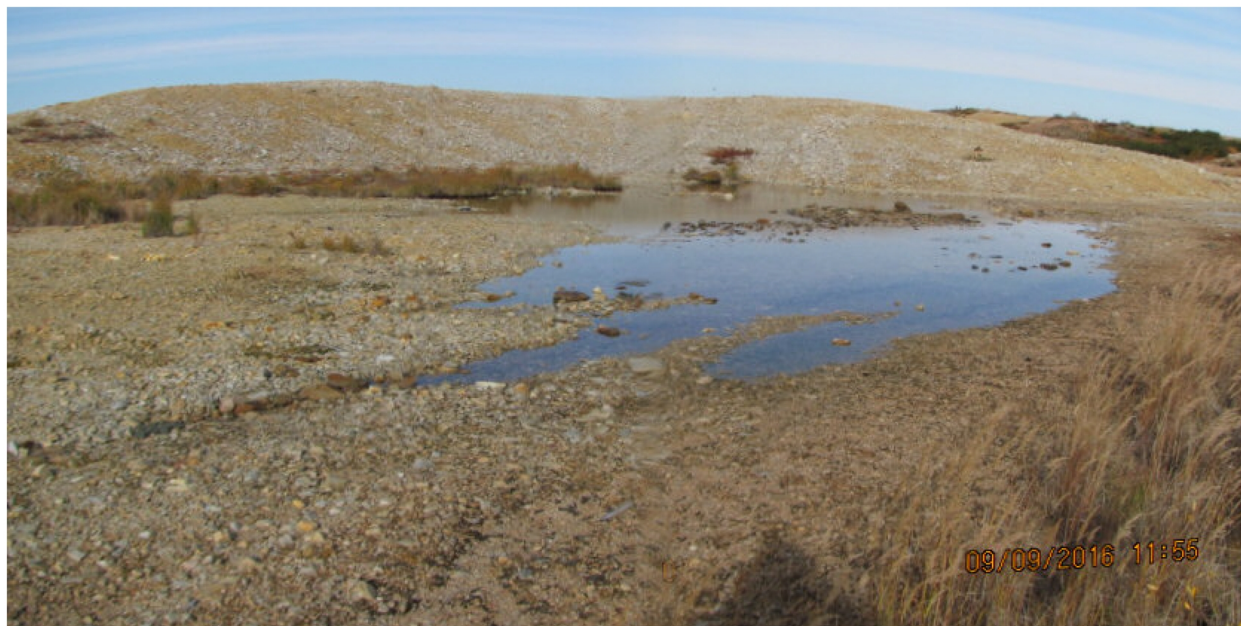
Photograph 5-5. Shear Lake Low pH Pool Area (SW6 sample location)

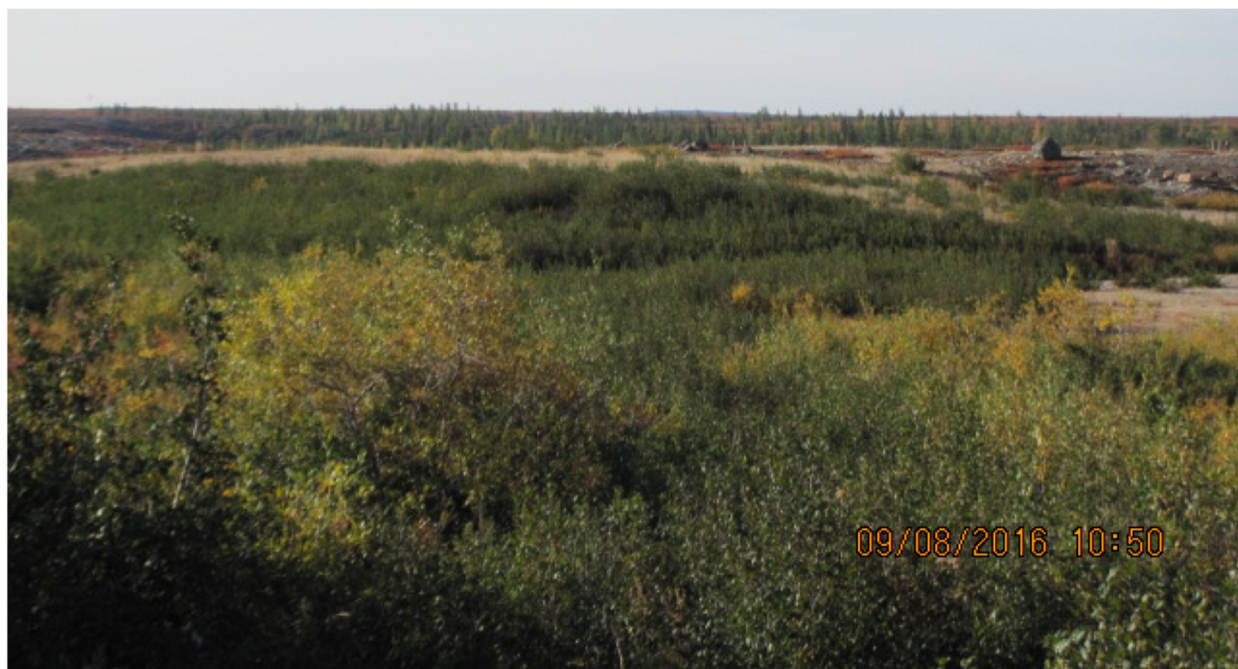
In 2005, Barrick personnel oversaw the re-seeding of the EWR cap (with grasses) to promote some vegetation growth and reduce the erosion of the cover due to runoff, particularly along the side slopes. While some sparse areas remain (particularly on the top), the vegetation is helping to reduce erosion, in that a few small erosion gulleys / channels (20 to 30 cm deep/wide) (exp. 2014) were observed on the side slopes. These generally were short and did not extend the full length of the slope. It is expected that it will take several more years for the vegetation to establish itself fully (Brugger, 2017). Photograph 5-6 shows a region of established vegetation on the waste rock cap.

Photograph 5-6. Encapsulated waste rock at Shear Lake 11 years after the application of additional seed and fertilizer

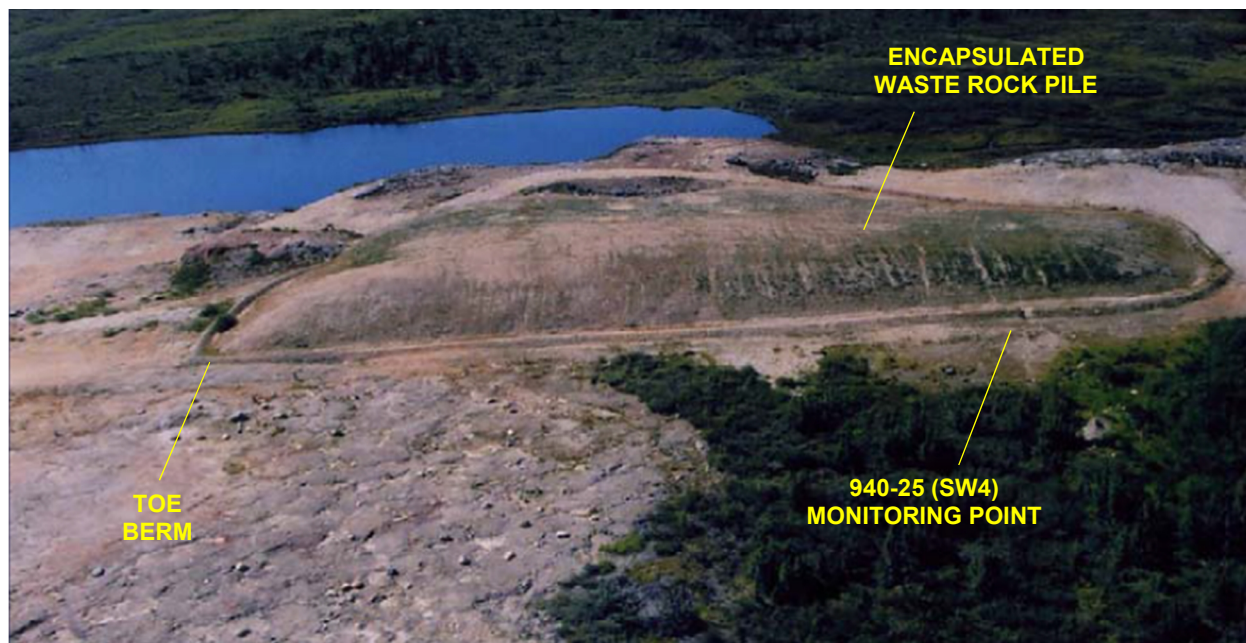
Photograph 5-7. Encapsulated Waste Rock Prior to Establishment of Vegetation

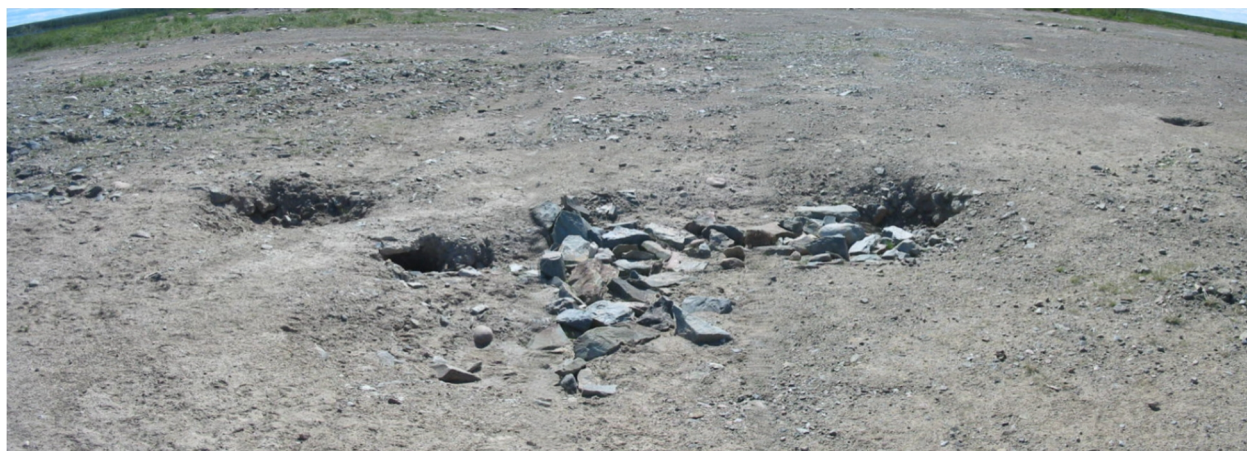
Minor settlement in the southeast corner of the quarry pit cover was observed during the annual inspection of 2007 (Photograph 5-12). The settlement areas remained largely unchanged and became populated by arctic ground squirrels until 2016, when two additional sinkholes were identified during the annual inspection (Photograph 5-13).

Photograph 5-12. Settlement areas in southeast corner of quarry pit cover (July 2007)

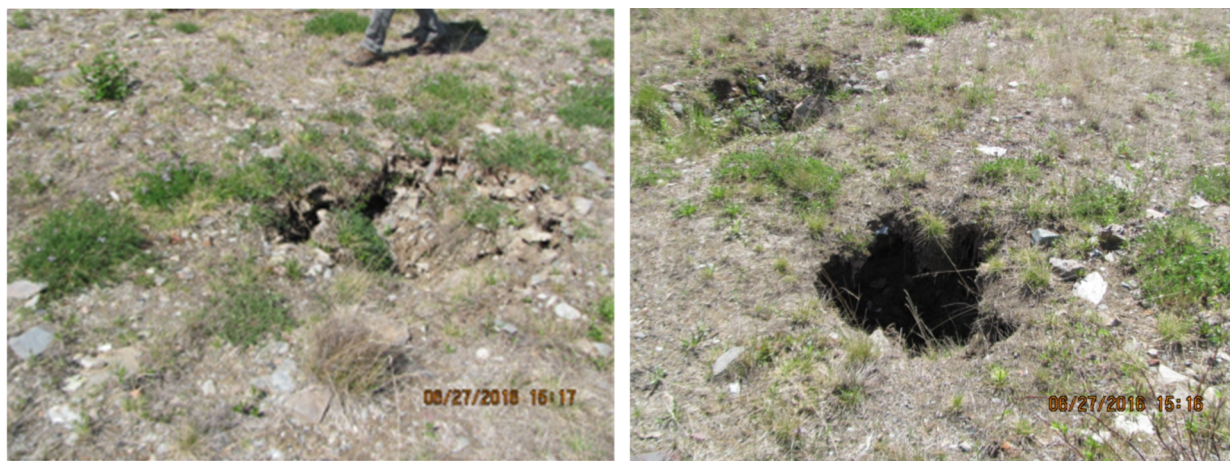
Photograph 5-13. Settlement areas in southeast corner of quarry pit cover (left) and new sinkholes identified in 2016 (right).

The 2016 inspection conducted in relation to the current water license identified that some of the sinkholes in the quarry pit cover expose metal waste.

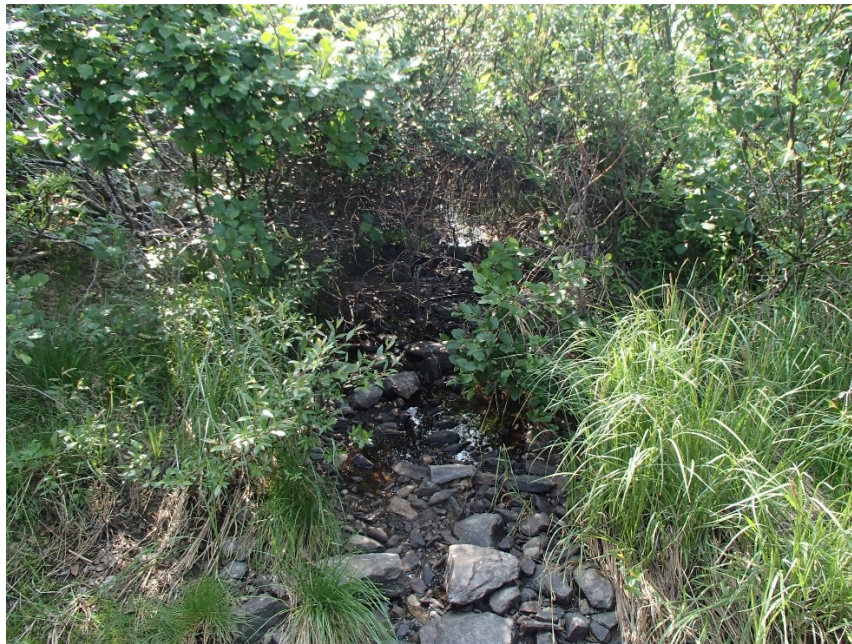
Figure 1. Tailings Pond #2 outflow creek looking upstream. No visible flow present. Photo taken on July 10th, 2018.

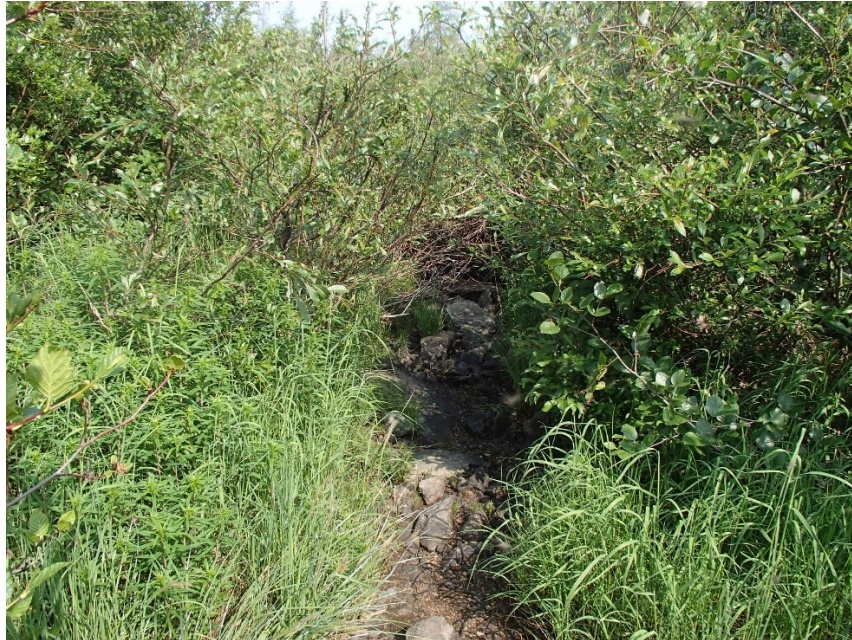
Figure 2. Tailings Pond #2 outflow creek looking downstream. No visible flow present. Photo taken on July 10th, 2018.
