Main Landfill

# Thermal Monitoring Ground Temperature Annual Maintenance Report

## Main landfill - Photo Record

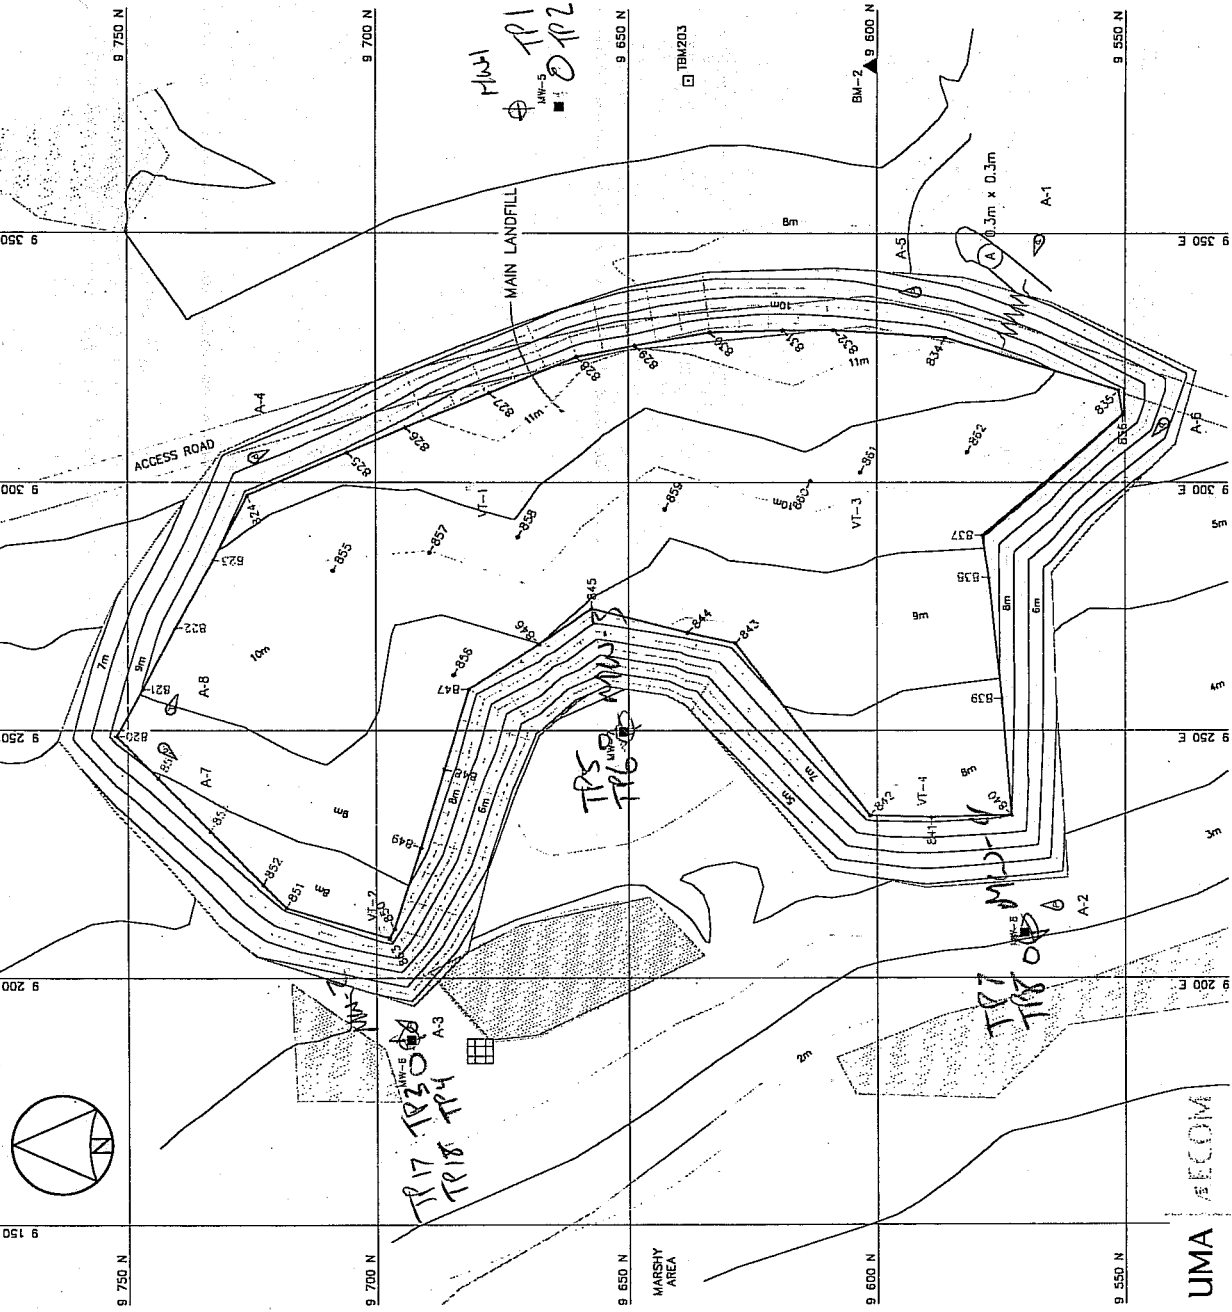
- LEGEND:
- TEMPORARY BENCHMARK
  - PERMANENT BENCHMARK
  - MONITORING WELL LOCATION
  - VERTICAL THERMISTOR
  - COORDINATE POINT
  - MONITORING SOIL SAMPLE LOCATION
  - PHOTOGRAPH REFERENCE
  - SETTLEMENT (NTS)
  - EROSION (NTS)
  - SPONDING
  - OBSERVATION OF CHECKLIST ITEM
