## HOPE LAKE REMEDIATION PROJECT

## ARCHAEOLOGICAL IMPACT ASSESSMENT

#### FINAL REPORT

# ARCHAEOLOGICAL IMPACT ASSESSMENT (AIA) OF THE HOPE LAKE MINING EXPLORATION CAMPS, DISMAL LAKES, NUNAVUT

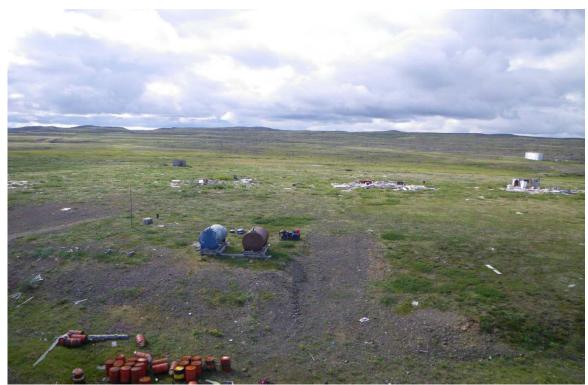
Plate 1 Aerial photo of the remains of the CRL Camp showing structure remains, barrels and bulk fuel storage tanks.

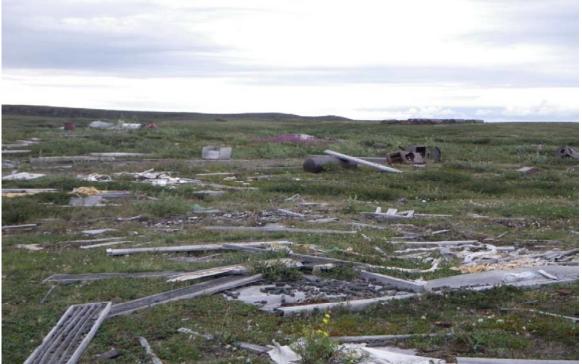
Plate 2 View east of the remains of the Hearne Camp with core boxes in the foreground, structure remains and bulk fuel 'sausage tanks' can be seen in the distance.

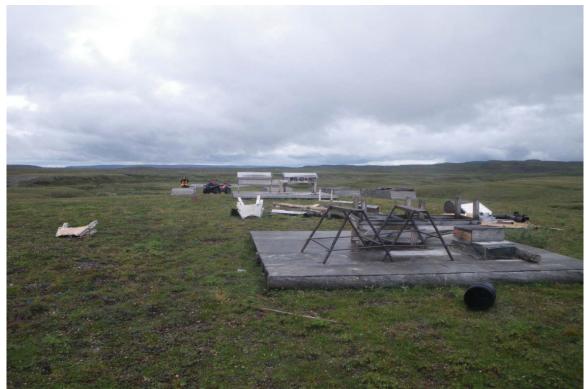
Plate 3 View northeast of the New Camp showing the remains of the floors of the shop tent and office tent with core boxes in the background.

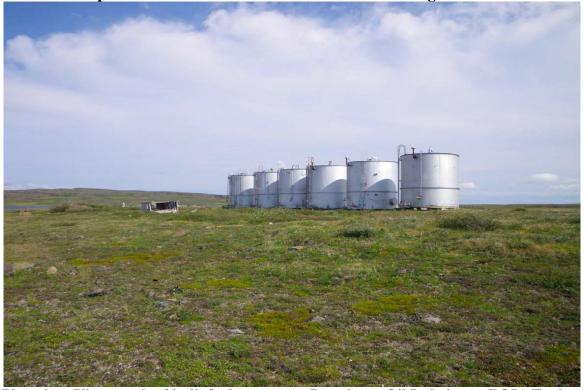
Plate 4 View north of bulk fuel storage or Petroleum Oil Lubricant (POL) Tanks.

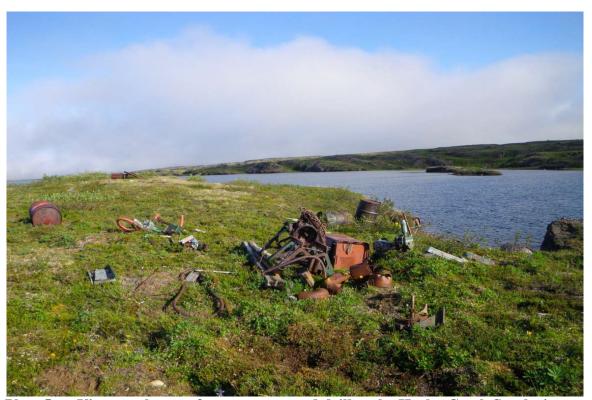
Plate 5 View northwest of water pump and drill at the Husky Creek South site.

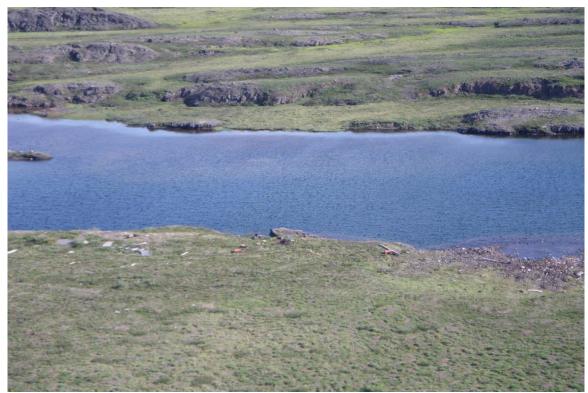
Plate 6 Aerial view north of Husky Creek South Site.

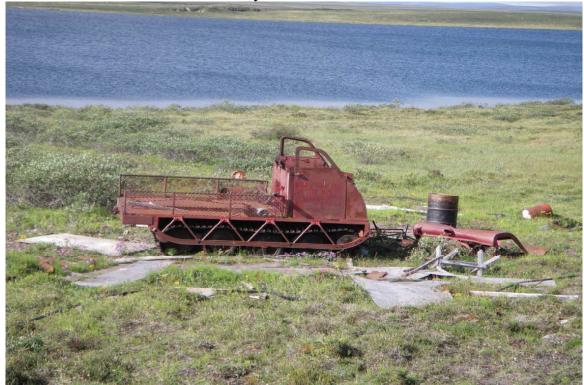
The Husky north site currently consists of an abandoned Bombardier Muskeg vehicle (Plate 7), wood and metal debris and three fuel drums (Plate 8). The site area is approximately 9,500 m<sup>2</sup>. The site was operated by Newmont Exploration of Canada

Plate 7 View southwest of the Bombardier Muskeg Vehicle and assorted debris.

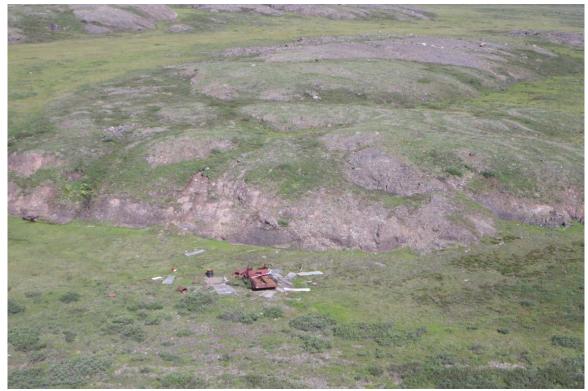
Plate 8 Aerial view northeast of Husky Creek North Site.

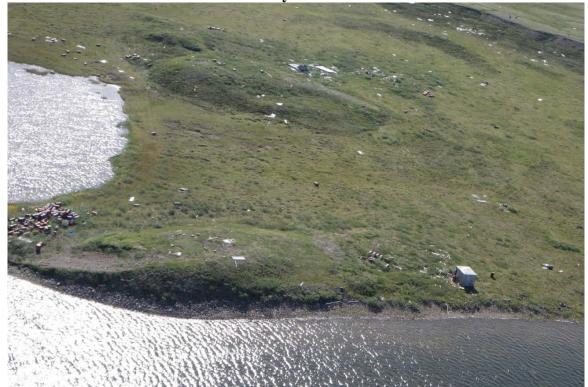
Plate 9 Aerial photo south of the Willow Lake Main site.

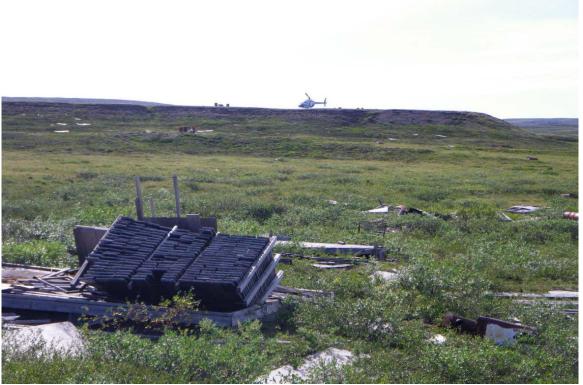
Plate 10 View southwest of building remains with cores boxes.

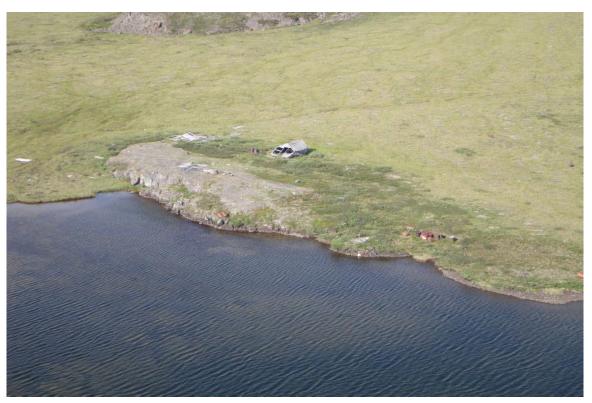
Plate 11 Aerial photo southwest of the Willow Lake South cabin.

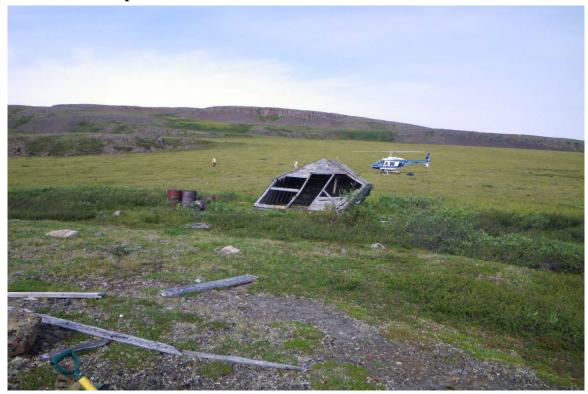
Plate 12 View northwest of dilapidated structure, Willow Lake South site.

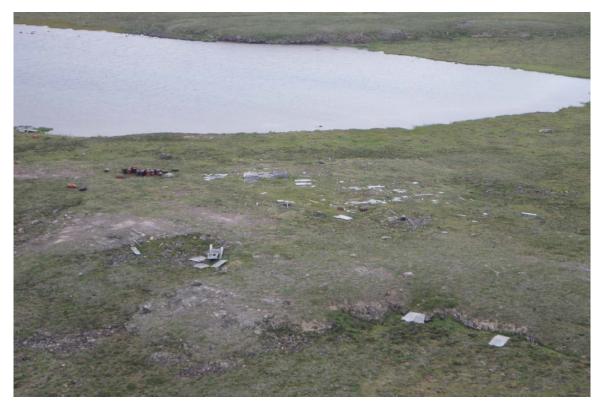
Plate 13 Aerial photo north of the Willow Lake Southwest cabins.

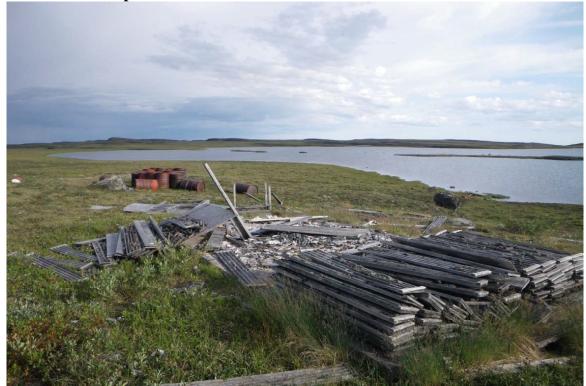
Plate 14 View north of core boxes, floor and fuel barrels, Willow Lake Southwest.

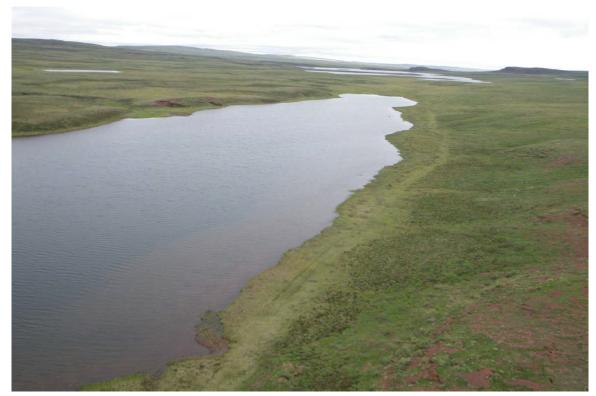
Plate 15 Aerial photo northwest along trail between Willow Lake and Hope Lake along unnamed lake.

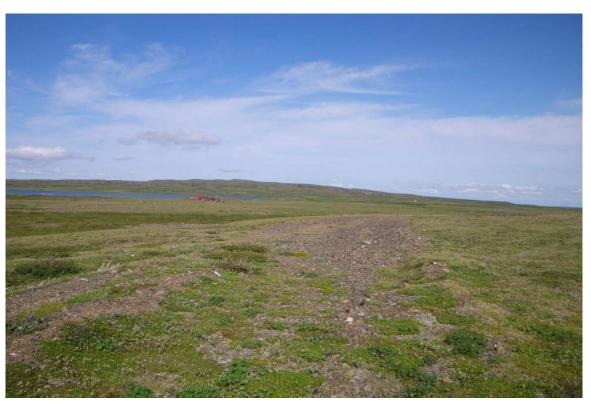
Plate 16 View east of potential borrow area at the Hope Lake site with barrel cache in the background.

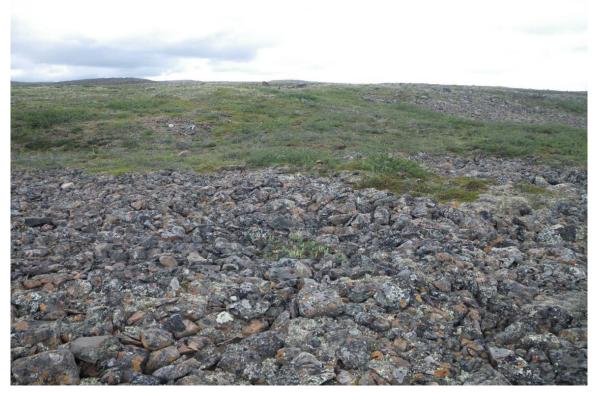
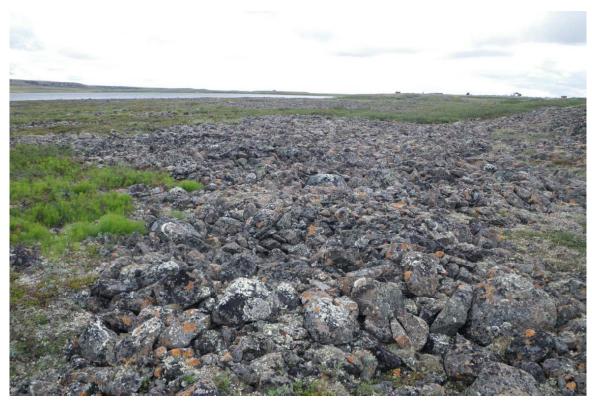
MiPn 1 is a stone feature site that is made up of four food caches in a boulder field along the southwest shore of Hope Lake. The four caches have been dug out of the boulders, are all open, and have diameters of between 2 and 2.5 m with depths ranging from 40 to 70 cm (Plates 17 and 18). The features appear to have sufficient lichen growth to indicate that they have been undisturbed. There is no evidence of recent use or of any remaining cultural material. However, three of the caches have slightly enhanced vegetation growth inside the cache area that may be due to organic nutrients that were once present inside, probably from cached meat. MiPn 1 is thought to be of moderate significance and it is recommended that any impacts to the site be avoided. At this time there are no plans to disturb MiPn 1 during the remediation of the Hope Lake Mining Exploration Camps.

Plate 17 View south of Feature 1, MiPn 1.

Plate 18 View east across MiPn 1 from Feature 4.

| Site | Туре | Significance | Recommendations |
|---|---|---|---|
| MiPn 1 | Stone cache | moderate | Avoidance is recommended |

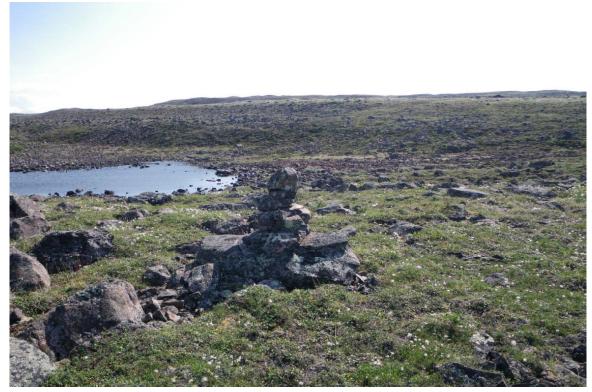
MiPn 2 is a stone feature site that is made up of a single inukshuk on a ridge overlooking the Hope Lake Mining Exploration Camps. The inukshuk is made up of ten stones on top of a large rock (Plate 19). Stones show evidence of age with moss and lichen "fusing" them together. MiPn 2 is thought to be of moderate significance and it is recommended that any impacts to the site be avoided. At this time there are no plans to disturb MiPn 2 during the remediation of the Hope Lake Mining Exploration Camps.

Plate 19 View southeast of MiPn 2.

| Site | Туре | Significance | Recommendations |
|---|---|---|---|
| MiPn 2 | Inukshuk | moderate | Avoidance is recommended |

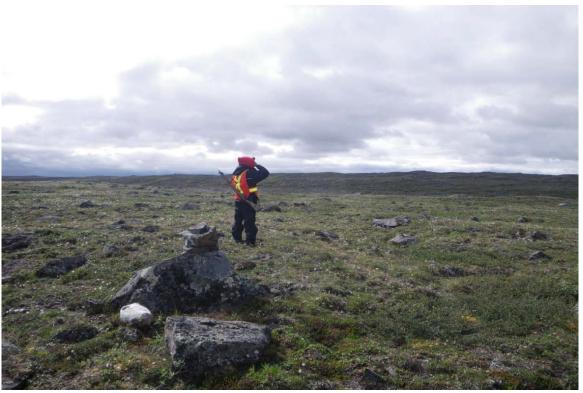
MiPn 3 is a stone feature site that is made up of a single inukshuk on a high ridge overlooking the Hope Lake Mining Exploration Camps. The inukshuk is made up of five flat stones and sits on top of a large boulder (Plate 20). Stones show evidence of age with moss and lichen "fusing" them together. MiPn 3 is though to be of moderate significance and it is recommended that any impacts to the site be avoided. At this time there are no plans to disturb MiPn 3 during the remediation of the Hope Lake Mining Exploration Camps.

Plate 20 View southeast of MiPn 3 with Kenny Kuodluak scouting for bears.

| Site | Туре | Significance | Recommendations |
|---|---|---|---|
| MiPn 3 | Inukshuk | moderate | Avoidance is recommended |
