## Field Photographs

# PHOTOGRAPHIC LOG

**Site Name:**  
Iqaluit Airport

**Project No.**  
60615382

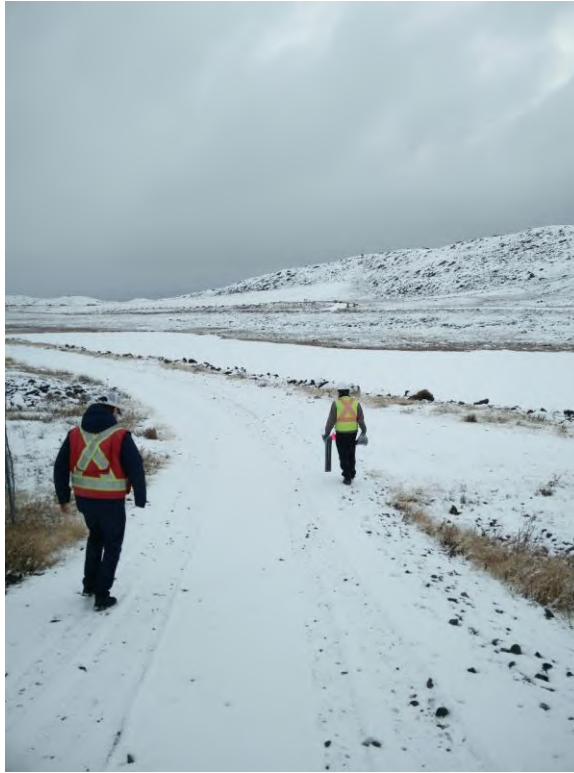
**Photo No.**  
1

Completing Private  
Locates in the vicinity of  
MW19-01

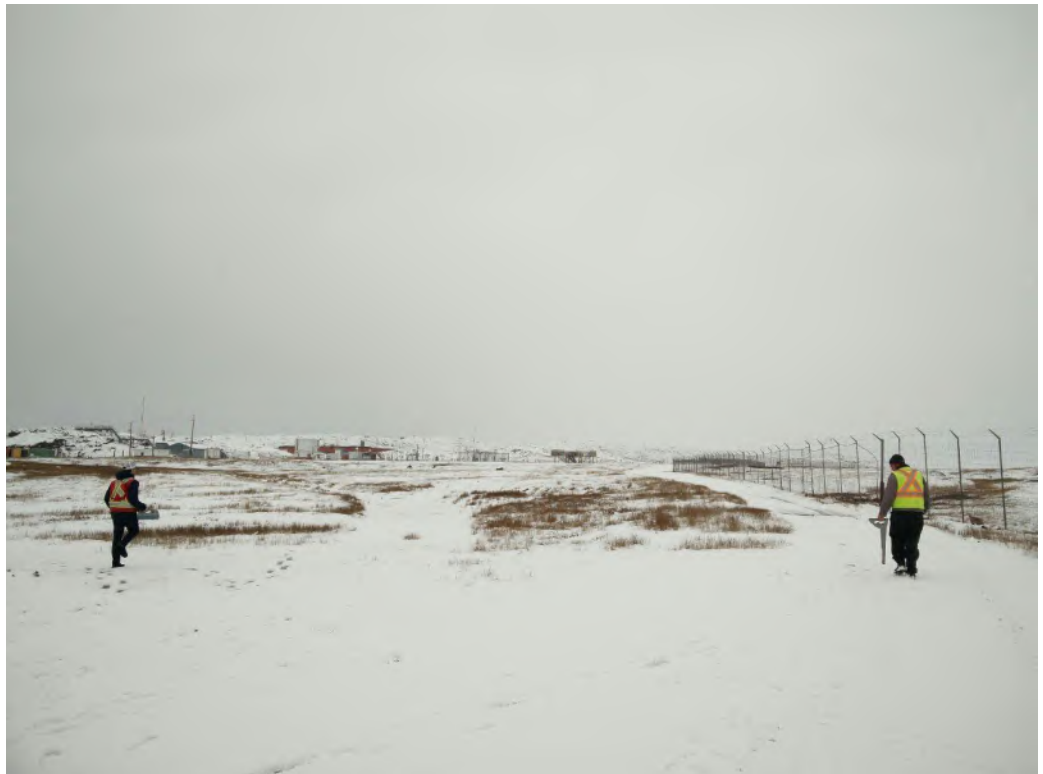
**Photo No.**  
2

Completing Private  
Locates in the vicinity of  
MW19-03

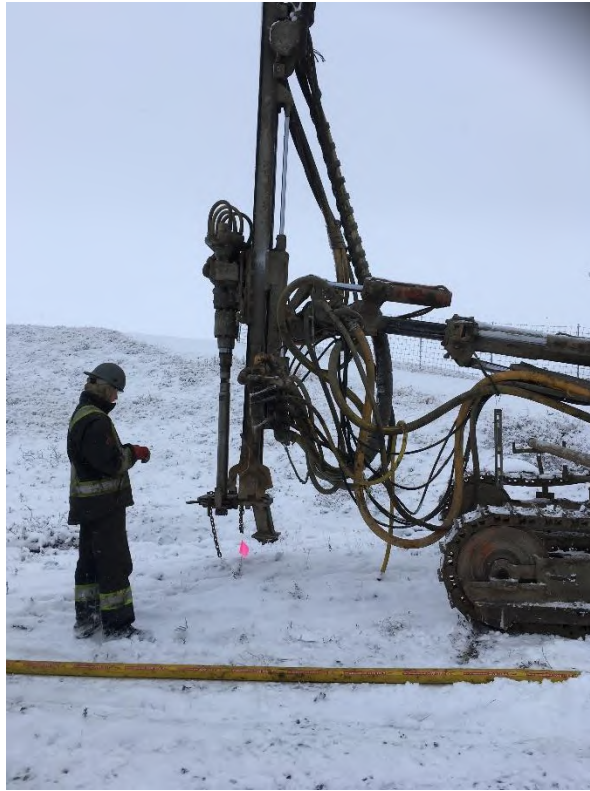
**Photo No.**  
3

Drilling MW19-01

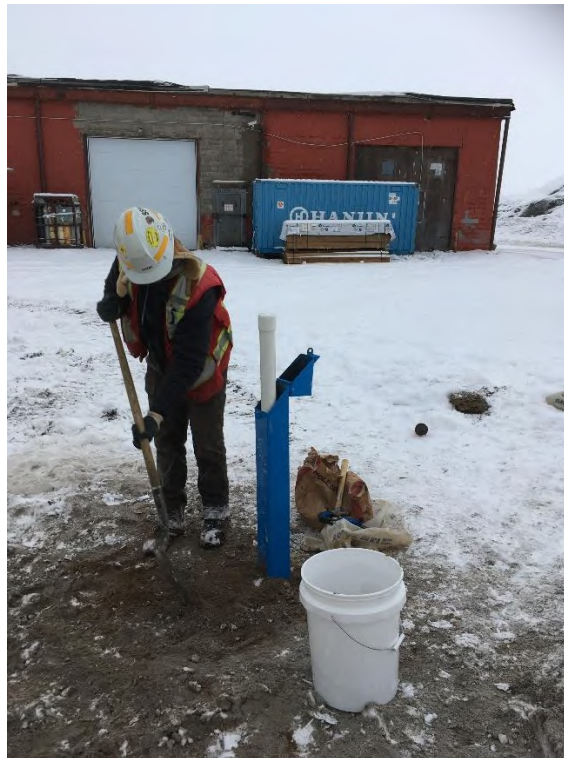
**Photo No.**  
4

Semi-completed  
MW19-02.

The PVC riser was later  
cut short and the stick  
up box was locked.

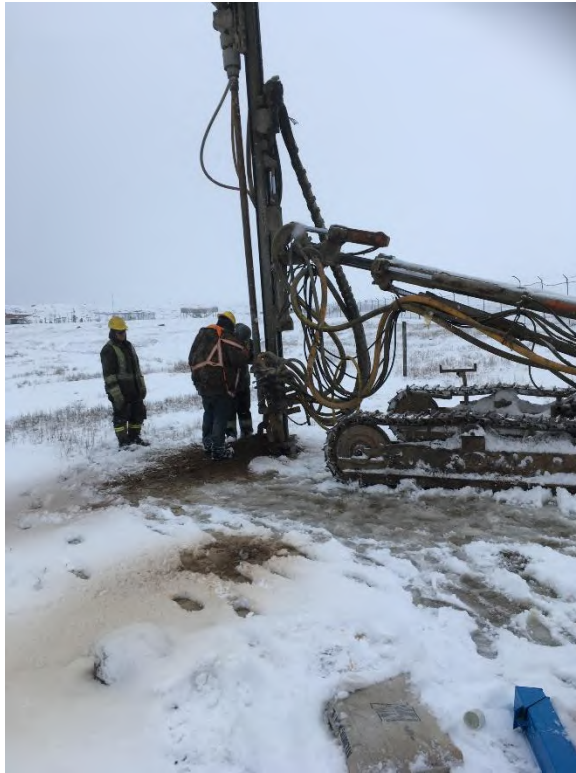
**Photo No.**  
5

Drilling of MW19-03.

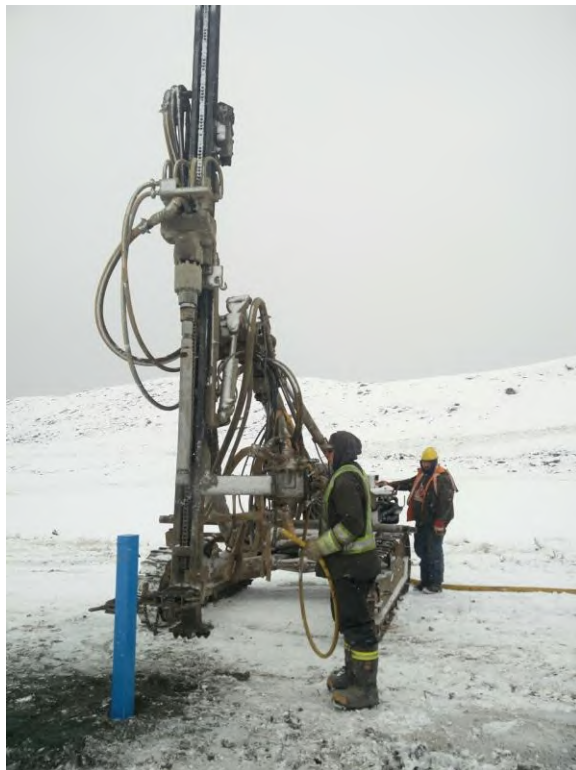
**Photo No.**  
6

Completed MW19-01.

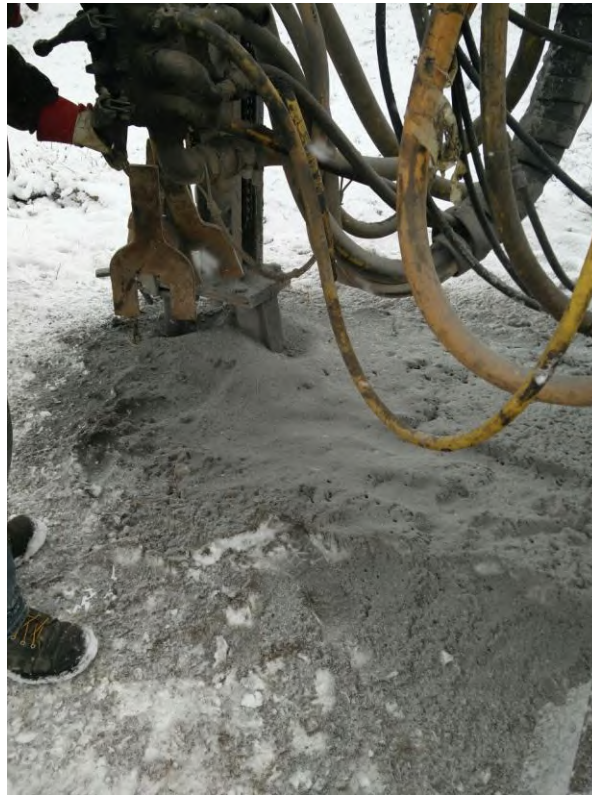
**Photo No.**  
7

Typical soil cutting  
generated by air-rotary  
drilling

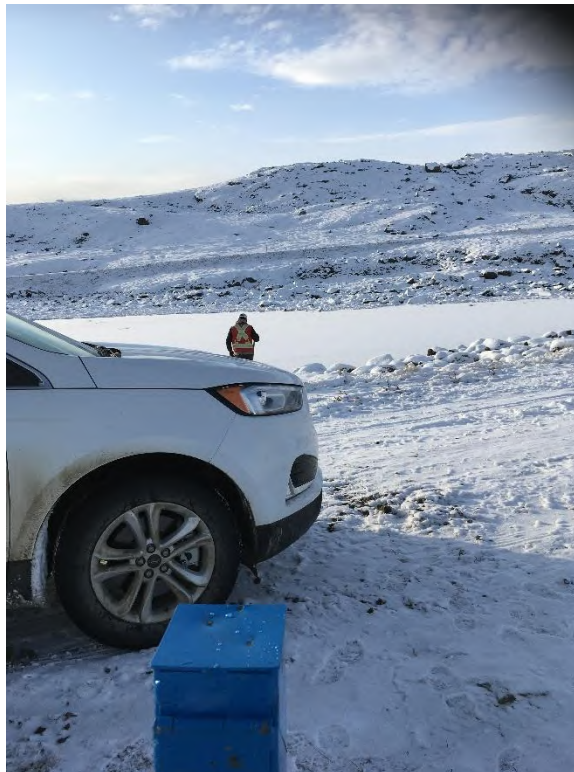
**Photo No.**  
8

The surface water body  
downgradient of MW19-  
01

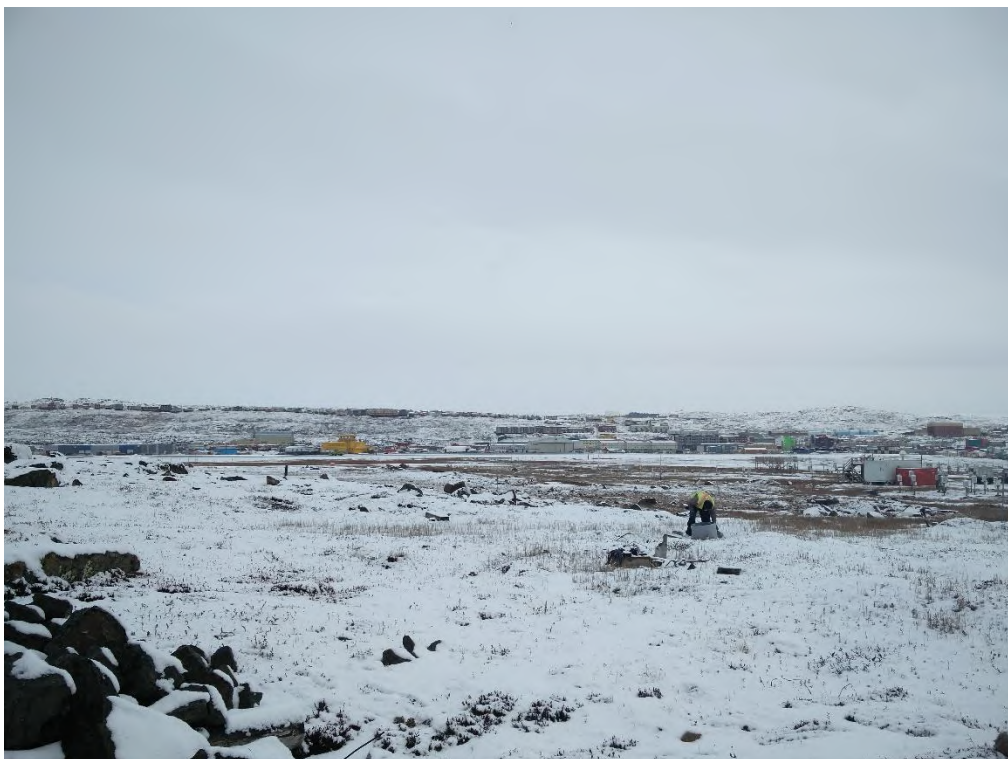
<b>Photo No.</b> 9	<b>Date:</b> 29/10/20 19

<b>Direction Photo Taken:</b>  Looking North		
<b>Description:</b>  View of Iqaluit Airport old building (yellow colour) from location of MW19-02

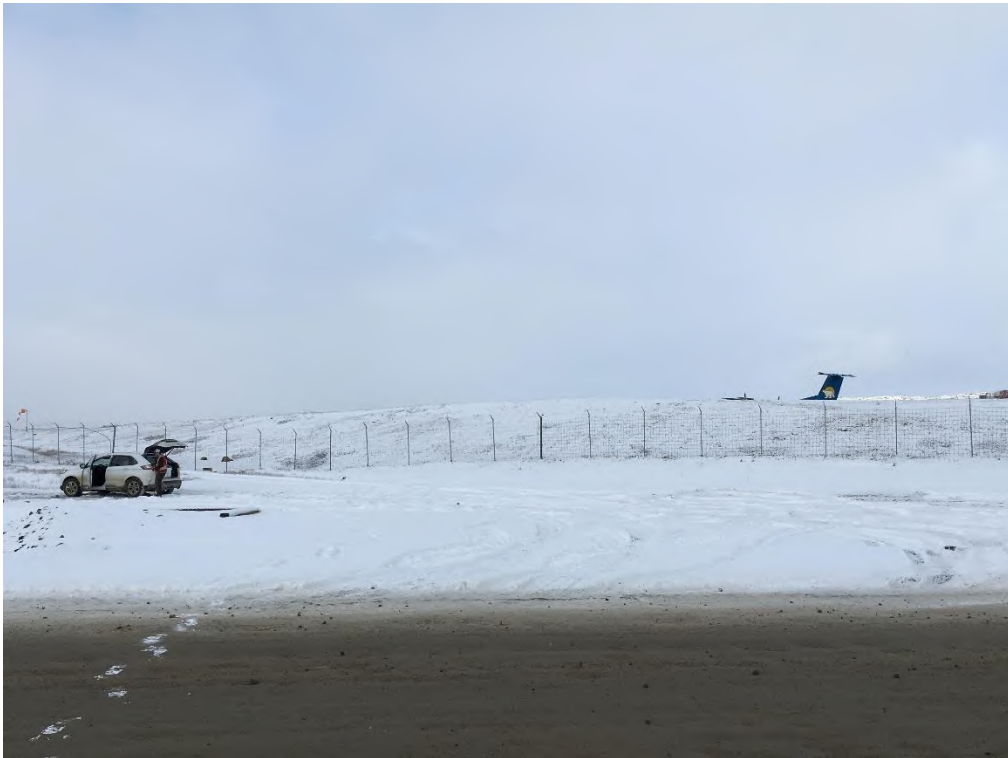
<b>Photo No.</b> 10	<b>Date:</b> 03/11/20 19

<b>Direction Photo Taken:</b>  Looking North-West		
<b>Description:</b>  View of Iqaluit Airport runway just upgradient from location of MW19-03.

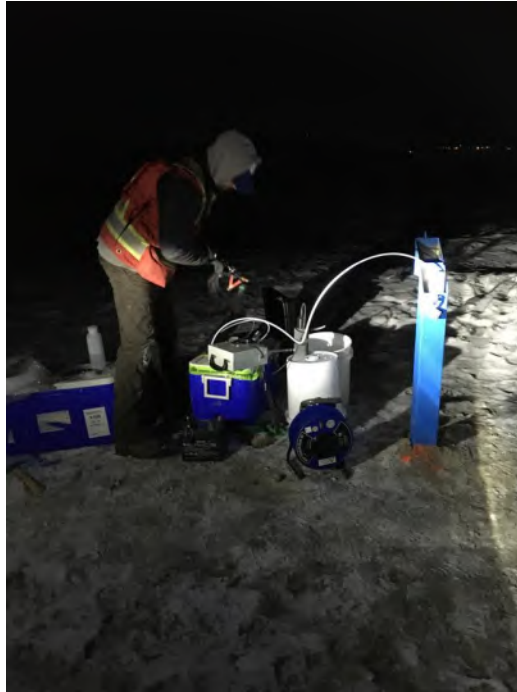
**Photo No.**  
11

Efforts to collect groundwater sample using low-flow sampling. Temperature was around -9 and groundwater temperature was at 0°C. The water got frozen as soon as it was pumped out of the well in the tubing and YSI flow cell.

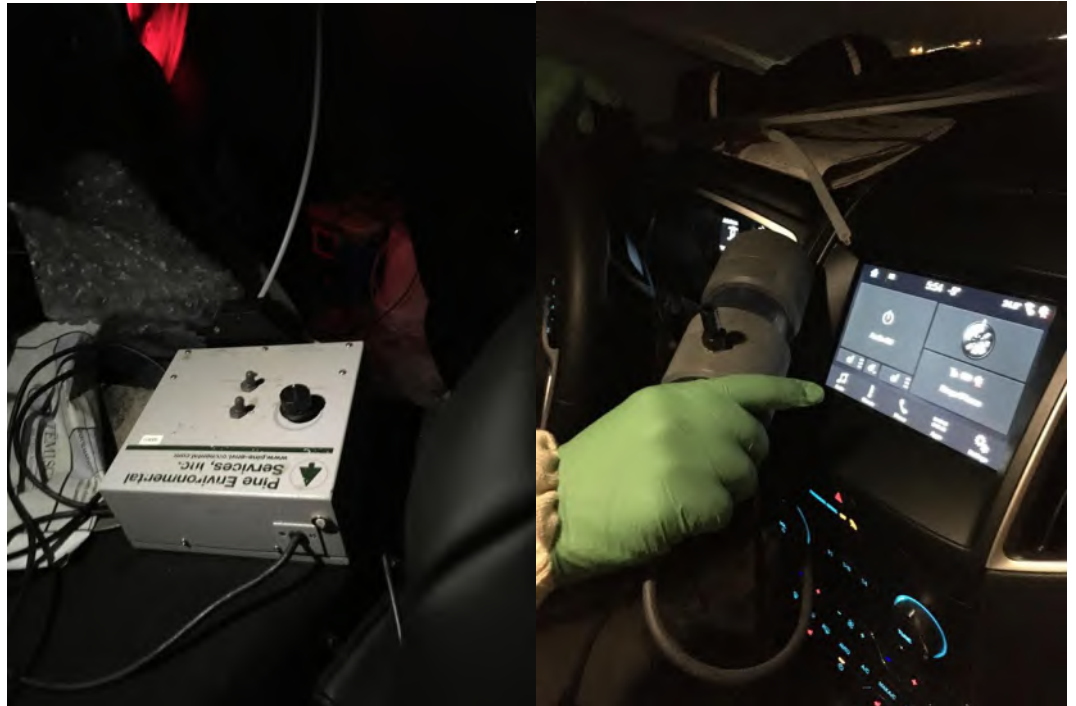
**Photo No.**  
12

Brought the pump, YSI and the flow cell inside the car to melt the ice clogging the flow, but the water still got frozen in the piece of tubing inside the well and make low flow pumping not feasible.

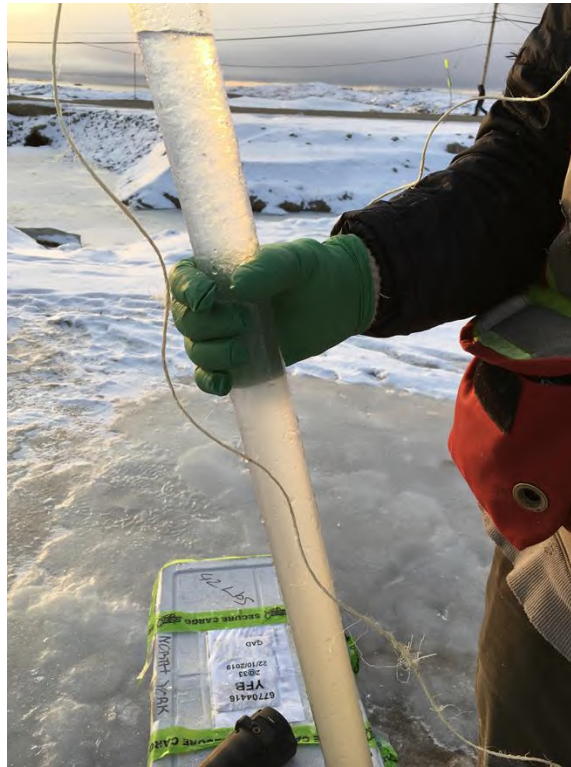
**Photo No.**  
13

Switched to using bailers for collecting samples. The temperature was still around -10 °C. The groundwater in the bailer was slushy and started freezing immediately.

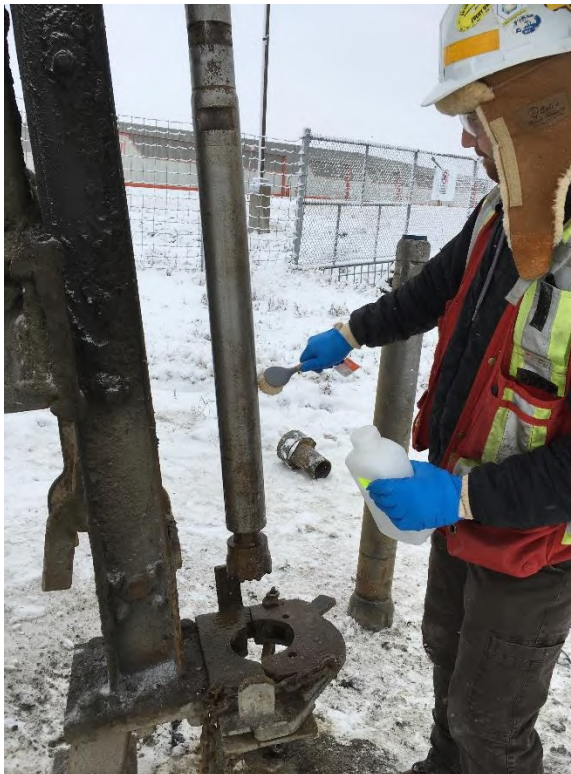
**Photo No.**  
14

Decontamination of drilling hammer with laboratory-supplied PFAS-Free water and PVC brush prior to collecting the equipment rinsate blank
