APPENDIX C

**MONITORING PROGRAM
STATIONS (SIM-1, SIM-2, SIM-3
AND SIM-4 AS PER PART K OF
THE WATER LICENCE)**

APPENDIX D

SOME BEFORE AND AFTER REMEDIATION PHOTOS

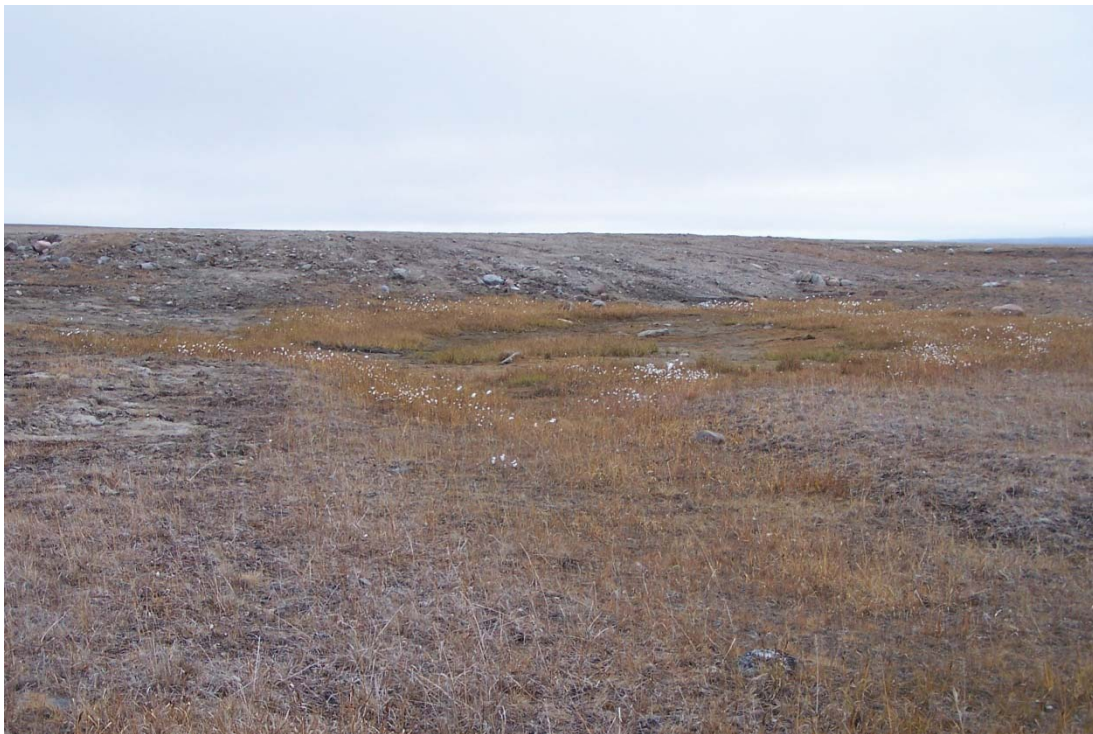
Photograph 4. After: View of Airstrip subsequent to surface debris removal. ↑

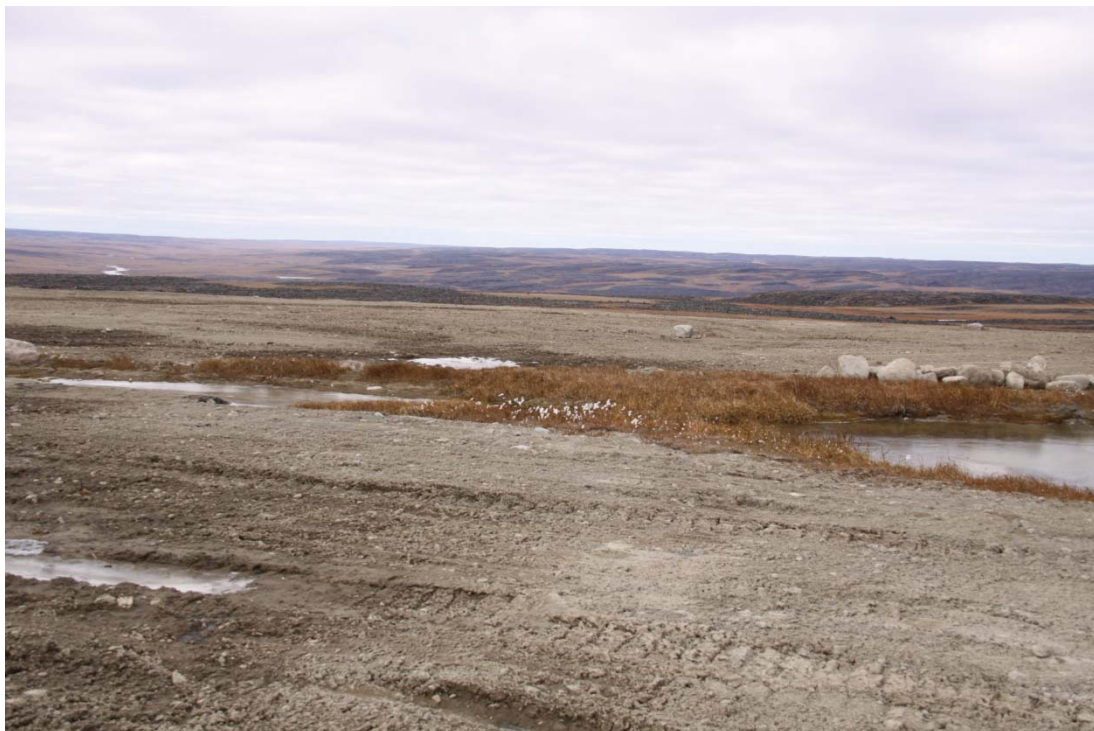
Photograph 8. After: View of Pallet Line after the completion of debris removal and soil excavation. ↑
