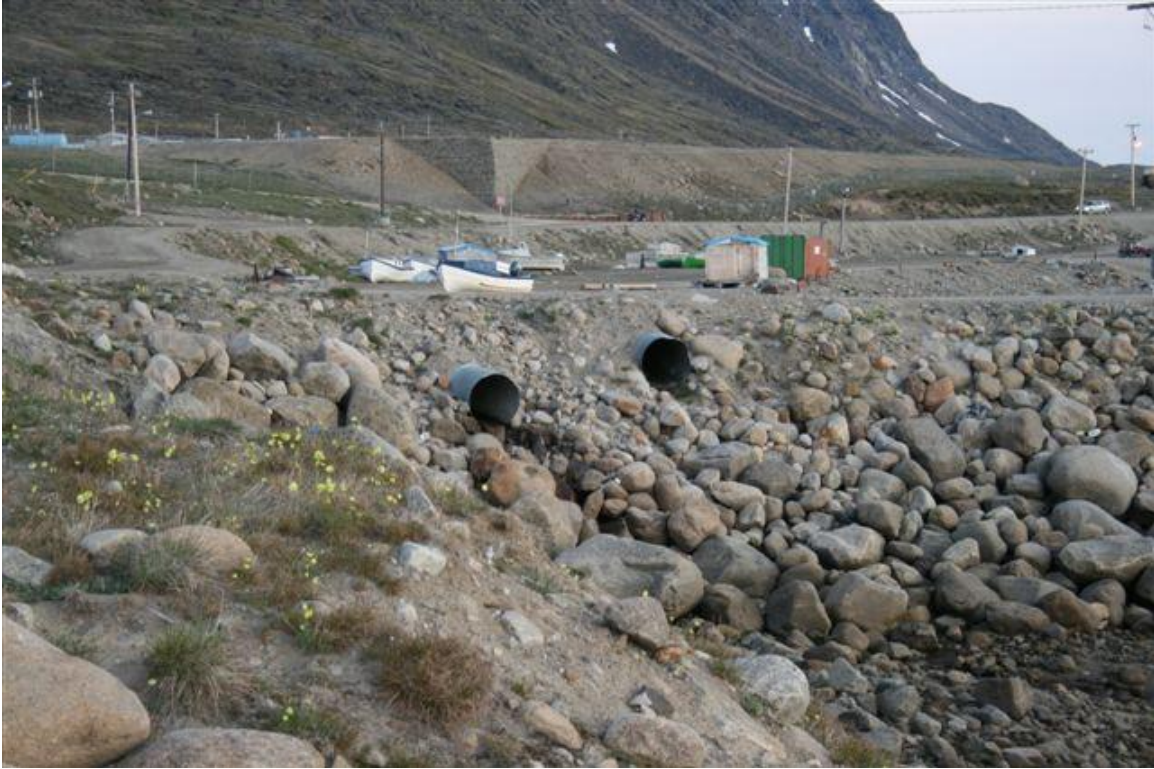
Photo 1 – showing outlet of drainage feature into the existing harbour
