Maze Lake Joint Venture
Laurentian Goldfields Ltd.
520 – 800 West Pender Street
Vancouver, BC
V6C 2V6

2012 Annual Report
for
Maze Lake Project Water Use and Waste Disposal
License # 2BE-MZE0712

Prepared by
Darin Labrenz, P.Geo.
17 March 2013

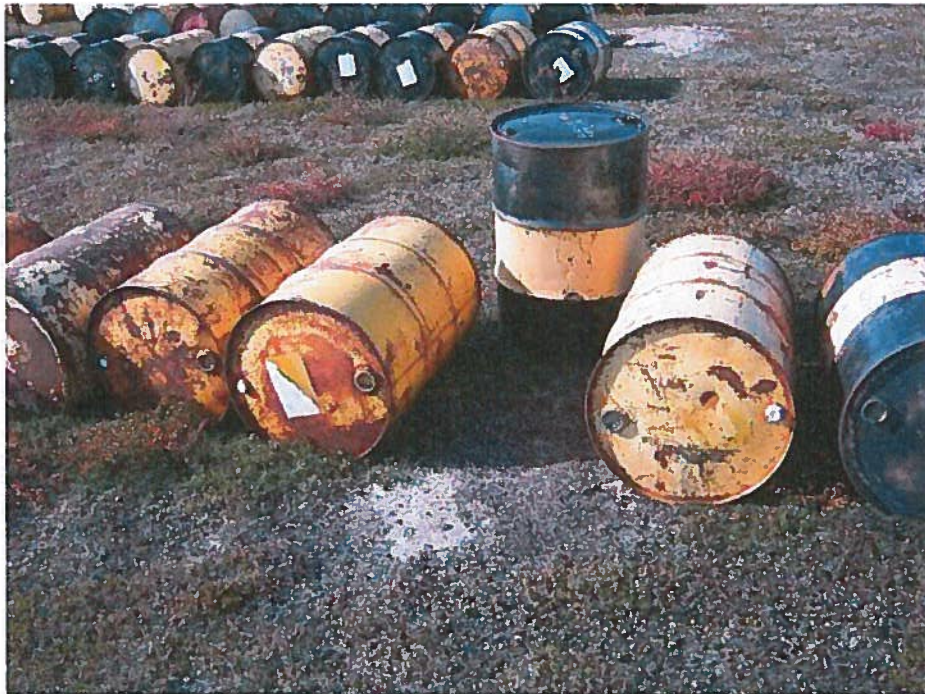
On the 10th of July, a Water License Inspection noted that fuel leakage was occurring from the bungs of five drums stored in a fuel cache proximal to the 2007 camp. On notification, the Maze Lake operator initiated immediate remedial and mitigation actions to address the issue. These actions included:

Figure 1: Drum showing identified spill

- Purchase and mobilization of new fuel containment berms

- Placement of fuel into containment facilities
- Removal of contaminated soil

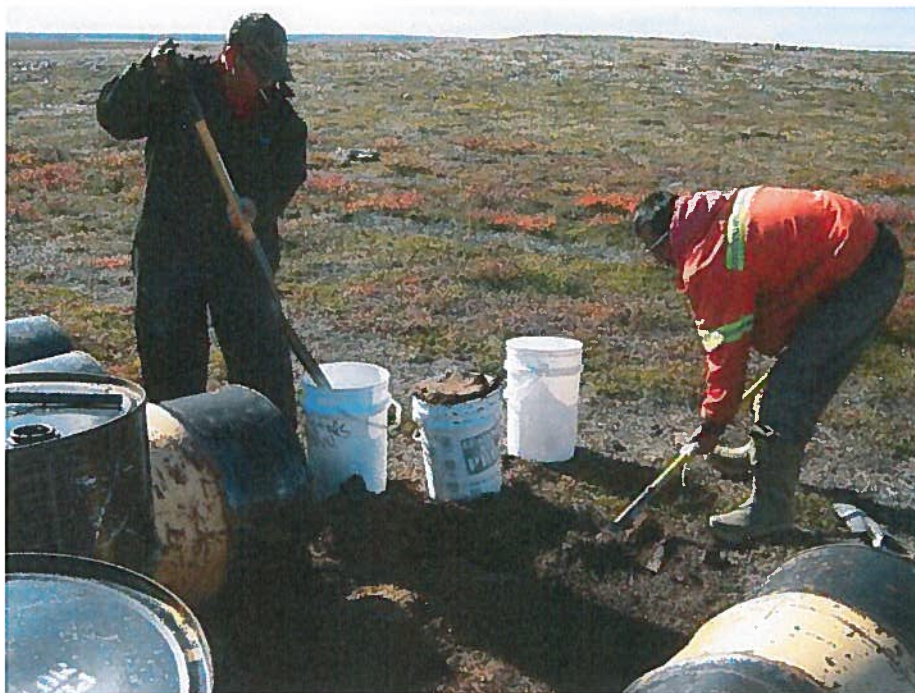
Figure 2: Removal of affected soil

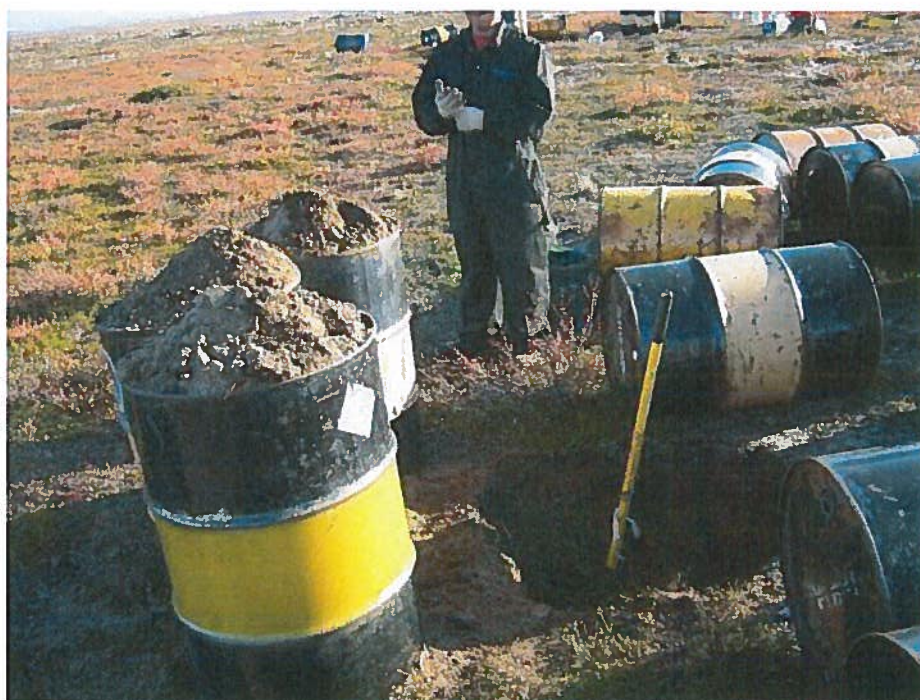
Figure 3: Removal of affected soil

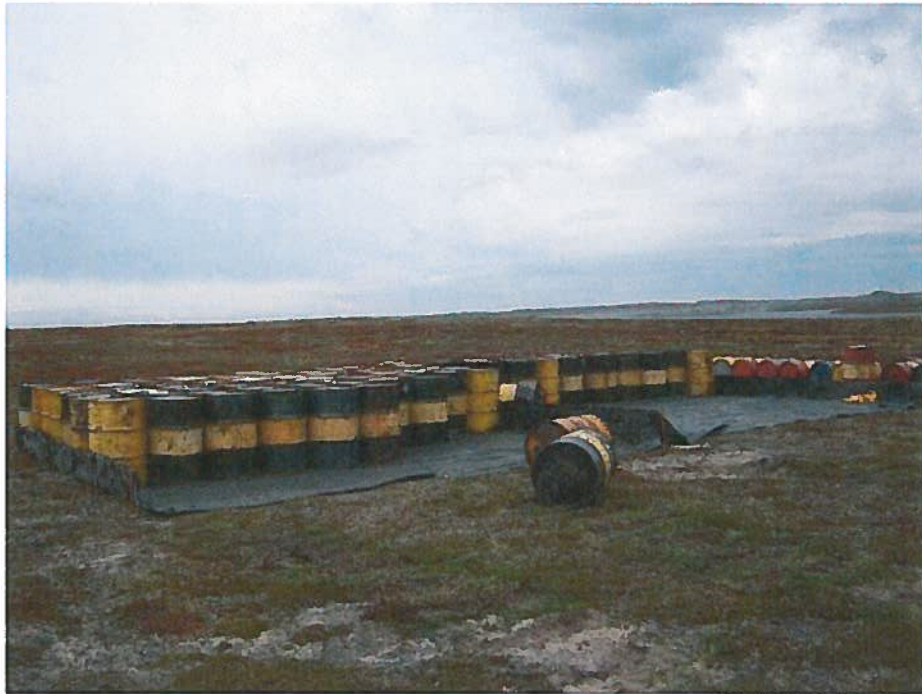
Figure 4: Secondary Containment

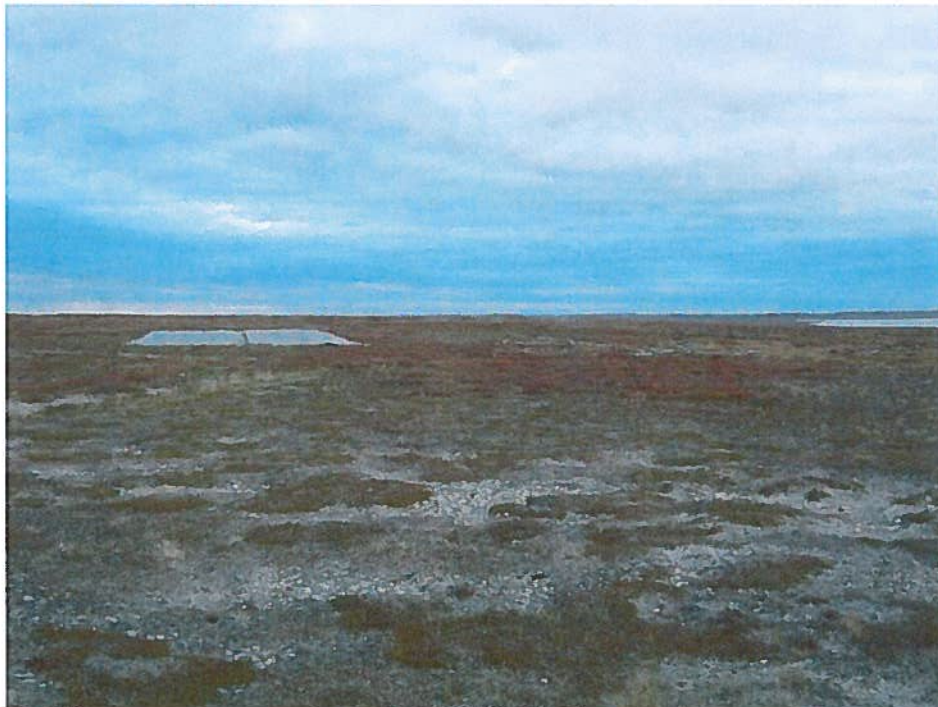
Figure 5: Secondary Containment
