**RE: Final Plan – Vale Exploration Canada Inc. NWB Water Licence 2BE-MVP1217**

## **Melville Project**

# **Annual Report & Final Closure and Restoration Plan**

Water Licence 2BE-MVP1217

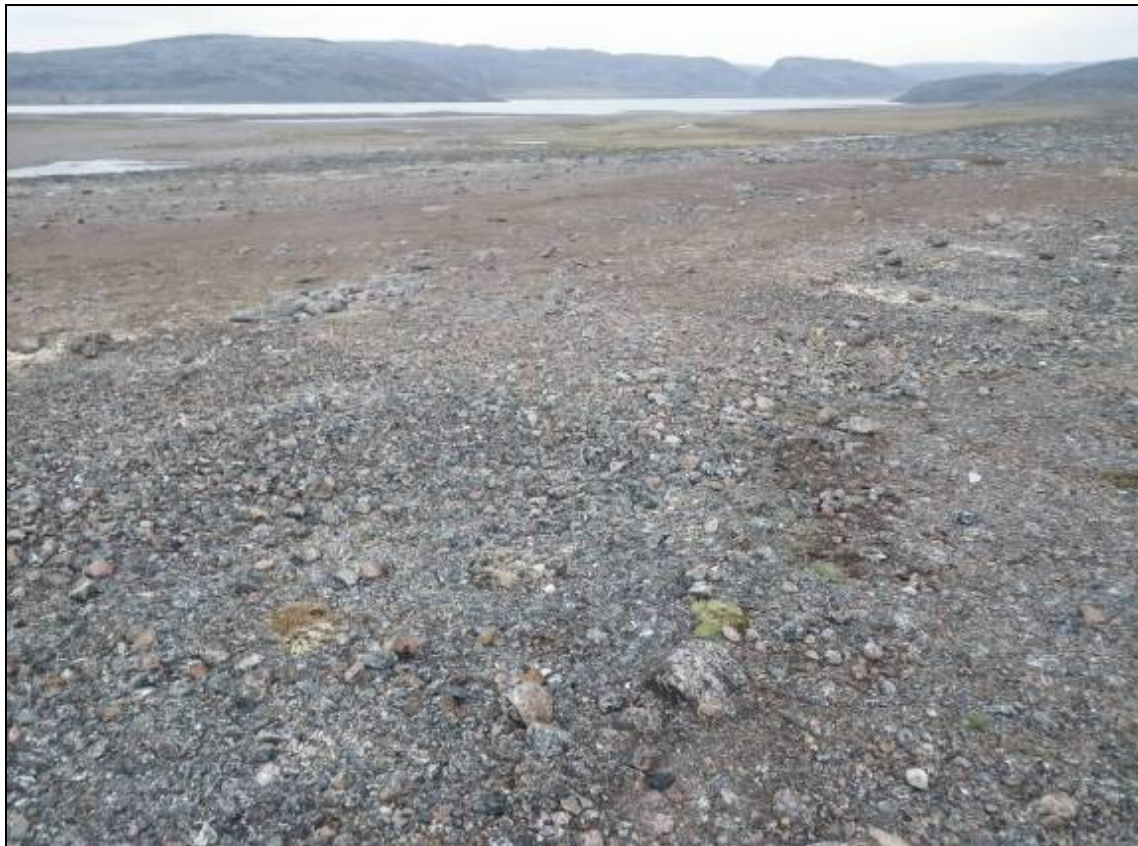
**Figure 4** Location of camp after final closure and restoration

The camp covered an area of approximately 0.25 ha and consisted of Weatherhaven tents and a small plywood generator building. All reusable equipment such as tents, ten frames, stoves, beds, showers, etc. were dismantled and removed from site by airplane to Hall Beach from where they were shipped on the sealift to Valleyfield, QC and onwards. All consumables associated with camp construction and operations, such as nails, screws, anchors, etc. were recovered as much as possible, packaged and flown out with other non-hazardous solid waste for disposal in Iqaluit.

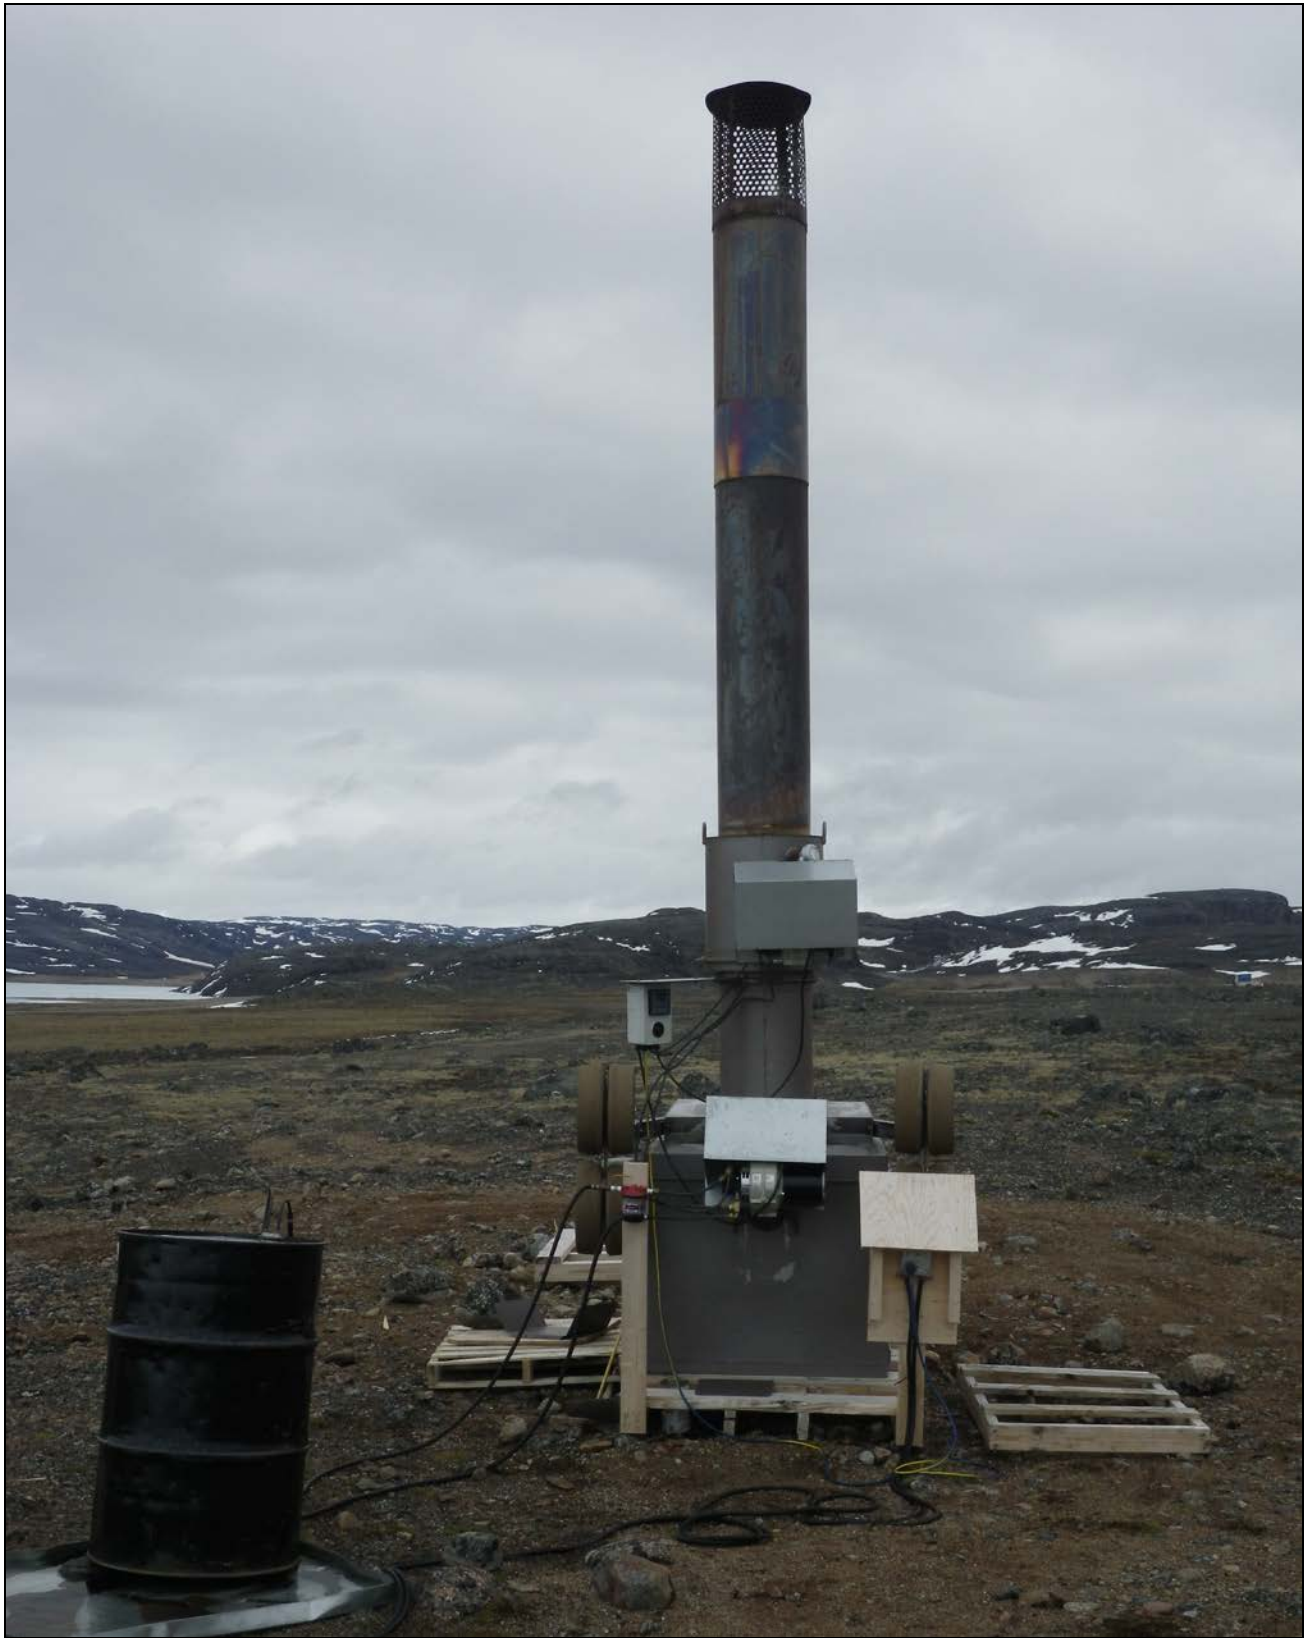
**Figure 7** High efficiency incinerator while in operation

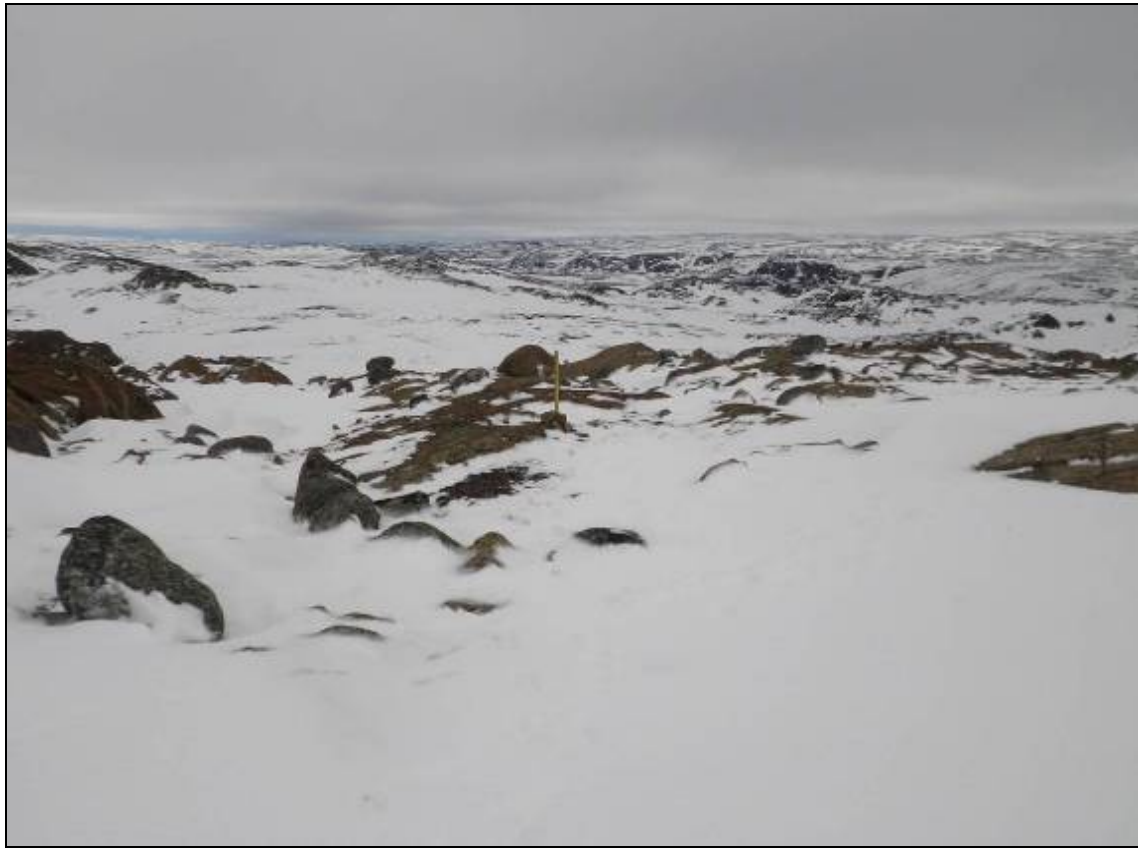
**Figure 10** Location of diamond drill hole MLVL-13-001 prior to drilling

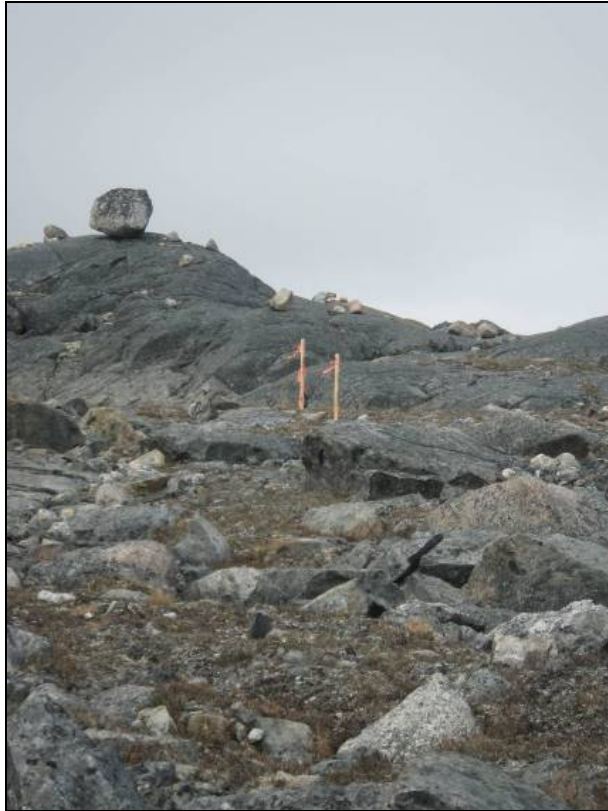
**Figure 12** Location of diamond drill hole MLVL-13-002 prior to drilling

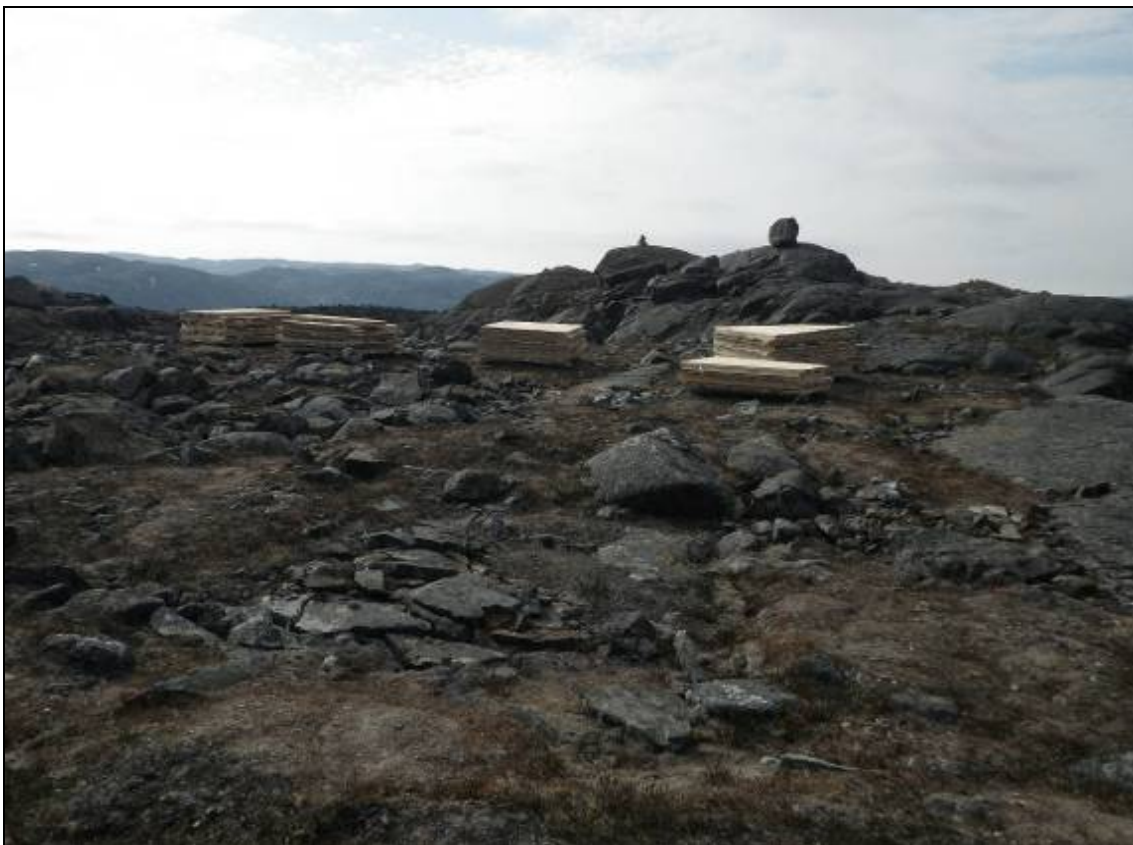
**Figure 13** Location of diamond drill hole MLVL-13-002 and final core storage after drilling and reclamation

All drill locations were inspected and photographed immediately after completion of the drill holes. All waste was collected and returned to the camp for incineration or removed to an approved disposal facility in Iqaluit. No sumps were dug as all drill cuttings were directed to natural depressions capable of containing their volume. A diligent inspection was conducted of the soil surrounding all drill sites with particular attention paid to any possible contamination.

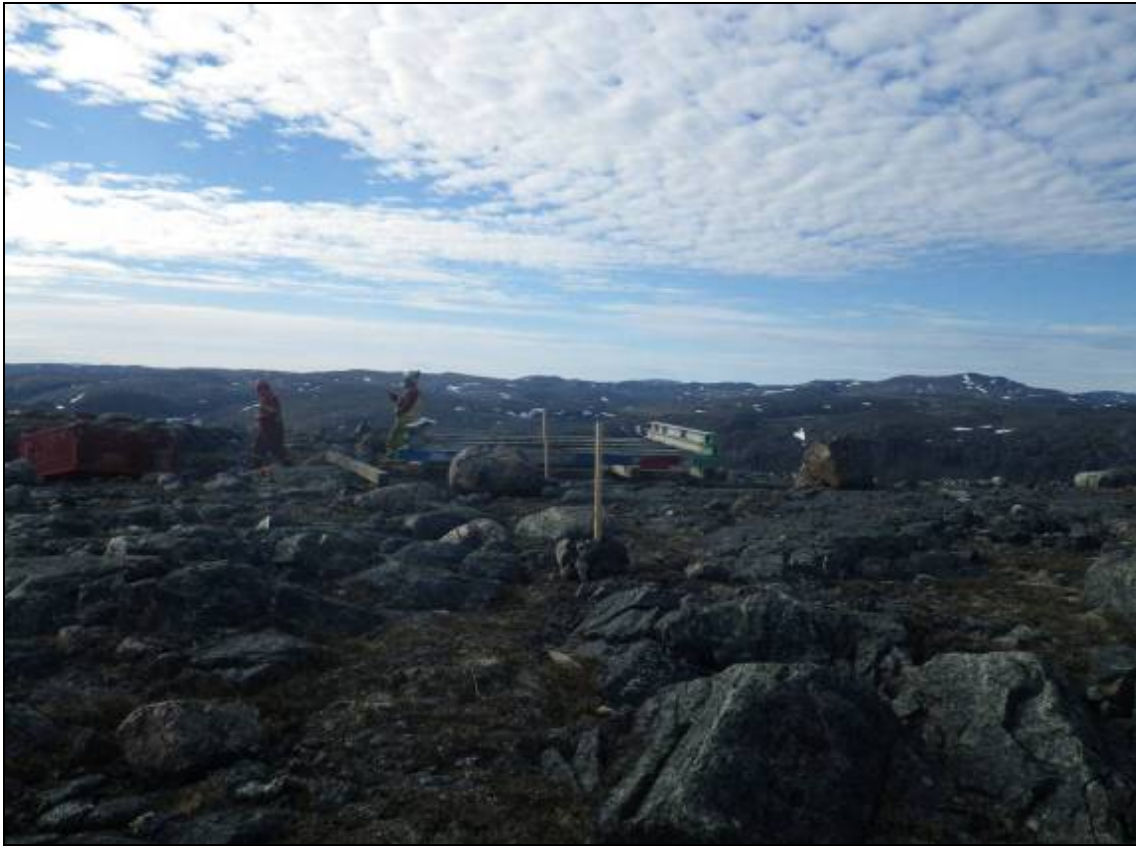
**Figure 16** Location of diamond drill hole MLVL-13-004 prior to drilling

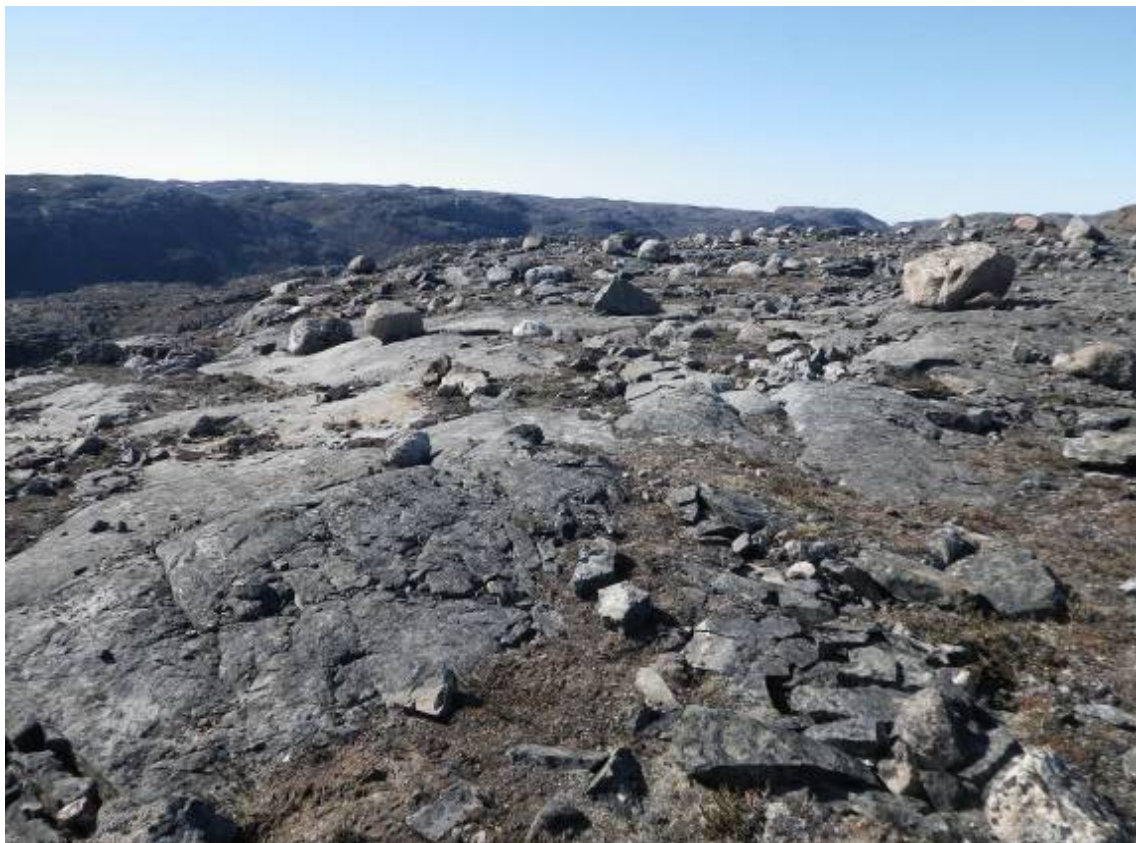
**Figure 17** Location of diamond drill hole MLVL-13-004 after drilling and reclamation

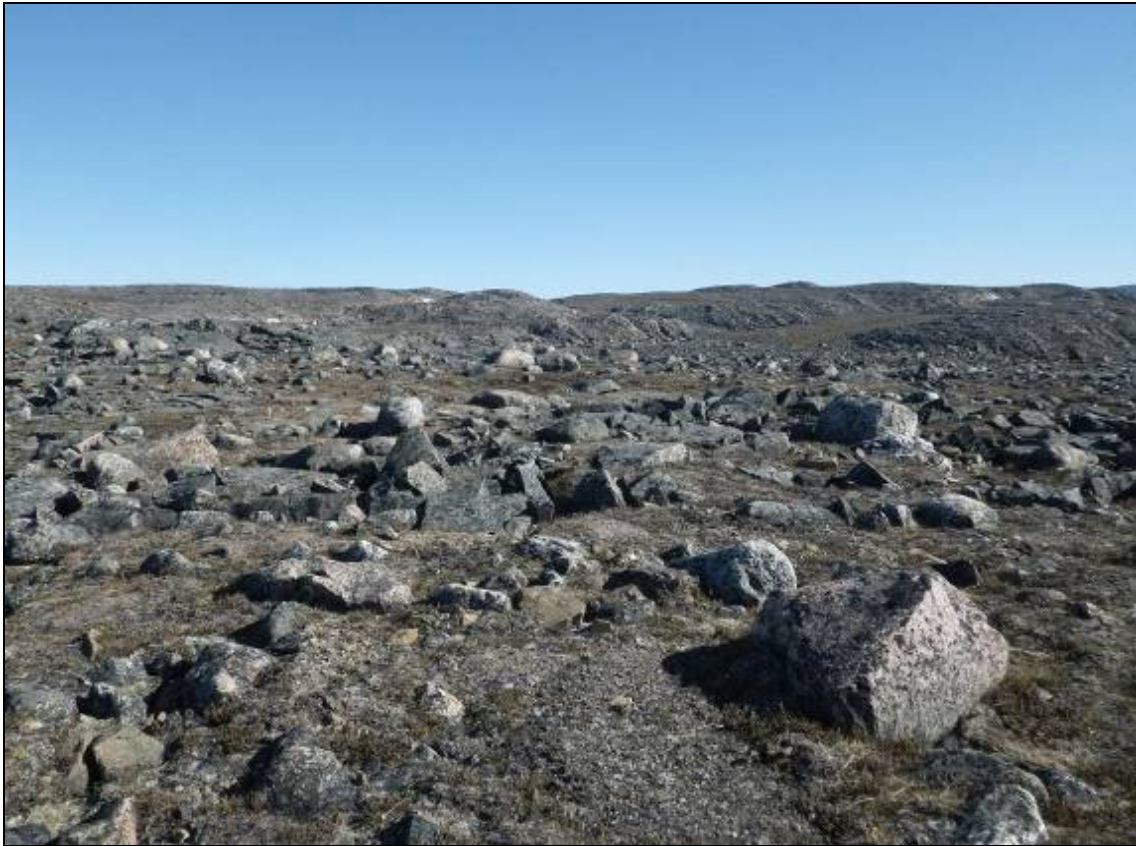
**Figure 18** Location of diamond drill hole MLVL-13-005 prior to drilling

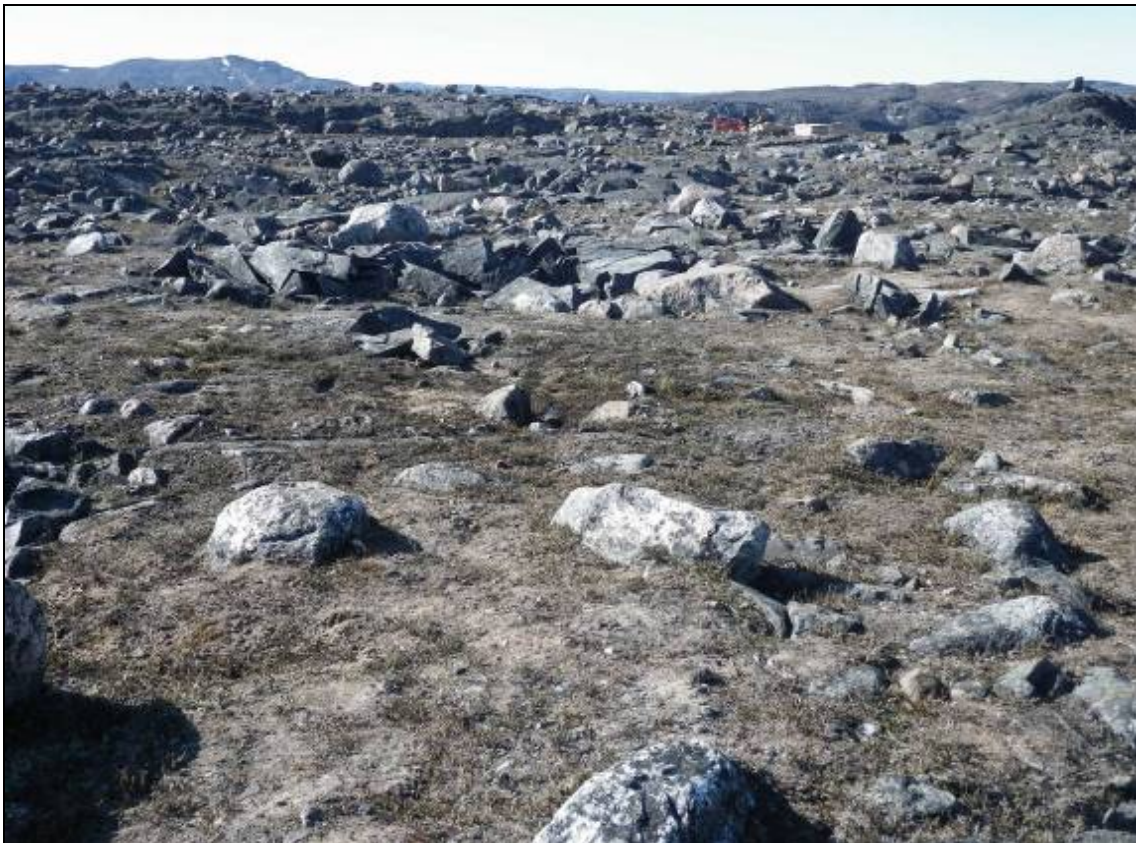
**Figure 19** Location of diamond drill hole MLVL-13-005 after drilling and reclamation
