2012 Annual Report on Vale Exploration Canada Inc. Southampton Project Nunavut Water Board Licence No. 2BE-SIP1117

Part B, Item 2

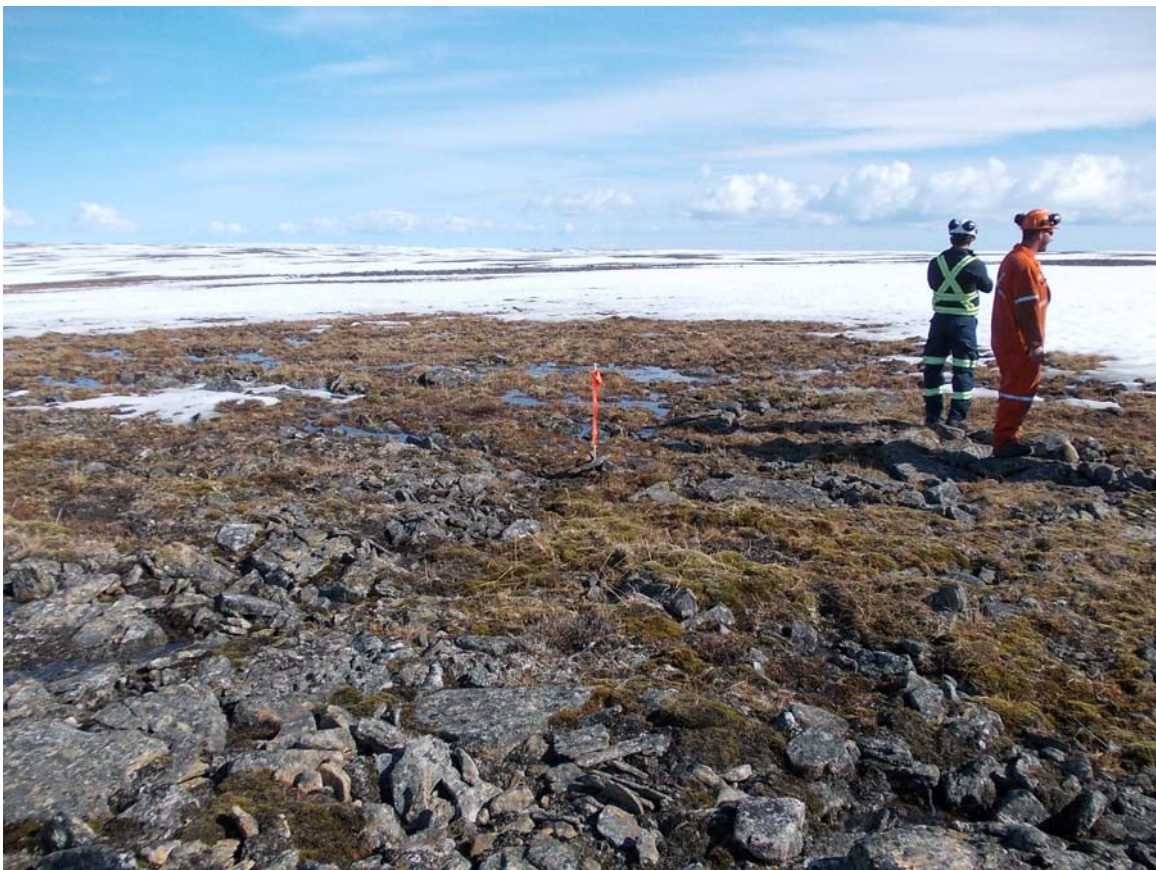
Photo 1: Drill site, pre operation. View towards the northeast, picket marks the collar location for the drill.

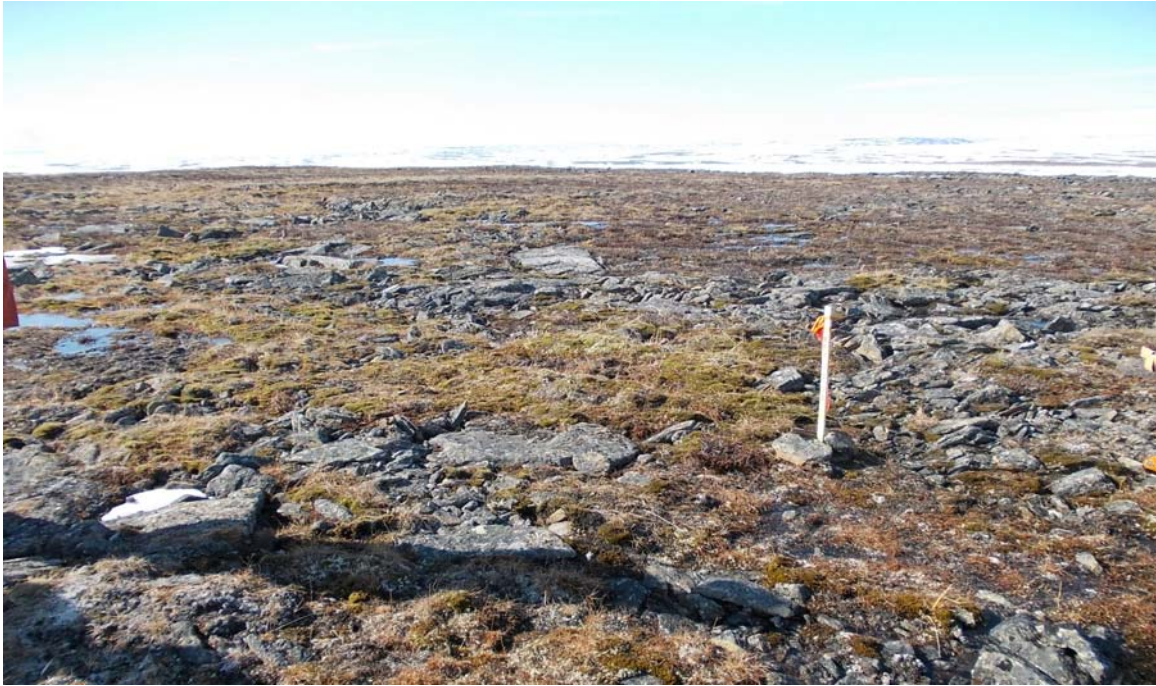
Photo 2: Drill site, pre operation. View looking northwest, picket marks the drill location.

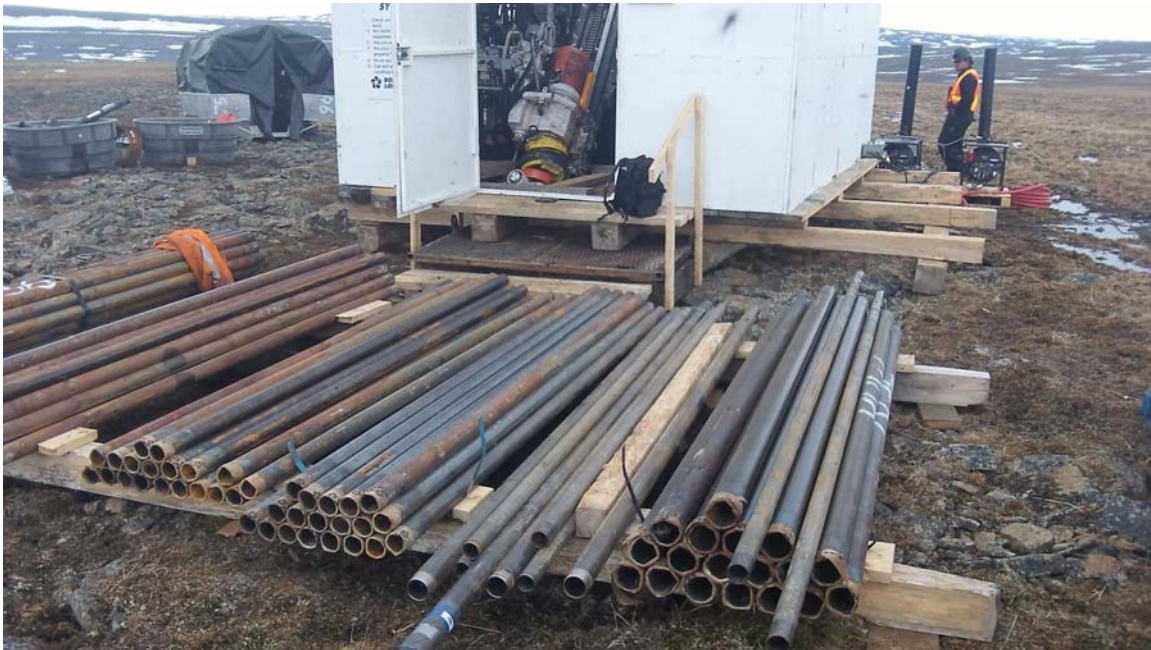
Photo 3: The drill during operation. View towards the east.

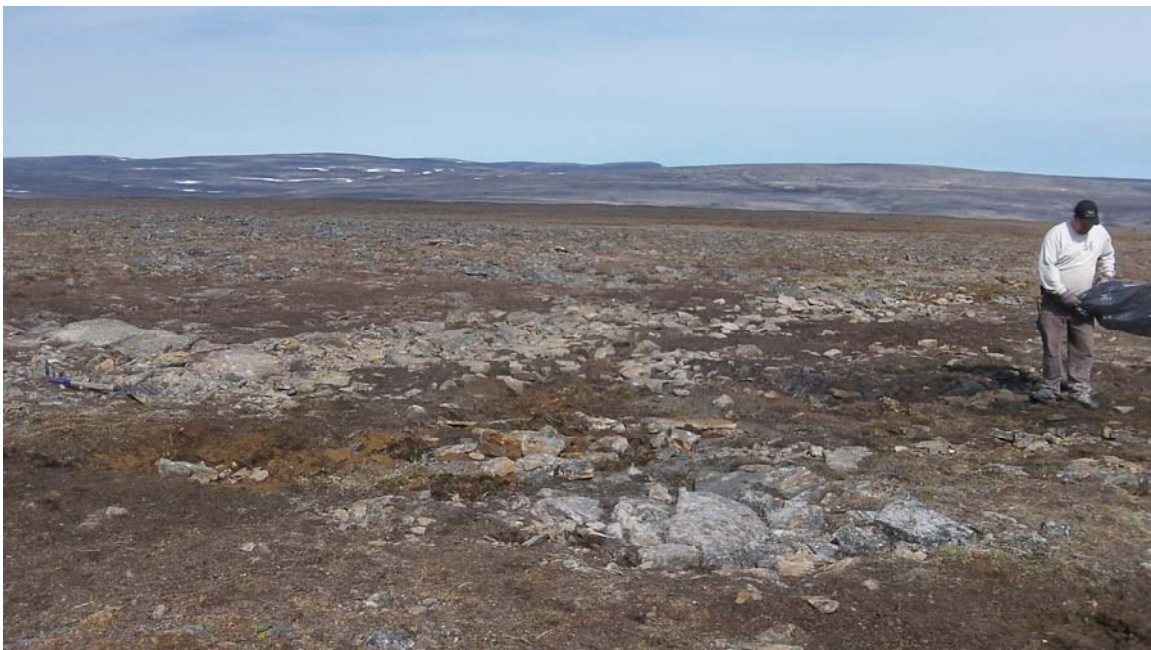
Photo 4: Drill site after reclamation. View towards the east. Sump is buried along with remaining cuttings.

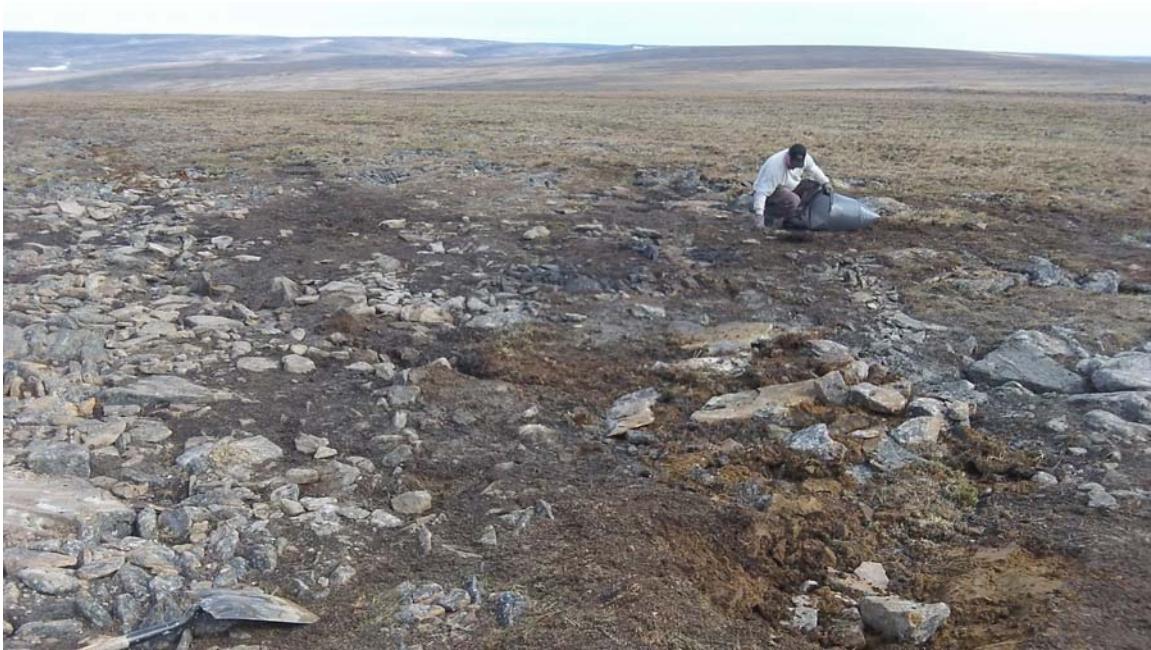
Photo 5: Drill site, post operation. View towards the south, sump has been buried in lower right hand corner.

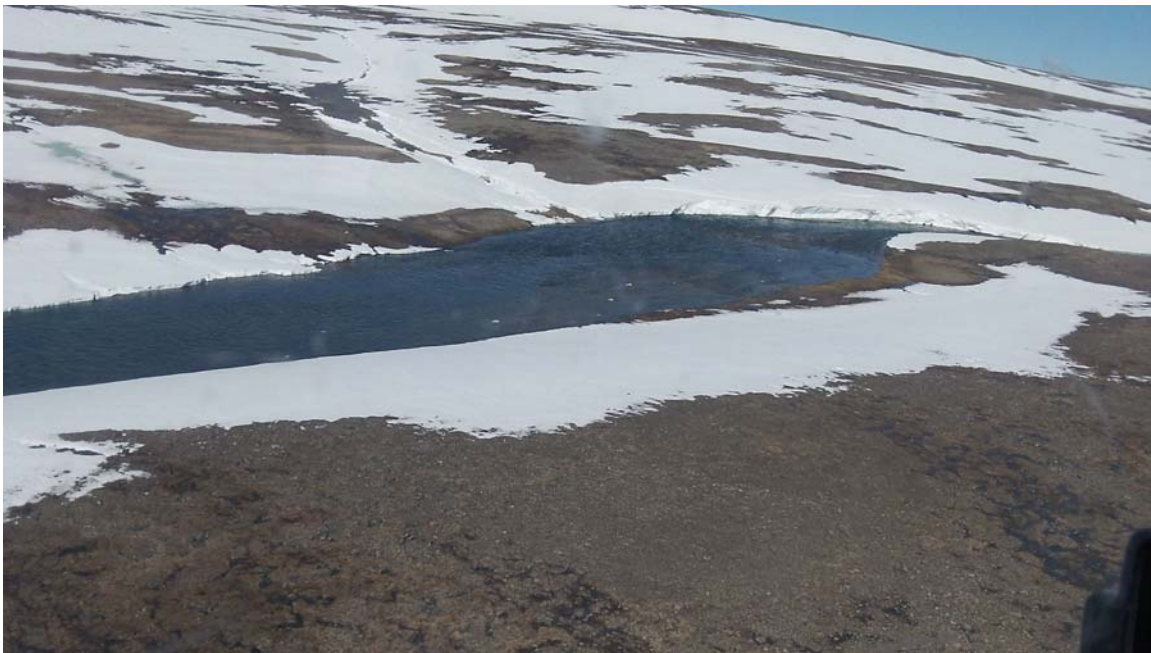
Photo 6: Water pump site, pre operation. View towards the north. The pump would be situated near the snow line on the southern side of the brook.

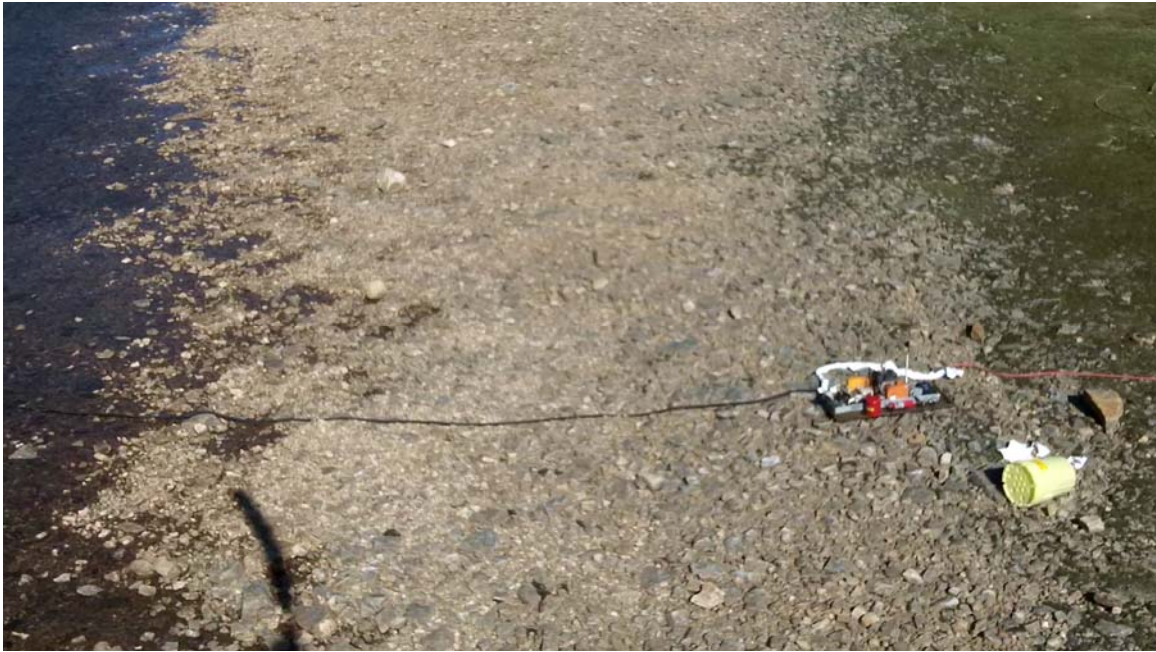
Photo 7: Pump site, during operation. View from helicopter towards the east.

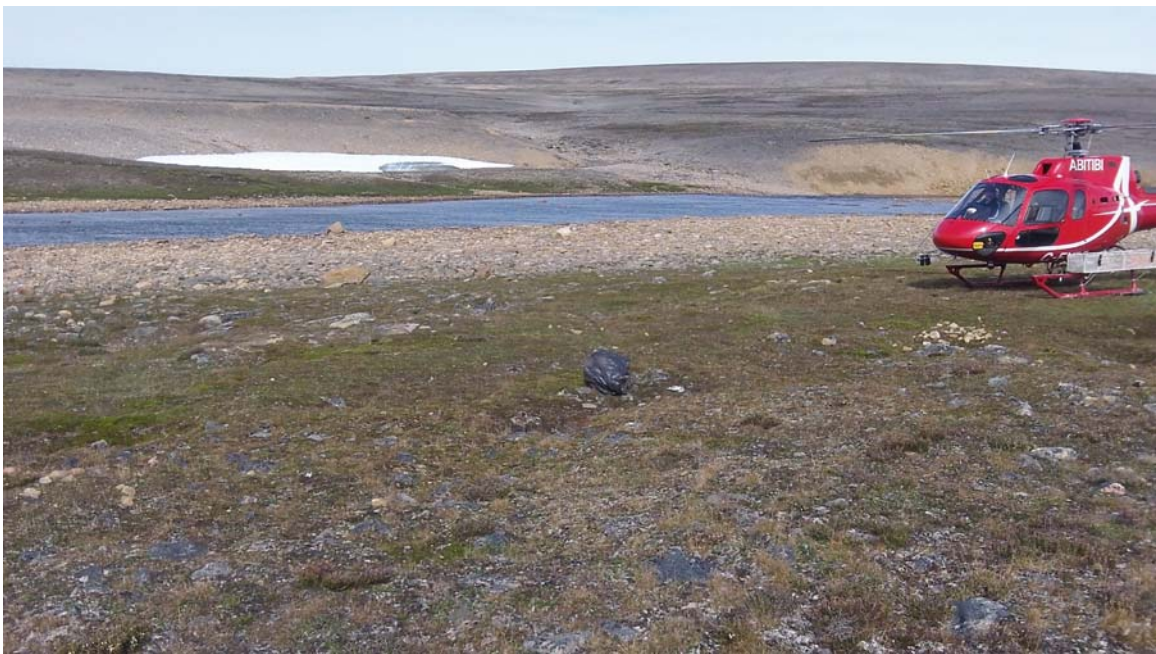
Photo 8: Pump site, post operation. View towards the north, garbage bag marks the pumps location.
