PHASE 2 OF THE HOPE BAY PROJECT
DRAFT ENVIRONMENTAL IMPACT STATEMENT

Doris North Gold Mine Project: Roberts Outflow
and E09 Fish Habitat Enhancement Report

Roberts Outflow and E09 Fish Habitat Enhancement Report

December 2012
Project #1009-008-11

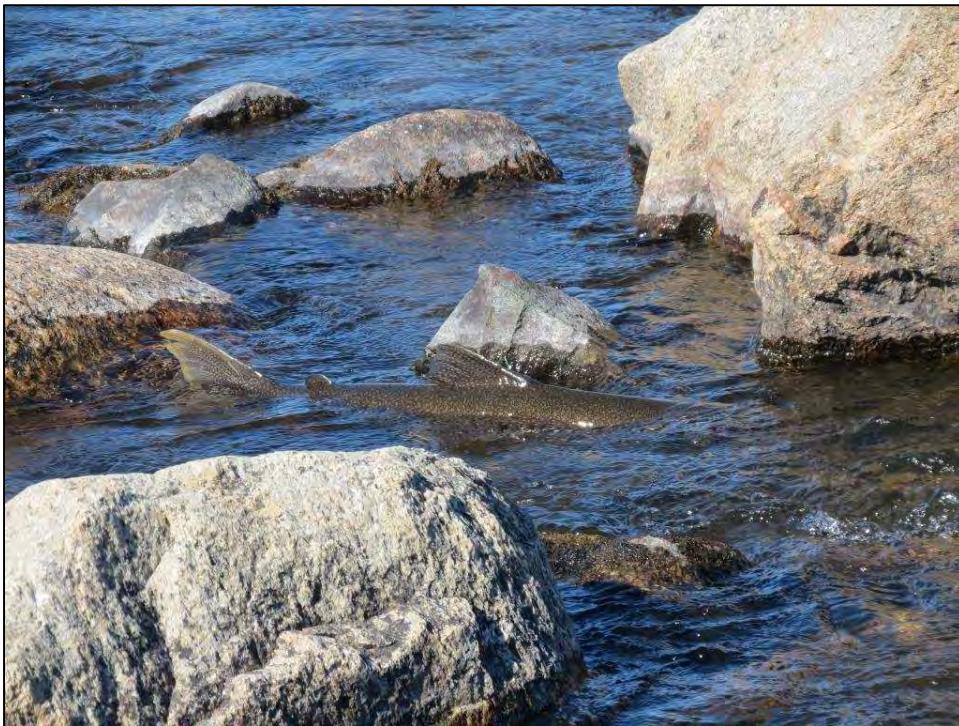
Plate 2.1-1. A large adult lake trout struggling in the stranding zone of the boulder garden.

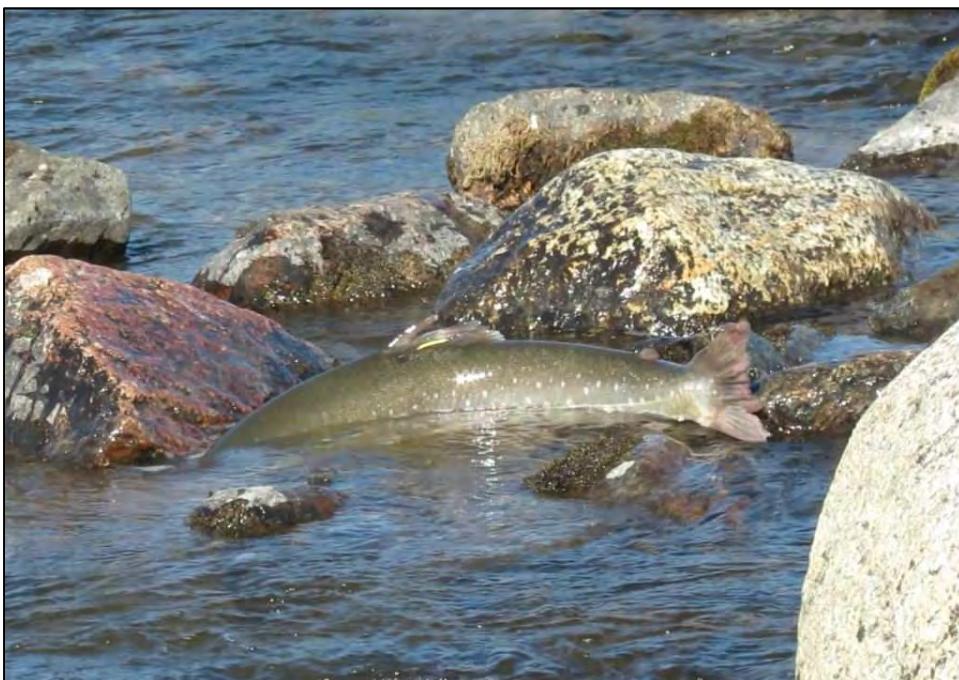
Plate 2.1-2. An Arctic char that was trapped between boulders upstream of the “stranding zone.”

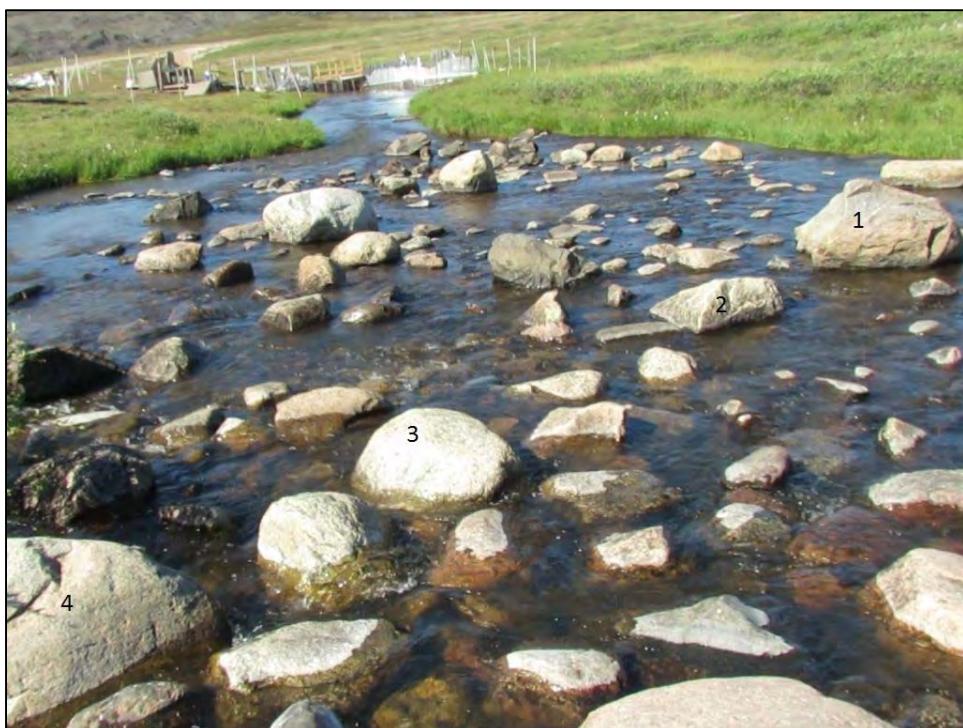
Plate 2.1-3. The stranding zone of the boulder garden before enhancement.

A channel 12 m in length was constructed through the “stranding zone”, following the approach described in the NNLP (channel 3 in Figure 2.1-2). This channel started at the upstream end of staging pools at the downstream end of the boulder garden, and travelled diagonally across the boulder garden to the far bank (Figure 2.1-2). Plates 2.1-3 and 2.1-4 are photographs from before and after construction of the channel through the “stranding zone”. Selected boulders are numbered in both plates for reference.

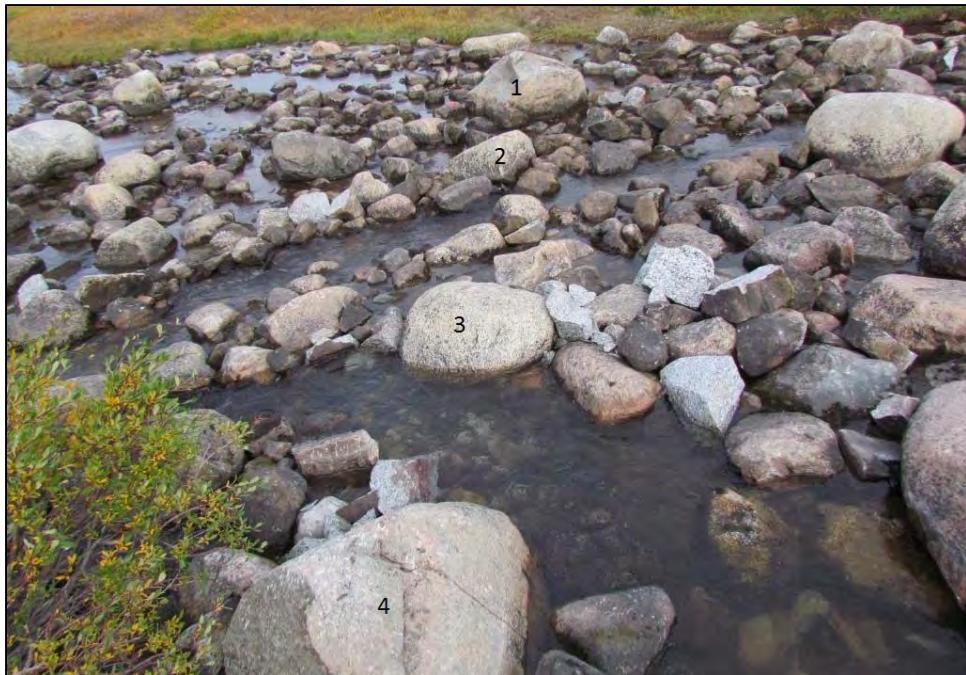
Plate 2.1-4. The stranding zone of the boulder garden following enhancement. Two channels traverse the stranding zone.

Additional channels were constructed to improve access to Roberts Lake. In addition, because fish struggled to get beyond the top of the original channel built through the “stranding zone”, this channel was extended (channel 1; Plate 2.1-5 and 2.1-6).

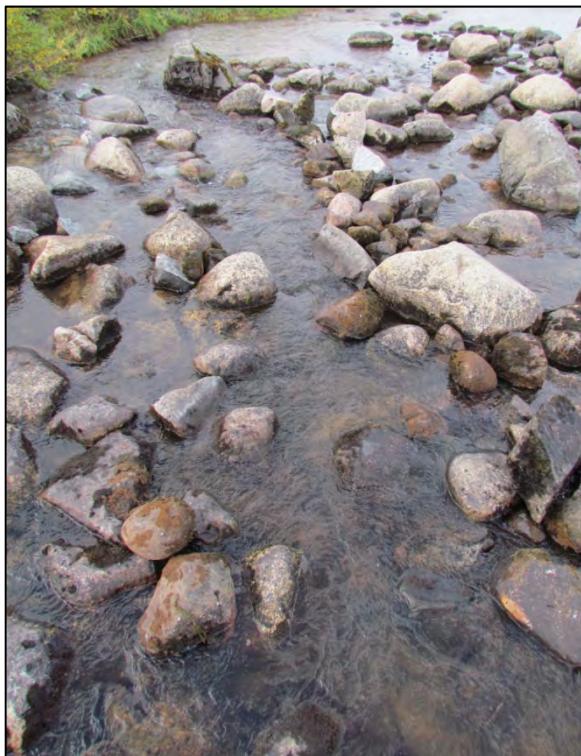
Plate 2.1-5. The constructed diagonal channel through the stranding zone of the boulder garden.

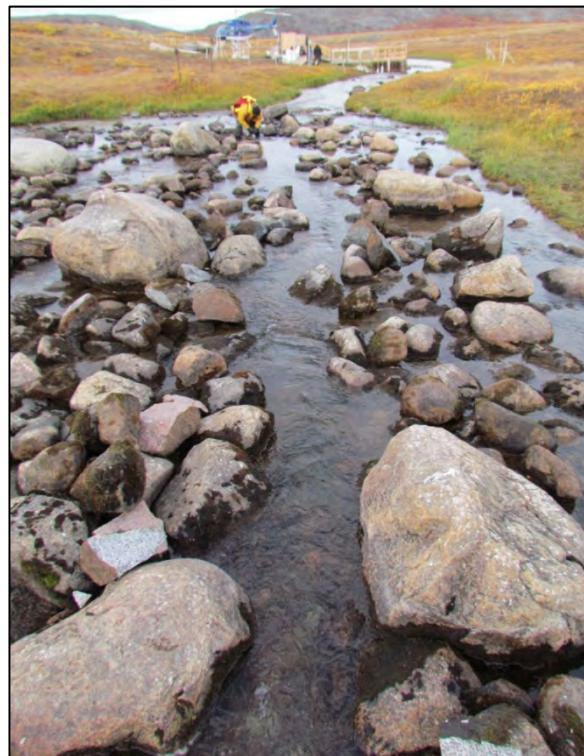
Plate 2.1-6. Channel 1 was constructed to provide access from the end of the channel through the stranding zone upstream to the lake.

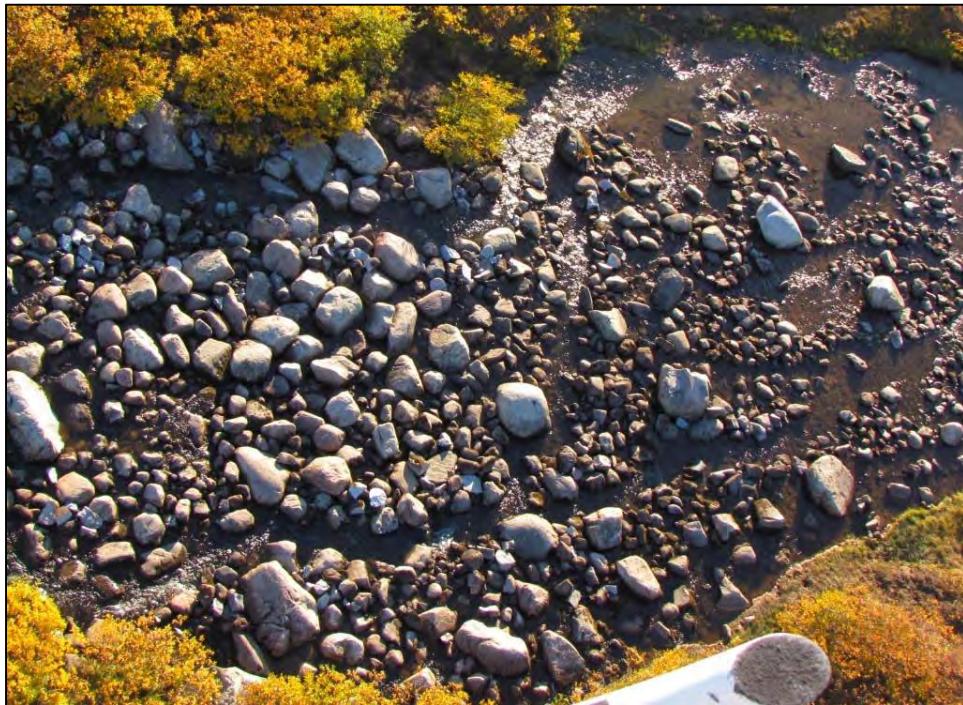
Plate 2.1-8. The middle section of the boulder garden with a new channel. Fish were observed freely swimming through the new channel.

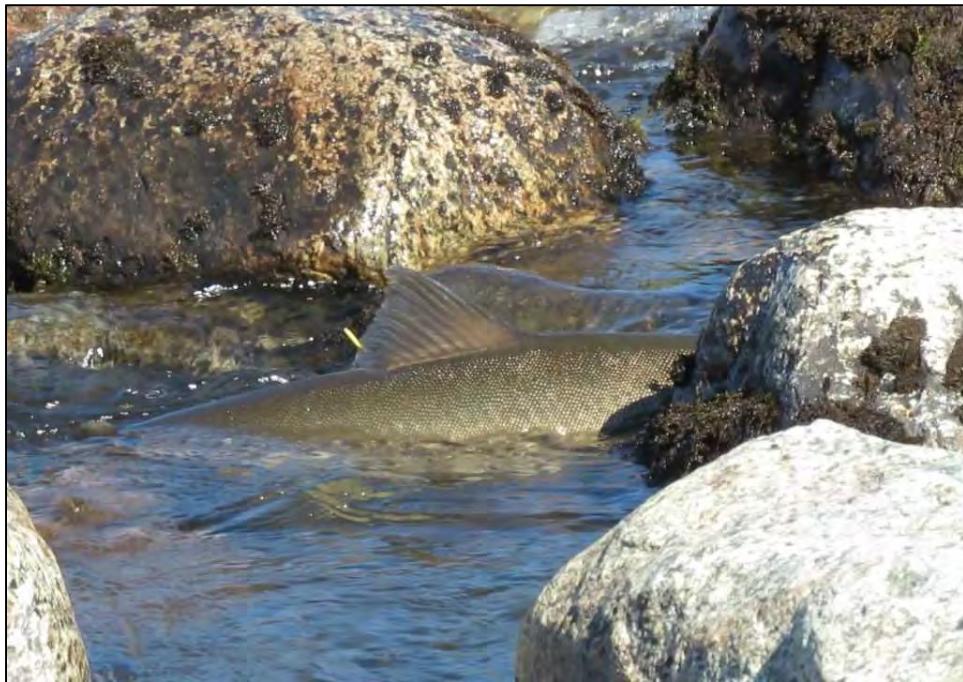
Fish were also easily observed when they were in the boulder garden. Plate 2.1-11 shows an Arctic char trapped in the boulder garden prior to the enhancement work and Plate 2.1-12 shows an adult Arctic char struggling upstream of the staging area. Crews completed an extensive search for fish prior to working in any area. If fish were found in an area, crews would relocate to another area.

Plate 2.1-11. Arctic char trapped in the boulder garden were easily observed by crew members.

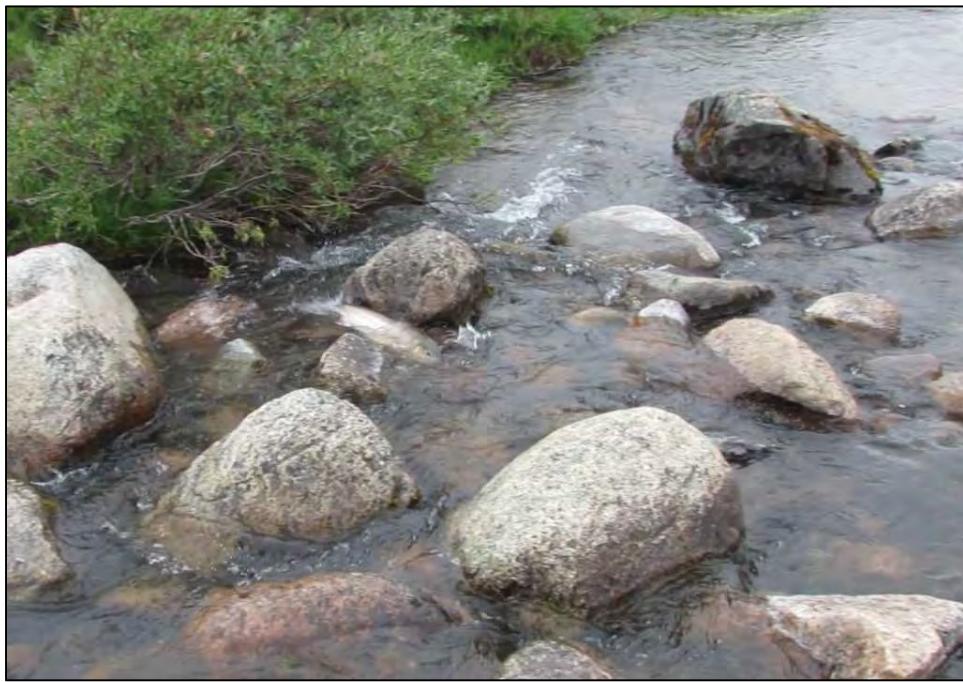
Plate 2.1-12. An Arctic char struggling upstream of the staging area.

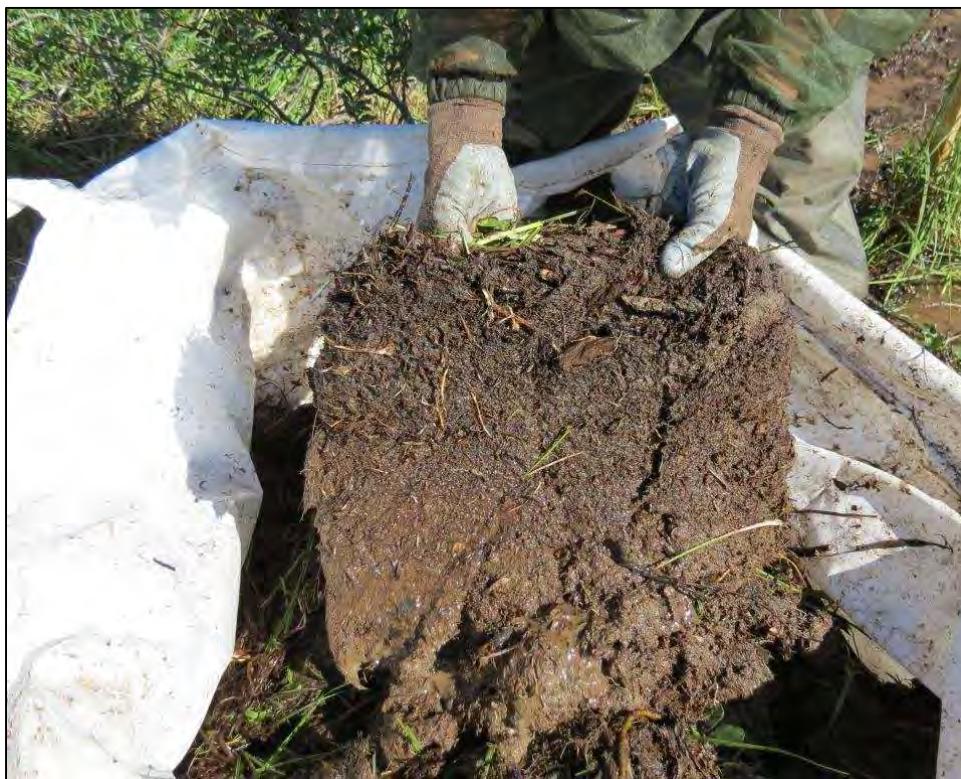
The ground in the work area was primarily made up of dense root masses of grasses, sedges and willows. Plate 2.2-1 shows an example of a root wad. These dense root wads were cut using a hand saw, pried out with shovels, loaded into mega bags, and removed from site by helicopter.

Plate 2.2-1. Dense root masses needed to be cut using hand saws, were loaded into mega bags, and removed from sites.

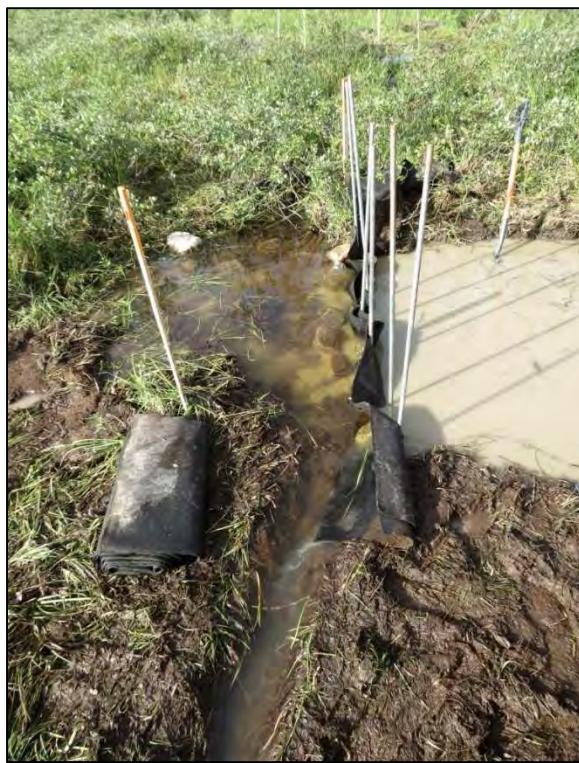
Plate 2.2-2. The work area (right) was effectively isolated from the flowing channel (left) using silt fences. This kept downstream turbidity within acceptable levels.

Silt fences were used to isolate the work areas and to minimize the release of turbidity into the creek. Each pool was constructed in sections and flow was maintained around the site. Plate 2.2-2 shows active work area on the right hand side, isolated from the creek by silt fences. This silt fence was left in place for four weeks after the completion of work so that most of the sediment would fall out of suspension before it was reconnected with the main channel.

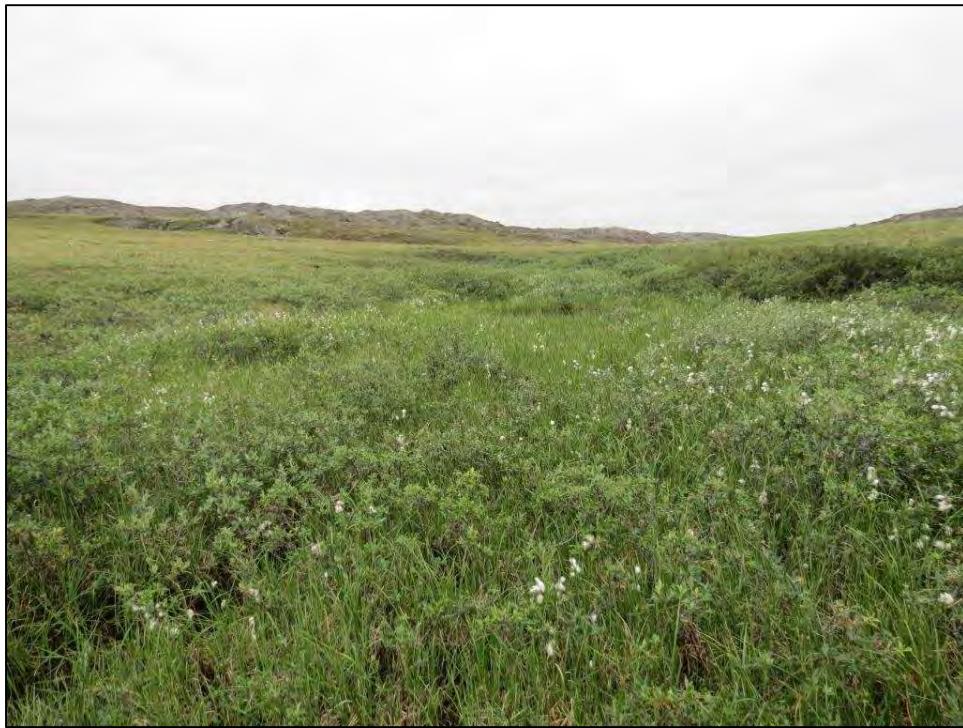
The channel through this area was poorly defined prior to the enhancement. Plate 2.2-3 shows the enhancement area before work started. Water was seeping through vegetation over an area several metres wide. Flow was widely dispersed and very shallow and would have restricted fish movement under most flow conditions. The lack of a defined channel meant there were no existing channel banks to define where the ponds should be located so they were positioned in the centre of the lowest point in the channel. As previously described, the pools were dug in sections and flow was diverted around the work area to reduce the release of sediment into the creek.

Plate 2.2-3. There was not a defined channel through the area prior to enhancement.

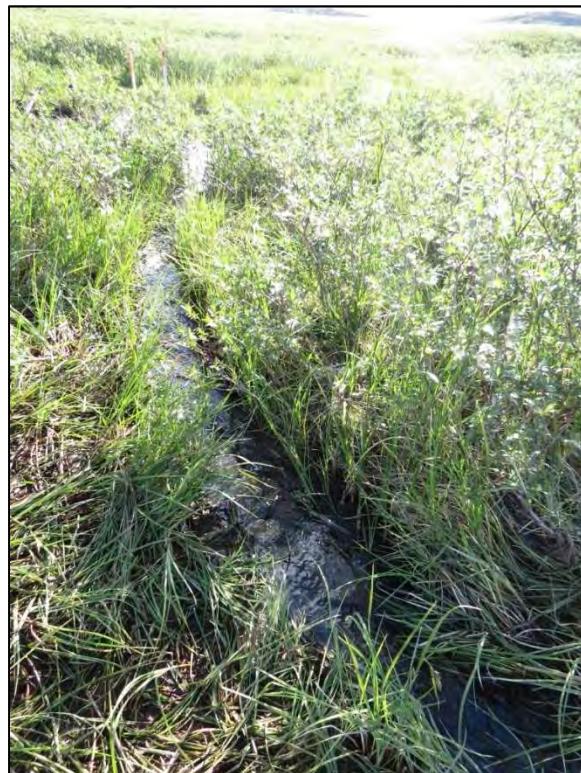
Plate 2.2-4. The new channel will allow fish to move through the area in low flow conditions.

A small channel was created upstream and downstream of the ponds to connect them to the nearest naturally occurring ponds in the area. As previously described, dense vegetation and dispersed flow reduced connectivity through the area. The new channel will permit the movement of fish through the area even in low flow conditions. Plate 2.2-4 shows the newly constructed channel flowing between the two new pools.

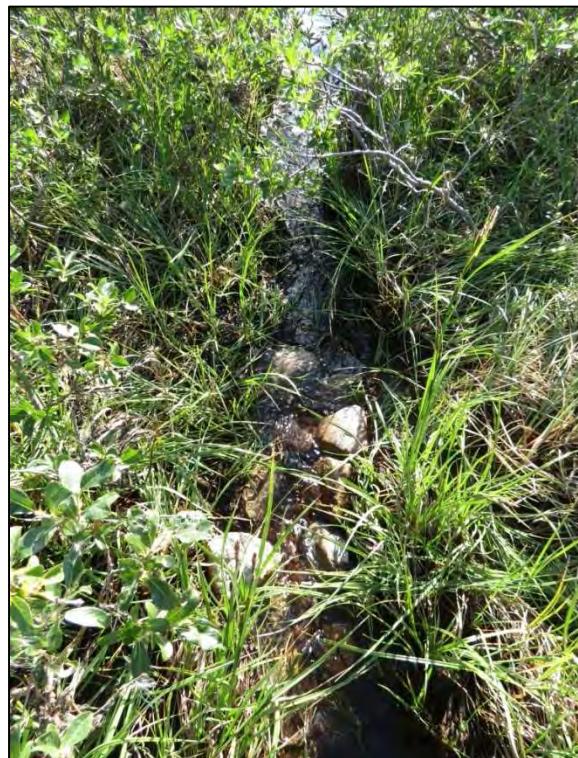
Plate 2.2-5. A small rock weir installed in the new channel will provide additional fish habitat.

The pools were constructed so that they mimicked other naturally formed pools in the area. Two mega bags of local, naturally occurring cobbles and boulders were slung to the site by helicopter and were used to enhance the site. The newly constructed channel that connected the pools was partly lined with rock and some small weirs were installed. These weirs were designed to provide additional habitat for fish. In addition, the focused flow and rock will prevent the channel becoming overgrown with vegetation. Plate 2.2-5 shows a rock weir constructed in the new channel.
