Review of Fuel Tank design at Goose Lake mine site, Back River Project

Re: Review of Fuel Tank Design at Goose Lake Mine Site, Back River Project.

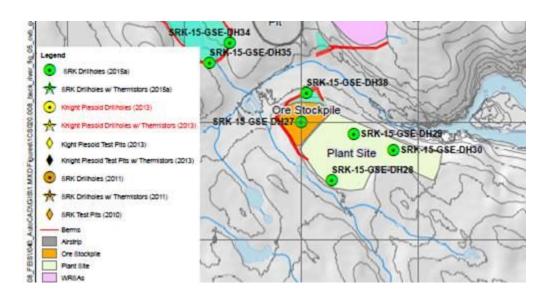
Map is provided by Sabina.

Sabina has numerous geotechnical holes in the Plant Site Area and specifically in the Fuel Storage Area at Goose collected during the original EA and Water Licensing Phase and in the years since. I will ensure this information is included in future applications. I have attached a map which illustrates the geotechnical holes drilled in 2017 – you will note there is one hole (17GGT012) directly on top of the 10ML fuel tank, 1 more directly in the in-Fuel Storage Area, and 2-3 more in the nearby vicinity. Below is also a snip from the Back River Property Geotechnical Design Parameters Report submitted during the original Type A Water Licence Application (171002 2AM-BRP----MAD App F-2_GeotechDesignRpt-IMLE) which illustrates additional geotechnical drill holes completed in 2015.
