Tahera Diamond Corporation

NORTH DAM  
GEOTECHNICAL SITE INVESTIGATION  
JERICO DIAMOND MINE, NU

1100060.011

July 2007

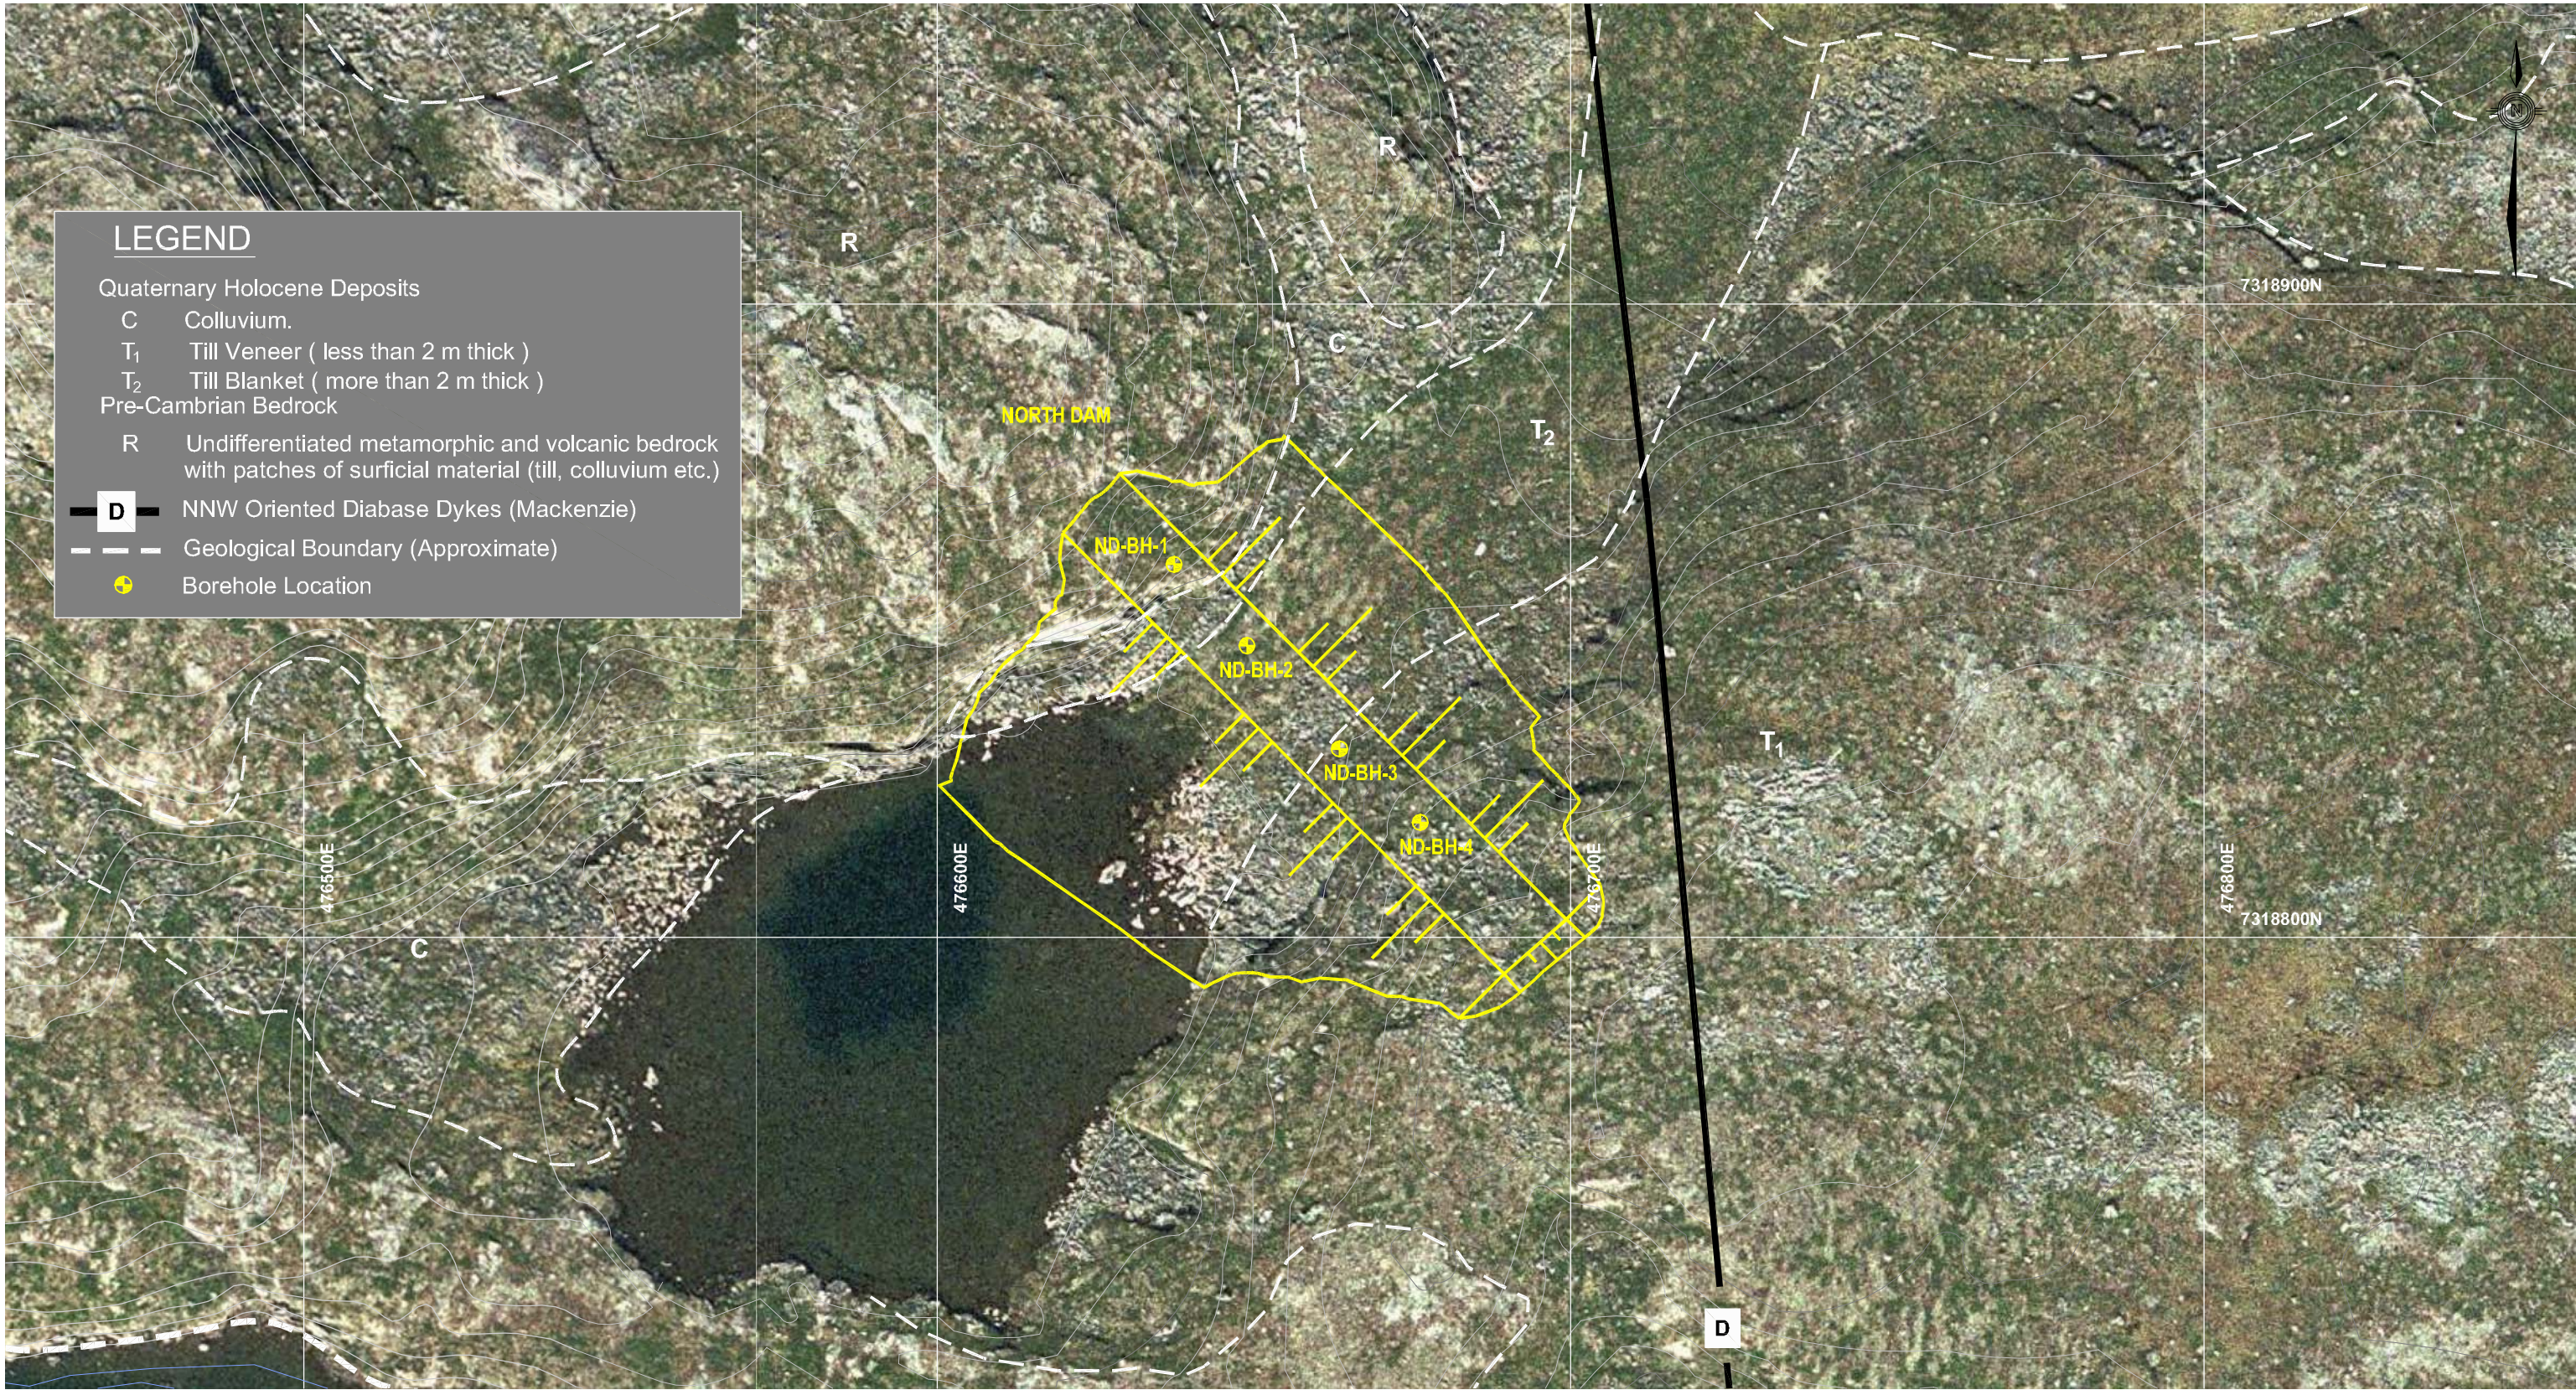
PROJECT NO./FILE NO. 1100060.011 1100060011Q012b.dwg	DWN DBD	CKD GK	REV 0	Figure 2
		OFFICE EBA-EDM	DATE July, 2007

Boreholes were drilled along the proposed dam alignment as shown in Figure 2. Boreholes ND-BH-1 and ND-BH-4 were located along the dam abutment and Boreholes ND-BH-2 and ND-BH-3 were located in the valley. Borehole ND-BH-3 was sited in an

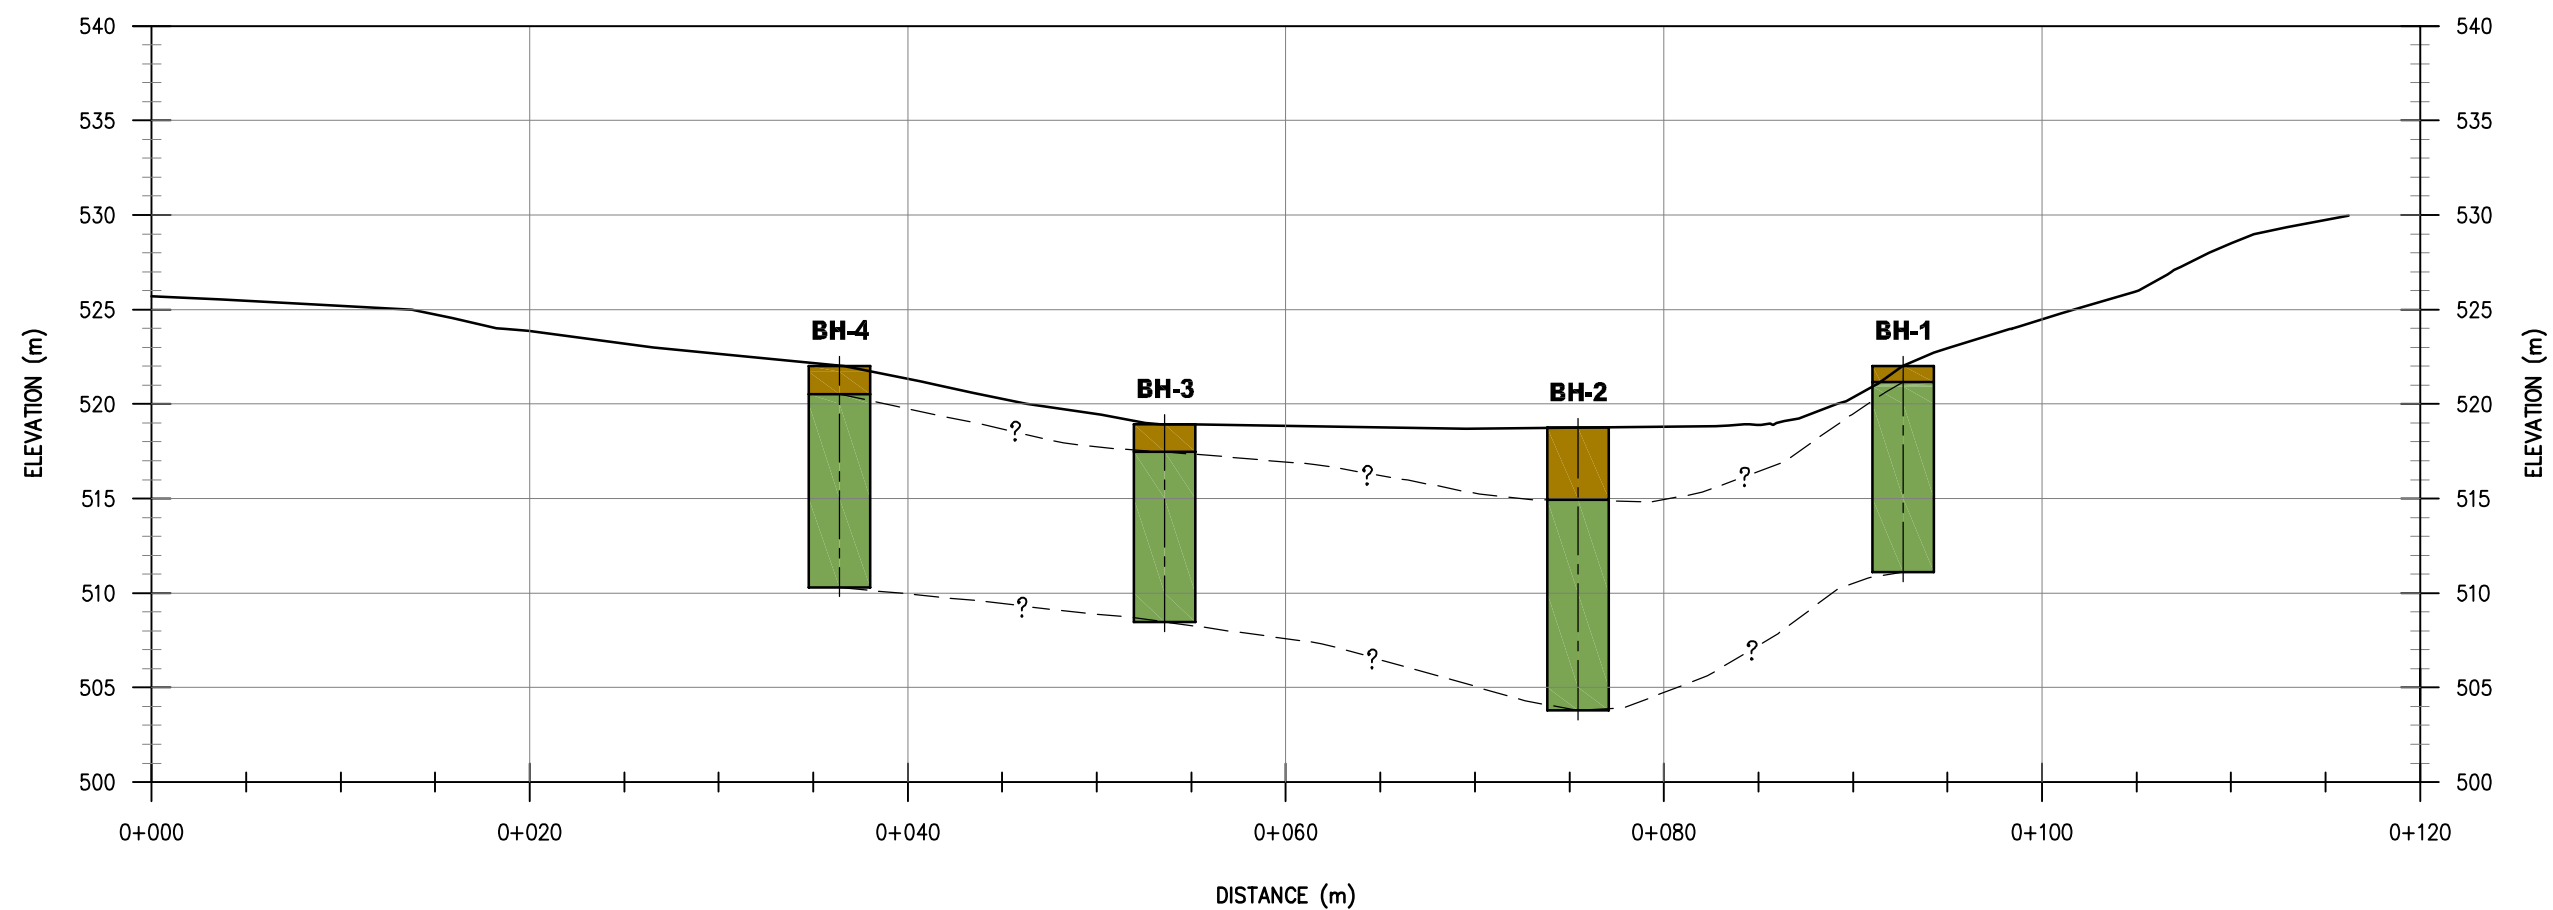
Figure 3 shows the subsurface conditions along the proposed dam alignment. Generally the soil stratigraphy can be described as silty sand till overlying bedrock. The overburden within the boreholes contains limited excess ground ice. A more detailed description of the overburden and bedrock follows.

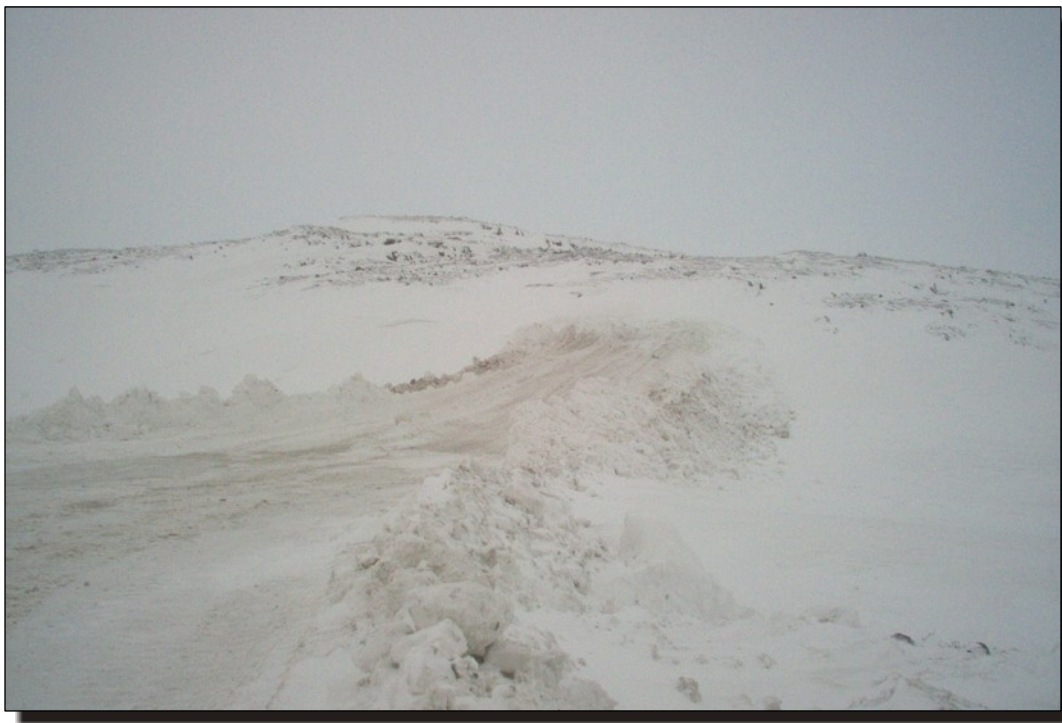
**Photo 1**

Snow/ice pad constructed to access Borehole ND-BH-1. Looking northwest from south abutment.  
Photo taken February 2007.

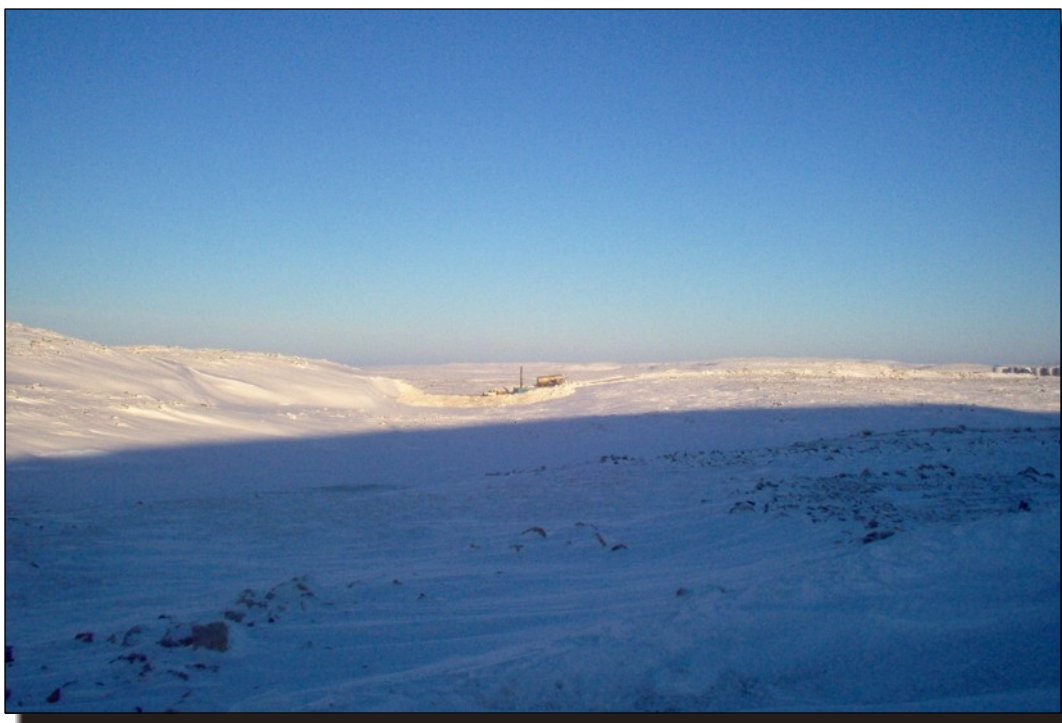
**Photo 2**

Ice pad at North Dam. Drill rig set up on Borehole ND-BH-04. Photo taken February 2007.

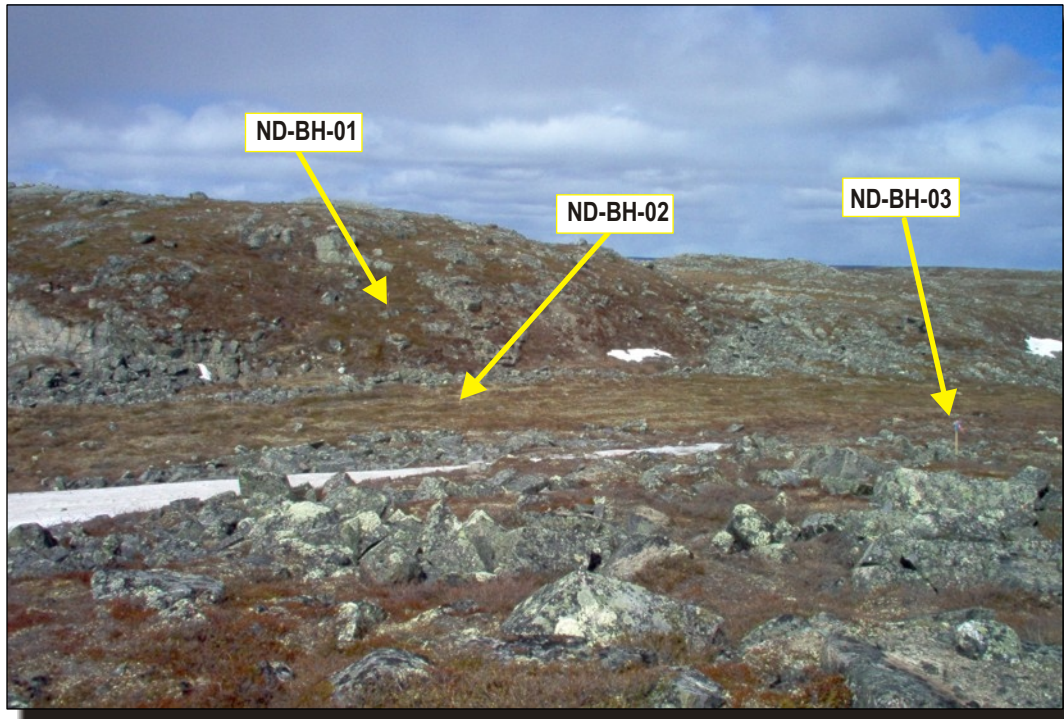
**Photo 3**

The valley floor is approximately 30 m wide and is located in the till blanket terrain unit. The valley floor is relatively flat and surface conditions consist of well vegetated till with some scattered boulders (Photo 3). There is a small boulder field at the toe of the south abutment, progressing a short distance up the slope.

Valley area and north abutment facing north. Photo taken June 28, 2005. Borehole locations have been staked.

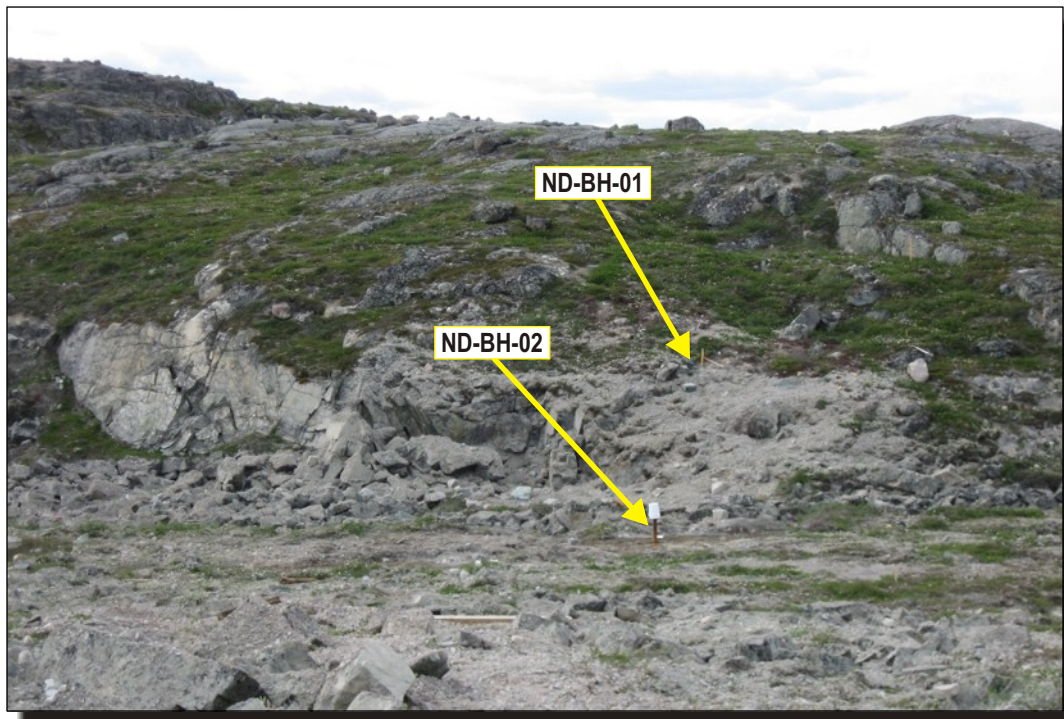
**Photo 4**

North abutment area, looking northwest. Surface gravel is from melting snow/ice pad. Photo taken July 11, 2007.

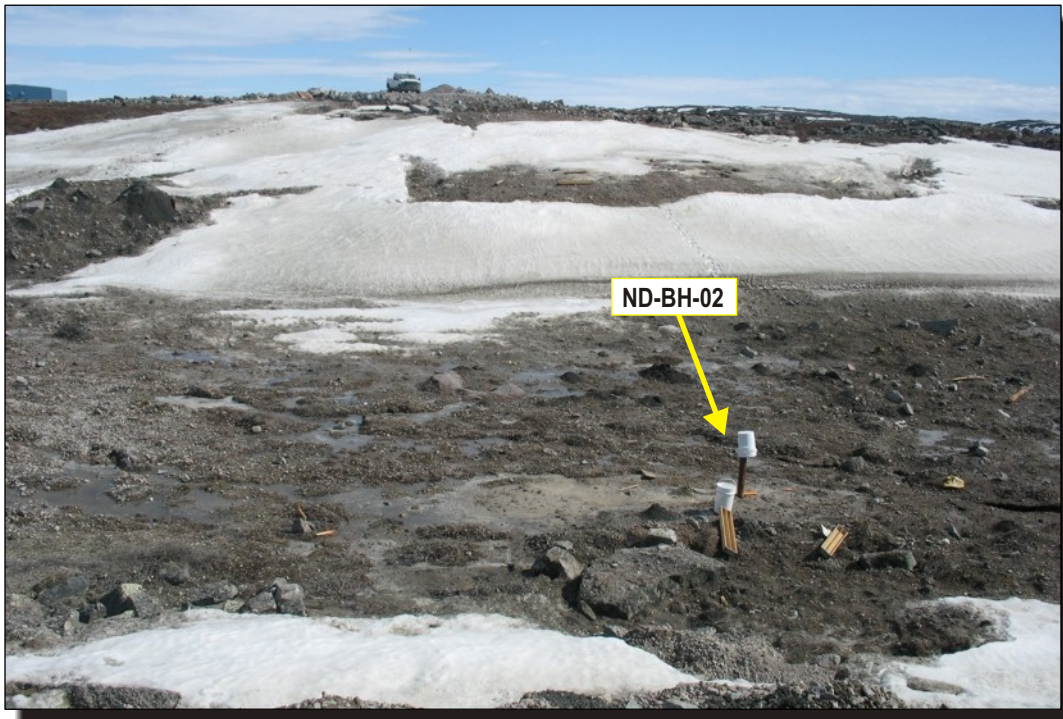
**Photo 5**

The south valley slope is less steep with grades in the order of 6.5H:1V. Surface conditions consist of scattered surface boulders separated by areas of vegetated till. The south slope is shown in Photo 5.

South abutment looking southeast. Note gentler slope and absence of outcropping bedrock. Surface gravel is from melting snow/ice pad. Photo taken June 11, 2007.
