MEADOWBANK GOLD MINE

FRESHET ACTION AND INCIDENT RESPONSE PLAN

OCTOBER 2015

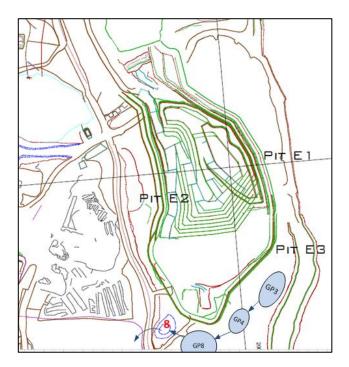
- A pond and ditch system south of Pit E pushback is presented in Figure 2-1. Runoff water accumulated in ponds GP-3, GP-4, GP-8 and Pond 8 will be pumped into Goose pit;
- A pumping station located in pit B (not shown) will be used to manage runoff water affecting the active mining production area in pit A. The water will be pumped to the South Cell Tailings Storage Facility (TSF); and
- A pumping station located in pit E (not shown) will be used to manage runoff water affecting the active mining production area in pit E. The water will be pumped to the South Cell TSF.

Figure 2-1: View of Portage Pit E area with the associated sumps and trenches

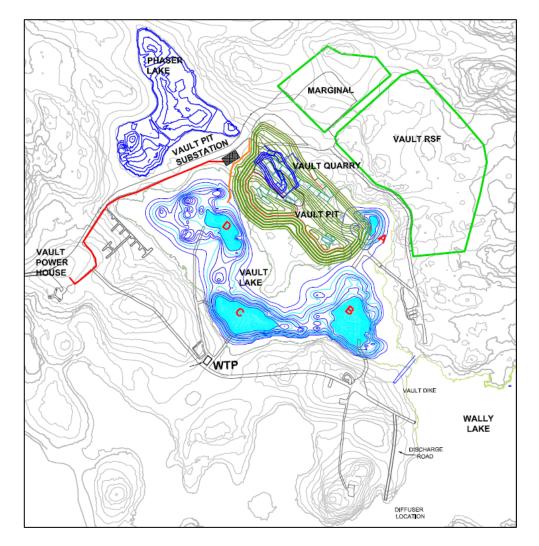
Since the summer of 2014 (dewatering completed) Vault Lake is now used as an Attenuation pond. The light blue surfaces in Figure 2-2 represent four isolated ponds that form the Attenuation pond (A, B, C & D) used to collect contact water from Vault Pit. Runoff from the pit area and the waste rock storage area that flows into the active mining areas will be pumped to the Attenuation pond.

Figure 2-2: View of Vault Attenuation pond its associated ponds

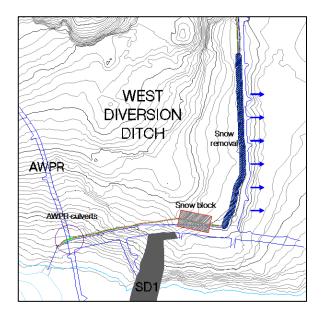
Figure 2-4 illustrates this culvert. Snow and/or ice must be removed using an excavator on each side of the culvert to allow water to flow through to prevent upstream ponding. The culvert may need to be steamed if blocked by ice. Before starting the cleaning operation, it is important to ensure that the electrical cable (5kV) location has been visually identified.

After flowing through the culvert the water discharges across the tundra into Third Portage Lake – see Figure 2-4 below. Snow and ice needs to be removed in early May to prevent any back up in the West Diversion ditch. This could increase water levels upstream in the ditch causing problems discussed in Section 2.3.1.2. If necessary silt curtains will be installed at the discharge area to Third Portage Lake to control elevated TSS during the freshet period.

Figure 2-4: West diversion ditches area of interest

A turbidity barrier installed in 2014 has been left in place over the winter. Additional barriers can be installed after ice melt as a contingency. Daily inspections will be conducted starting in mid-May. Sample monitoring will commence when open water is present in accordance with the Water License (ST-6). Sampling frequency of ST-6 may be increased if TSS results are near 30 mg/L (grab) and 15 mg/L (monthly average), or visually elevated. If a discharge of TSS occurs, the Environment Department will notify DFO.

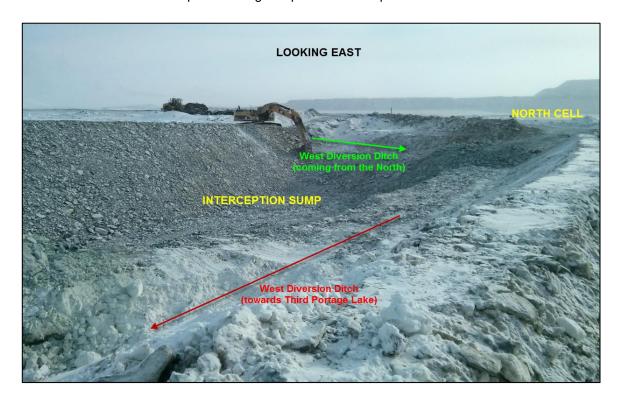
As a further precaution, AEM constructed an interception sump located at the west diversion ditch elbow location in 2014. The sump has a capacity of 3000 m³. The sump is designed to intercept water coming from the most critical parts of the West Ditch. Sample monitoring will determine if there is any seepage from the TSF or elevated TSS from the ditch. If water does not meet discharge criteria it will be pumped back to the North Cell TSF. These measures will prevent any contaminated water from reaching Third Portage Lake. This sump will also act as a settling pond

to prevent water with elevated TSS from reaching Third Portage Lake. Daily inspections will be conducted during the freshet. Sample monitoring will also be conducted if necessary. Figure 2-5 shows the North Cell interception/settling sump after the completion of the construction.

Figure 2-5: North Cell West Diversion ditch interception sump

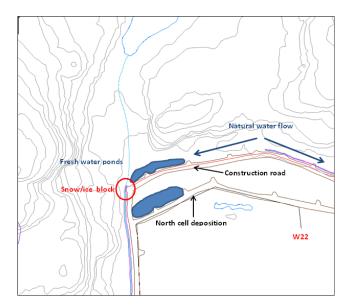
The construction access road at the Northwest corner of the North Cell TSF (see Figure 2-6 and Figure 2-3 #3) is vulnerable to damage from the freshet water flow from the northern watershed (see watercourse flow in Figure 2-6 denoted by light blue dotted line). The start of the West Diversion ditch is also located in this area and is designed to collect most of the freshet flow – note arrows in Figure 2-6. In order to prevent the water from accumulating against the access construction road and possible overflow to the tailings pond, the snow and ice must be removed in early May from the areas indicated by the red circle in Figure 2-6. This is very important as the start of the West ditch is shallow, must manage a high initial flow rate and can plug easily (with snow). Also, note in the Figure 2-6 two areas where water ponded during the 2013 and 2014 freshet. As a contingency, a pump can be utilized to transfer this water to the North Cell TSF or the West Diversion ditch (non-contact water only). In addition, to prevent any contamination of Third Portage Lake, daily inspections will be completed and samples will be taken if AEM suspects that any seepage contamination is migrating out of the TSF (analysis for CN and metals). If water is contaminated with tailings, the water will pumped back to the TSF.

Figure 2-6: View of the northwest corner of the ditches

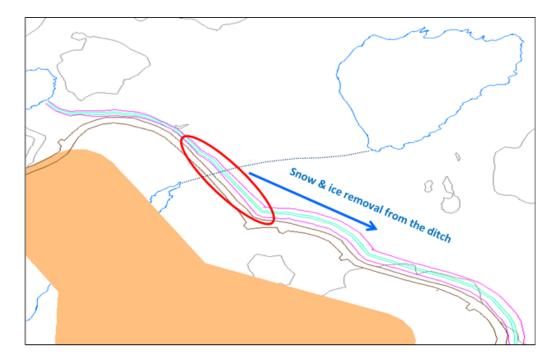
There is a low point located on the northernmost portion of the East Diversion ditch – see Figure 2-7 below and Figure 2-3 #4. Snow needs to be removed from this area, denoted by the blue arrow, to prevent watershed flow from following the historical watercourse (dotted line) and reaching the toe of the NPAG Waste Rock extension (RSF). Removing the accumulated snow in early May at a downstream location referenced by the blue arrow will allow the runoff to flow freely through the East Diversion ditch to NP-2 Lake. Daily inspections will be undertaken to ensure the watershed non-contact water flows freely in this section of the East Diversion Ditch.

Figure 2-7: View of the north low area where a snow build up retained water in spring 2013

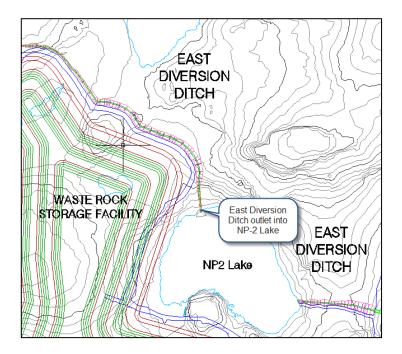
This area of the East Diversion ditch, seen in Figure 2-8 and Figure 2-3 #5, is critical as it acts as the outflow of the North part of the East Diversion ditch into NP-2 Lake. This outlet must be cleared of obstructions – snow and ice in early May to promote drainage through the ditch and into NP-2 Lake. The presence of ice blocks will be mitigated using the steam machine to melt away the obstruction. Daily inspections will commence in early May and sample monitoring will be conducted monthly during open water in accordance with the Water License (location ST-5). Sampling frequency of ST-5 may be increased if TSS results are near 30 mg/L (grab) and 15 mg/L (monthly average), or visually elevated. Turbidity barriers have been installed at the ditch outlet into NP-2 in 2013 to mitigate elevated TSS. If a discharge of TSS occurs, the Environmental Department will notify DFO.

Figure 2-8: View of the East Diversion ditch outlet into NP-2 Lake

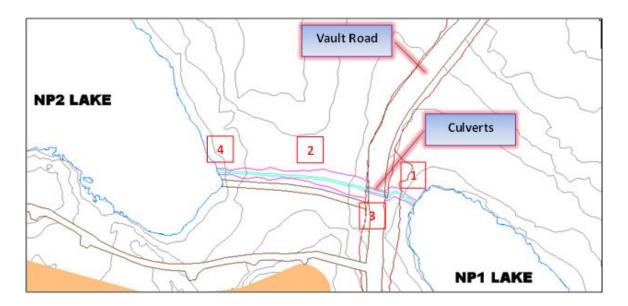
This area of the East Diversion ditch is critical as it acts as the outflow of NP-2 Lake through the Vault Road culvert (see Figure 2-3 #7). The culvert seen in Figure 2-9 connects the East Diversion ditch from Lake NP-2 to NP-1. Snow and ice must be removed from the area, including upstream at the exit of NP-2 Lake in early May to ensure that the outlet of NP-2 flows freely to NP-1 and ultimately to Dogleg Lake. Back up could cause upstream water raises in Lake NP-2 which could cause overflow into the RSF at ST-16. First, snow from the ditch between NP1 and the road (1) would be removed in early May. Next, any obstruction between the road and NP2 Lake (2) would be removed. If needed, the steam machine would be used to remove the ice and snow from inside the culvert (3) and ensure that any other ice obstructions were removed from the outlet of NP2 Lake (4) to allow free flow of melt water. Daily inspections will commence in early May and TSS sample monitoring will be conducted monthly. Sampling frequency may be increased if TSS results are near 30 mg/L (grab) and 15 mg/L (monthly average), or visually elevated. A turbidity barrier (orange barrier #1) was installed in 2014 at the ditch outlet into NP-1 to mitigate the risk of elevated TSS (Figure 2-10). If a discharge of TSS occurs, the Environmental Department will notify DFO.

In June 2015, while conducting regular inspections as per the Freshet Action Plan, AEM staff observed elevated TSS in the water running under Vault Road (culvert) toward Lake NP-1. The flow was largely localized due to a large accumulation of snow in this area, significant snowmelt occurring due to spring freshet and recent heavy rain. After some additional melting of ice and snow it was clear that water with elevated TSS was flowing past the turbidity and silt barrier that

Figure 2-9: View of the diversion ditches at the Vault road area

was in place from last year, onto the lake ice. A second turbidity barrier (yellow barrier #2) was installed just outside of the first barrier. Two additional barriers were also installed as a precautionary measure at the outlet of NP-1 (barrier #3) and at the inlet of Dogleg Lake (barrier #4) (Figure 2-11). The incident was of short duration and the turbidity barriers prevented migration of TSS to Dogleg Lake which is fish bearing. AEM also proceeded to raise the Vault road near NP-1 culverts (Figure 2-12). A different source of aggregate — NPAG from Vault was used (harder material) which will prevent an accumulation of fine material and will allow for water to runoff instead of accumulating or percolating through the road. For the next winter season there will be no additional snow from ploughing placed in this area.

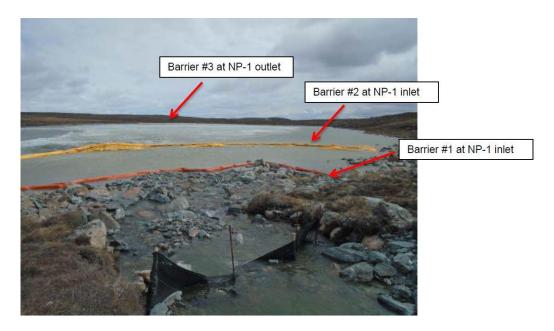
Figure 2-10:Turbidity barriers at inlet of NP1

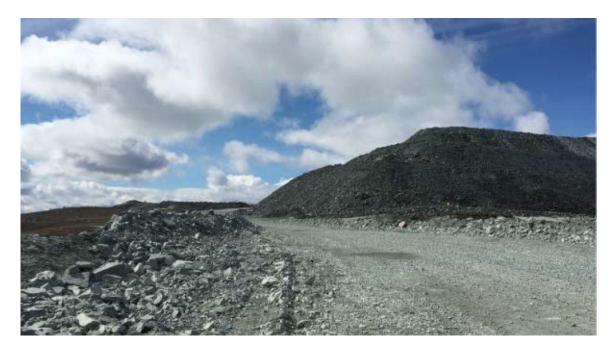
Figure 2-12: Vault Road repair

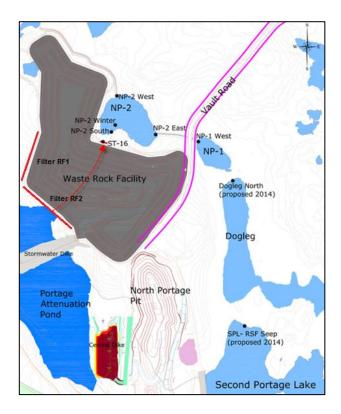
In July 2013, it was noted that seepage from the Waste Rock Storage Facility (RSF) had migrated through a rockfill road at a seepage sump located on the north-east side of the RSF (see ST-16 on Figure 3-1). The seepage, which contained elevated copper, nickel, ammonia and cyanide entered NP-2 Lake. It was determined through investigation that the likely source of the contaminants was reclaim water from the North Cell TSF. This water migrated underneath the RSF through a former watercourse into the seepage sump area (ST-16). AEM took immediate measures to stop the seepage and implement corrective measures to prevent a recurrence. This included, keeping the sump area pumped to a low level, installation of an impermeable barrier (till plug) in the rockfill road, implementation of a comprehensive monitoring program and ensuring tailings deposition was enhanced in the North Cell to create beaches that would stop any water egress (this activity is continuous as it is part of AEM's Tailings Deposition Plan). A permanent pumping system was installed in 2014 in order to direct seepage back to the North Cell TSF. In addition, as mentioned previously (Section 2.3.1.6), snow will be removed from the ditches and culvert at the outlet of NP- 2 to NP-1 Lake to ensure freshet flows do not back up and overflow into the ST-16 seep location and that the north watershed non-contact runoff flows freely through to NP-1 Lake and further downstream (Dogleg Lake) Pumped volumes will be documented and daily inspections of the area will be undertaken. Please note that 2014 pump volumes are reportred in the AEM 2014 Annual Report within the Water Management Report and Plan (Section 3.1.9) and in Table 1 below.

Figure 3-3-1: View of the RSF seepage observed at the ST-16 station with a red arrow representing the flow of the seepage. Red Lines represent installed filters and areas where tailings beaches were built up to minimize flow through.

Also, in 2014, in accordance with the overall mitigation plan for this incident, tailings beaches were built along RF-1 and RF-2 before tailings deposition switched to the South Cell TSF on November 19 2014. Filters barriers were installed along RF-1 and RF-2 to prevent water egress from the North Cell (suspected source area). Coverplacement was installed in late 2014 and early 2015 along RF-2. Thermistors installed in 2013 indicate that freezeback is occurring along the seepage path. All the information collected in 2014 from the inspections, pumping, thermistors, and sampling results were compiled and submitted as progress reports to regulators. This report "Follow up AEM Report – Seepage Water From Waste Rock Storage Facility – Sample Location ST-16" can be found in Appendix G2 of the 2014 Annual report.

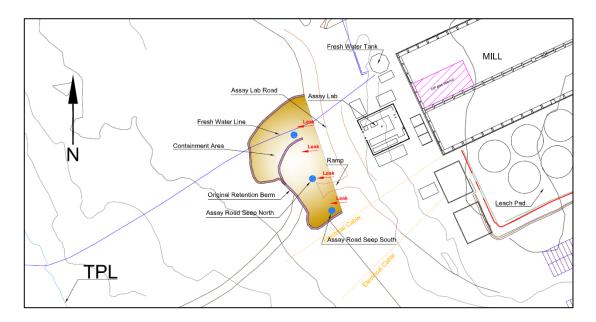
In November 2013, AEM observed seepage discharging at a location West of the site access road in front of the Assay Lab (see Figure 3-2). Initial sample results revealed elevated cyanide and copper which is indicative of mill processes. After an investigation, which included sampling, the source was determined to be seepage from several containment areas within the mill; the worst being the CIP tank overflow collection sump. Repairs to seal all the mill sumps and containment areas was completed in 2014 thus stopping the source of the seep. AEM hired Tetra Tech in December 2013 to propose a drilling delineation program and further steps necessary to control the seepage and prevent offsite migration to Third Portage Lake – see Figure 3-3 for the seep location. AEM completed the drilling program and based on the results constructed an interception/collection trench prior to the 2014 freshet (completed early May 2014).

Figure 3-3-2: View of the mill seepage area and initial retention berm construction

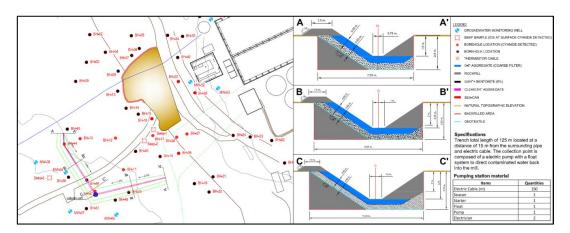
Figure 3-3: View of the mill seepage area and interception trench design

The design of the trench can be seen in Figure 3-3. A pumping system was installed and all water collected is pumped back to the mill. Pumping begins as soon as water is evident and volumes are recorded monthly – See Table 2 below.
