RE: Meliadine Mine Jetty A8 Design Report and Drawings for 2AM-MEL1631 water licence

## **Water Licence Inspection Report**

Authorization	Representative	
2AM-MEL1631	Sara Savoie	
Authorization No. / Expiry	Representative's Title	
March 31, 2031	Environmental Superintendent	
Inspection Date	Inspector	
May 21, 2025	RMO Kyle Amsel	
Other Authorization/s		
Activities Inspected		
☐ Municipal ☑ Camp, Commercial ☐ Drilling ☒ Mining ☒ Construction ☒ Reclamation ☒ Fuel Storage ☒ Roads/Hauling ☐		
Winter Hauling  Camp, Private  Other Click or tap here to enter text.

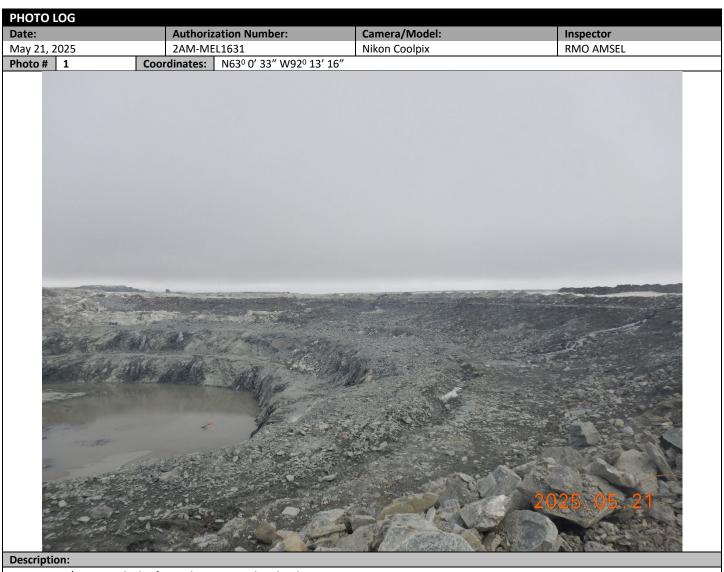
- 1) Pump Development
  - a) Pump 1/Containment Pond (CP) 9 (Photo 1 & 2)
    - i) During inspection it was noted that CP9 is not in it's completed phase for freshet. Representatives indicated at time of inspection that further removal of ore was required prior to commissioning as a containment pond. It is also noted that guarding of permafrost in the overburden layer is not completed.

- iii) Water from this area is pumped to CP4.
    - iv) The Inspector is concerned that melting of the permafrost around CP9 could occur with summer season approaching.

Pump Pit 1/CP9. Not lack of guarding on overburden layer.

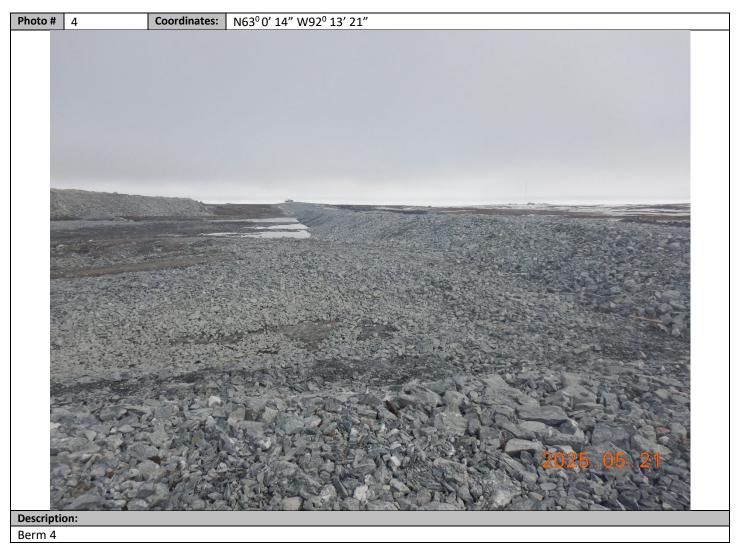
- c) Berm 4 (Photo 4)
    - i) Berm 4 has been completed and there are no concerns noted by the Inspector.
  - d) CP9 Thermal Berm (Photo 5 & 6)
    - i) The CP9 Thermal Berm has been completed. All capping and thermistors to monitor freeze level are in place. There are no concerns raise by the Inspector.

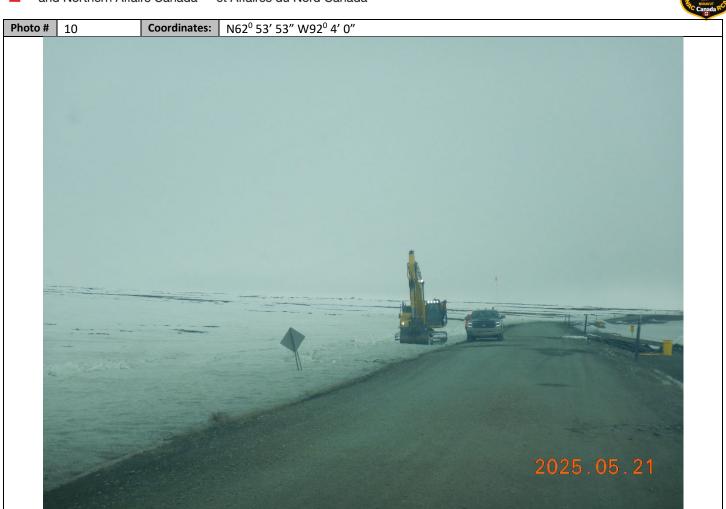
**Description:**

- f) Work is continuing on Pump Pit 2 (Photo 9)
- 2) Pre-Freshet work
  - a) During the inspection activities on the All-Weather Access Road (AWAR) were ongoing. An excavator was actively engaged in the clearing of culverts between km 12 and km 13.(Photo 10)

Crews removing snow and ice from culverts along the AWAR.

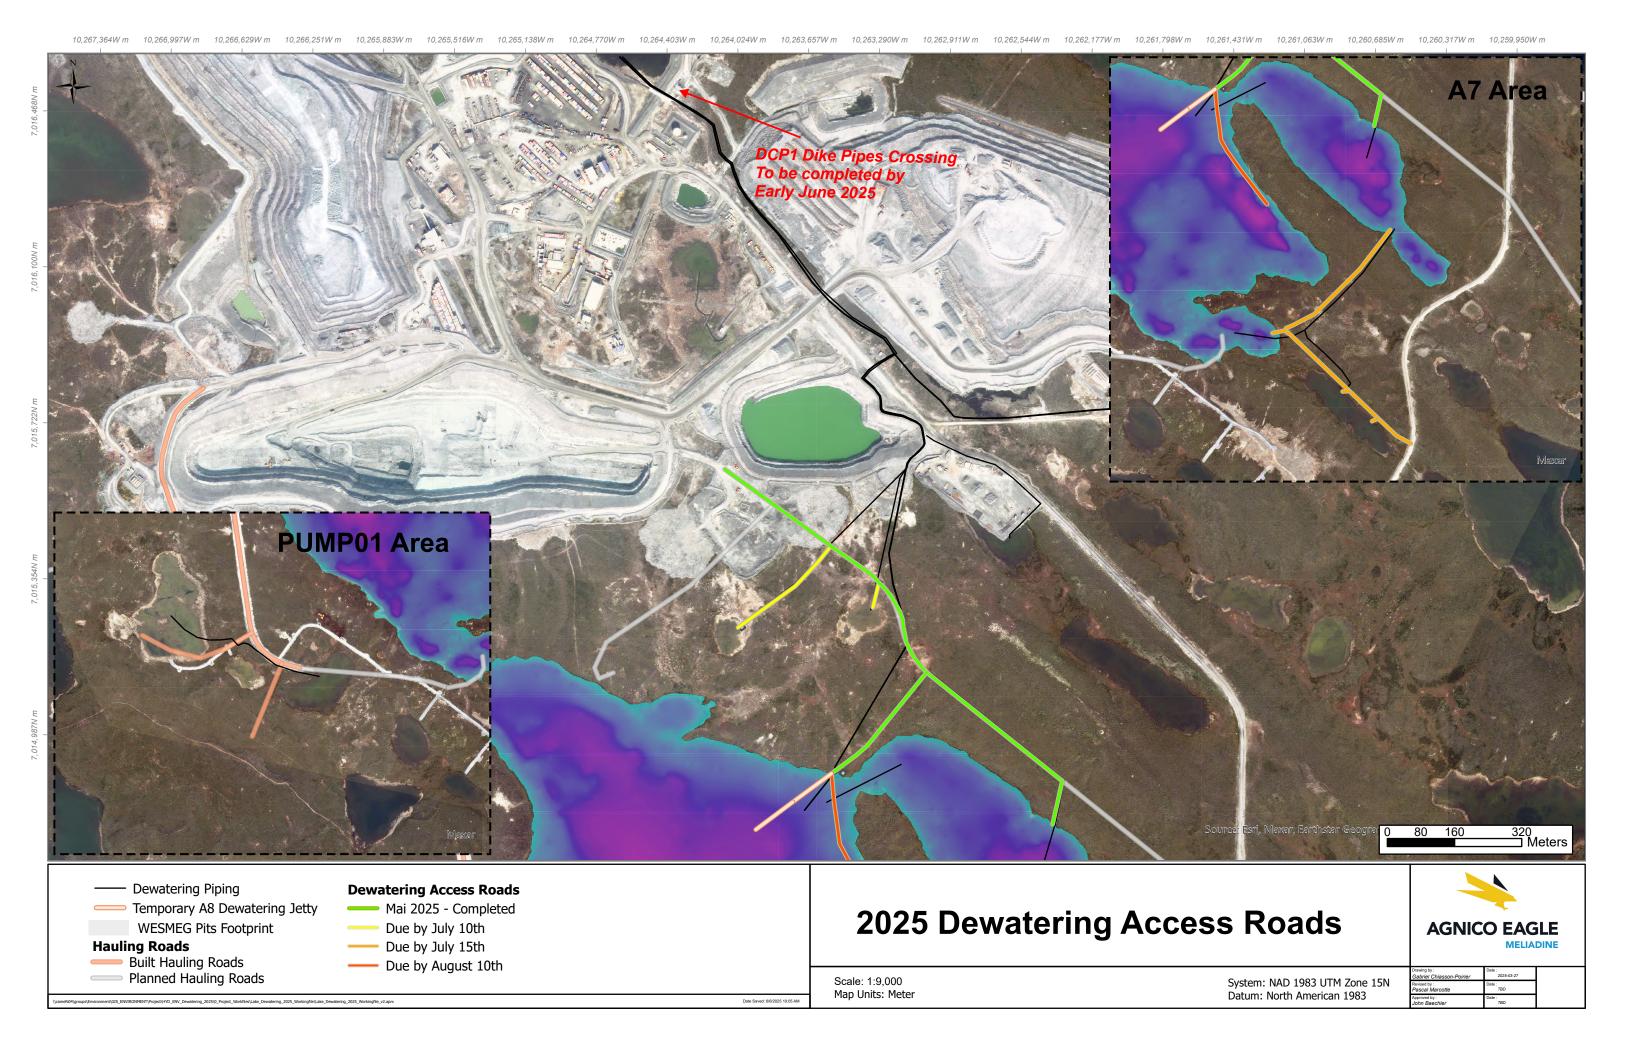
**Appendix 3: 2025 Dewatering Access Road**

of the tundra these access roads are following the exact same path as the final haul roads that are planned to be built in winter 2026 in the area. The paths of the access roads and planned haul road are shown on the 2025 Dewatering Access Roads Layout provided in Appendix 3.
