Rail Alignment Watercourse Crossing Assessments

Crossing ID: 1

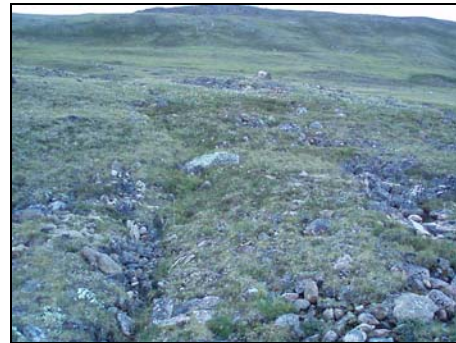
Figure 1: View upstream of crossing 1A

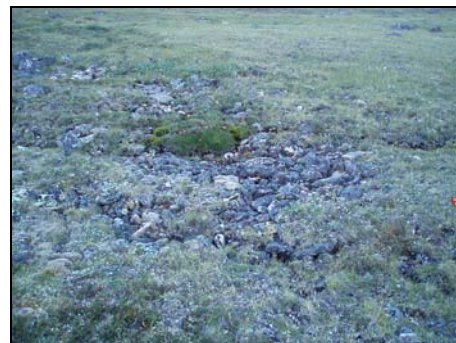
Figure 2: View across crossing 1A from left bank

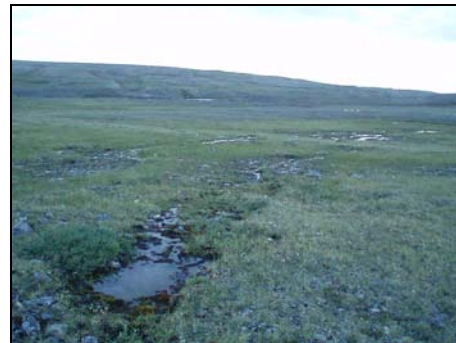
Figure 3: View downstream of crossing 1A

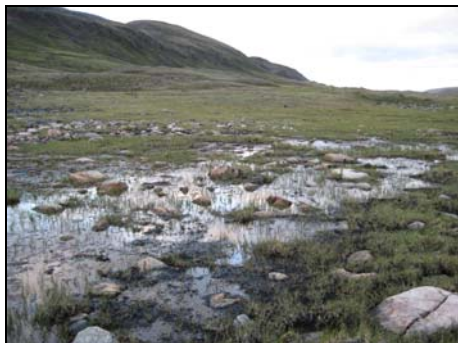
Figure 2: View across crossing 2 from right bank

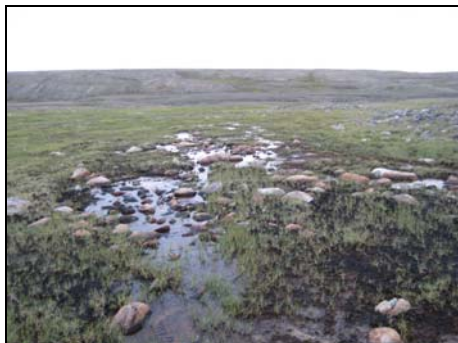
Figure 3: View downstream of crossing 2

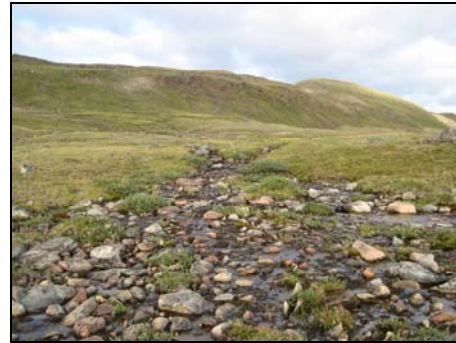
Figure 1: View upstream of crossing 3

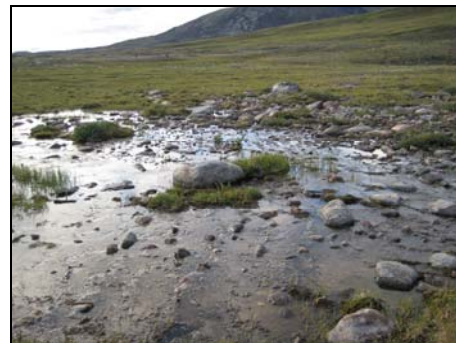
Figure 2: View across crossing 3 from right bank

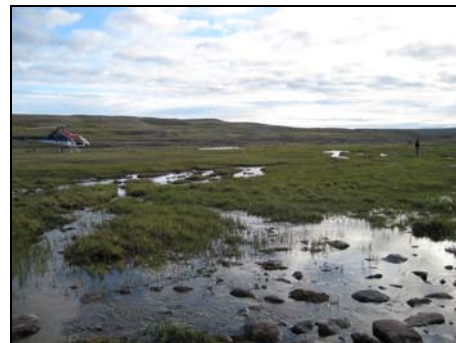
Figure 3: View downstream of crossing 3

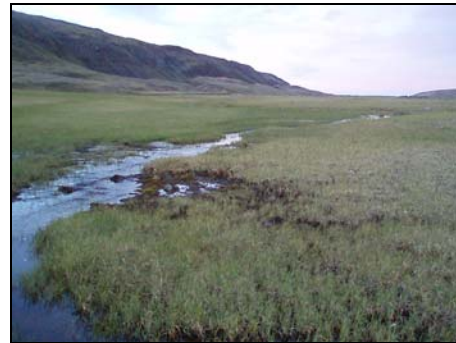
Figure 1: View upstream of crossing 5

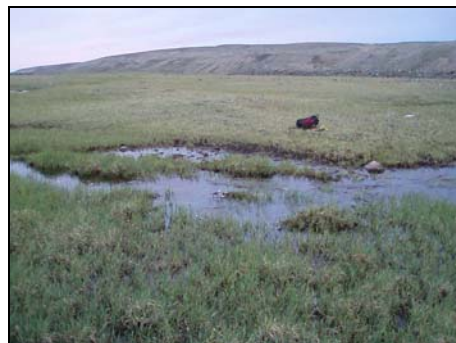
Figure 2: View across crossing 5 from right bank

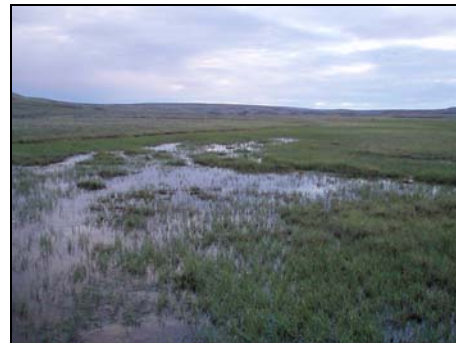
Figure 3: View downstream of crossing 5

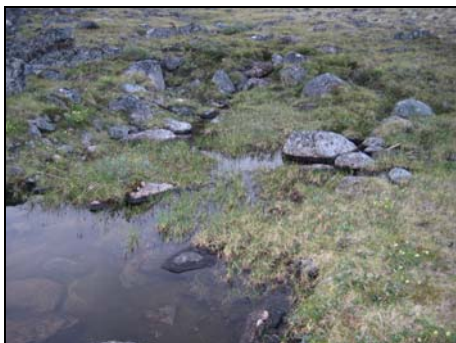
Figure 1: View upstream of crossing 6

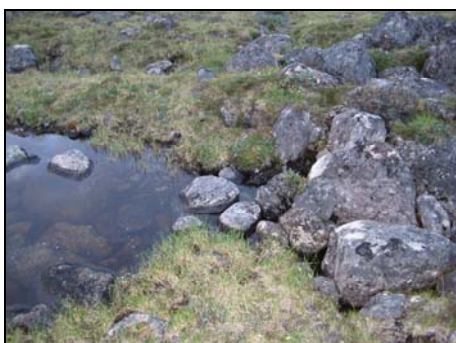
Figure 2: View across crossing 6 from left bank

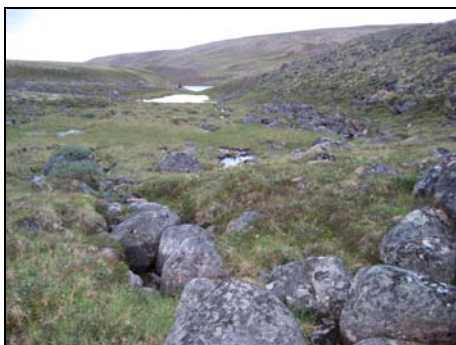
Figure 3: View downstream of crossing 6

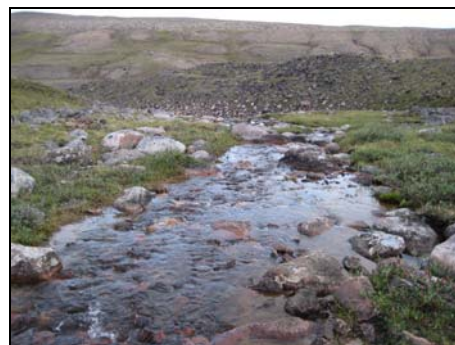
Figure 3: View downstream of crossing 6A

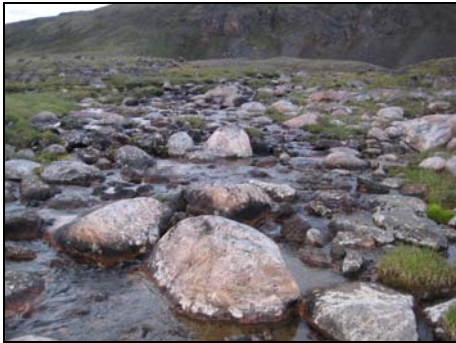
Figure 1: View downstream of crossing 7, looking upstream

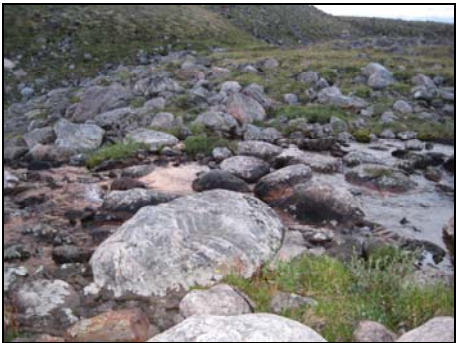
Figure 2: View downstream of crossing 7, across from right bank

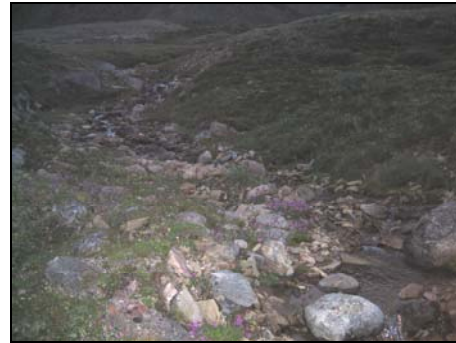
Figure 1: View upstream of crossing 8

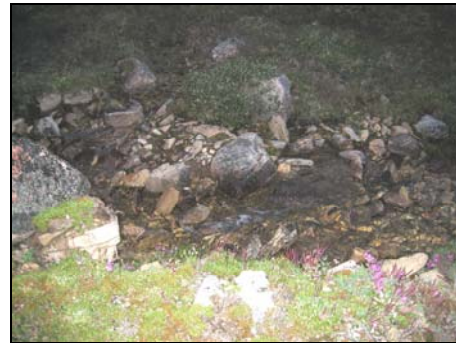
Figure 2: View across crossing 8 from left bank

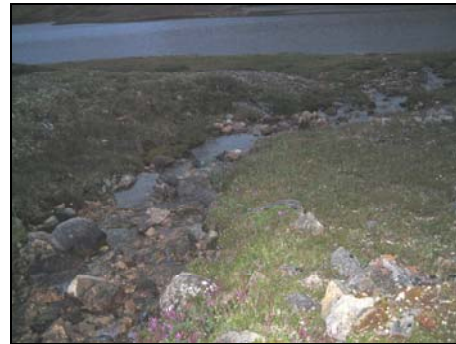
Figure 3: View downstream of crossing 8

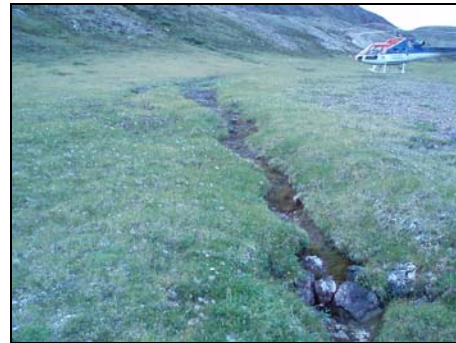
Figure 1: View upstream of crossing 10

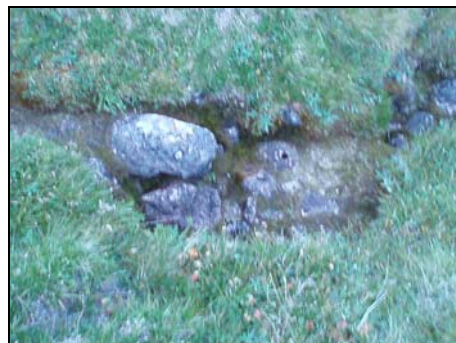
Figure 2: View across crossing 10 from left bank

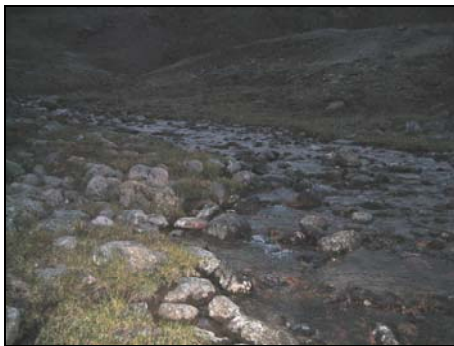
Figure 3: View downstream of crossing 11

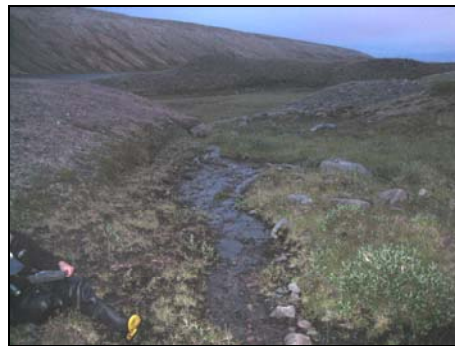
Figure 3: View downstream of crossing 12

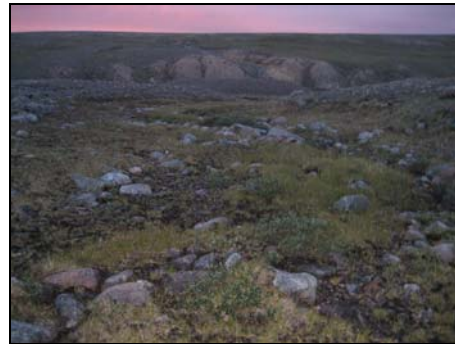
Figure 3: View downstream of crossing 14

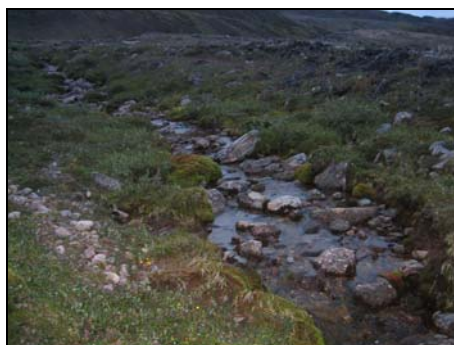
Figure 1: View upstream of crossing 16

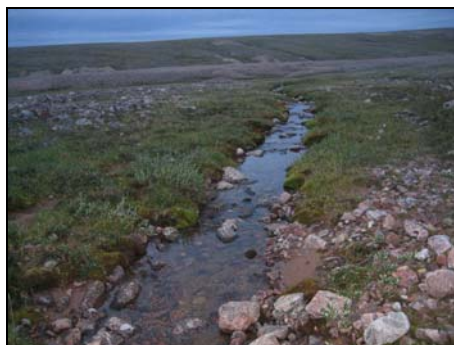
Figure 3: View downstream of crossing 16

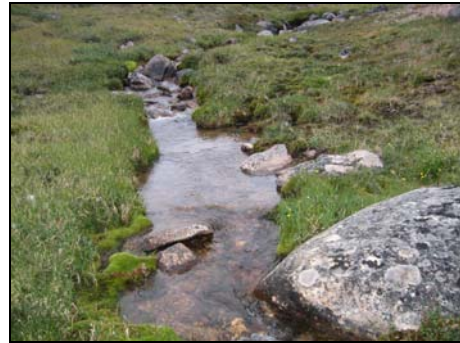
Figure 1: View upstream of crossing 21

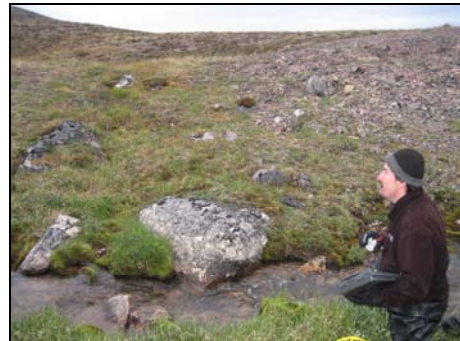
Figure 2: View across crossing 21 from left bank

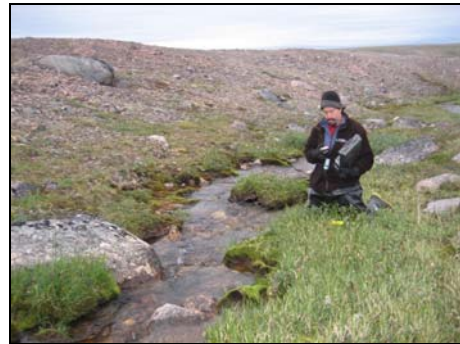
Figure 3: View downstream of crossing 21

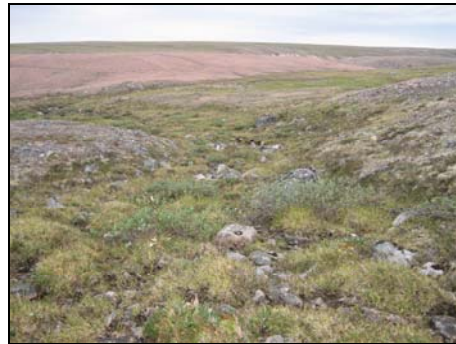
Figure 3: View downstream of crossing 22A

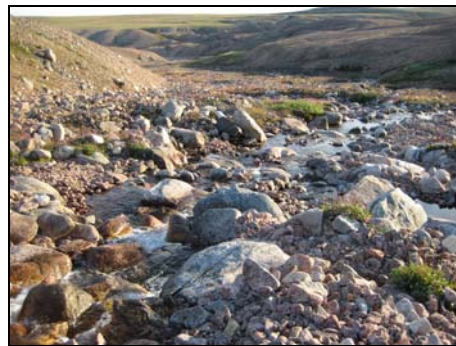
Figure 3: View downstream of crossing 24

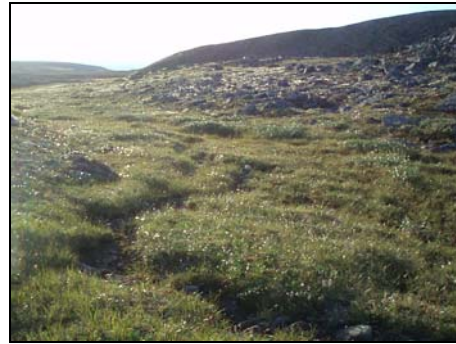
Figure 3: View downstream of crossing 26

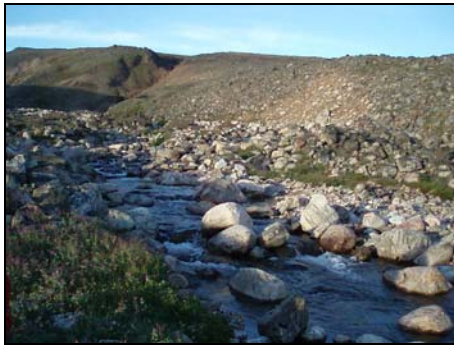
Figure 1: View upstream of crossing 27

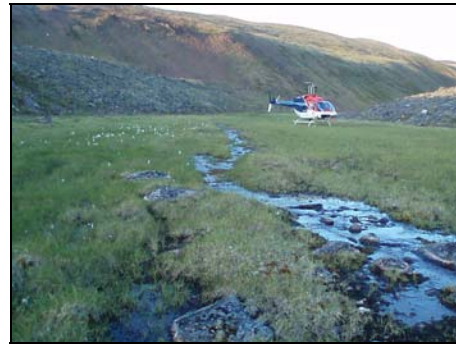
Figure 1: View upstream of crossing 28

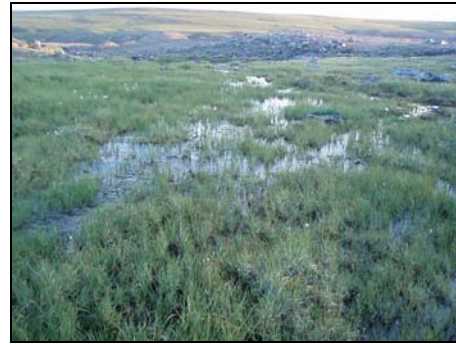
Figure 3: View downstream of crossing 28

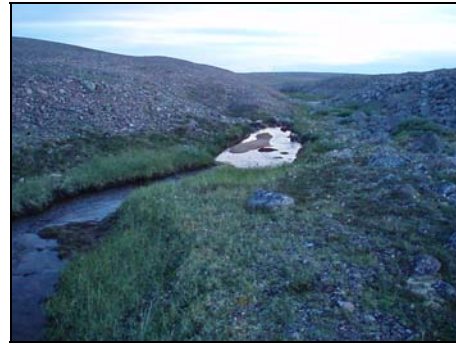
Figure 3: View downstream of crossing 31

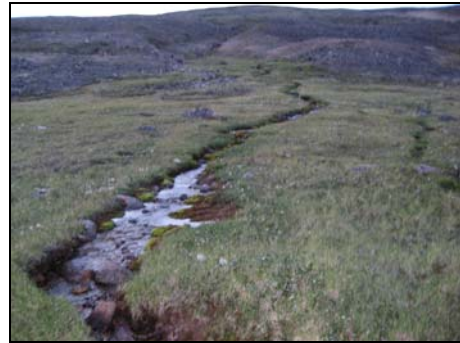
Figure 1: View upstream of crossing 33

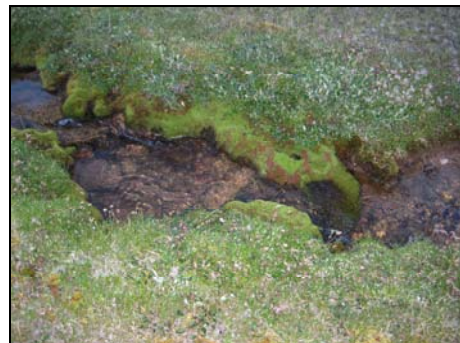
Figure 2: View across crossing 33 from left bank

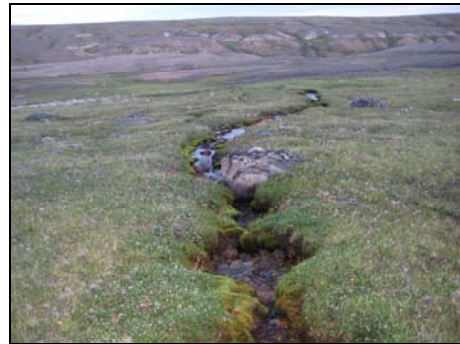
Figure 3: View downstream of crossing 33

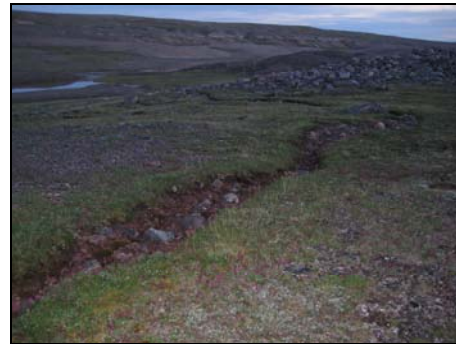
Figure 3: View downstream of crossing 36

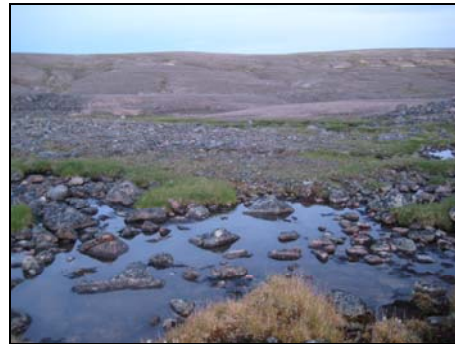
Figure 3: View downstream of crossing 40

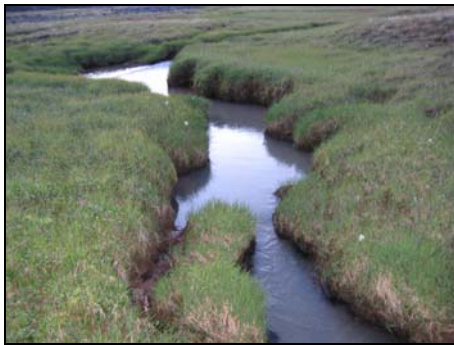
Figure 1: View upstream of crossing 43

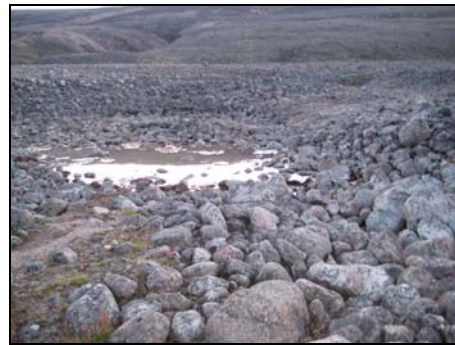
Figure 1: View upstream of crossing 44

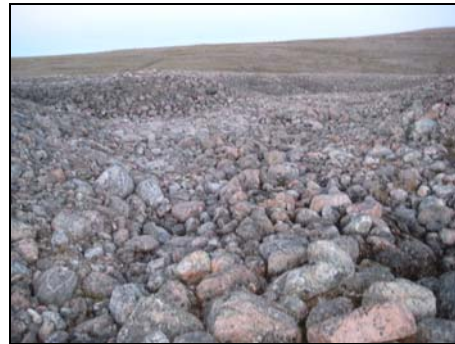
Figure 3: View downstream of crossing 44

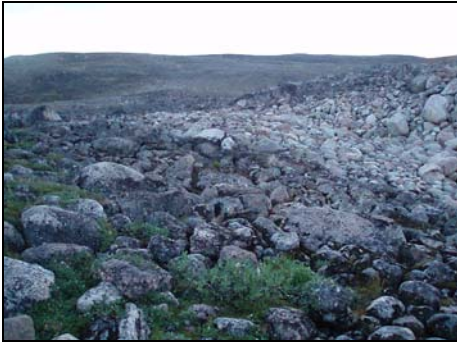
Figure 1: View upstream of crossing 47

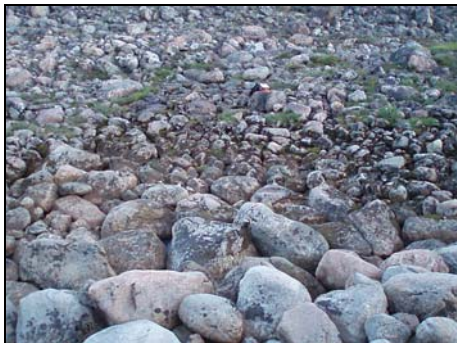
Figure 2: View across crossing 47 from right bank

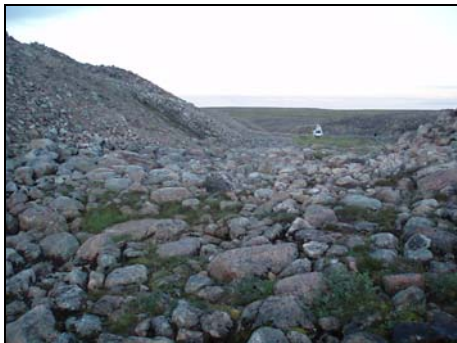
Figure 3: View downstream of crossing 47

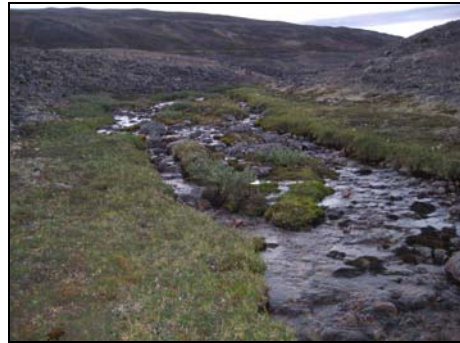
Figure 1: View upstream of crossing 48

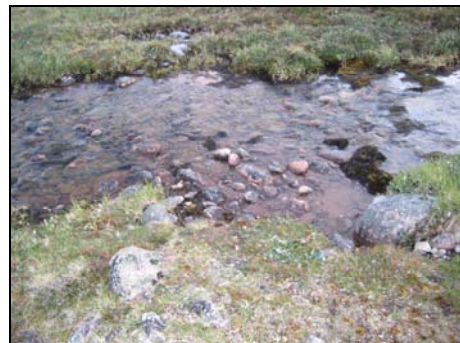
Figure 2: View across crossing 48 from right bank

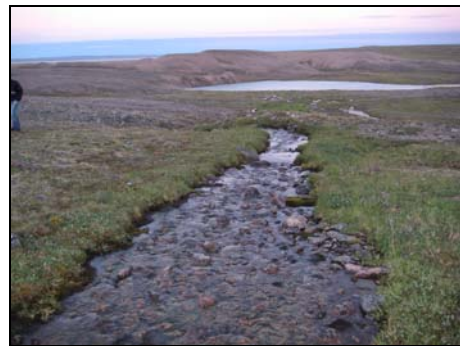
Figure 3: View downstream of crossing 48

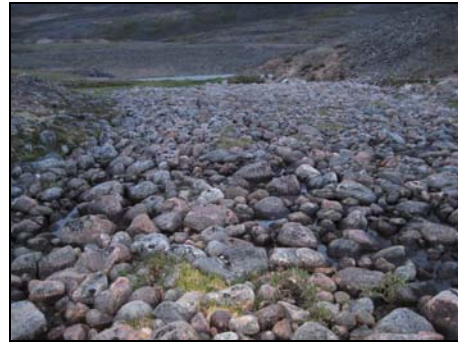
Figure 1: View upstream of crossing 58

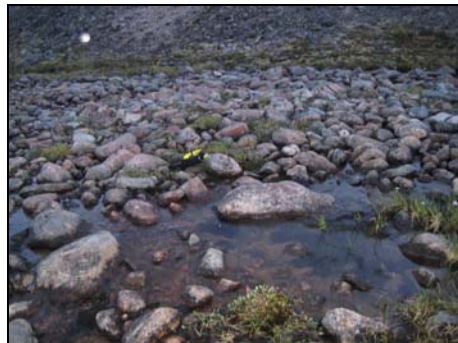
Figure 2: View across crossing 58 from right bank

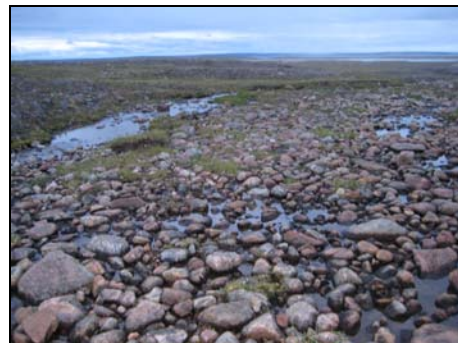
Figure 3: View downstream of crossing 58

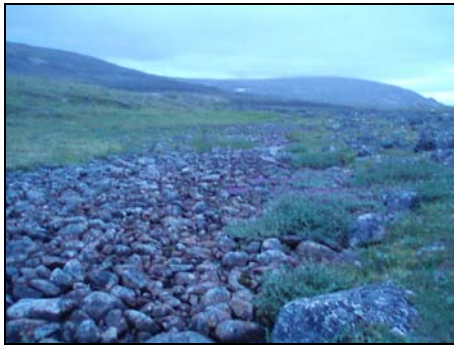
Figure 1: View upstream of crossing 63

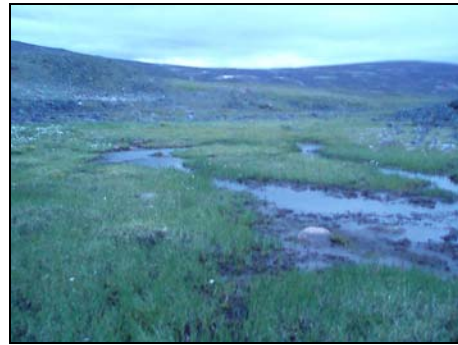
Figure 1: View upstream of crossing 64

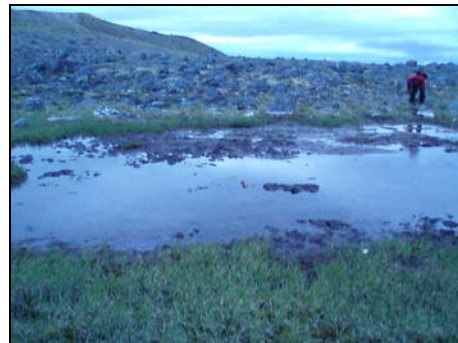
Figure 2: View across crossing 64 from left bank

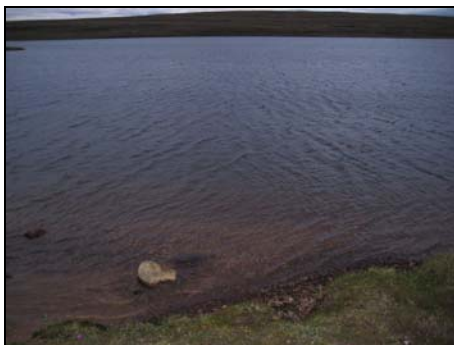
Figure 2: View downstream of crossing 78

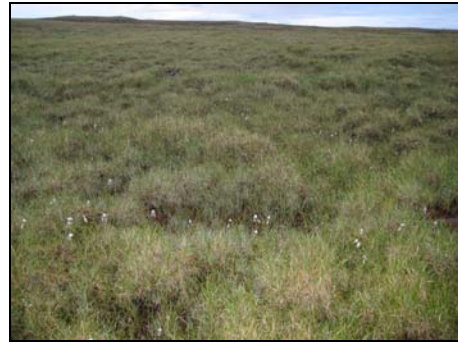
Figure 1: View upstream of crossing 89

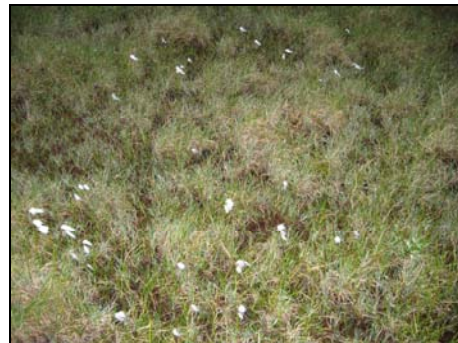
Figure 2: View across crossing 89 from left bank

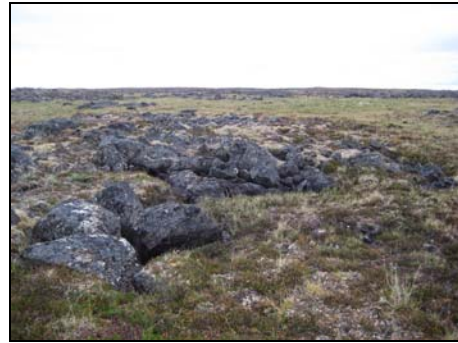
Figure 1: View upstream of crossing 96

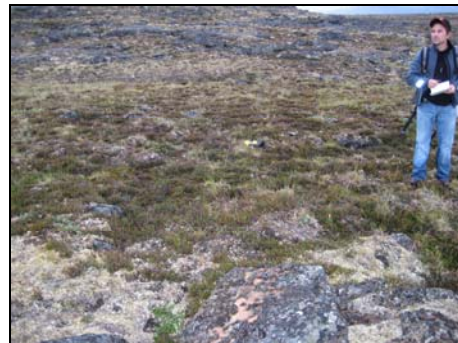
Figure 2: View across crossing 96 from right bank
