Rail Alignment Watercourse Crossing Assessments

Crossing ID: 106**UTM:** 17W 599076 / 7875790**Latitude / Longitude:** 70°57'56.289" N / 78°16'38.296" W**Date / Time Surveyed:** 11-Aug-07 / 23:10

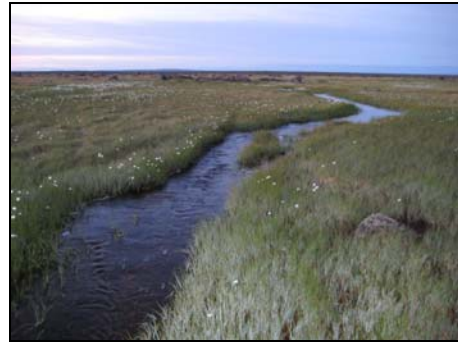
Figure 1: View upstream of crossing 112

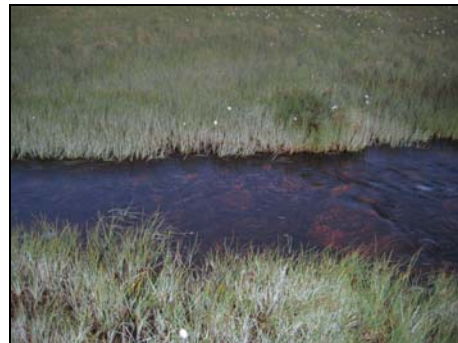
Figure 2: View across crossing 112 from left bank

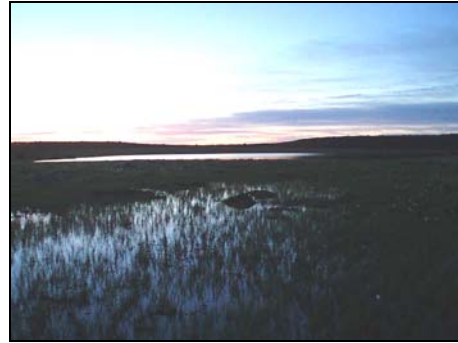
Figure 1: View upstream of crossing 118

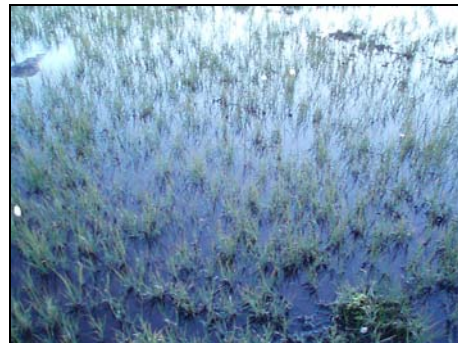
Figure 2: View across crossing 118 from right bank

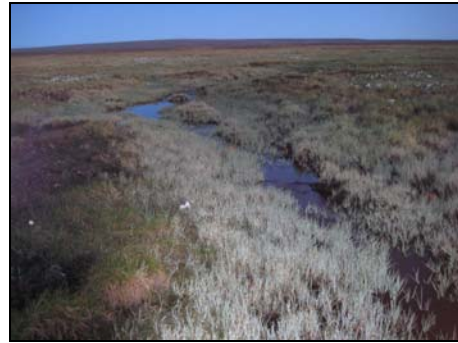
Figure 1: View upstream of crossing 120

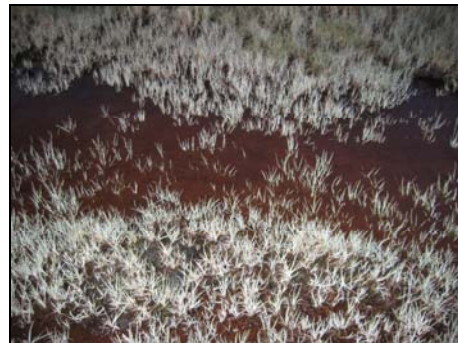
Figure 2: View across crossing 120 from right bank

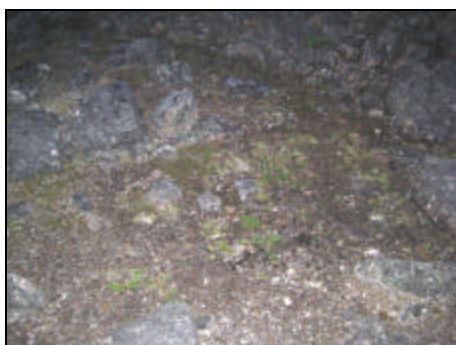
Figure 2: View across crossing 152 from left bank

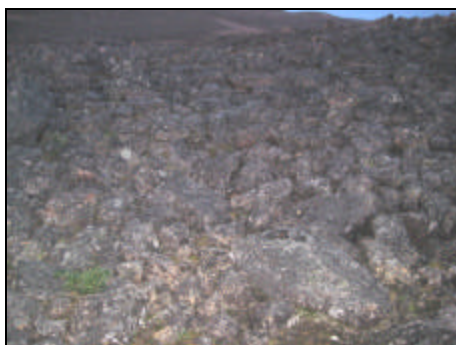
Figure 3: View downstream of crossing 152

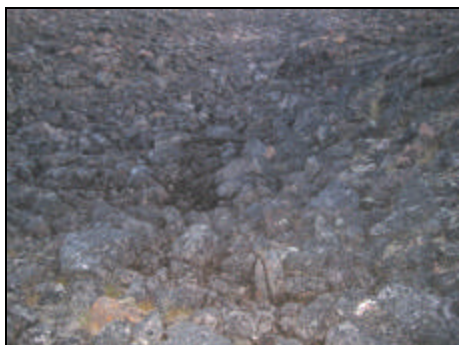
Figure 1: View upstream of crossing 156

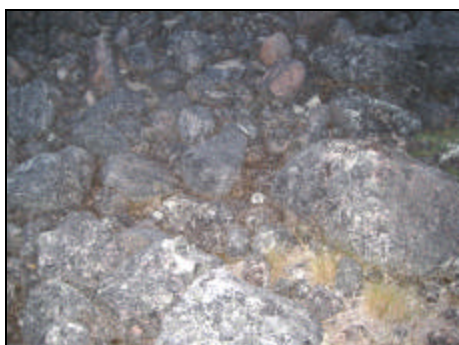
Figure 2: View across crossing 156 from left bank

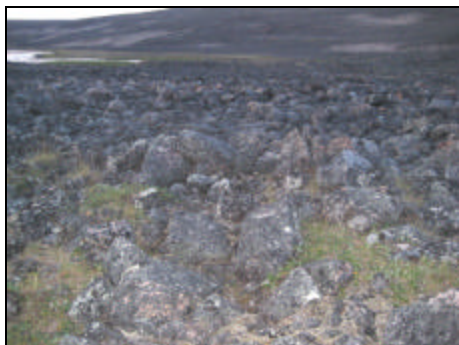
Figure 3: View downstream of crossing 156

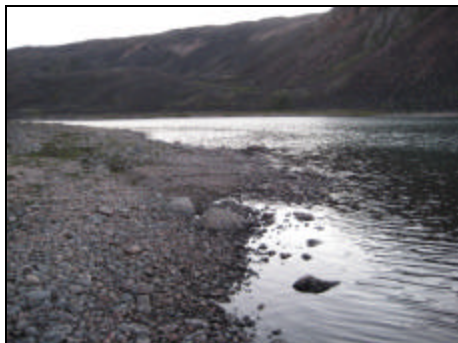
Figure 1: View upstream of crossing 164

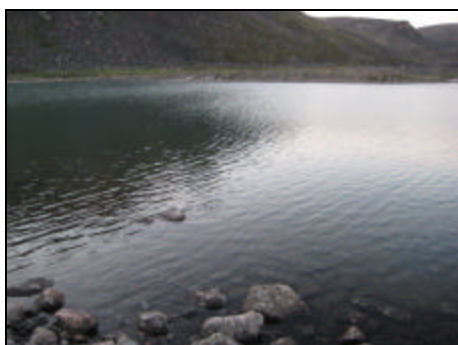
Figure 2: View across crossing 164 from left bank

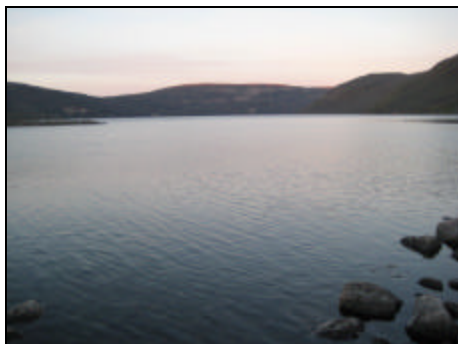
Figure 3: View downstream of crossing 164

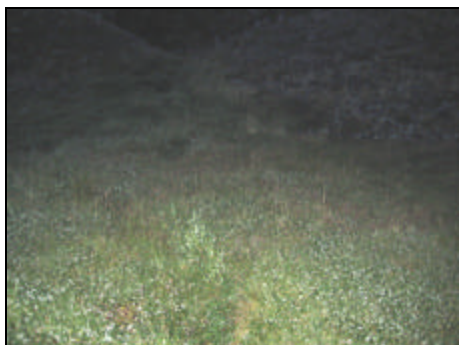
Figure 1: View upstream of crossing 198

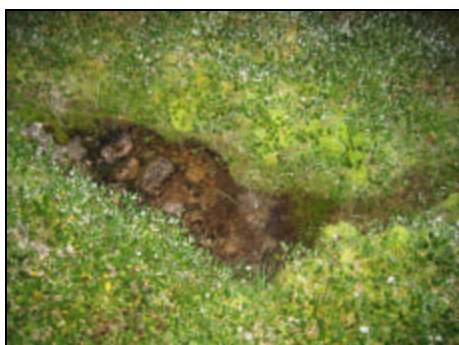
Figure 2: View across crossing 198 from left bank

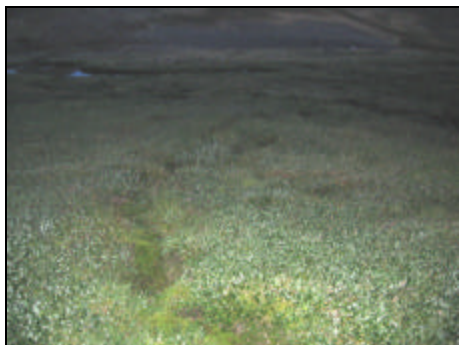
Figure 3: View downstream of crossing 198

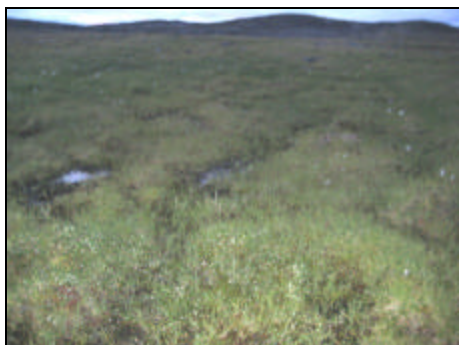
Figure 1: View upstream of crossing 212

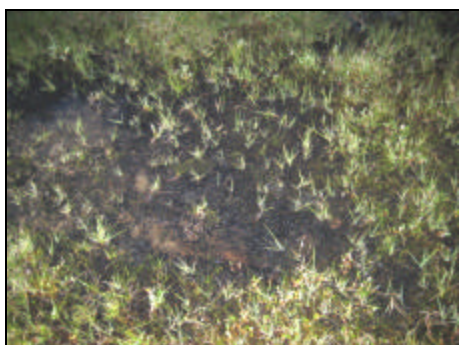
Figure 2: View across crossing 212 from right bank

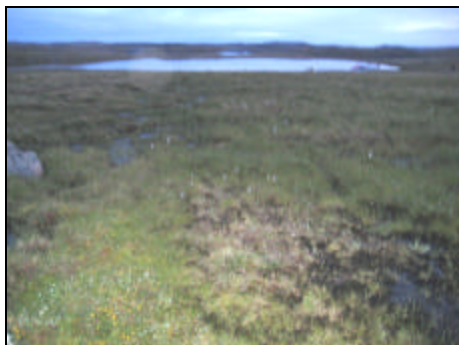
Figure 3: View downstream of crossing 212
