BAFFINLAND IRON MINES CORPORATION

MARY RIVER PROJECT

**APPENDIX 4. DETAILED HABITAT ASSESSMENTS AND SUMMARY OF RESULTS FOR RAILWAY AND TOTE ROAD REALIGNMENT STREAM CROSSINGS**

## Phase 2 Milne Rail Corridor Aquatic Habitat Assessment

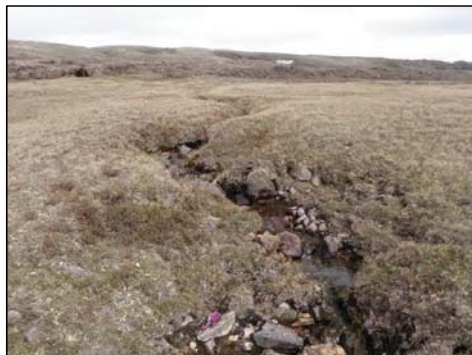
This small stream maintains flows throughout the open-water period, but there is a very steep gradient and vertical barriers between the rail crossing and Phillips Creek downstream. Fish have never been captured or observed in this stream during annual Tote Road monitoring and there is no fish habitat use in the vicinity of the rail crossing.

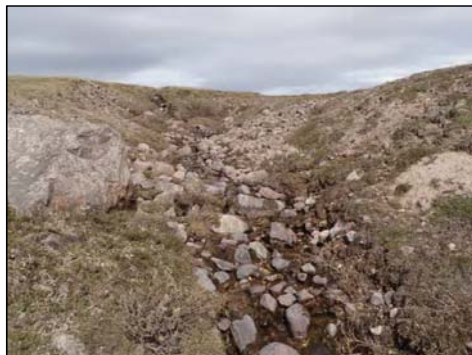
This small stream maintains flows throughout the open-water period, but there is a very steep gradient and vertical barriers between the rail crossing and Phillips Creek downstream. Fish have never been captured or observed in this stream during annual Tote Road monitoring and there is no fish habitat use in the vicinity of the rail crossing.

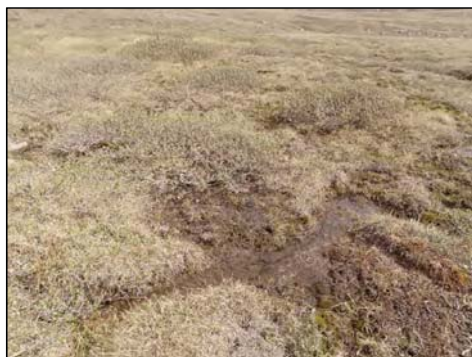
This site was moist throughout the open-water period in 2018, but there is a very steep gradient and permanent vertical barriers between the rail crossing and Phillips Creek downstream. Fish have never been captured or observed in this stream during annual Tote Road monitoring and there is no fish habitat use in the vicinity of the rail crossing.

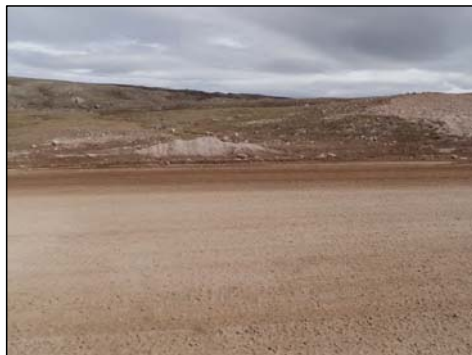
This shallow rail crossing is immediately upstream of the Tote Road. There are permanent vertical barriers between the rail crossing and Phillips Creek downstream. Fish have never been captured or observed in this stream during annual Tote Road monitoring and there is no fish habitat use in the vicinity of the rail crossing.

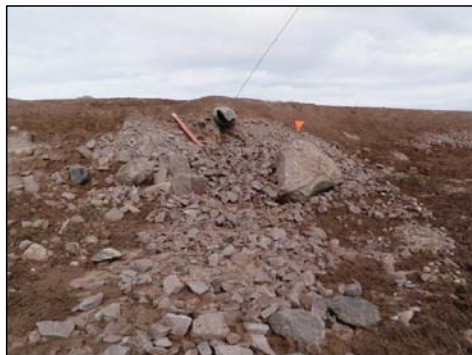
This was a dry, pile of rocks on a steep hillside downstream of the Tote Road in summer and barely wetted during fall 2018. The soft gradient barrier and consistent lack of sufficient water (as noted during previous Tote Road surveys) prevent fish access to the crossing. There is never aquatic habitat at this crossing.

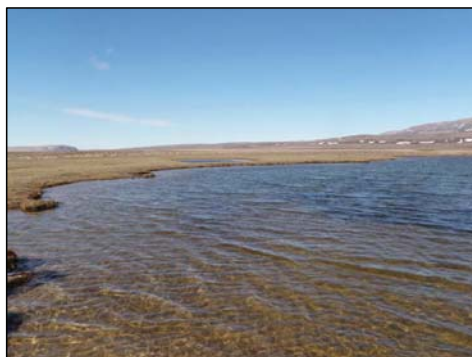
This pond was fished in 2017 and no fish were captured or observed. It is too shallow for overwintering and is unconnected to CV-15-5 upstream due to a permanent vertical barrier at the confluence. There is no fish habitat at this crossing.

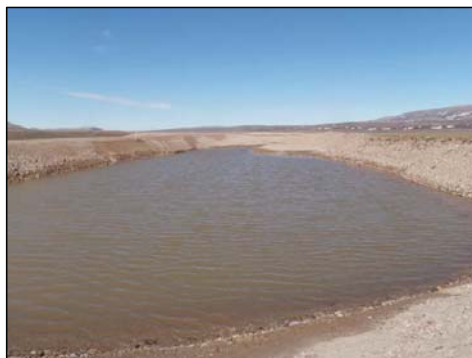
This is a small, shallow, isolated pond beside the Tote Road. Fish were not observed and overwintering is not possible. There is no fish habitat at this crossing.

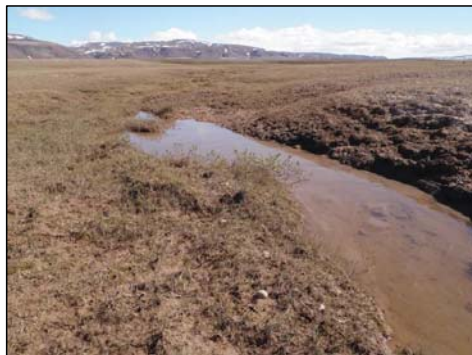
This site is an area of shallow ponding on the upstream side of the Tote Road. There is a steep gradient and no channel downstream of the road, creating a barrier under all flow conditions. There is no fish habitat at this crossing.

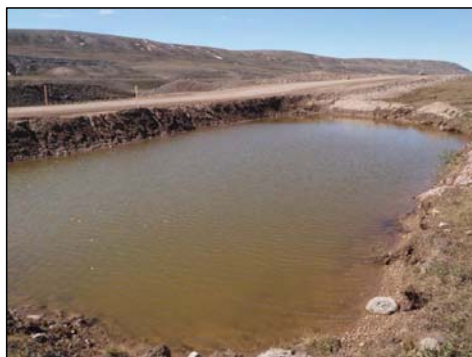
This is a shallow, isolated pond upstream of the Tote Road. Fish were not observed. It does not provide overwintering habitat and there are no connections to other fish-bearing waterbodies. There is no fish habitat at this crossing.
