Phase 2 Milne Rail Corridor Aquatic Habitat Assessment

Crossing ID: CV-54-2

**Baffinland Iron Mines
Mary River Project**

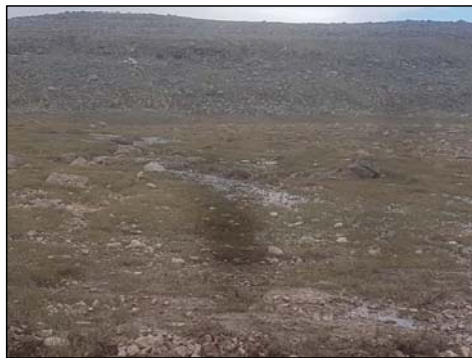
This site was nearly dry in 2018 with multiple soft barriers to fish movement and no connectivity with overwintering habitat under any flow condition. There is never fish habitat at this crossing.

Figure 1. Views of CV-54-2 at the rail crossing during summer (A) and fall (B).

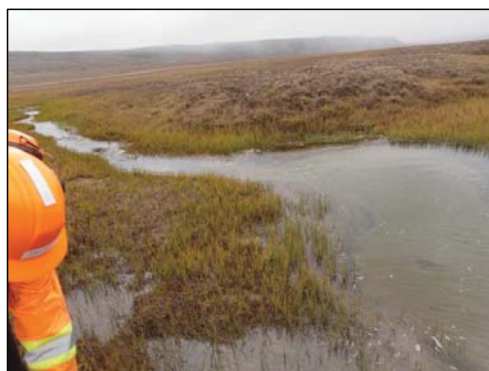
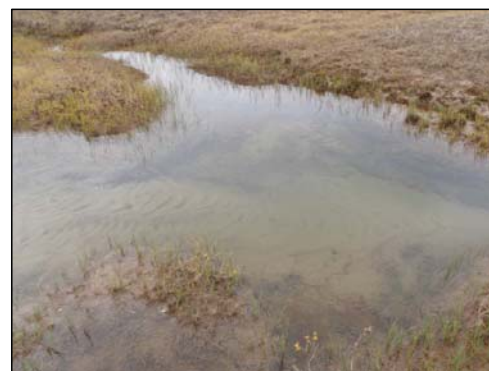
Figure 1. Summer (top) and fall (bottom) views of CV-55-3 at the 100 m downstream cross-section; (A) looking upstream; (B) looking downstream; and (C) looking across.

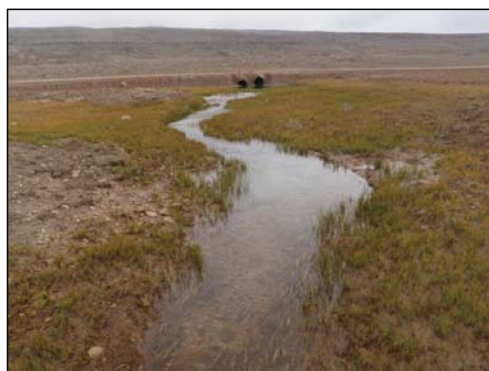
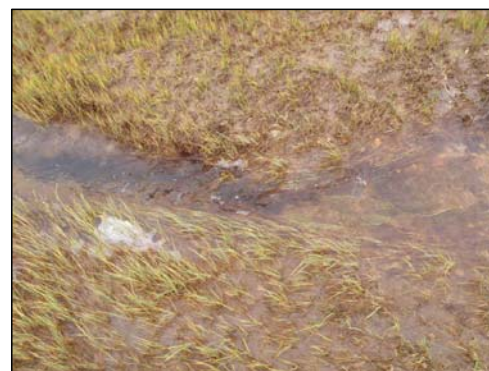
Figure 2. Summer (top) and fall (bottom) views of CV-55-3 at the 80 m downstream cross-section; (A) looking upstream; (B) looking downstream; and (C) looking across.

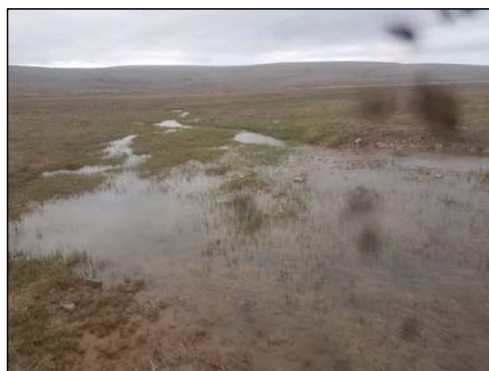
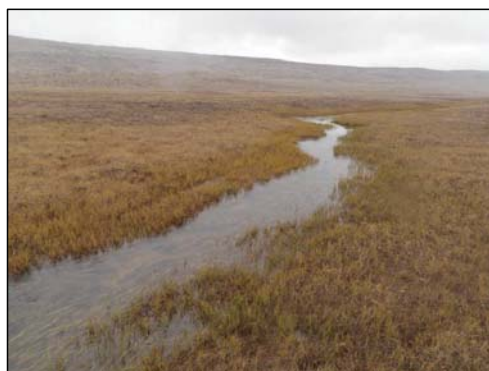
This rail crossing is immediately upstream of the Tote Road crossing at CV-060. In addition, there are two proposed road diversion crossings CV-060-1 and CV-060-2. CV-60-1 is approximately 100 m downstream of the existing road crossing, while CV-60-2 is approximately 160 m upstream of the existing road crossing. Habitat data from those two assessments complement the data found here. This stream is important rearing habitat for juvenile char throughout the open water season, but particularly during summer.

Figure 6. Summer (top) and fall (bottom) views of CV-55-3 at the rail crossing; (A) looking upstream; (B) looking downstream; and (C) looking across.

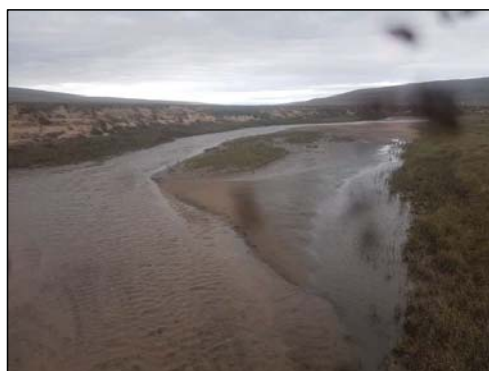
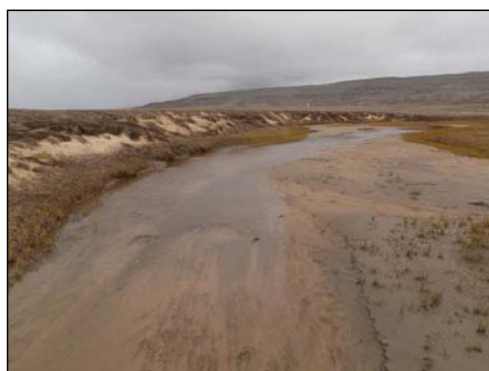
Figure 1. Summer (top) and fall (bottom) views of CV-56-1 at the 100 m downstream cross-section; (A) looking upstream; (B) looking downstream; and (C) looking across.

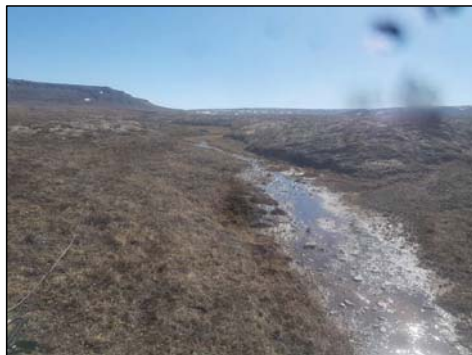
This stream was shallow (1 cm maximum depth) with almost no flow in 2018. In addition, there is a soft barrier downstream (lack of surface flow and no channel) preventing access from a possible overwintering lake. The barrier may be sufficient to prevent access to the rail crossing under all flow conditions.

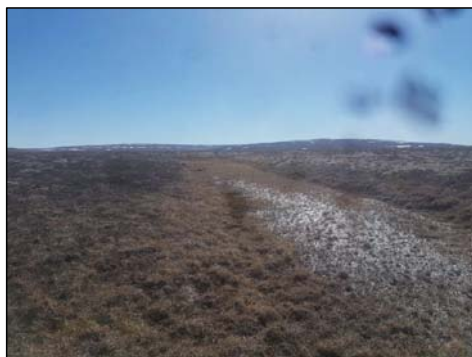
This stream was nearly dry at the rail crossing in both June and August and no fish were observed. In addition, there were several downstream locations where there was no surface water or the channel disappeared and water dispersed across the tundra, creating a soft barrier to fish movements.

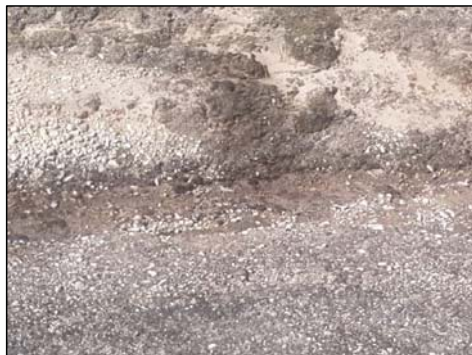
This stream was nearly dry at the rail crossing in 2018. In addition, there were several soft barriers downstream and no access from other waterbodies. There is likely no fish habitat at this site under all flow conditions.

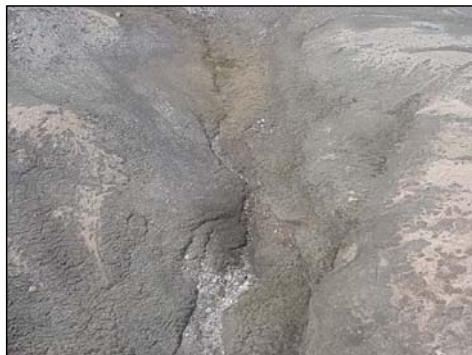
This stream was nearly dry in 2018. Lack of surface flow downstream and a steep gradient near the crossing likely combine to prevent access during all flow conditions. There is probably never fish habitat at this rail crossing.

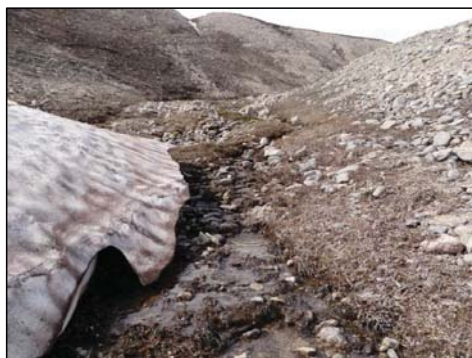
This crossing was shallow and steep (~15°) and the gradient continued to increase upstream. The nearest any char were captured or observed was 200 m downstream of the rail crossing. Starting approximately 125 m downstream the channel widens considerably and maximum depth is 1 cm. This likely represents a barrier to fish movements under most, if not all, flow conditions. Habitat downstream of the soft barrier is good quality for char. Fish use of habitat at or near the crossing is unlikely.

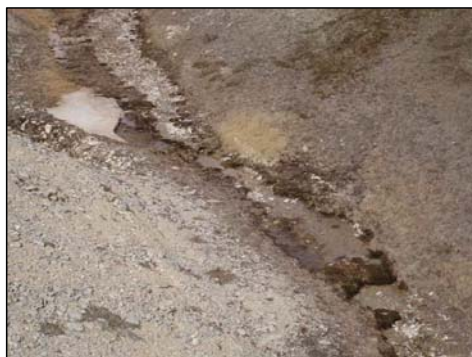
This crossing was very shallow and steep (~15°) and the gradient continued to increase upstream. Starting approximately 200 m downstream, the channel widens and flows become subsurface. This likely represents a barrier to fish movements under most, if not all, flow conditions. Fish use of habitat at or near the crossing is unlikely.

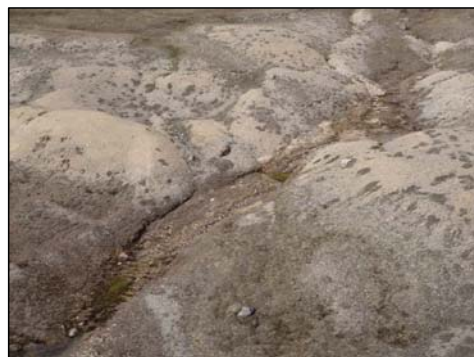
This crossing was very shallow in 2018 and steep (~15°). There are multiple gradient and subsurface flow barriers to movement downstream that likely prevent fish movements under most, if not all, flow conditions. Fish use of habitat at or near the crossing is unlikely.
